Bundesstelle für Seeunfalluntersuchung
Federal Bureau of Maritime Casualty Investigation
Federal Higher Authority subordinated to the Ministry of Transport
and Digital Infrastructure

Investigation Report 160/17

**Line accident with minor physical injury
on board the traditional ship WISSEMARA
at 1400 on 24 May 2017
in the port of Wismar**

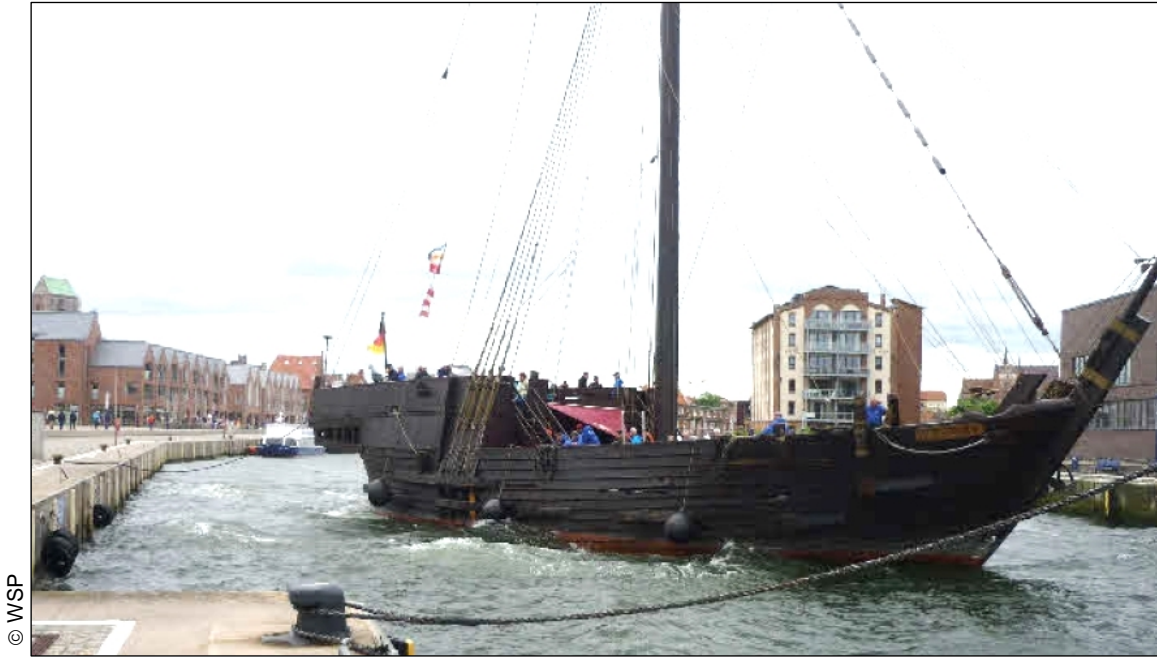
Figure 5: Berthing manoeuvre seen at the bow

A crew member who was also located there due to the berthing manoeuvre suffered minor injuries on his leg.

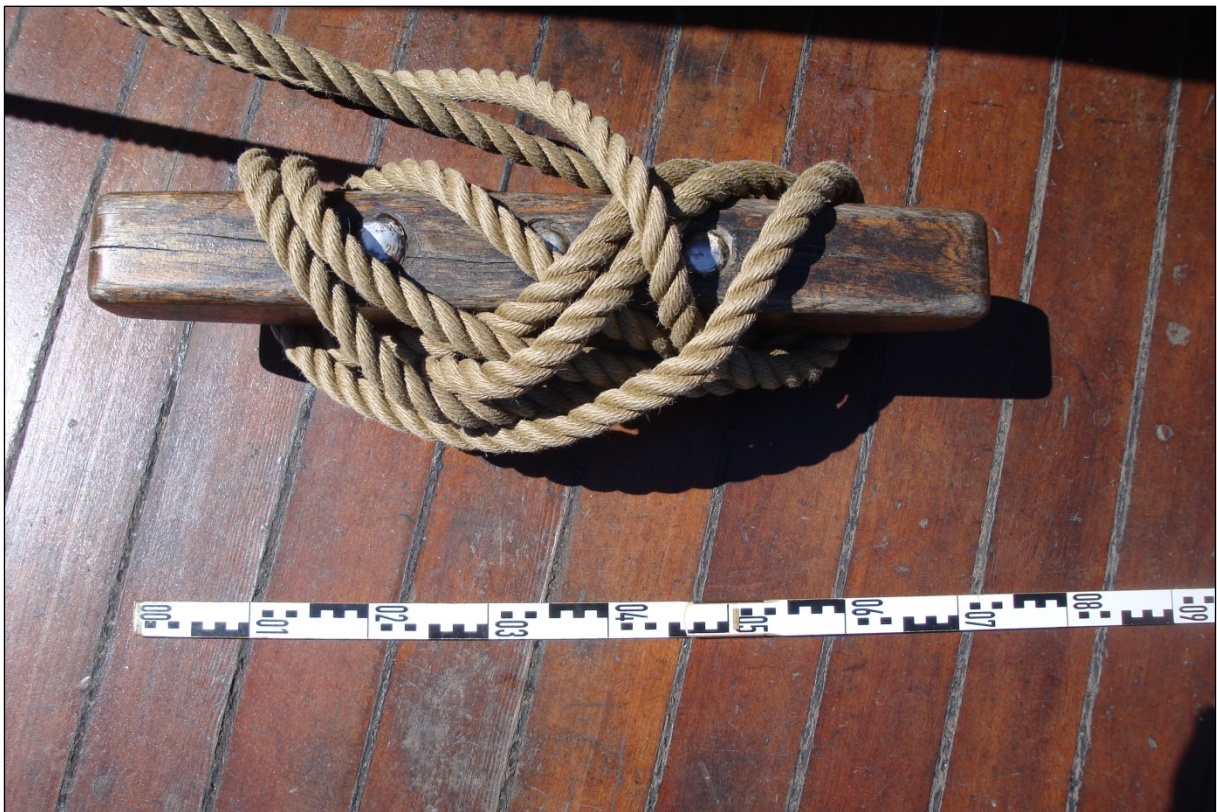
Figure 10: Example of a wooden cleat in use

A cleat is a device for fastening lines. It consists of two horns opposite one another, around which the line is alternately placed.

As a result, the rope remains fastened to the cleat due to stiction with the horns and itself. A frictional force greater than the strength of the line normally develops after 2-3 'S' turns around the cleat. The turns are finished off with a cleat hitch, which also protects against accidental loosening.
