Bundesstelle für Seeunfalluntersuchung
Federal Bureau of Maritime Casualty Investigation
Federal Higher Authority subordinated to the Ministry of Transport
and Digital Infrastructure

Investigation Report 198/15

Serious Marine Casualty

**Chemical reaction within the fertilizer load on
board the PURPLE BEACH in the
deep water roadstead on the German Bight
on 25 May 2015**

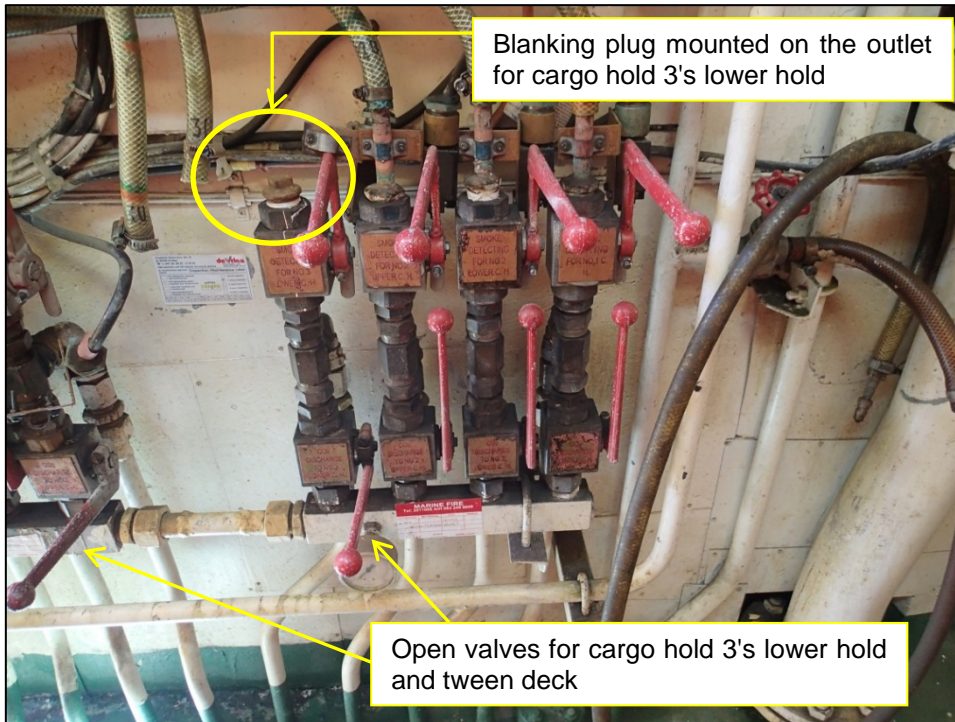
Figure 10: Valve group for the cargo holds in the CO2 room

An inspection was later made inside the superstructure, various storage rooms, the CO₂ room, engine room, and engine control room. It was found in the CO₂ room that certain connections (for the aspirating smoke detection system connecting hoses) of the cargo hold valve group were closed off with blanking plugs (Figure 10). The two closed connectors referred to cargo hold 3. According to information given by the chief engineer officer, a leak was found there when the CO₂ was discharged in cargo hold 3. This was possibly due to the fact that after the alarm was triggered by the smoke detection system, an attempt was made to determine the cause of the fire with an odour test by removing the hoses and that the system was no longer sufficiently tight subsequently. The blanking plugs did not interfere with the discharge of CO₂ into cargo hold 3.

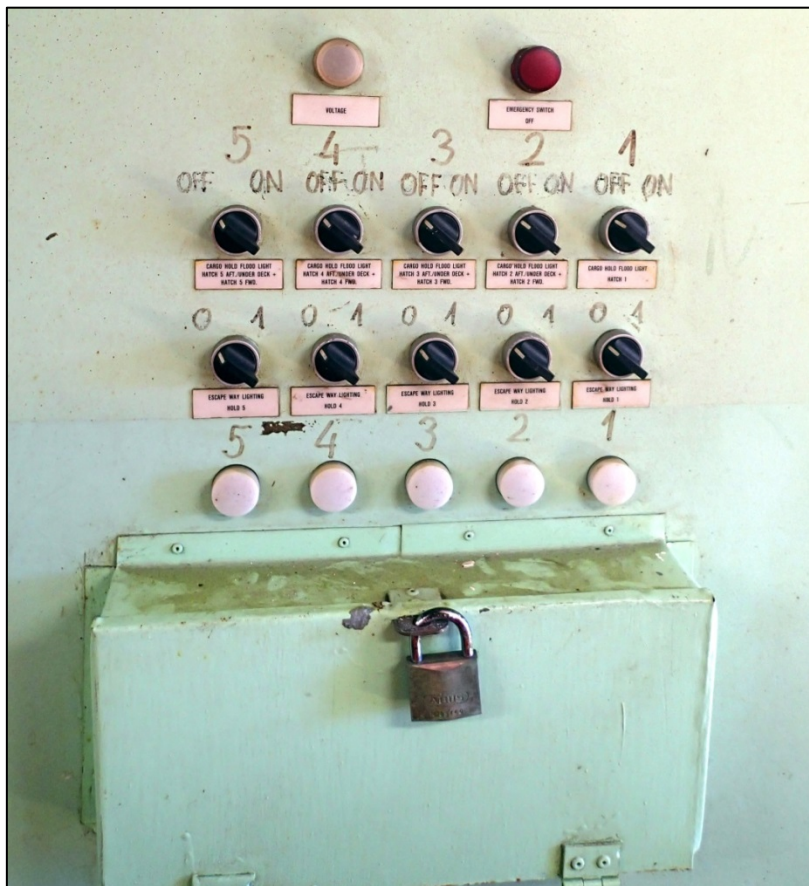
Figure 11: Switches of the switch cabinet for the cargo hold lighting

In a storage room/workshop used by the bosun in the superstructure level with the main deck, a visual inspection was made of the switch cabinet for the cargo hold lighting (Figure 11). Two readily accessible switch rows were identified. The labelling indicated that the upper switch row was intended for the lighting in the respective cargo holds. The lower switch row was used to switch on the lighting for the hold ladders for each cargo hold. All the switches were in the 'null' (or off) position. Part of the switch cabinet was closed by a cover secured with a padlock, meaning it could not be checked at this point.

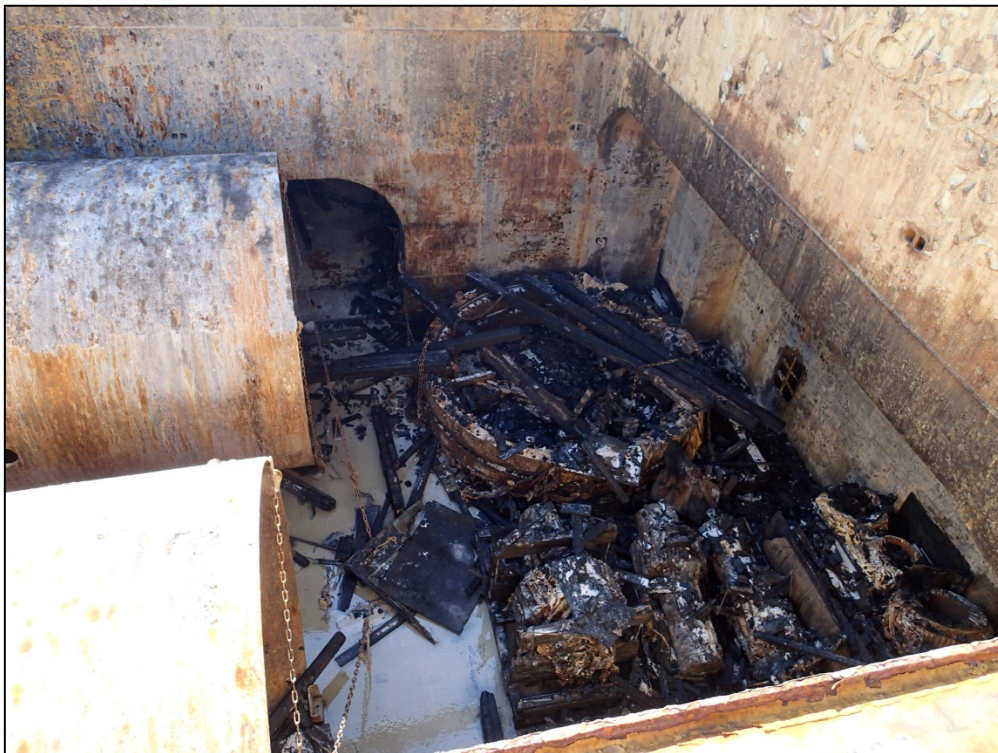
Figure 16: Cargo hold 3, tween deck, port side aft, 5 June 2015

- on the port side of cargo hold 3, large cylindrical steel structures were stowed in the aft area. They were heavily corroded due to the aggressive combustion gases and water which covered all the parts in the meantime. Other machinery parts were stowed further aft. The wood packaging that was there previously was destroyed due to exposure to temperature. A large amount of charred wooden parts and a meshed container were found in the forward area of the tween deck (Figures 14, 16, 17);
- there was no cargo in cargo hold 2's tween deck. The tween deck was completely covered with extinguishing water. Due to the fluid equalisation between cargo holds 2 and 3, the water level at the aft edge of cargo hold 2 was approximately 48 cm above the hatch covers and thus corresponded to the water level at the forward edge of cargo hold 3 (Figure 18 and 19).

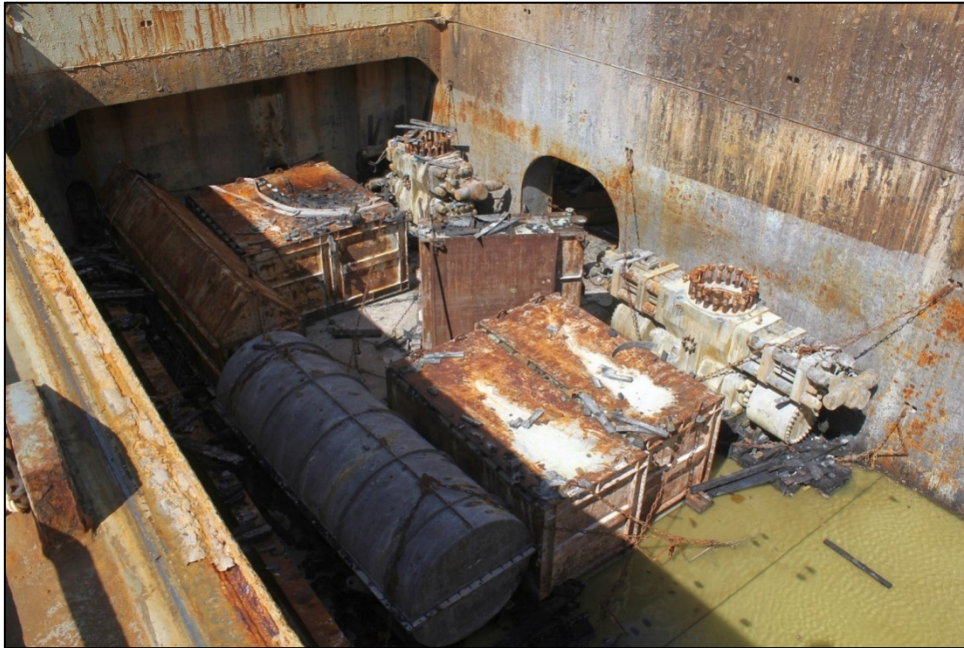
Figure 21: Cargo hold 3, tween deck, starboard side aft, 8 June 2015

On 8 June 2015, more photographs of the tween decks were taken by WSP Wilhelmshaven after the starboard side of cargo hold 3 was opened. A photo of the original condition has been inserted for comparison here, too (Figures 20 and 21).

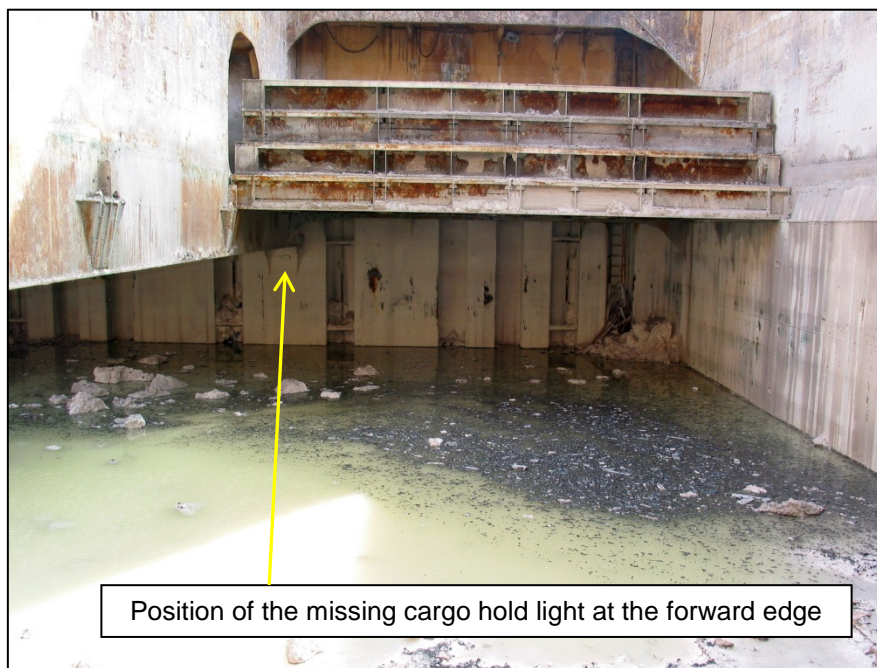
Figure 26: View into cargo hold 3's lower hold

Crew members lifted several pontoon hatch covers with the help of a loading crane to gain an overview of the situation in the lower hold. It was then possible to gain a more detailed overview with the help of a conveyor cage. It was found in the process that neither of the two cargo hold lights was still present. The level of the fertilizer found did not allow any conclusions to be drawn as to the original loading condition. Firstly, the load seemed to have collapsed due to the introduction of water; secondly, it could have floated due to the introduction of water and thus been able to reach all areas of the lower hold. In addition, the product had lost mass and volume due to the chemical reaction.

Left behind B hoses from the firefighters were noticed in the lower hold of cargo hold 3 at the forward edge on starboard side and at the aft edge port side.

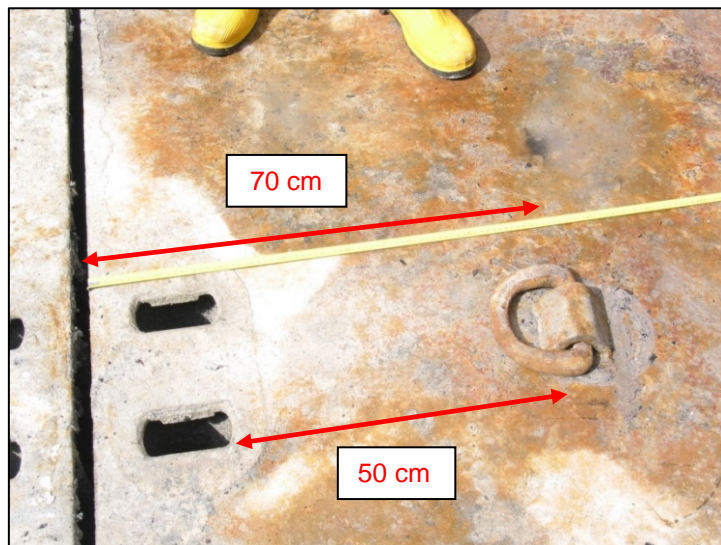
Figure 28: Top view of the aft pontoon hatch cover

The D-rings installed in cargo hold 3's tween deck were surveyed and it was found that the size of the ring was smaller on some of them. In this case, the ring's length was 10 cm instead of the 12 cm found otherwise. Two of these D-rings were mounted on the aft pontoon hatch cover. Two others were on the outer side wall in this area. The four D-rings were additionally welded on in Antwerp for securing the load in the tween deck.

Openings for attaching the crane gear for the hatch cover and D-ring

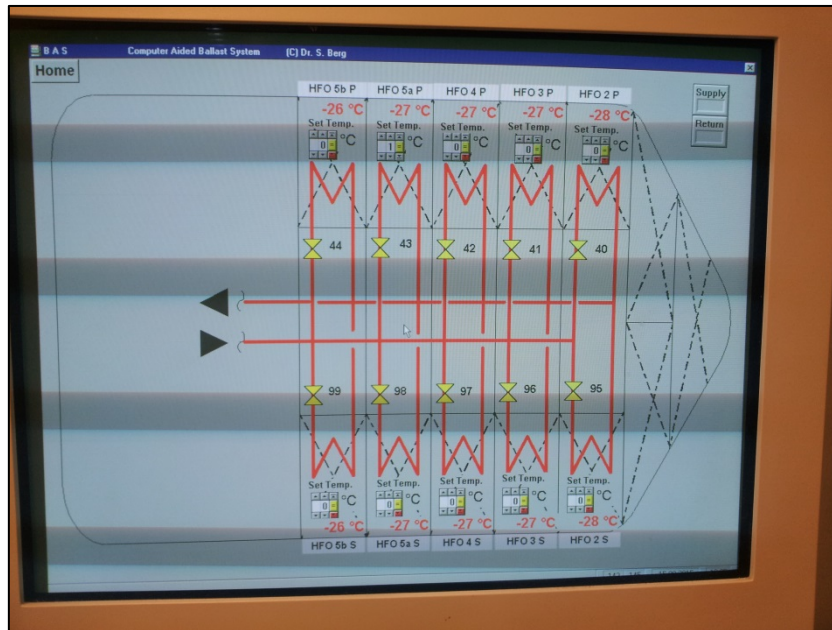
Figure 38: Computer screen display

Basically, it should be noted that there are two options for controlling the temperature. One is the option of manual control, which is independent of the pre-set or current temperature and achieved by the remote-controlled opening and closing of the corresponding valve in a remote switch cabinet in the engine room. The other option is by means of the secured computer, where the tank temperature can be set and the system controls independently. The actual and target values are displayed. The condition before the accident is unknown and was not saved by the computer. Temperatures or other data were not saved either. The situation shown in Figure 38 was found after logging in to the computer.

After consulting with a representative of the system's manufacturer, it was concluded that the figures shown after it was switched on at the BSU made no sense, as the temperatures measured cannot be in the minus range. There is no target value set for any of the tanks. This confirmed the earlier finding of 5 August 2015 that in the final operating condition the temperatures of the HFO tanks were controlled manually. During the survey of the ship on that day, the technical inspector of the ship was questioned on the temperature controls for the bunker tanks. The inspector explained that the temperature in all tanks was controlled based on experience and the return temperature of the heating medium by regulating the flow rate.

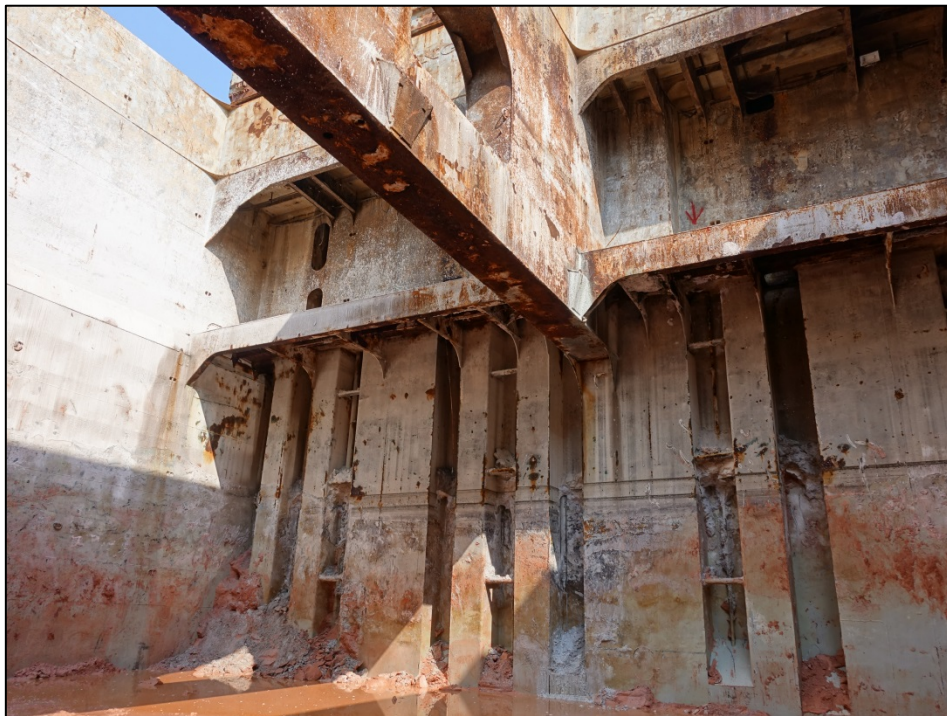
Figure 41: Aft edge of cargo hold 3, starboard side

The cargo holds were double-walled on the outside. Therefore, all the side walls were smooth in all decks. In the lower holds, the transverse bulkheads were only partially designed as a cofferdam. The transverse bulkheads had several offsets here, where hold ladders or ventilation ducts were located on the other side without a double wall being situated there (see Figure 41).

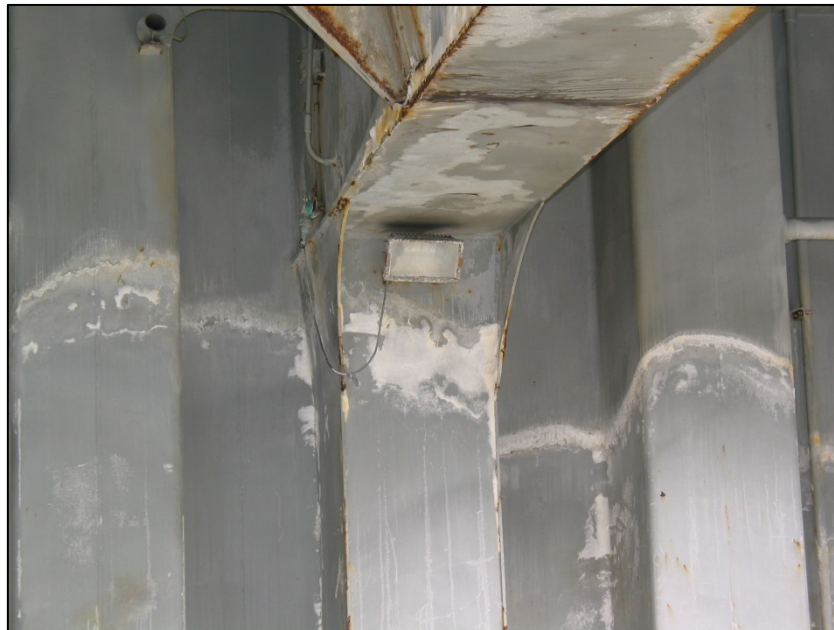
Figure 46: Cargo hold 4, lower hold, aft cargo hold light

Cargo hold 4 was then surveyed, where changes to the colour of the coating were found on the transverse bulkhead as a result of the high temperatures in cargo hold 3. Cargo hold 4 still contained remaining items of cargo at this point. Consequently, the walls were not yet cleaned, meaning the previous filling level was still easy to discern there due to the deposits. It was apparent here that the cargo had been loaded well trimmed. The majority was in the aft section and it seemed as if the aft cargo hold light was at least in the immediate vicinity of the cargo.

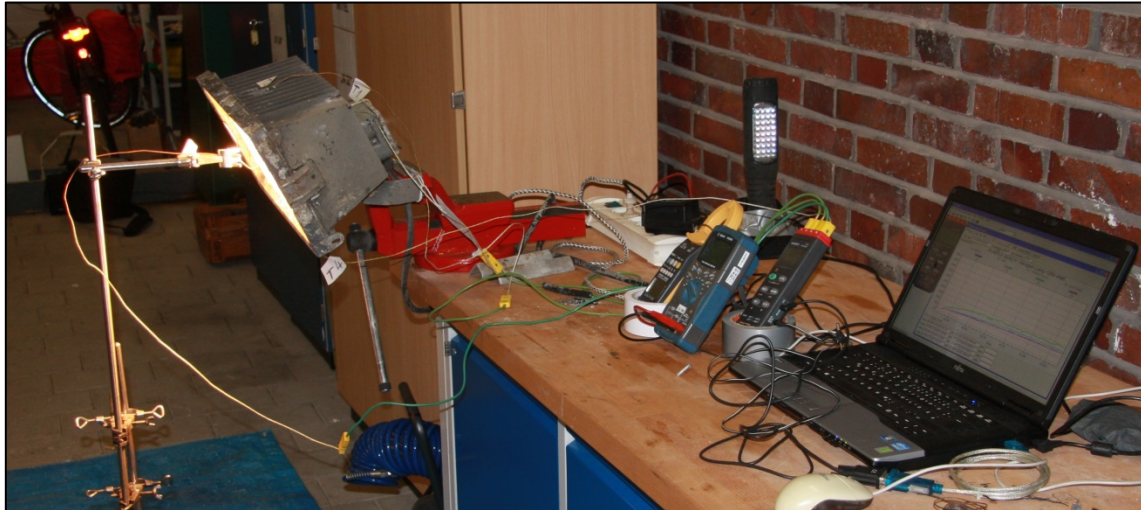
Figure 48: Measurement setup for determining the surface temperature of the cargo hold light

The second day was initially spent measuring and documenting the temperatures this light was exposed to based on the light from cargo hold 5. The light source's output was first determined to be 750 W. Four measuring points were attached to the light for temperature measurement. These were on the glass on the light emission side, on the upper side of the light housing, on its rear side and on its underside. All the measuring points were connected to a recording device for the temperature curve at the sensors.

At the front of the glass, a temperature of only 140 °C was initially measured with the tip of the measuring wire. Later, the measuring wire was attached to the glass surface using aluminium adhesive tape, where 244 °C was then reached. The temperature was then measured at 298 °C with aluminium adhesive tape covering a larger area. The temperatures at certain distances from the front of the glass were to be determined in a further test. A temperature of 74 °C was measured at a distance of 10 cm and 70 °C at a distance of 20 cm.

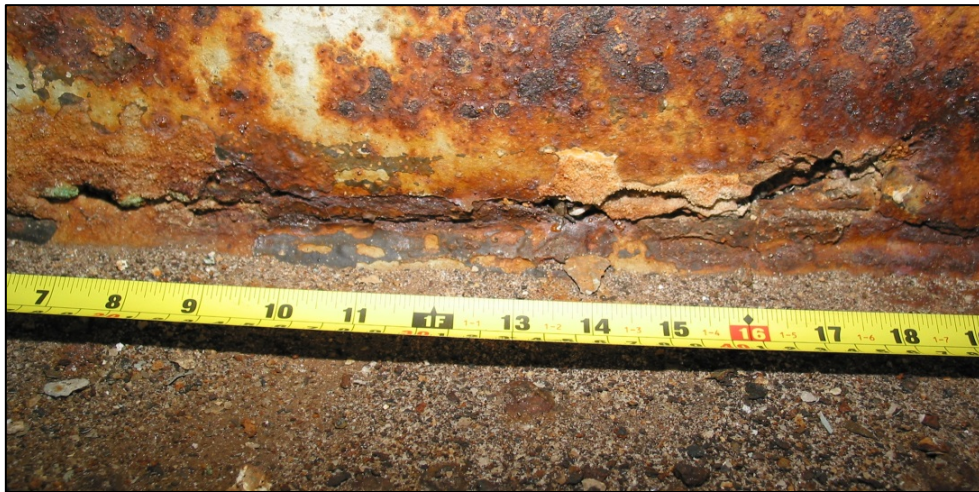
Figure 50: Close-up taken from Figure 49

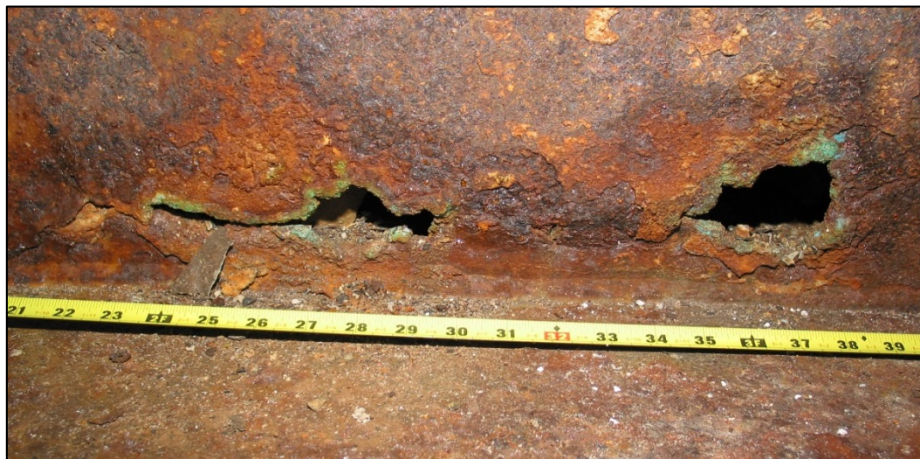
Figure 51: Close-up to figure 49, holes A and B

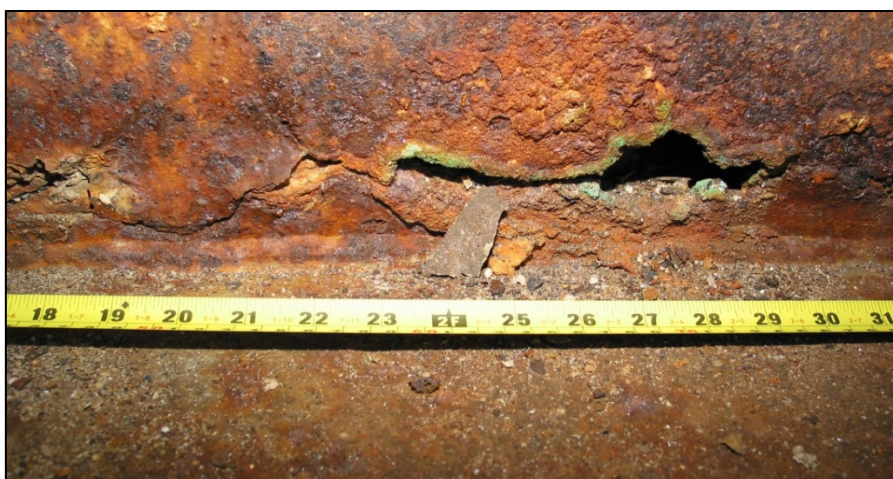
Figure 52: Close-up to Figure 49, hole A

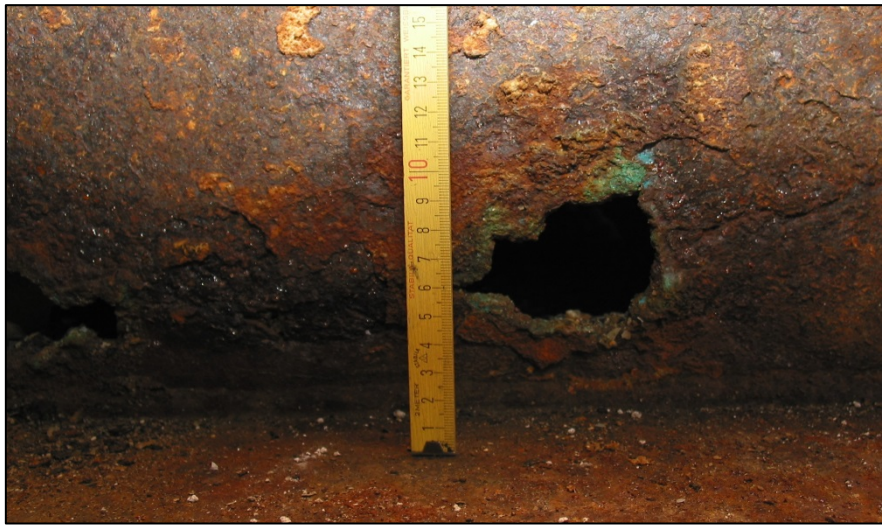
Figure 53: Close-up to Figure 49, hole B

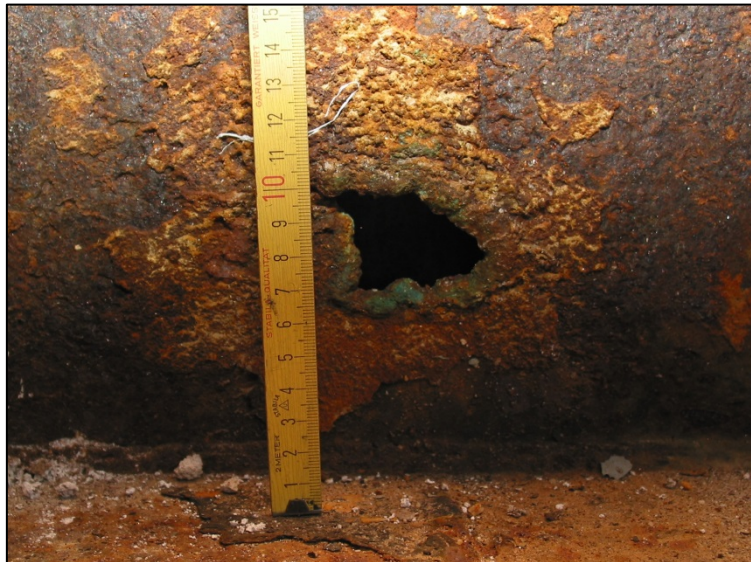
Figure 54: Close-up to Figure 49, hole C

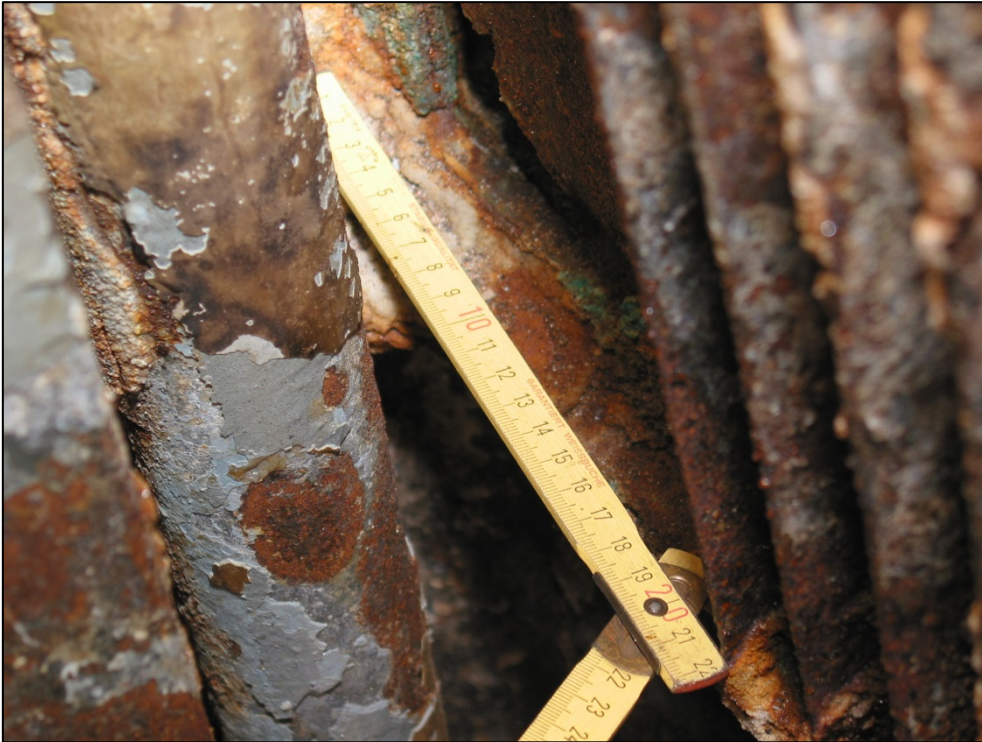
Figure 60: Hold ladder trunk to cargo hold 2

In this case hold ladder at the aft edge of cargo hold 2 at port side. Rust penetration in the direction of hold ladder trunk from cargo hold 3; see also figures 37 and 56.

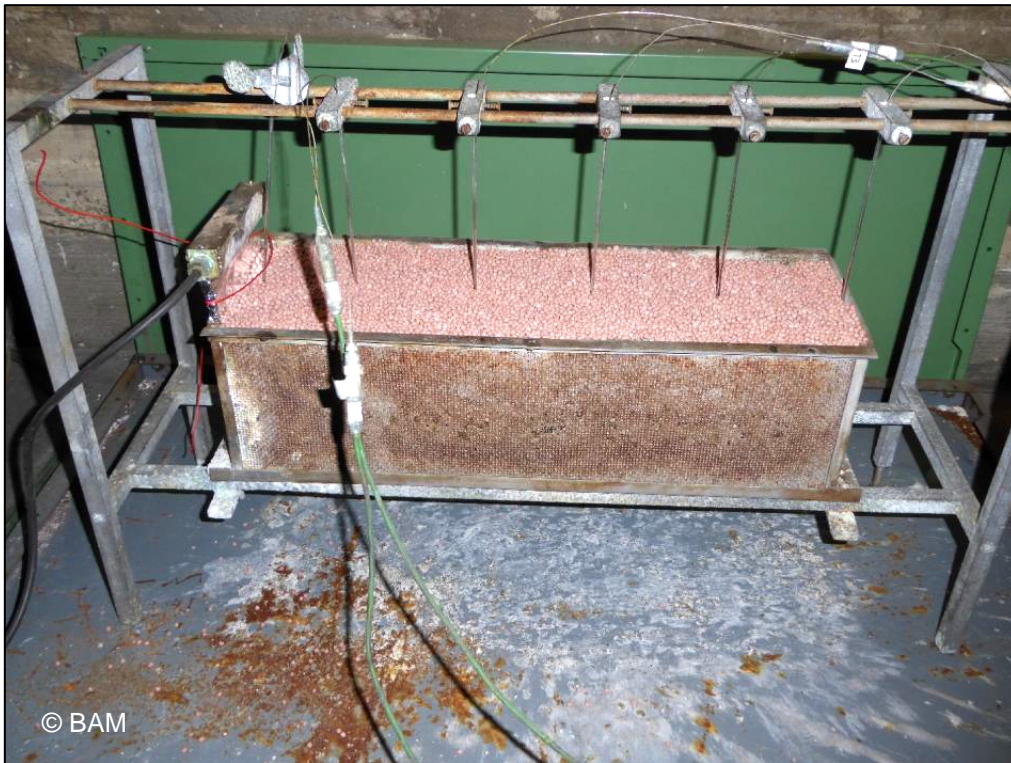
In the course of each test, the change in colour of the reddish raw material was clearly visible. The decomposed material took on a whitish colour (see Figures 63 and 64).

Figure 63: Photo of the trough made ready for the first test

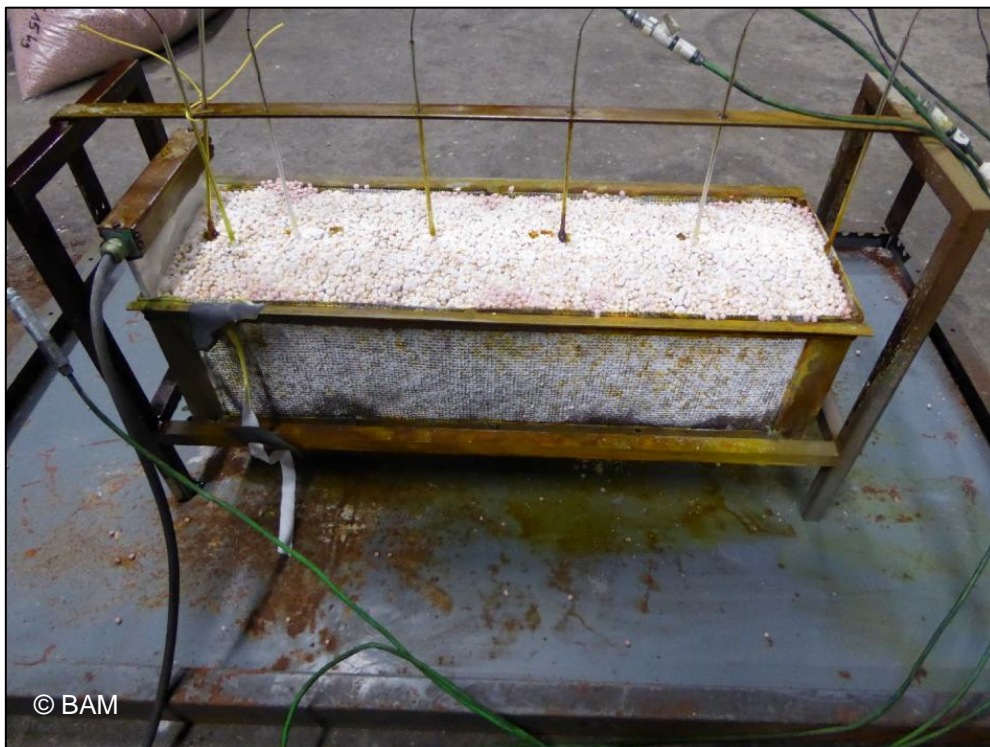
Figure 64: Result of the fifth trough test with fully reacted sample
