Bundesstelle für Seeunfalluntersuchung
Federal Bureau of Maritime Casualty Investigation
Federal Higher Authority subordinated to the Ministry of Transport
and Digital Infrastructure

Investigation Report 289/17

Less Serious Marine Casualty

**Collision between the
MV FINNSKY and the
steam icebreaker STETTIN
on the River Warnow
on 12 August 2017**

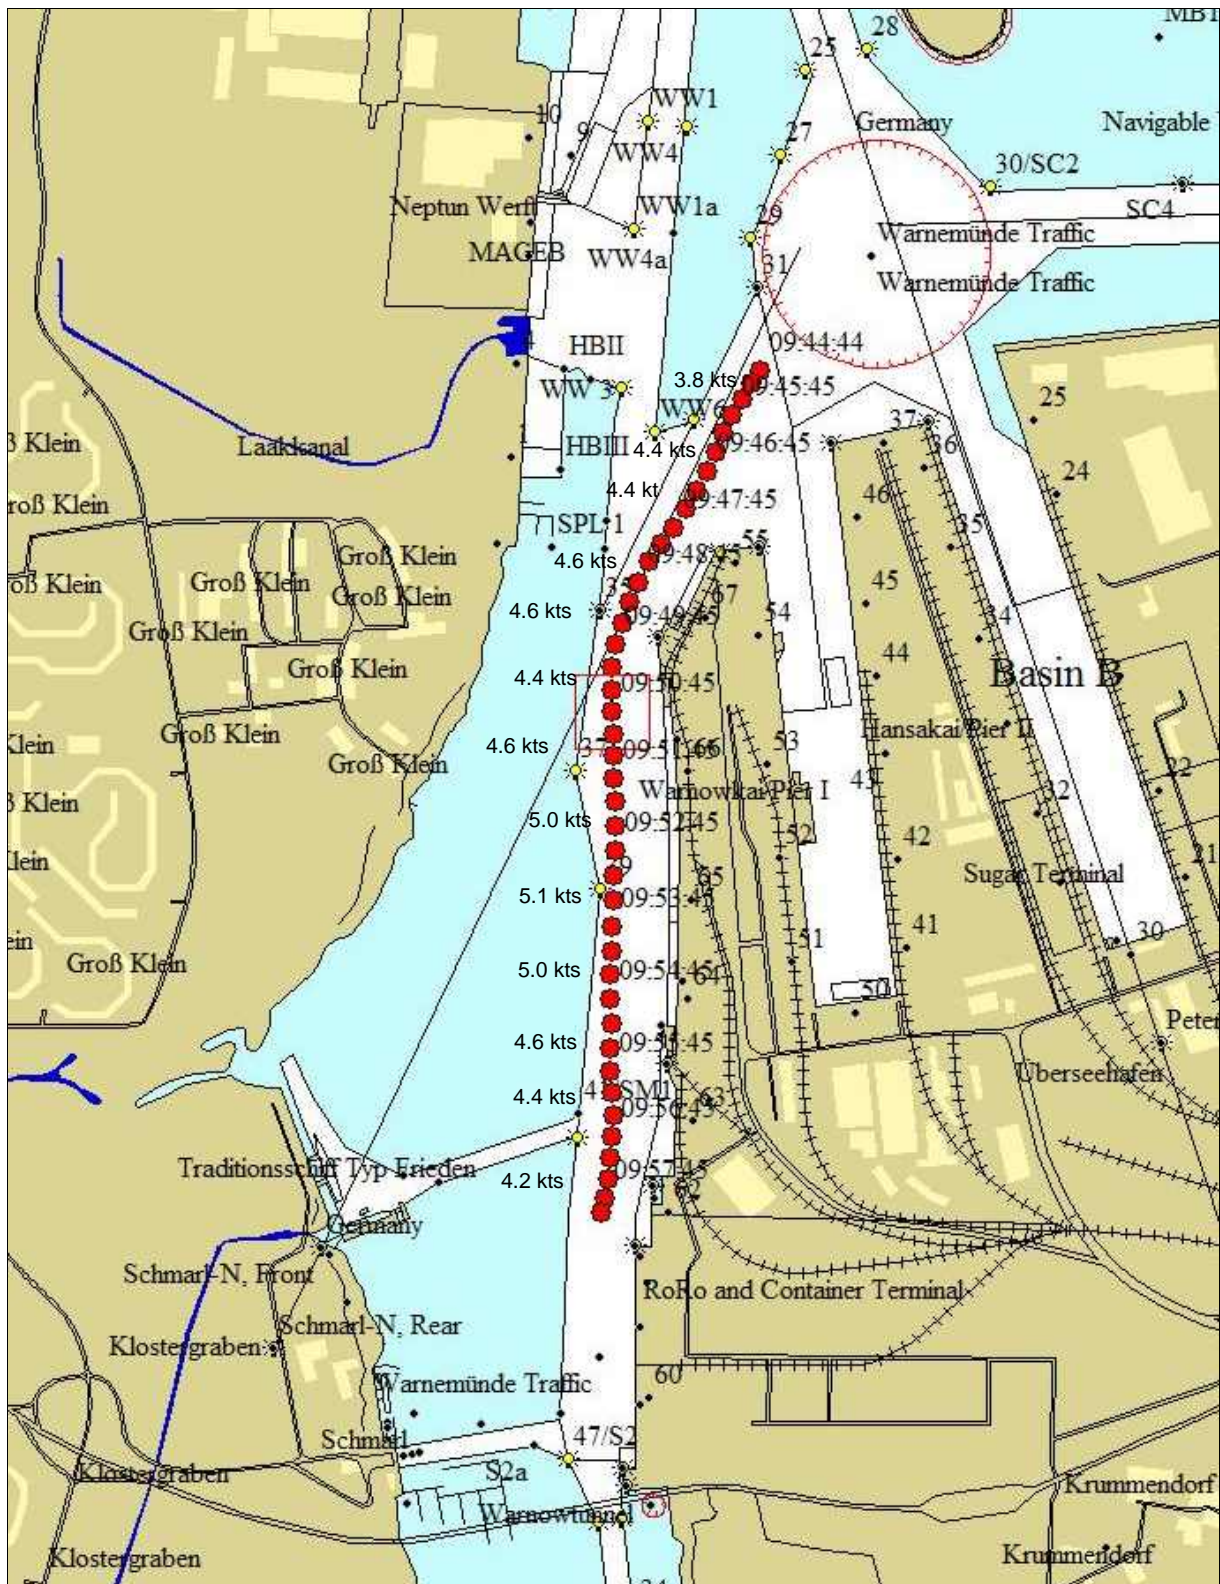
Figure 4: Course steered by the FINNSKY

The following three images show that the FINNSKY's track is stable. The heading oscillations in the six minutes leading up to the collision stood at $\pm 2^\circ$. In contrast to the recorded speed over ground (SOG) of the GPS, the speed through water (STW) of the recorded Doppler log yielded no plausible results. Here, the SOG measured via GPS always delivers positive values in all directions. The speed measured via the Doppler log yields a negative sign when sailing astern and a positive sign when sailing ahead. The STW values should have been slightly over or about the same as the SOG values. No values were recorded for the transverse STW values. The inaccuracies in the Doppler log were probably due to the shallow water effect and the turbulence at the transducer when sailing astern, which is mounted in front of the bow thrusters under the FINNSKY's hull. Accordingly, a plausible measured deep-water current on the Unterwarnow could not be derived from the difference between the SOG and STW.

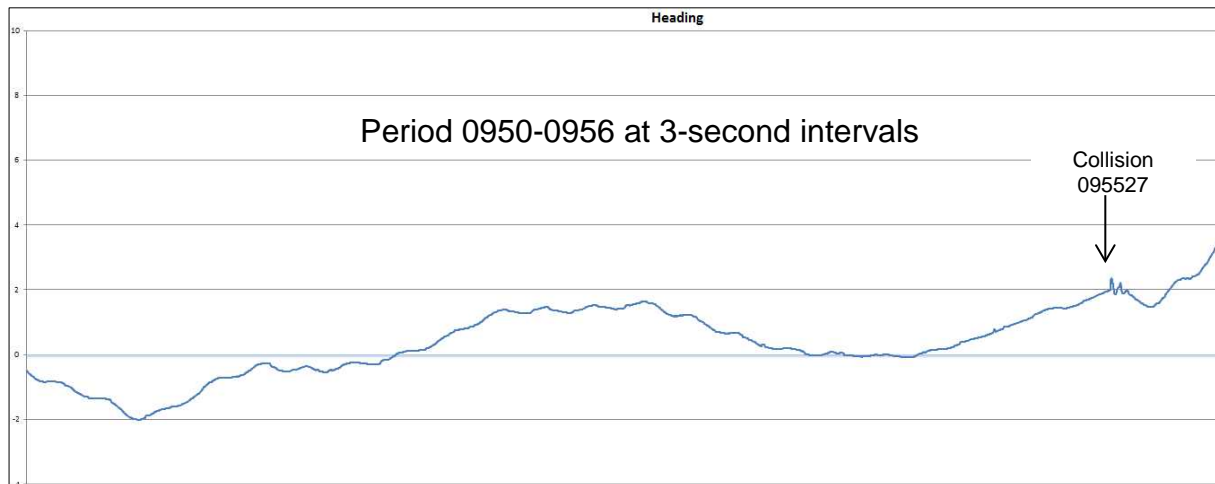
Figure 5: The FINNSKY's headings²

The FINNSKY continued sternward on 180° and at 4-5 kts on the western side of the fairway. To remain on a stable track the aft course had to be corrected several times using the bow thrusters while going astern. There were heading oscillations of up to +/- 2° in the final six minutes before the collision (see Figure 5). This may have been a cause of irritation for nearby traffic because the COG was relatively stable but visible, unlike the course steered (see Figure 13 – drawing by knowledgeable witness who observed a movement of the stern to the west shortly before the collision. Moreover, he stated that the ferries normally sail down on the eastern side along the quay wall and was surprised that neither ship had taken any evasive action). In west-north-west winds of initially 4 Bft at the turning basin, later decreasing to 3 Bft, sailing astern at 4-5 kts with no officer on watch at the aft manoeuvring station, who may have been more resolute in warning of the risk of collision with a recommendation to kick ahead or slow down than the bosun acting as lookout, merit criticism. The STETTIN may then have sailed clear. In making this assessment, it is important to take into account the fact that at no time did the officers on watch on the FINNSKY or STETTIN recognise the risk of a collision on their bridges and for the part of the FINNSKY, the STETTIN executed an unpredictable manoeuvre to port instead of using the clear area on her starboard side. Nevertheless, an officer on watch at the aft manoeuvring station, which was a long way away from the bridge, could have made a more qualified assessment of the traffic situation.

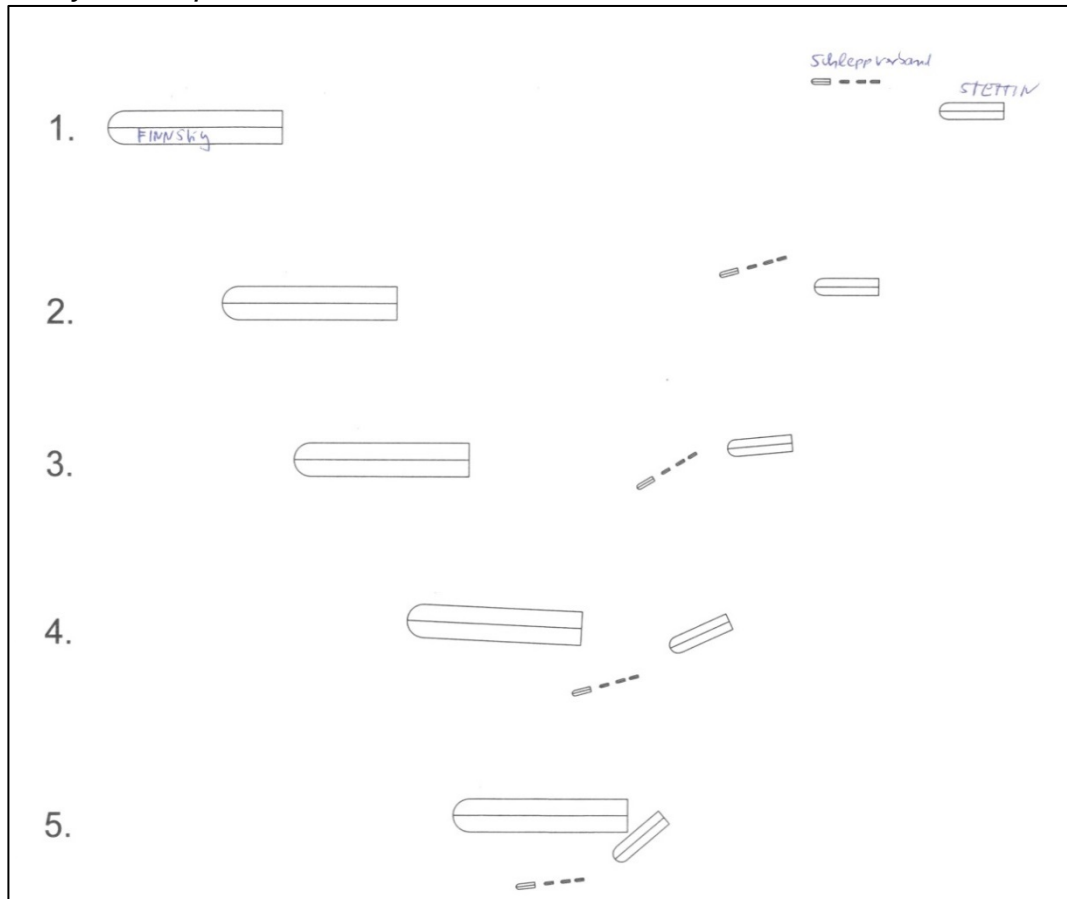
Figure 13: Drawing of the course of the collision based on witness testimony

1. *This is the initial situation. The FINNSKY is approaching on a southerly course and the STETTIN on a northerly. Both vessels are heading toward one another. The towed convoy of cutters is just on the starboard bow and a little slower than the STETTIN. At this point we are on the starboard side level with the fire extinguishing connections below the overhang of the upper deck. I have noticed the FINNSKY at this point but not given her further consideration, as the distance still stood at an estimated 500 m.*
2. *In the prevailing situation, the towed convoy decided to move to port to pass the ferry on the port side.*

3. *In the prevailing situation, the ships are already much closer together. The effect of the rudder can now be felt. The towed convoy has disappeared from view at this point.*

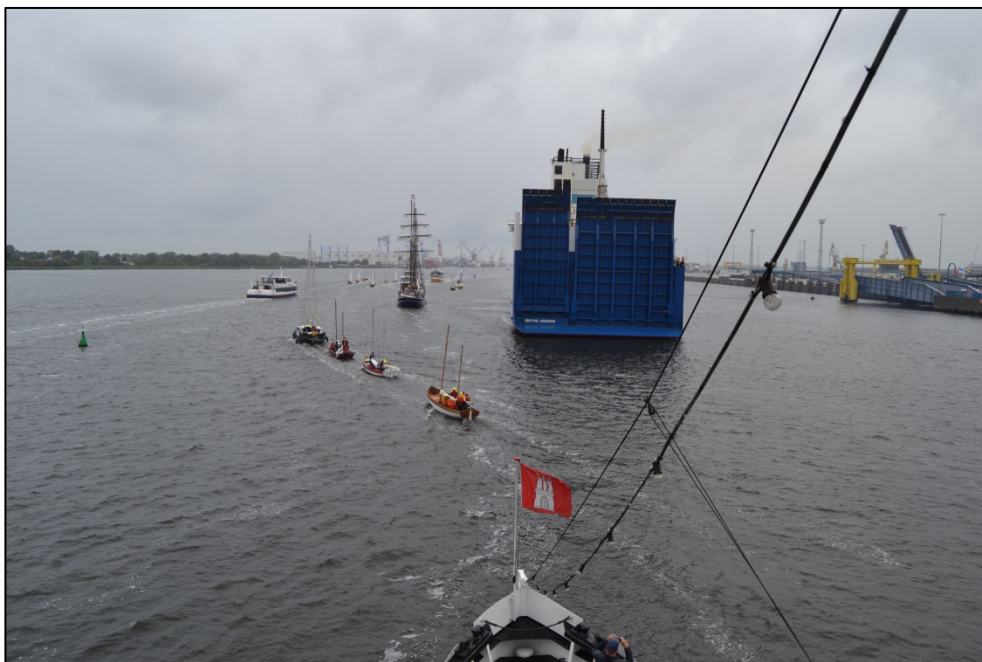
Figure 17: Fairway on the STETTIN's starboard and port side

The STETTIN sailed under pilotage. Shortly after casting off, the master handed over command to his mate, who executed the pilot's engine commands and controlled the manual steering. Prior to the collision, various rates of speed were applied with an average SOG of 6.4 kts on the River Warnow. This speed also corresponds to the STW, as there was almost no current at different water depths according to the BAW report. The position of the fairway buoys on the figures (see Figure 17, *inter alia*) does not indicate any significant surface current, either.

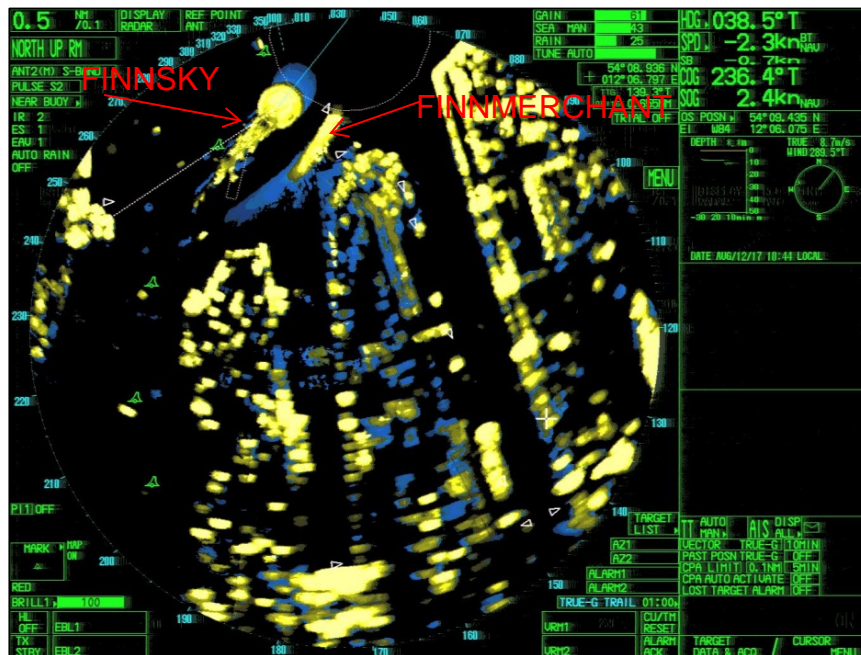
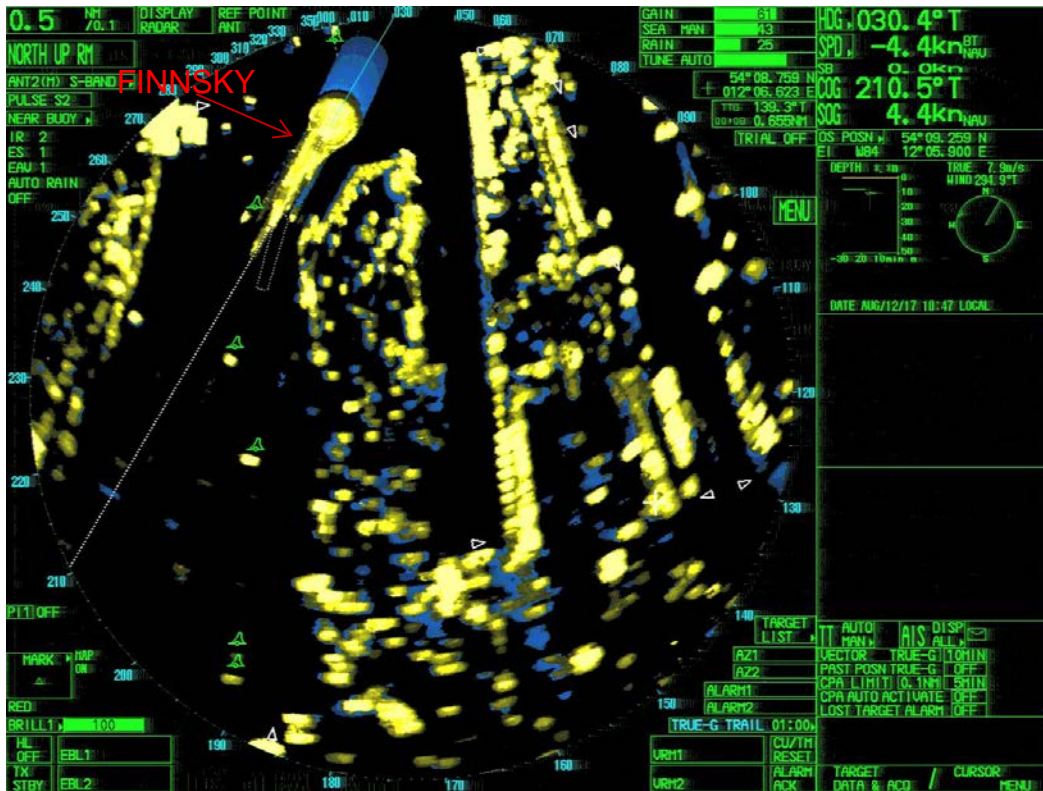
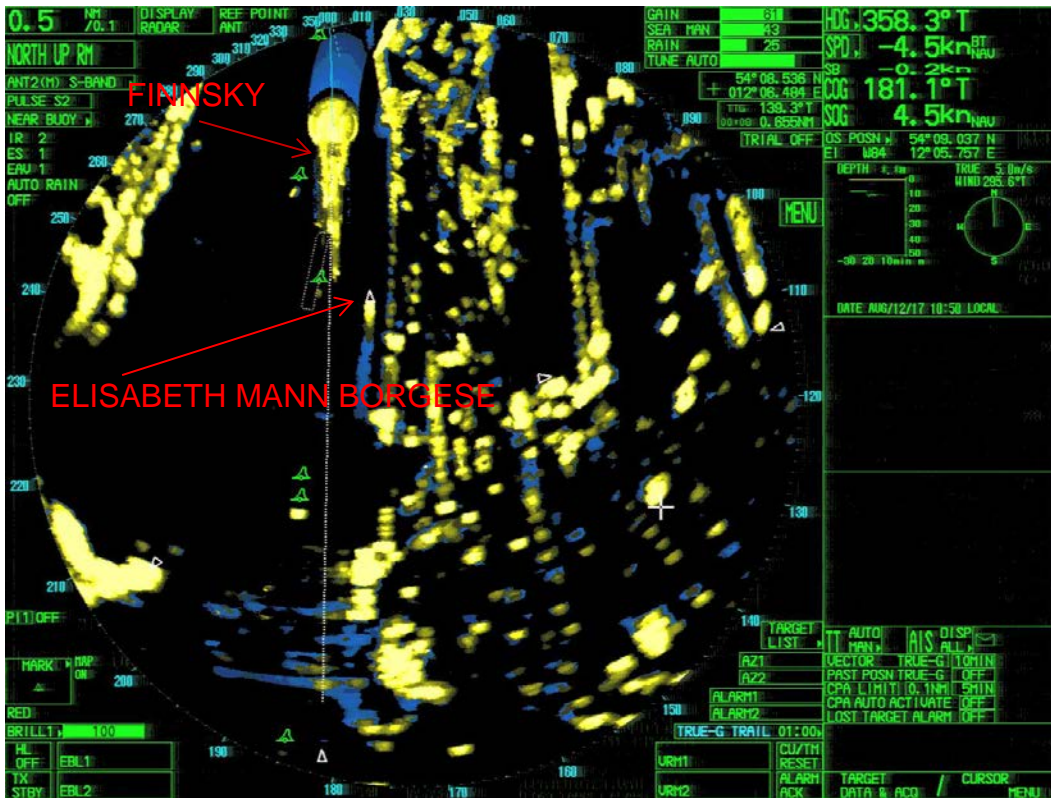
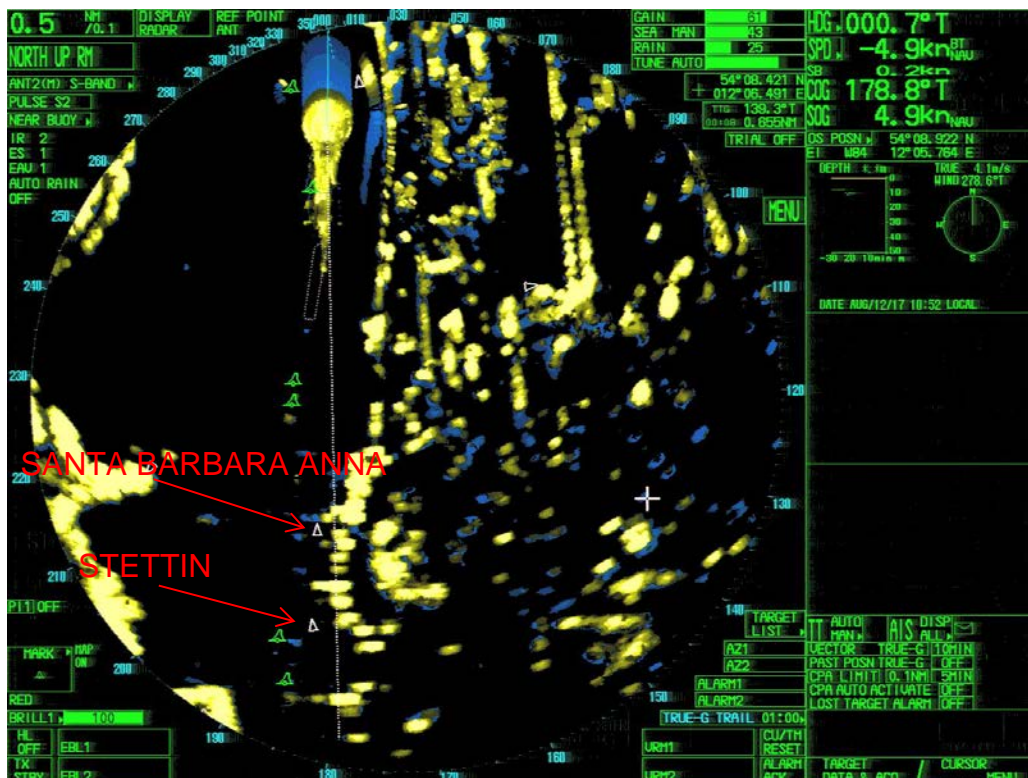
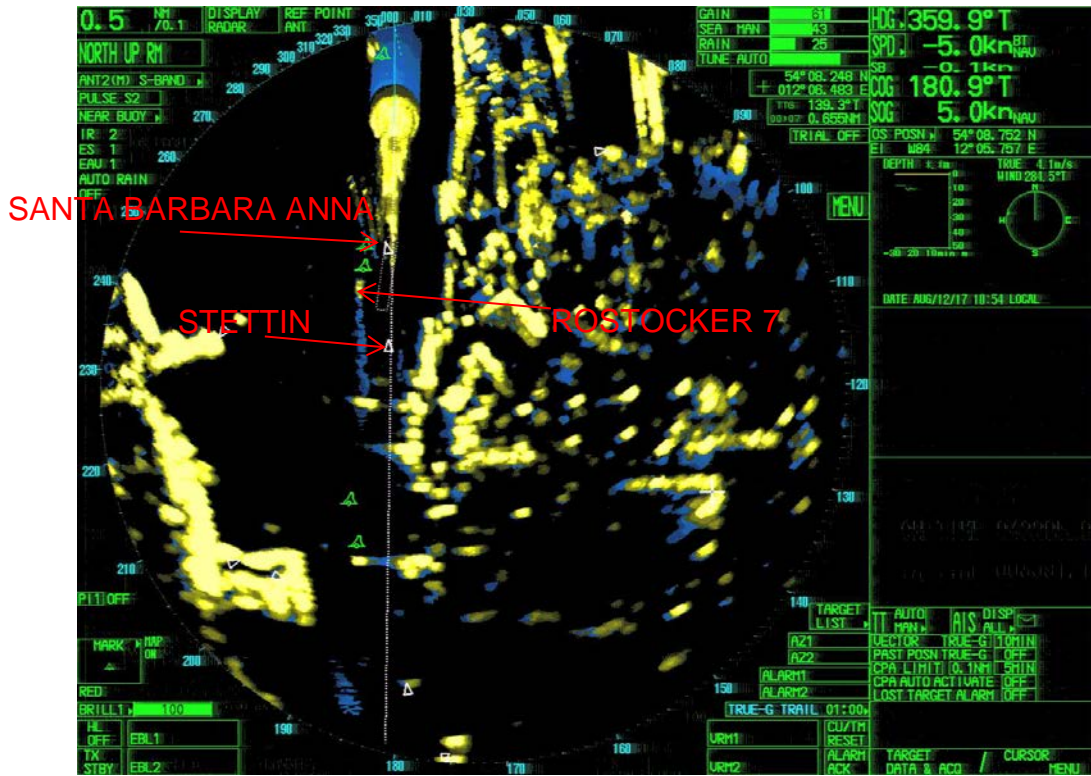
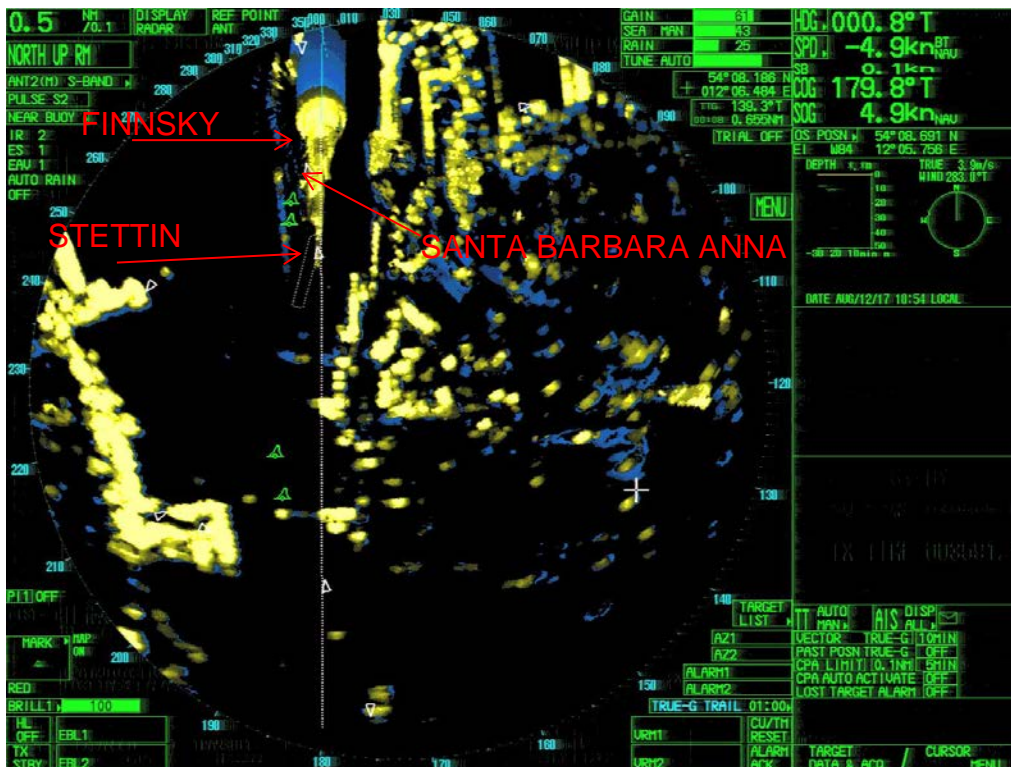
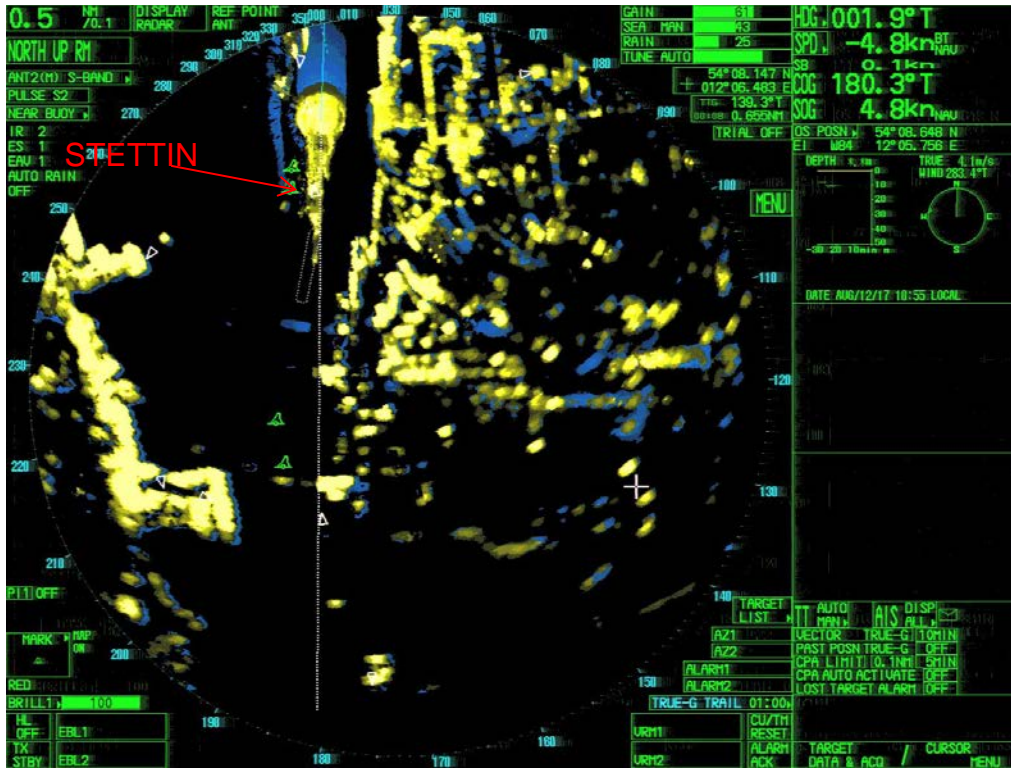
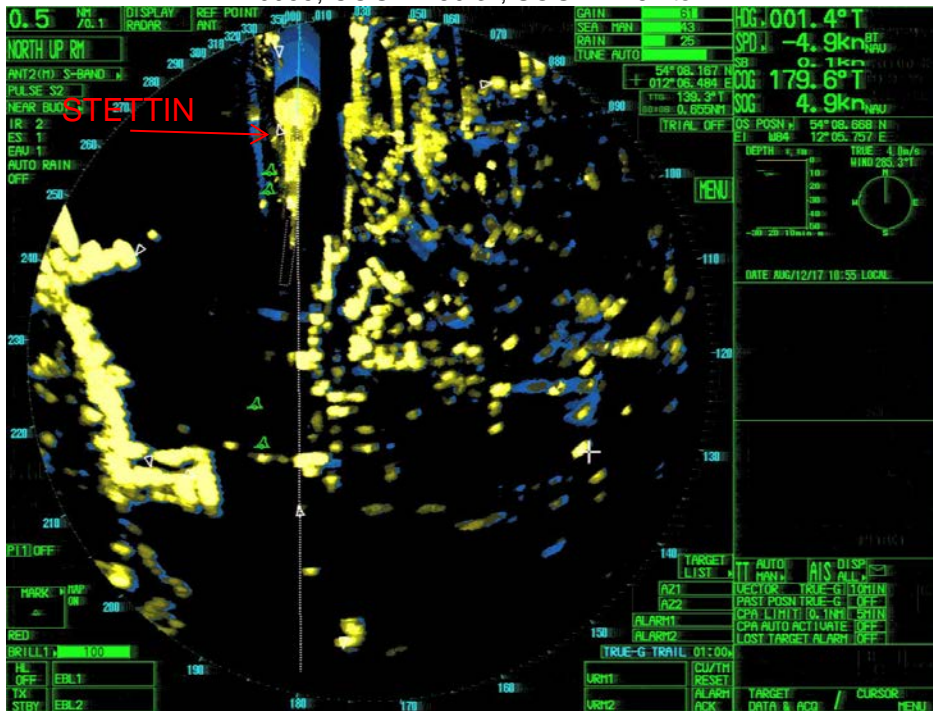
The analysis of the radar images reveals that the FINNSKY is keeping to the western side of the fairway and exhibited a western movement tendency for the prediction. It can also be seen that both the SANTA BARBARA ANNA and the STETTIN did not display a radar echo, while the AIS signals are recorded. Due to the FINNSKY's long radar lobe, radar echoes precisely astern of the ship are not displayed.

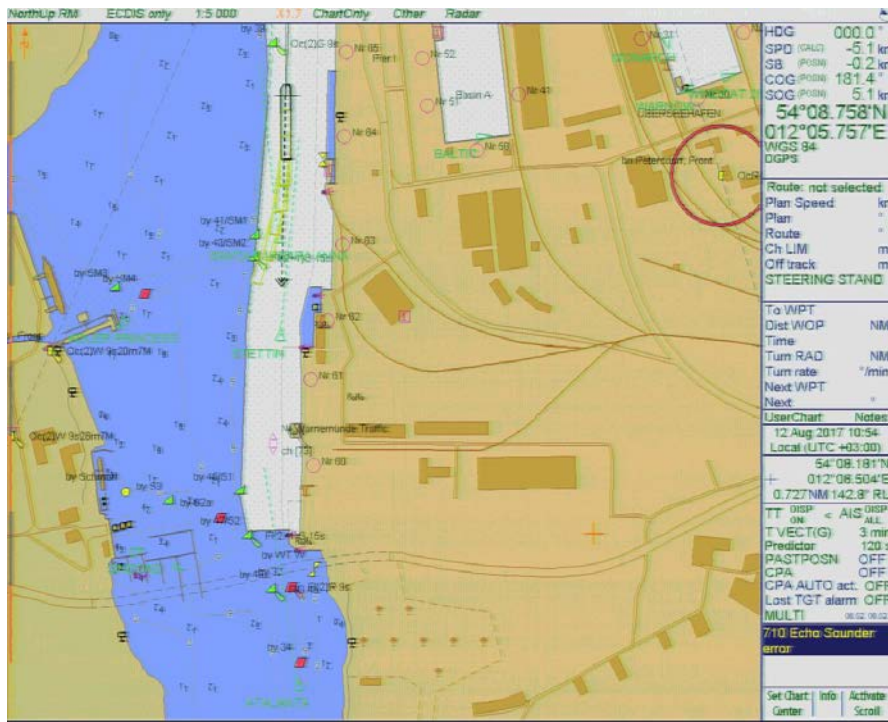
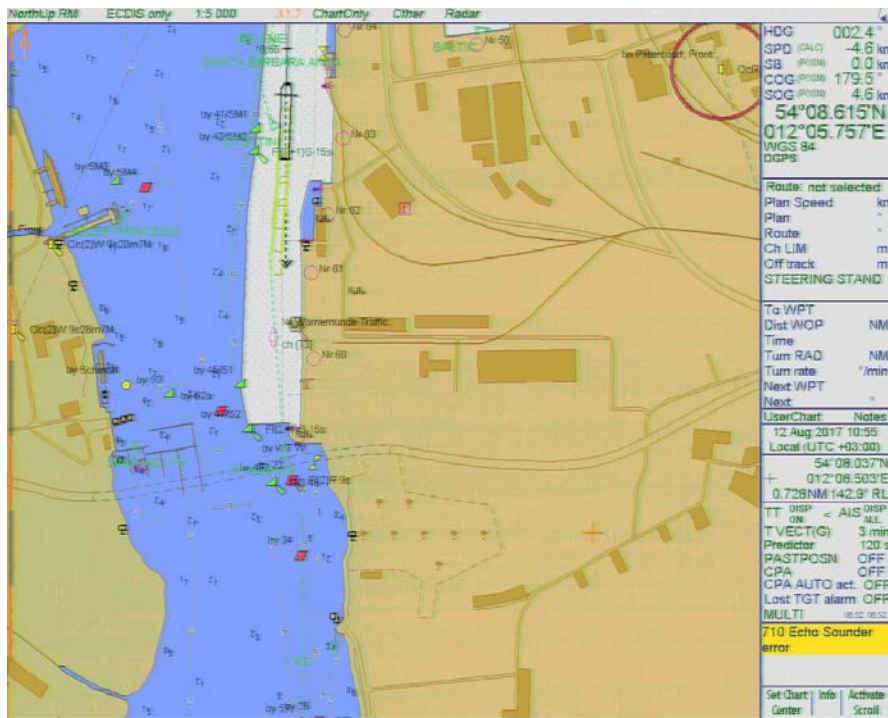
Figure 32: ECS at 0954

Figure 33: ECS at 0955

The ECS recordings show that the FINNSKY kept to the western buoy line. It also indicates that at 0954 the SANTA BARBARA ANNA intends to pass to the west on the FINNSKY's port side and that the STETTIN's vector ahead shows an eastern tendency at this point.

The STETTIN's voyage planning should have been reconsidered at this point at the latest, as it was planned from the outset to pass the FINNSKY on the western side of the fairway because the pilot believed that the ro-ro ferries would mainly use the eastern side of the fairway and sail astern when berthing. The traffic situation would have been defused if the STETTIN had stopped and waited behind the small craft in good time (see Figures 32 ff.). This scenario would also have made it easy to give way to starboard in consultation with the FINNSKY and VTS. The STETTIN's vector ahead already revealed a starboard tendency in Figures 32 and 33.

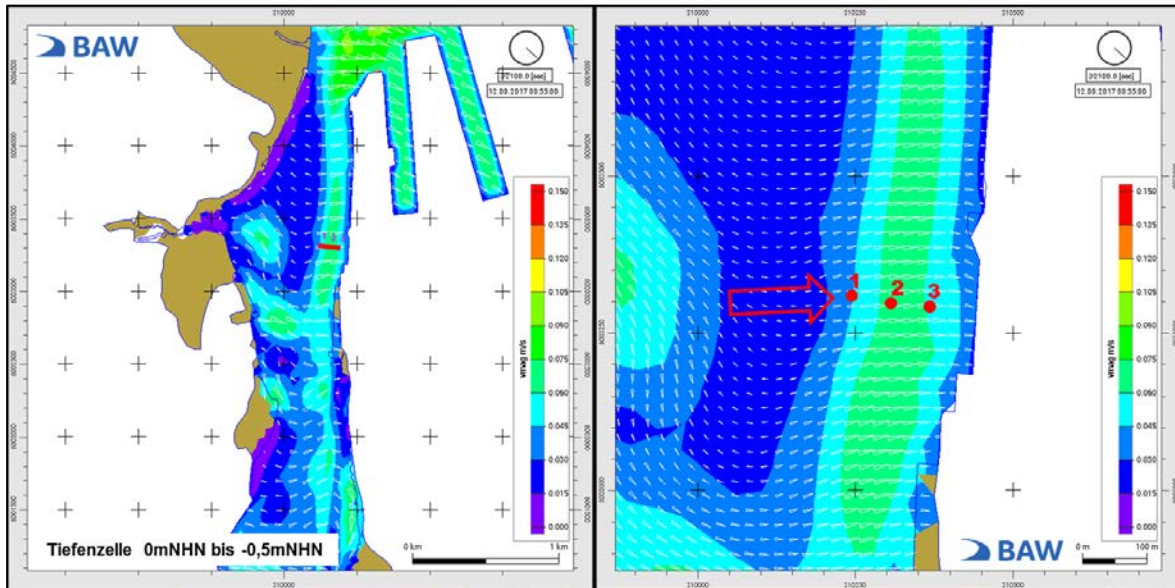
Figure 40: Surface current data

The near-surface current velocities in the deep cell layer surface up to -0.5 m AMSL calculated in Figure 40 indicate an eastern current direction (ESE to E) over a water depth of approximately 0.7 m, which was excited at about 8 m/s by the WNW wind and

influenced by local bathymetric effects. In addition to the area-related white arrows, the direction of current at the scene of the accident was illustrated by an optically averaged direction of current with colour highlighting, e.g. at Pos1.

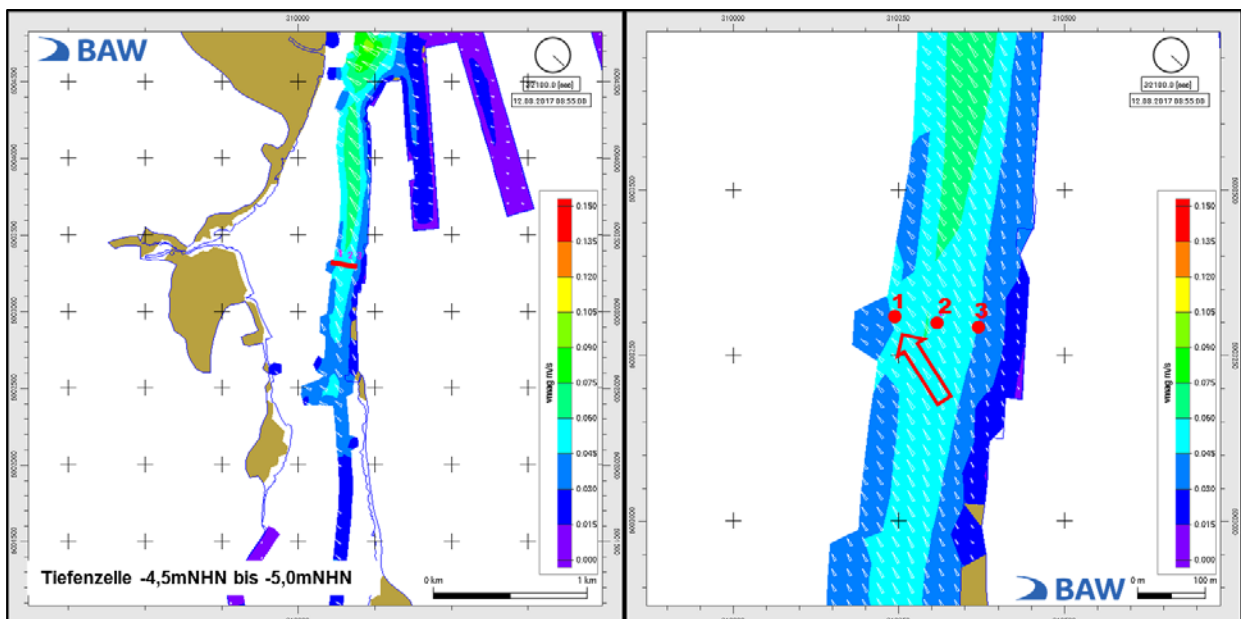
Figure 41: Deep fairway current data

The area-related current in the deep fairway calculated of -4.5 m to -5.0 m AMSL (Figure 41) is approximately $v = 0.05$ m/s lower at the scene of the accident than the surface current according to Figure 40, but with a direction of current that is almost opposite to the wind-induced surface conditions. This depth level is chosen as an example to show the return flow of the wind-induced surface current.

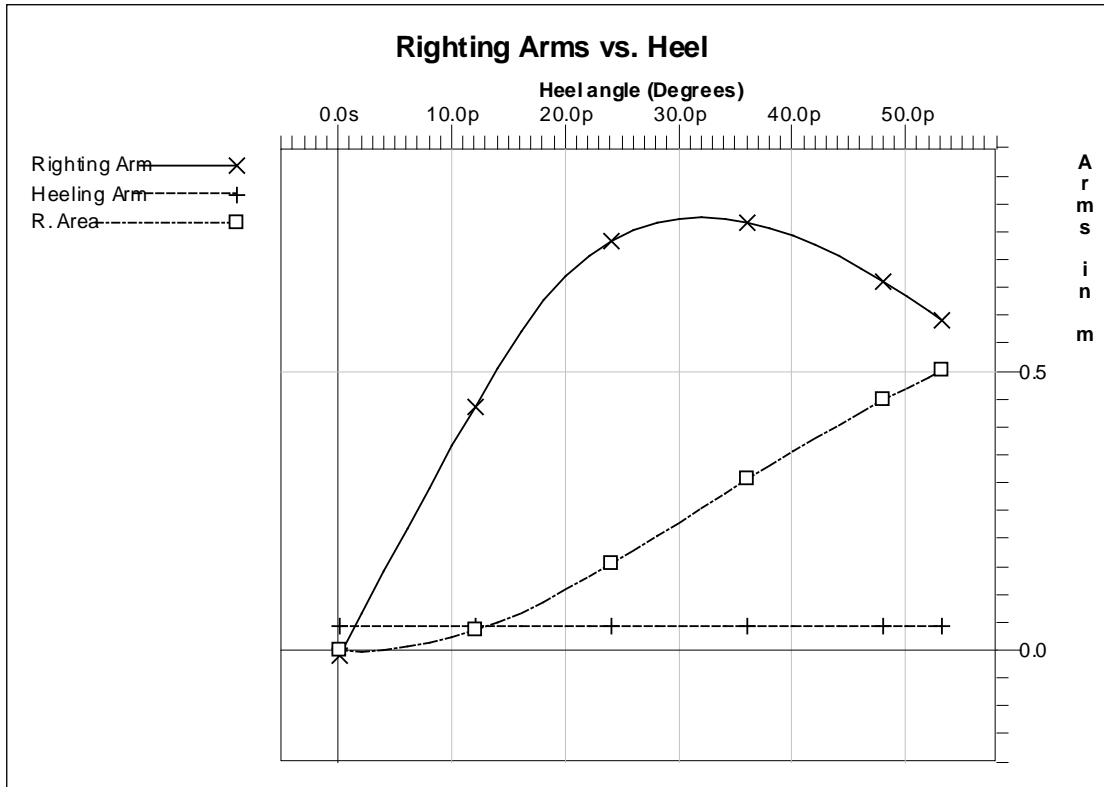
Load case 1: Righting lever curve

Taking into account the analysis of an inclining test made on 15 April 1994 and the assumptions made here, the results of this calculation confirm that the STETTIN complies with the intact stability requirements of Directive 2009/45/EC (as last amended by Directive (EU) 2017/2108). The stability criteria are met in all the load cases required for a passenger ship. The ship displays extremely high initial stability GM' of more than 1.86 m and has high maximum lever arms of more than $GZ' = 0.77$ m. The range of stability is greater than 60° .
