**Bundesstelle für Seeunfalluntersuchung**  
**Federal Bureau of Maritime Casualty Investigation**  
Federal Higher Authority subordinated to the Ministry of Transport  
and Digital Infrastructure

## Investigation Report 423/16

**Serious Marine Casualty**

**Collision between the MV MERIDIAN,  
MV NEWYORKER and MSC DIANA  
at the Stromkaje, Bremerhaven,  
on 20 November 2016 at 0153**

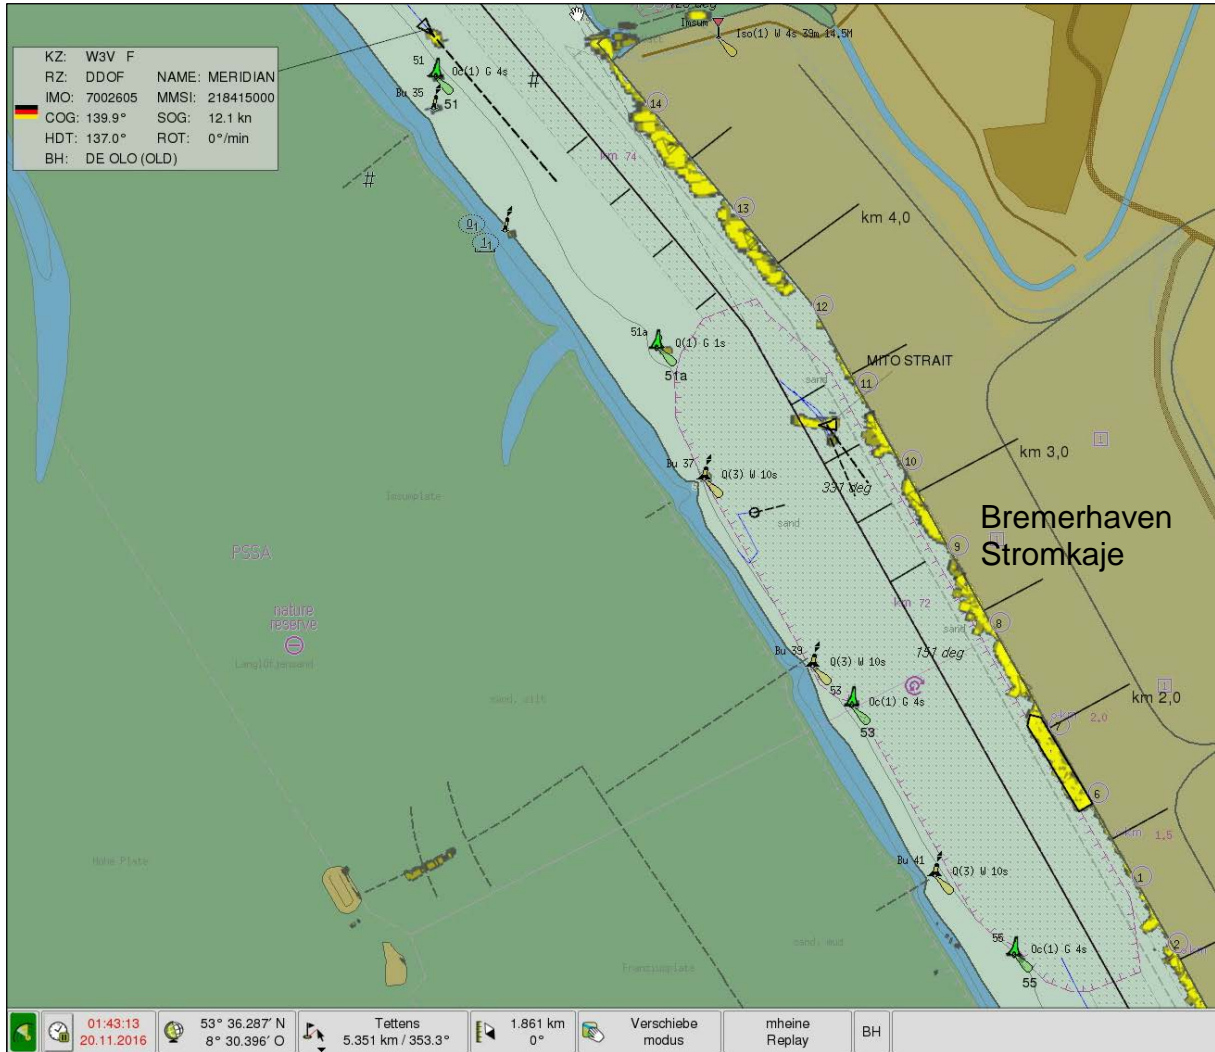
Figure 10: 014313 – shortly before passing buoy 51

Figure 10 shows the MERIDIAN shortly before she passed buoy 51. She is maintaining a course of 140° at a speed of 12.1 kts on autopilot.

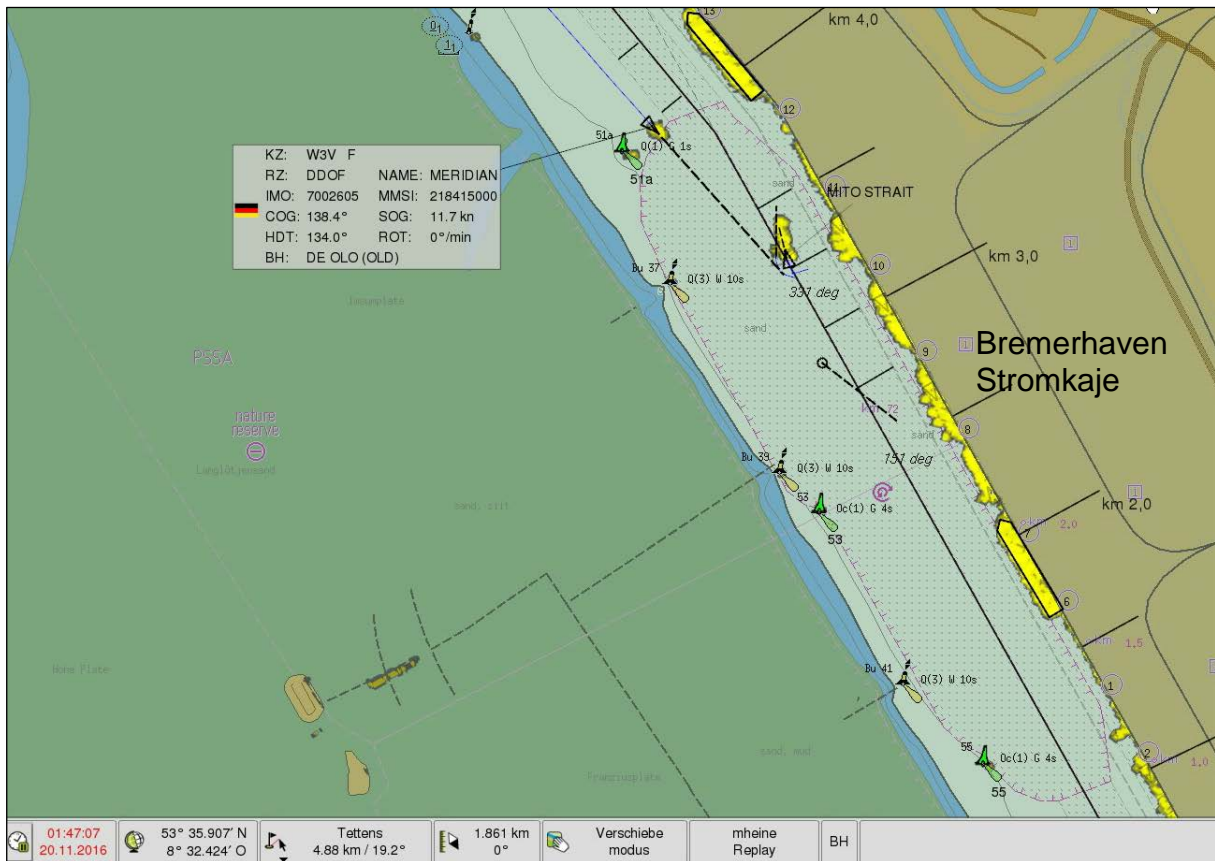
Figure 11: 014707 – buoy 51a is passed

*At the time of Figure 11, when buoy 51a was passed, the officer on watch was on the bridge and the rating on watch making a safety inspection of the ship. The fourth crew member was asleep. The master had just been woken so that he could take over the navigational watch as planned<sup>5</sup>.*

*The helmsman then switched from autopilot to riverpilot because he thought this would allow him to steer the ship better. When he intended to make the necessary course alteration to starboard about a minute later, he noticed that the rudder was not responding (not immediately but only after he had to move the tiller further and further to starboard). He then switched on the second steering gear but the rudder did not move. Following that, he set the control lever to STOP but was aware of the low effect. The AIS data in Figure 12 confirm this. At 014947, the speed dropped from 11.7 to 11.3 kts. At this point, the NEWYORKER was no more than two ship lengths away. He reportedly failed to notice the contact with the NEWYORKER (at 015136 – see Figure 13). [Rather than there being a direct collision, she probably 'slid along' because the collision angle was so shallow.] Shortly afterwards, the MERIDIAN collided with the pier at an acute angle between the NEWYORKER and the MSC DIANA and then came to a standstill (Figures 14 and 15).*

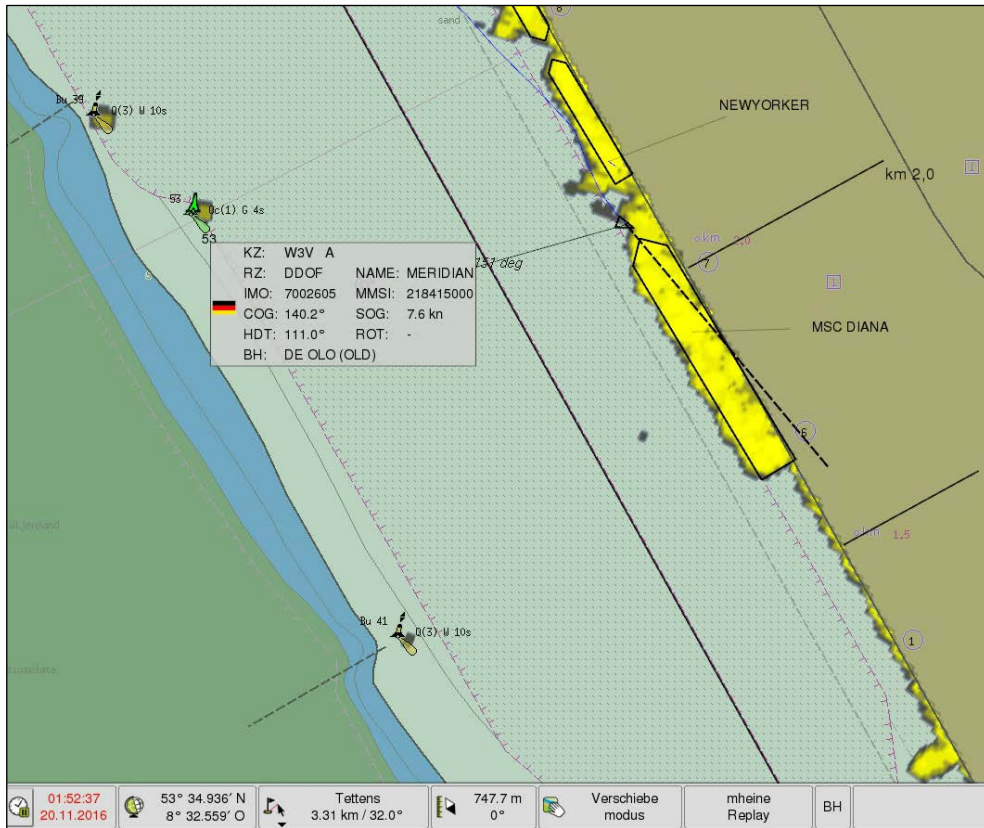
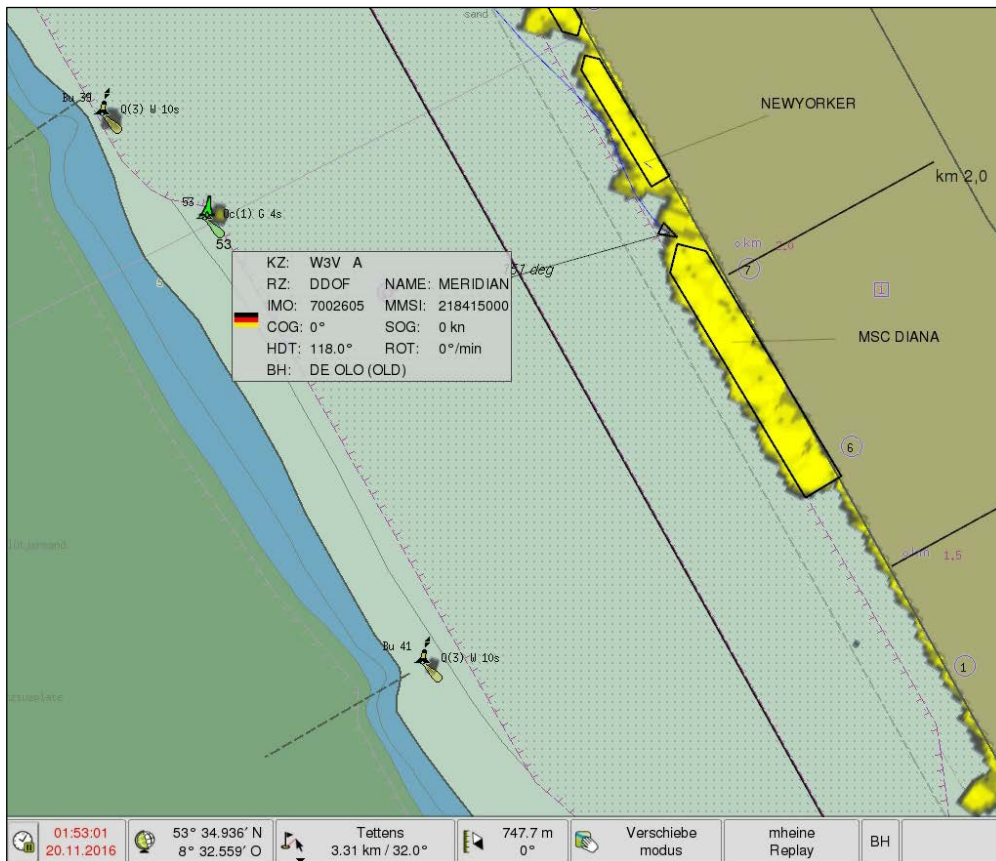
Figure 14: 015237 – collision with pier

Figure 15: 015301 – STOP at the pier

The master appeared on the bridge at the moment of the collision with the pier so as to take over the watch immediately.

The rising tide immediately started to push the MERIDIAN's starboard side against the bulbous bow of the MSC DIANA. Although this did not cause any damage to the MSC DIANA, the starboard side of the MERIDIAN was dented to such an extent that a small crack formed level with the waterline (with slight water ingress), which the crew was able to seal quickly, however.

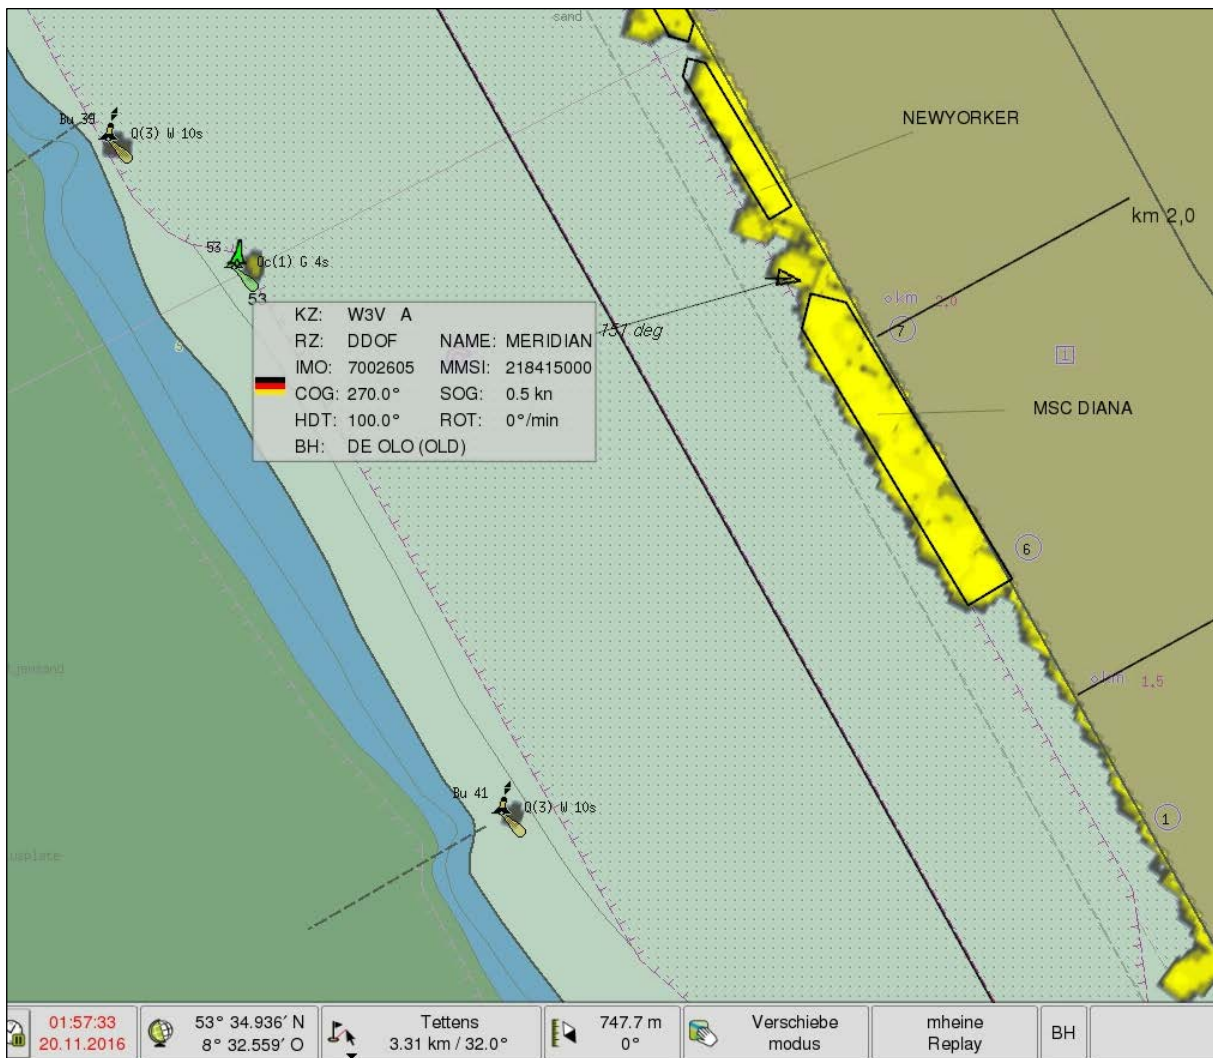
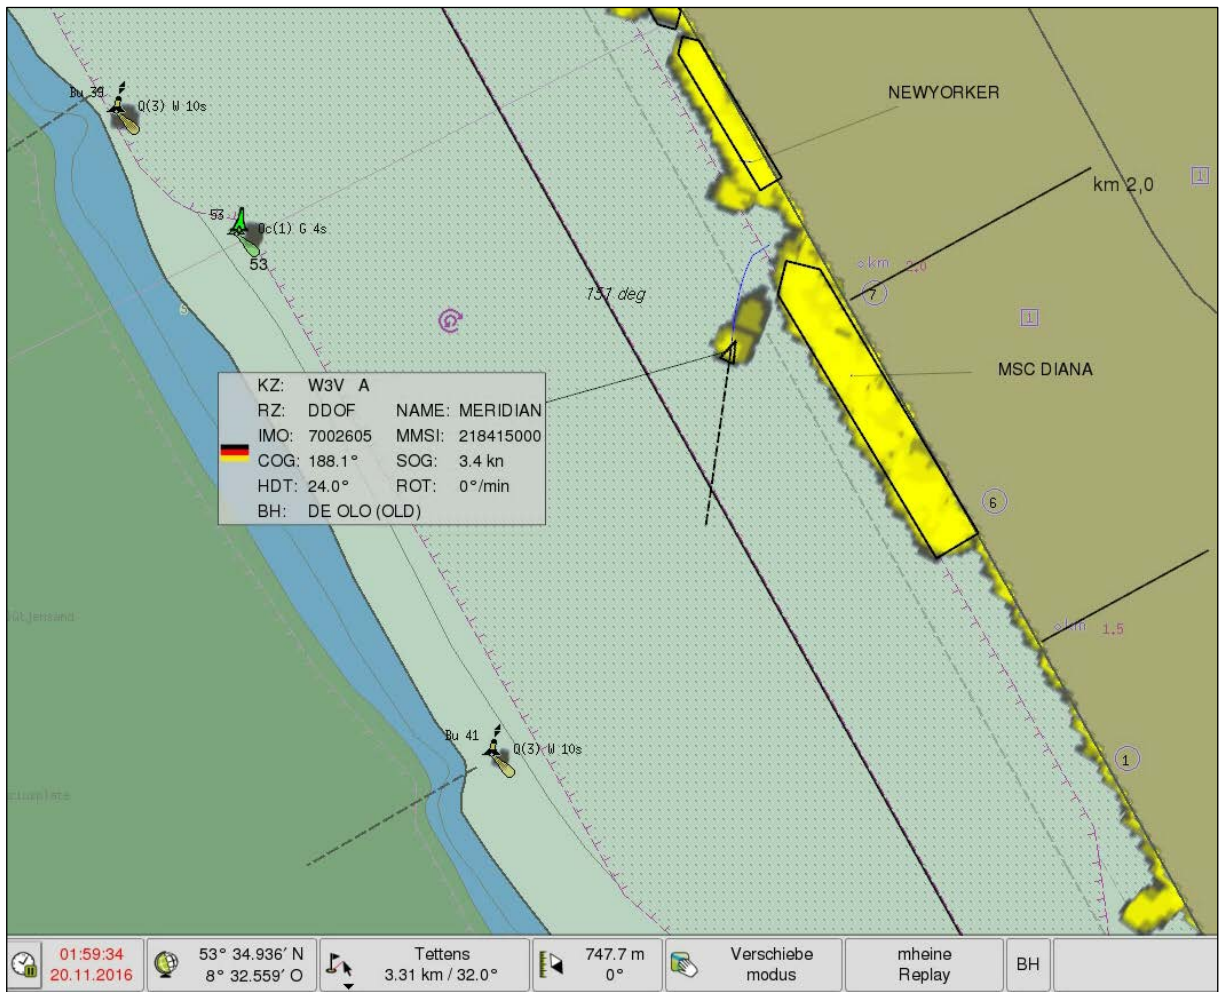
He then started the main engine and began to manoeuvre the ship astern and away from the pier (see Figures 16 and 17).

Figure 16: 015733 – start of the astern manoeuvre

The master sailed the MERIDIAN to the Seebäderkaje quay and made fast there. When he tested the steering gear there in normal operating mode again, it failed to respond.

Figure 17: 015934 – the MERIDIAN is clear again

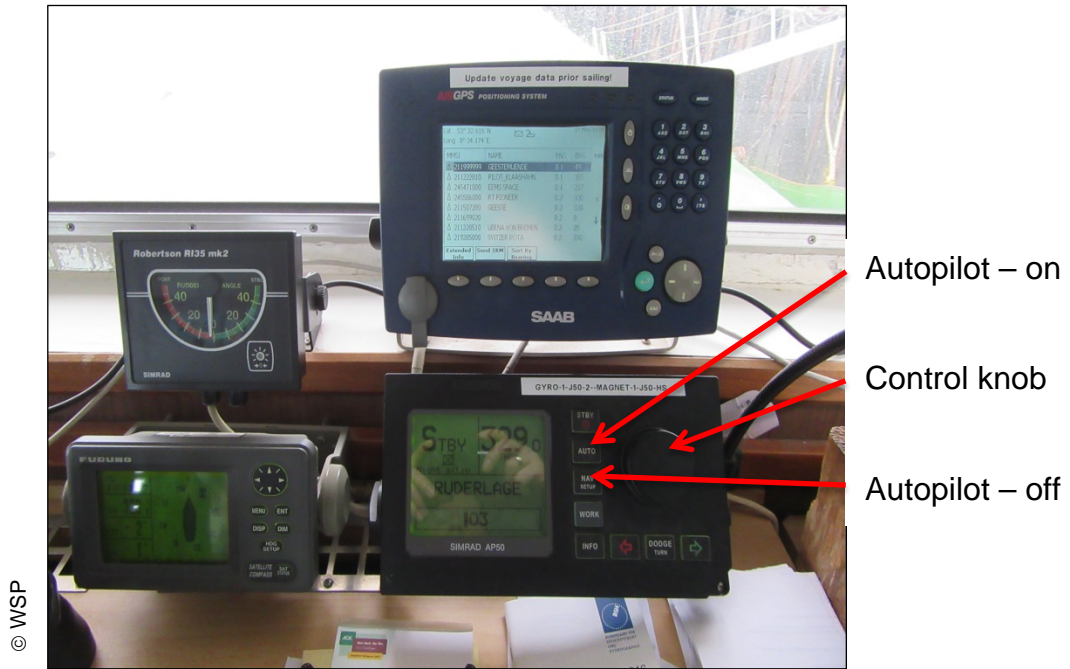
Figure 28: SIMRAD AP 50

The system is connected to the ship's gyrocompass. In operating mode, the desired course is entered by means of a control knob (Figure 28). The autopilot then sends electrical control pulses to the hydraulics of the ship's steering gear. The specified course is achieved through the thus obtained rudder angles. Once the ship has reached a specified course, the system uses the connected gyrocompass to monitor whether the course is maintained and responds with appropriate rudder angles in the event of deviations.

On board the MERIDIAN, the autopilot is switched on using the rotary switch (Figure 27). The switch is set to position 1 and the autopilot is switched on at the unit (AUTO). The current course is shown on the display and can now be changed using the control knob.

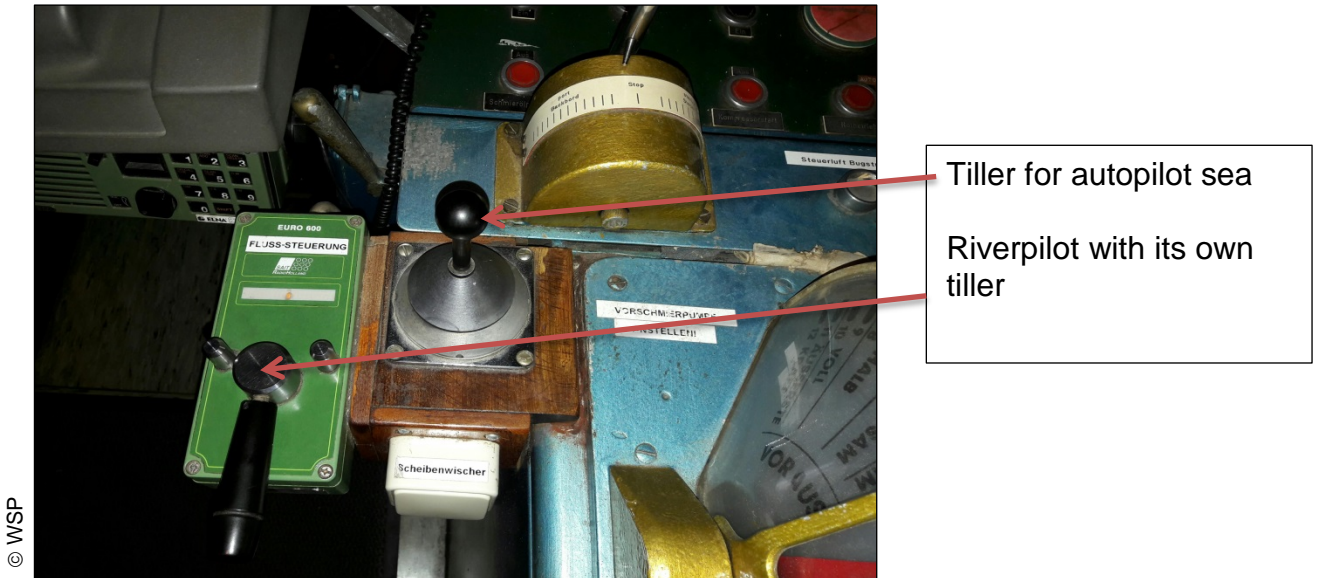
Figure 29: Tiller and riverpilot

When the rotary switch is in position 2, the riverpilot is used, which can also be operated by its own tiller (Figure 29).

To switch from autopilot to rudder control using the riverpilot tiller, the switch must pass the '0' position. This switching must have rendered the entire electric steering gear inoperative.

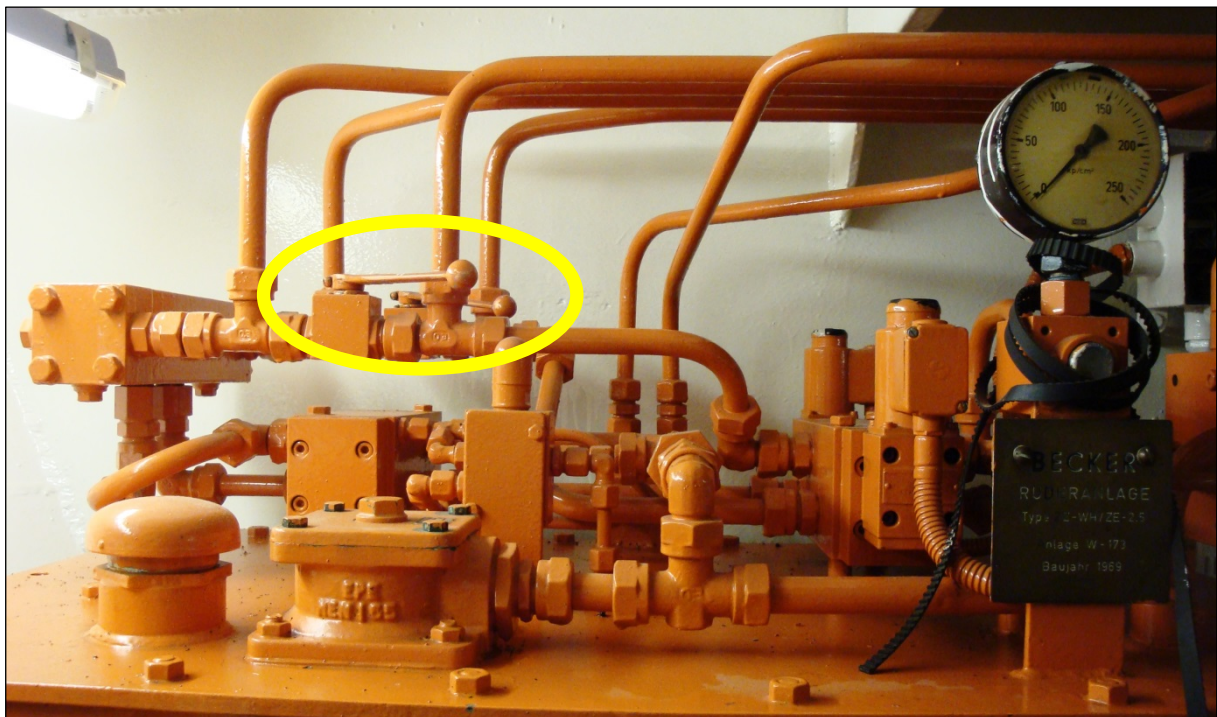
Figure 30: Steering gear valves for manual operation

After the collision, the master enabled the manual steering by switching the two required valves in the steering gear compartment, among other things (see Figures 26 and 30). This enabled him to manoeuvre the ship away from the scene of the collision and steer her to the berth.
