Investigation Report 431/15

Serious Marine Casualty

**Serious engine damage
followed by fire
on board the cargo vessel THETIS D
on 26 October 2015
in the Kiel Bight**

14 June 2018

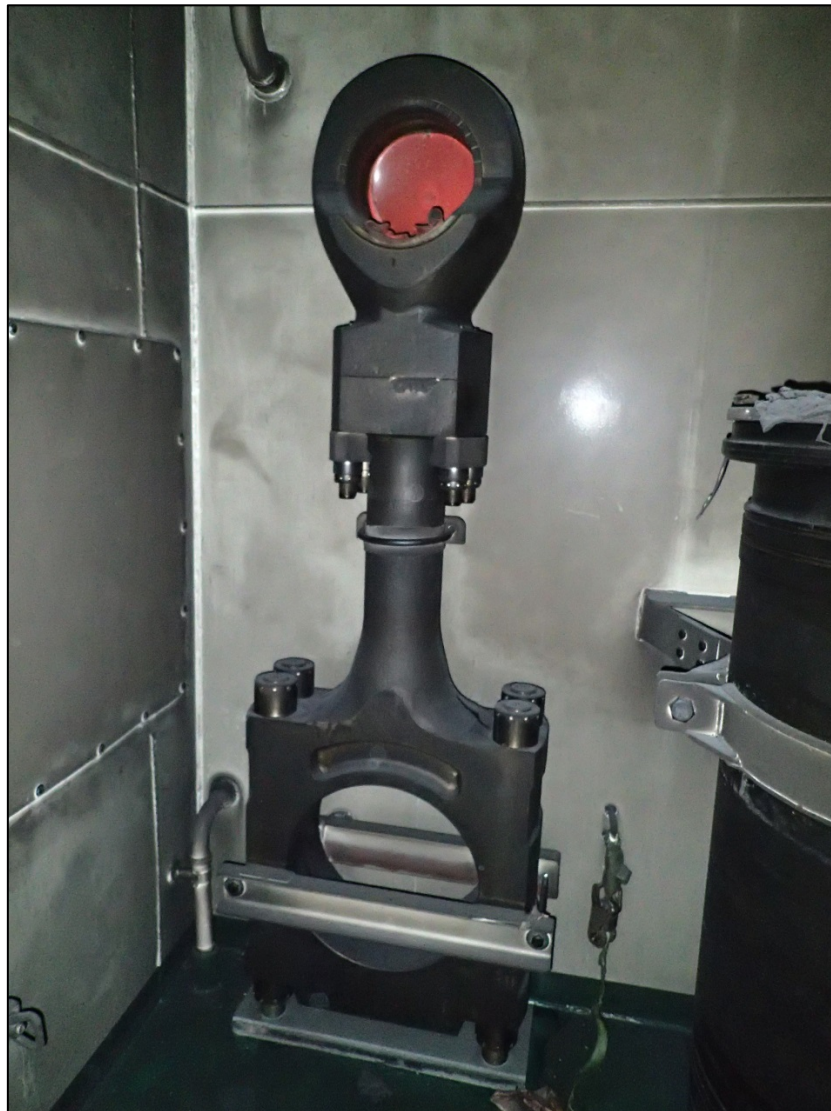
Figure 9: Replacement connecting rod in the THETIS D's engine room

A replacement connecting rod was carried on the THETIS D (see Fig. 9), meaning exchanging it would have been possible if necessary.

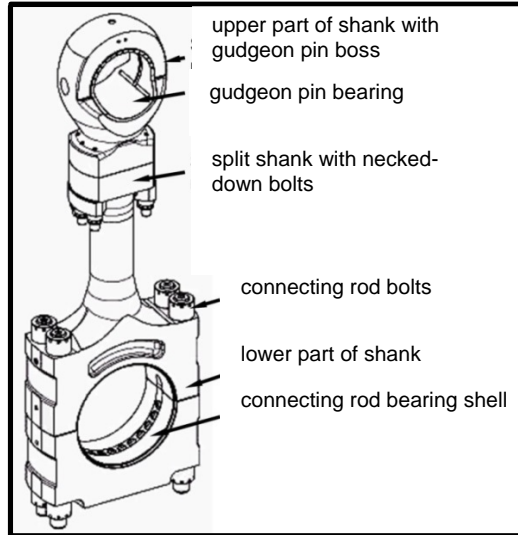
Figure 11: Technical drawing of the connecting rod

"The split connecting rod consists of the upper part with a connecting rod eye and the lower part with the connecting rod bearing. Both parts are connected to each other on the split shank with six necked-down bolts."

[The small end bearing] is a single piece and pressed into the gudgeon-pin boss. The connecting rod bearing is in two parts with an upper and a lower shell, which is clamped in the bearing housing with four bolts. [...] The [THETIS D's] connecting rod has broken apart at the split shank and broken just above the connecting rod bearing.

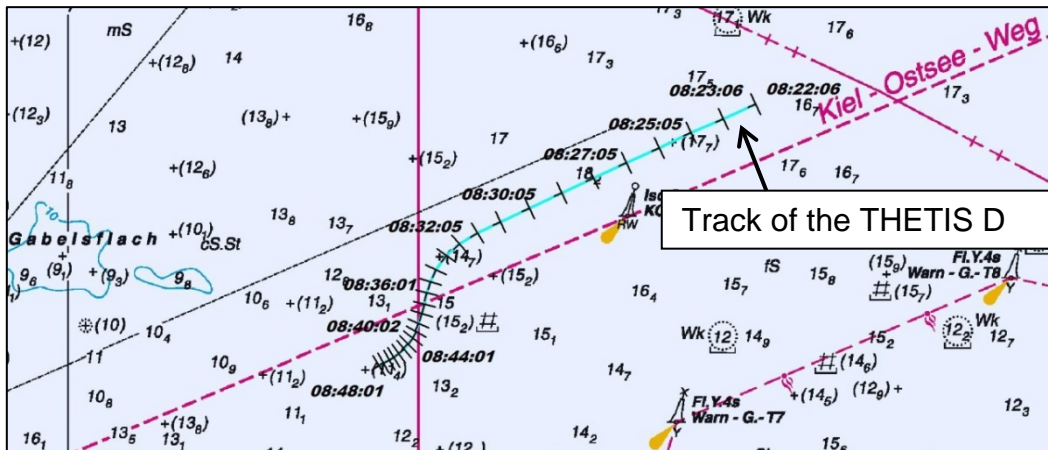
Figure 17: Course of the voyage taken by the THETIS D

The course of the voyage shows that the THETIS D started to cross the Kiel-Baltic Sea route separation line at 0837 and then drifted NUC against the recommended direction of the Kiel-Baltic Sea route in the German Exclusive Economic Zone of the Baltic Sea.

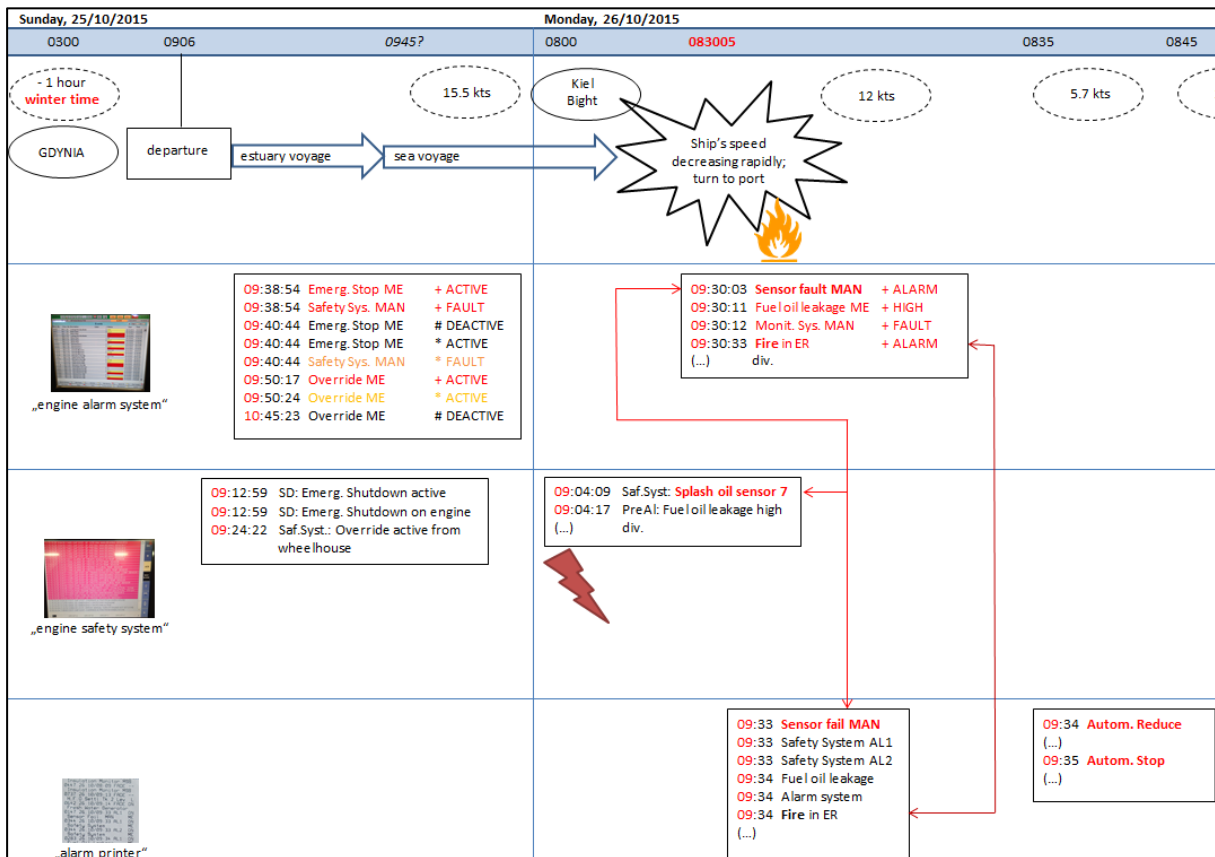
Figure 18: Engine alarms occurring at the time of the accident, extract from the BSU's graphical presentation

Reconstructing the course of the accident using alarm records from the THETIS D's ECR proved difficult. Some of the recordings of the various safety systems were only partially available and their entries differed from one another significantly. For example, the engine safety system recorded a splash-oil alarm for cylinder unit 7 26 minutes⁹ before the accident (see Figure 18¹⁰).

On the other hand, explaining the timing differences of the alarms recorded by the engine safety system was not so easy (see Fig. 18 on p. 29; synchronised to local time below):

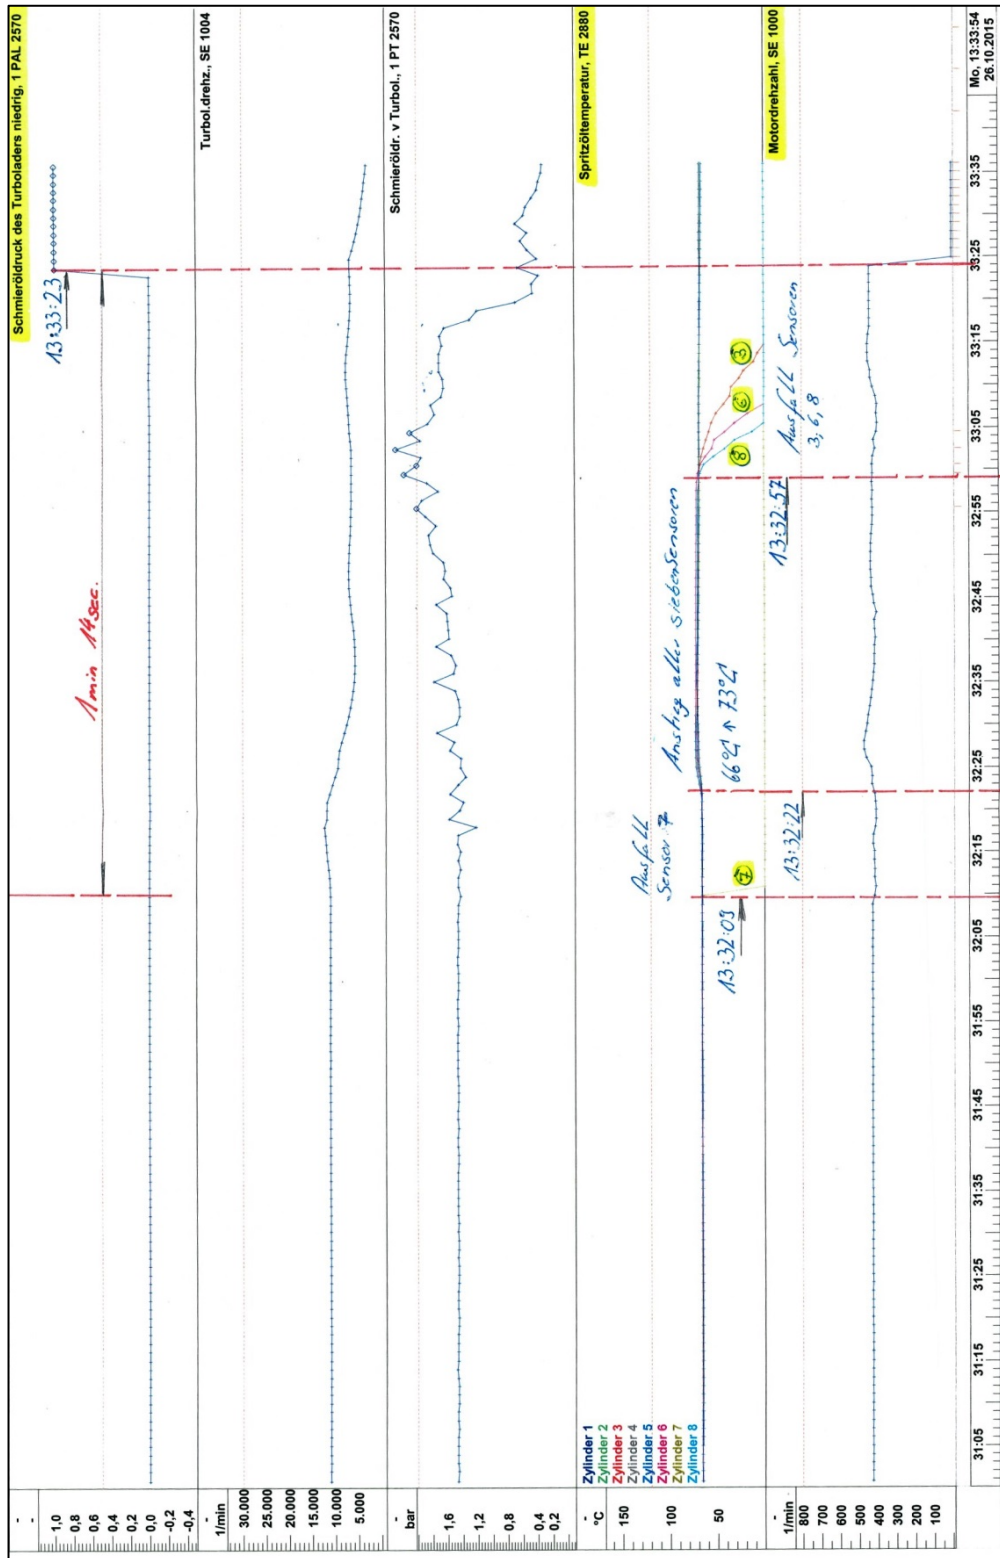
Figure 19: Extract from the manufacturer's diagnostic system for the main engine (splash-oil temperature and lubricating oil pressure in the turbocharger)

According to the configuration, the splash-oil monitoring system would have stopped the main engine with a delay of only 1.7 seconds if one of the two critical criteria had been met. This means that the main engine could not continue to run for several minutes after the damage occurred if the splash-oil monitoring system was functioning as it should. To prove serviceability, the BSU was submitted an extract from the manufacturer's own diagnostic system for the main engine in November 2016 (see Figures 19 and 20). The system time in the recordings deviates from local time by + 5 hours (13xx instead of 08xx). According to the recordings, the sensor in cylinder 7 failed initially. This was followed by a simultaneous increase in splash-oil temperature from 66°C to 73°C in the other sensors, before the sensors from cylinders 3, 6 and 8 also failed. The automated shutdown of the main engine

was triggered by insufficient lubricating oil pressure in the turbocharger before other safety systems were able to have any affect.

The documents show that at the time of the automated engine shutdown, neither of the two conditions (temperature 80°C or temperature difference +3 K) that would have prompted the splash-oil monitoring system to trigger the engine shutdown were met. The monitoring system for the turbocharger lubricating oil pressure was calibrated so that a drop in pressure to 0.9 bar would cause an automated engine shutdown. According to the recordings of the diagnostic system, this criterion was met at 083323, therefore causing the engine shutdown. Taking into account the time difference of + 5 hours, the documented time is consistent with the recordings on board (engine alarm system and alarm printer, recorded in UTC + 2 h) and the shore-based AIS recordings of the VTS (including SOG, recorded in UTC + 1 h) – see Spreadsheet 4 with synchronised times for ease of reference; all information in UTC + 1 h = local time.

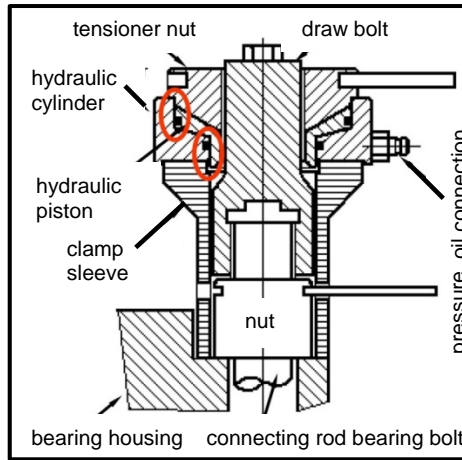
Figure 21: Hydraulic tensioning tool (schematic drawing)

The tightening of connecting rod bearing bolts as per the manufacturer's instructions required the use of hydraulic tensioning tools connected to a high-pressure pump (see Figure 21). The manual states the following with regard to functioning:

"The high pressure pump feeds a relatively small volume of liquid (if required, at a pressure of up to 1,500 bar) through the pluggable hose lines to one or more tensioning tools. If the piston of the tensioning tool is screwed onto the thread of the screw, the liquid raises the piston in the casing and extends the screw, whilst the tensioning tool is supported by the surrounding parts of the screw. The high pressure pump is operated by compressed air. The air is directed through control elements to a piston. This piston can be pressurized from both sides and is equipped with pistons of smaller diameter on both sides which draw in hydraulic oil from the surrounding reservoir, or which feed it to the distributor on the opposite side. As soon as the piston reaches an end position, the air flow is directed to the other side of the piston by a pilot valve, and the pumping and suction action is repeated. The effective pressure of the air is normally reduced in order to produce a pressure of 1,500 bar on the hydraulic side. An outlet pressure of 1,500 bar must not be exceeded."
