**Interim Report
to Investigation Report 52/18**

Serious Marine Casualty

**Allision between the container ship AKACIA
and a lock gate on the Kiel Canal
in Kiel-Holtenau on 19 February 2018**

18 February 2019

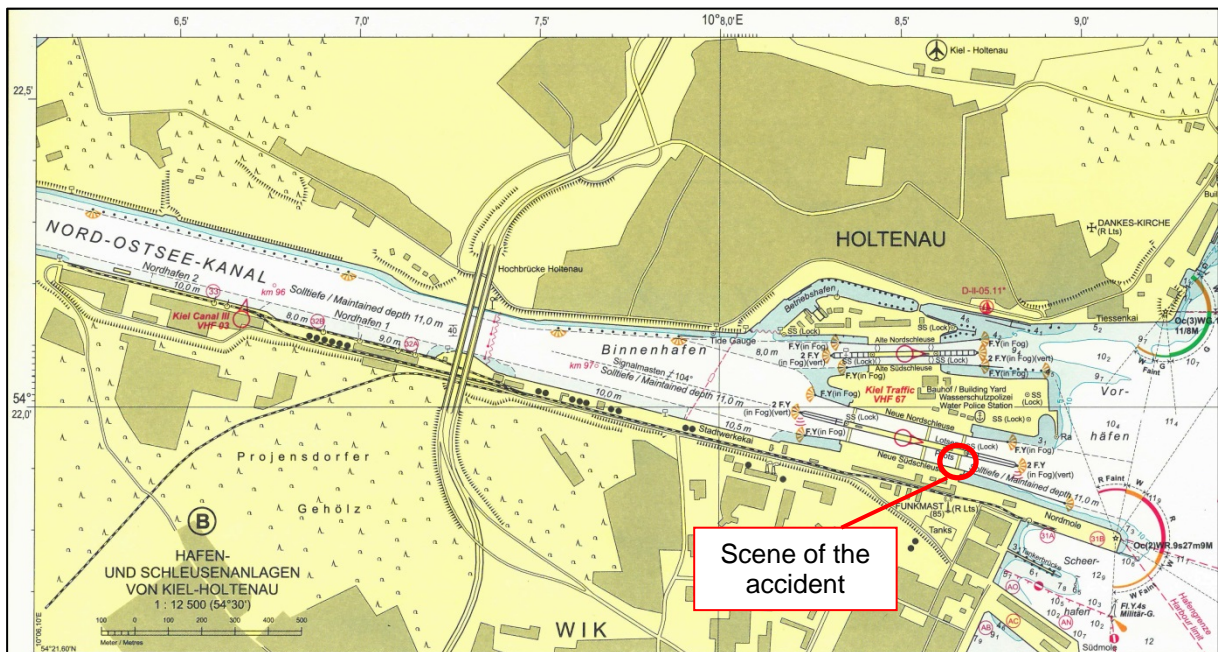
Figure 2: Navigational chart showing the scene of the accident

Type of marine casualty:	SMC, allision with lock gate
Date, time:	19/02/2018, 2354
Location:	Kiel-Holtenau, Kiel Canal
Latitude/Longitude:	$\phi 54^\circ 21.9'N$ $\lambda 010^\circ 8.6'E$
Ship operation and voyage segment:	Harbour mode
Consequences:	Ship unstopable due to damage to the controllable pitch propeller (CPP) system. She struck the Neue Südschleuse lock's seaward lock gate. This resulted in major damage to the lock gate and the ship's bow section. No people injured or water pollution

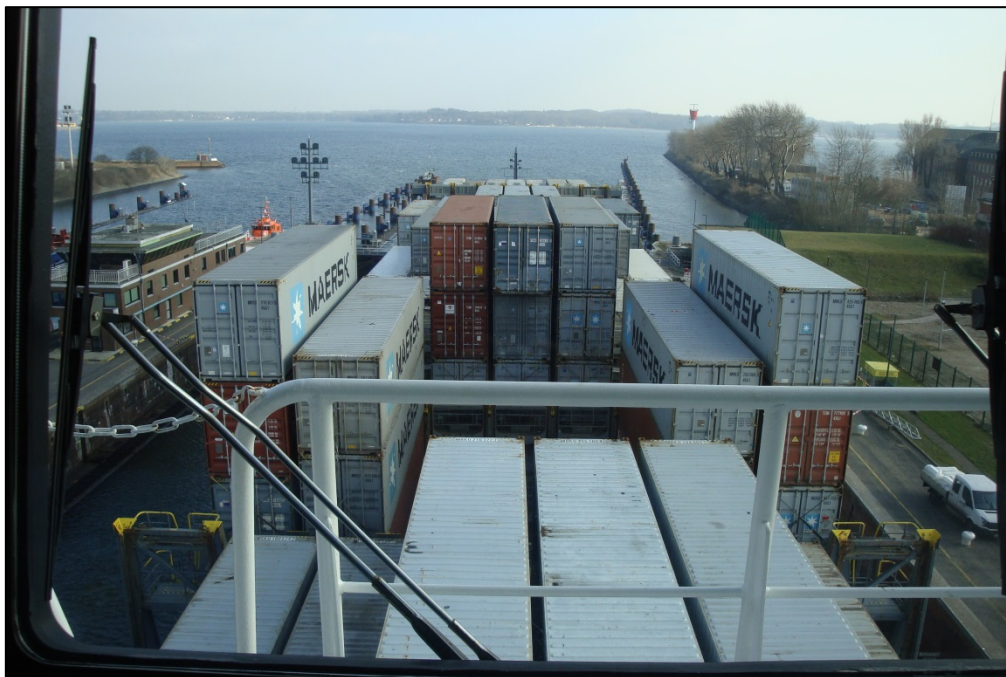
Figure 5: View ahead from the AKACIA's bridge

The AKACIA is a Sietas 168-L full container ship without cargo gear. Her storage capacity is 1,008 TEU³. The ship's superstructure is located aft. The ship has a completely enclosed bridge without open wings. Despite the deck cargo, visibility was not restricted any more than usual at the time of the accident.
