Bundesstelle für Seeunfalluntersuchung
Federal Bureau of Maritime Casualty Investigation
Federal Higher Authority subordinated to the Ministry
of Transport and Digital Infrastructure

Investigation Report 118/18

Less Serious Marine Casualty

Allision between VOS STONE and a wind turbine on 10 April 2018 in the Baltic Sea

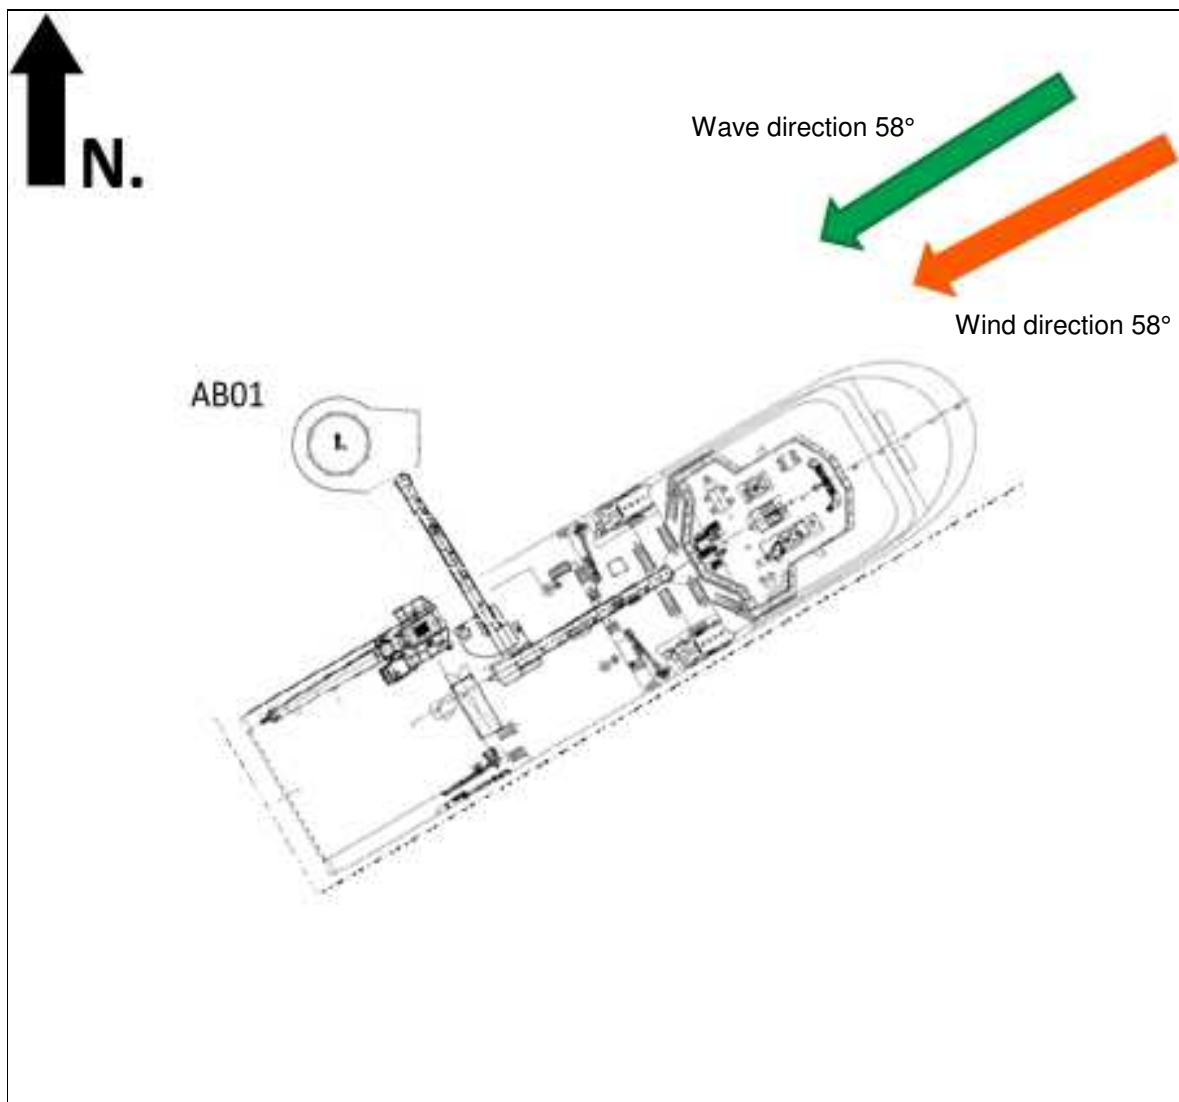
Figure 4: Initial situation at 1047

On the morning of 10 April 2018, the offshore supply vessel VOS STONE was operating in the AOWF at TP AB01, a wind turbine under construction. At about 1020, the VBMS tower work team, which was making the preparations necessary for feeding the cable on TP AB01, was called back to the VOS STONE due to deteriorating weather conditions. The return to the ship was carried out by means of an Ampelmann gangway and was completed at 1047 (see Figure 4).

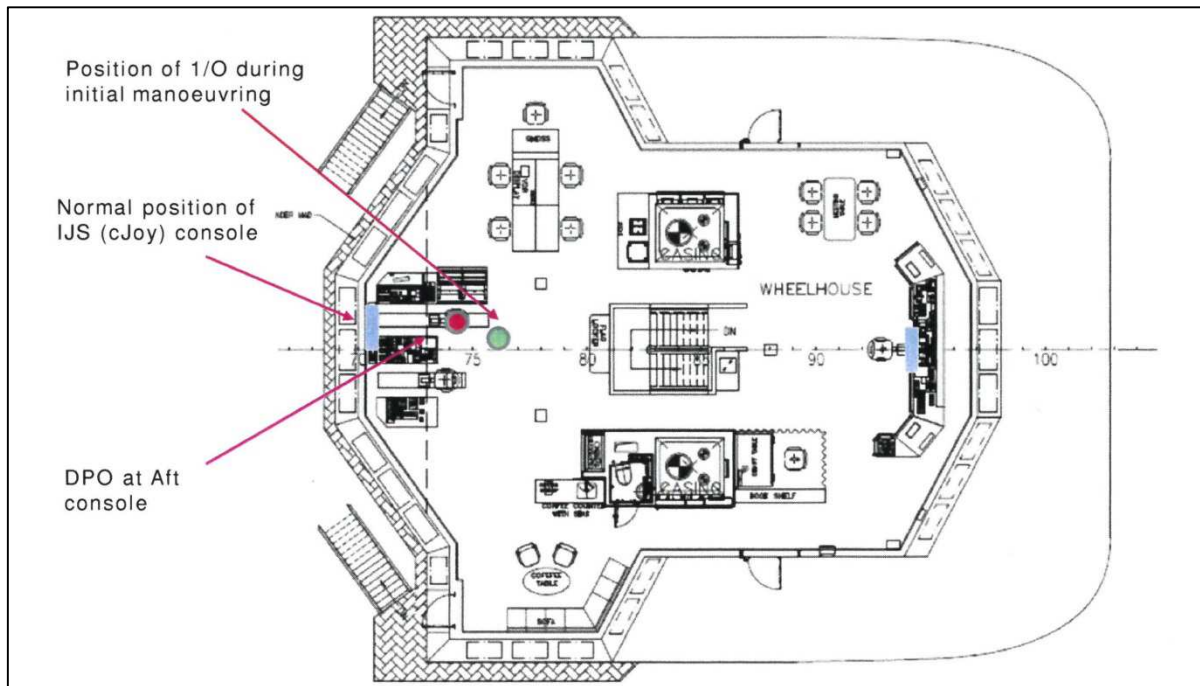
Figure 6: Initial situation at 1053

At 1047, the ship left the transition piece (AB01) under DP. The following people were on the bridge at this point: 1/O in the role of OOW/SDPO and 2/O in the role of DPO. After the Ampelmann gangway team had reported to the bridge that all workers were back on the ship and the completion of the personnel transfer, the 1/O instructed the 2/O to manoeuvre the ship away from TP AB01 and out of the area under DP (see Figure 6).

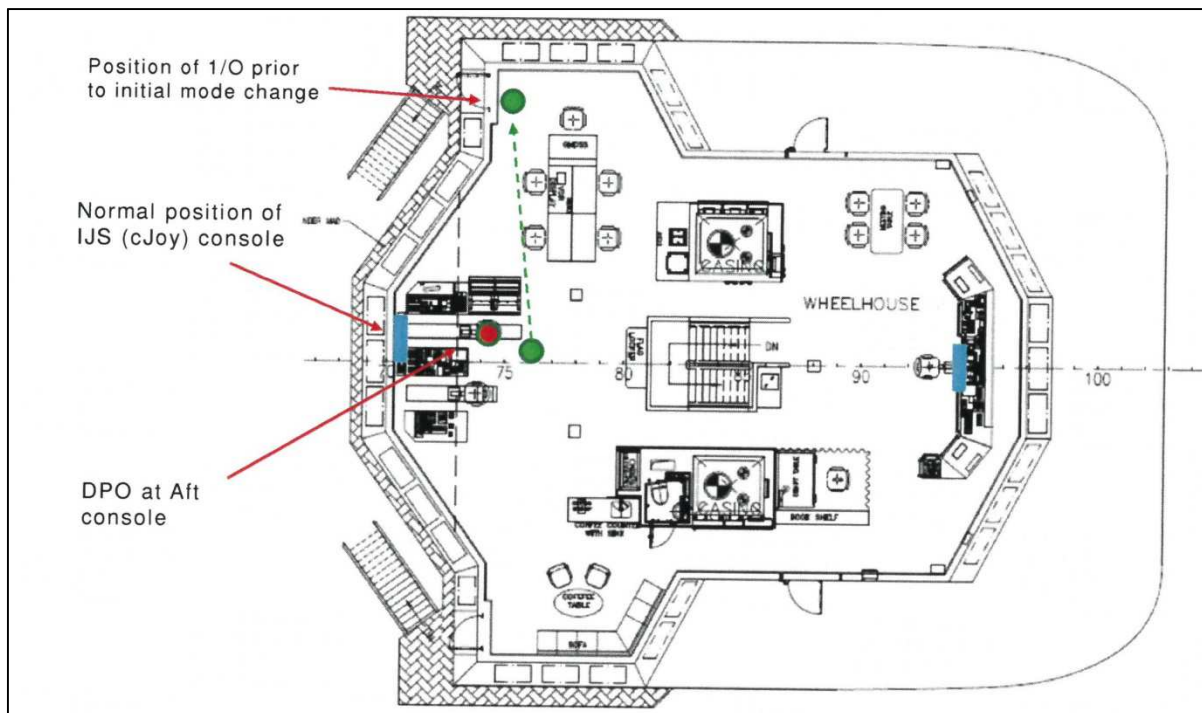
Figure 7: Situation at about 1055

The 1/O observed the manoeuvre until he was satisfied that the 2/O had implemented his instruction correctly and then went to the other side of the bridge to carry out a shift handover at the port and aft entrance to the bridge and to discuss the scope of work with the two crane operators (see Figure 7).

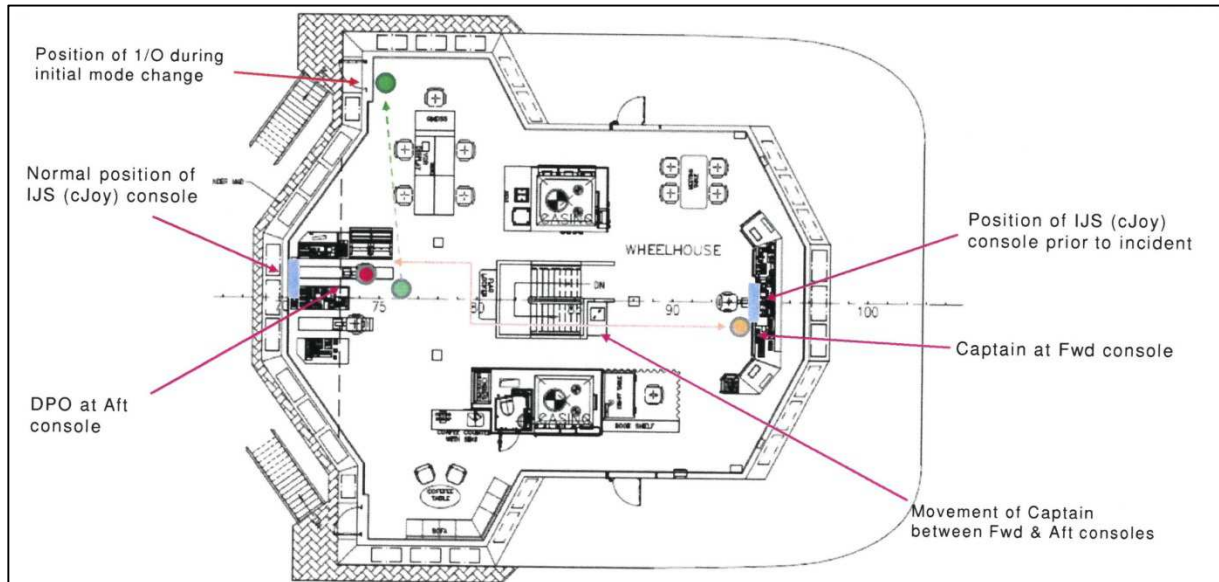
Figure 8: Situation at about 1059

At this point, the master returned to the bridge to enable and test the IJS cJoy at the forward control position. He did not notify the OOW of this. After the connection with the console had been established, he instructed the 2/O, from his position at the aft control position, to switch from DP to the IJS cJoy. However, since the 2/O was not sure how to switch over, he brought the ship to a standstill using DP, while the

master proceeded to the aft control position to show the 2/O the switch in question. The master switched the selector from DP to cJoy before returning to the forward control position (see Figure 8).

After this switch over, the DP system was disabled, as was the thruster control, resulting in the ship drifting in a north-easterly wind (wind speed about 28 kts) at a distance of about 119 m from TP AB01 (see Figure 4). The motion of wind and waves had already turned the ship back toward the TP when the master, after going from the aft console to the forward edge of the bridge, tried to take control by means of the IJS cJoy, albeit unsuccessfully. He then requested assistance, at which the 1/O went to the master's position and attempted to enable the IJS. However, he only succeeded in doing this just before the first allision.

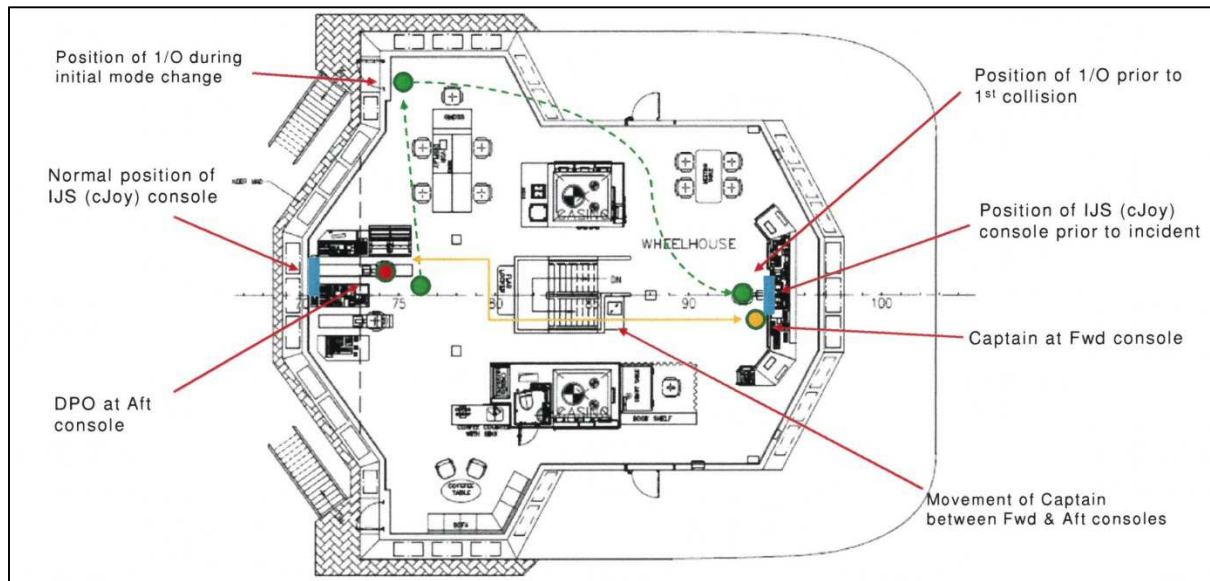
Figure 9: Situation at about 1101

After the master failed to regain control of the thrusters, he requested assistance. The 2/O notified the 1/O and asked him to assist the master at the forward console. The 1/O hurried to assist and attempted to take manual control by asking the 2/O to transfer control from the aft DP station. The master instructed the 2/O to switch to manual operation, but the latter did not understand or hear this instruction and switched the selector back to DP.

At this point, the master wanted to know who was steering and went to check. He found that DP mode was selected and switched back to manual mode just before the first collision. The first collision happened at about 1102 when the VOS STONE's upper port bulkhead struck the outer edge of the external platform of the TP on AB01, resulting in damage to the hull level with the crew's living quarters on the port side and thus at three empty cabins. The force of the impact lifted the support bolts of the external platform on the flange deck out of their mounts and the deck rotated some 90° anticlockwise. The 1/O switched to full thrust at the forward steering console and turned the ship to port, so as to move the stern away from the TP (see Figure 9). A second collision nonetheless occurred at 1103, this time when the outer edge of the ship's crane platform struck TP AB01's external platform.

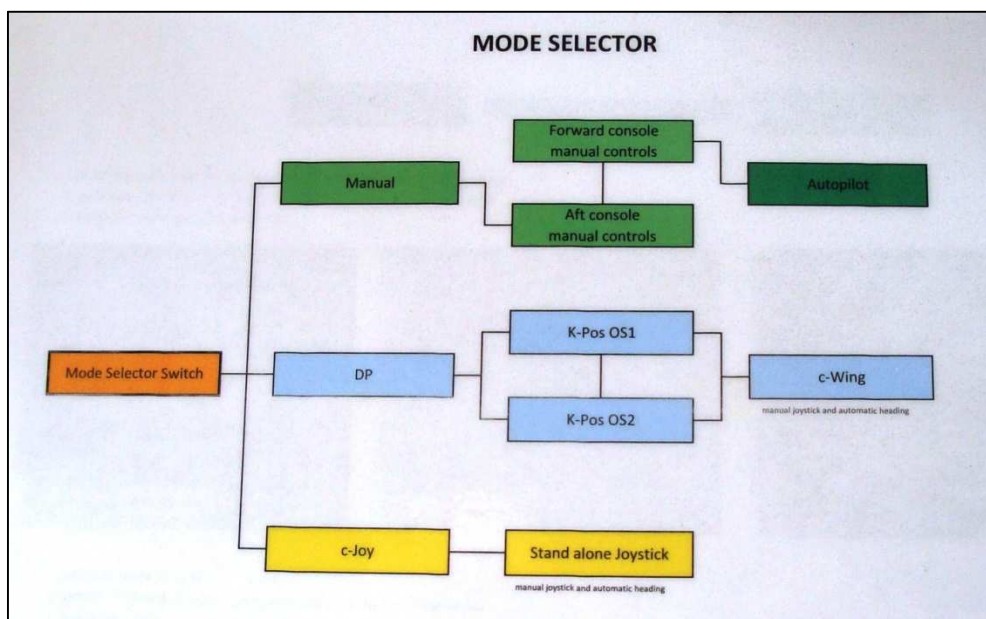
Figure 18: Options for controlling the ship

Unlike transferring at the joystick on the DP operator stations, which would have made it possible to continue accessing the ship's thrusters and sensors with DP at the touch of a button, switching the manual selector for the control mode to the IJS (which is basically a backup system for thruster control and not affected by DP) isolated the ship from DP control.

There are three modes available for controlling the VOS STONE from the bridge: Manual, DP, cJoy.

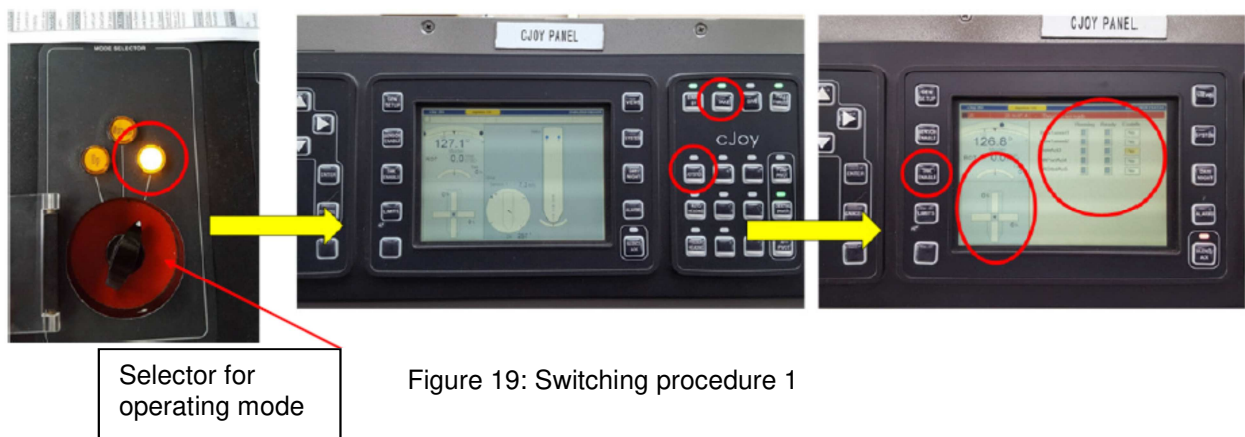
Figure 19: Switching procedure 1

1. Switch selector from *DP* to *cJoy* (left image).
2. Confirm command on cJoy control panel by means of *Take* and *Joystick* => Confirm all thrusters are available and enabled (middle image).
3. Check if cJoy is responding by changing the default value and waiting for the thrusters to respond (right image).

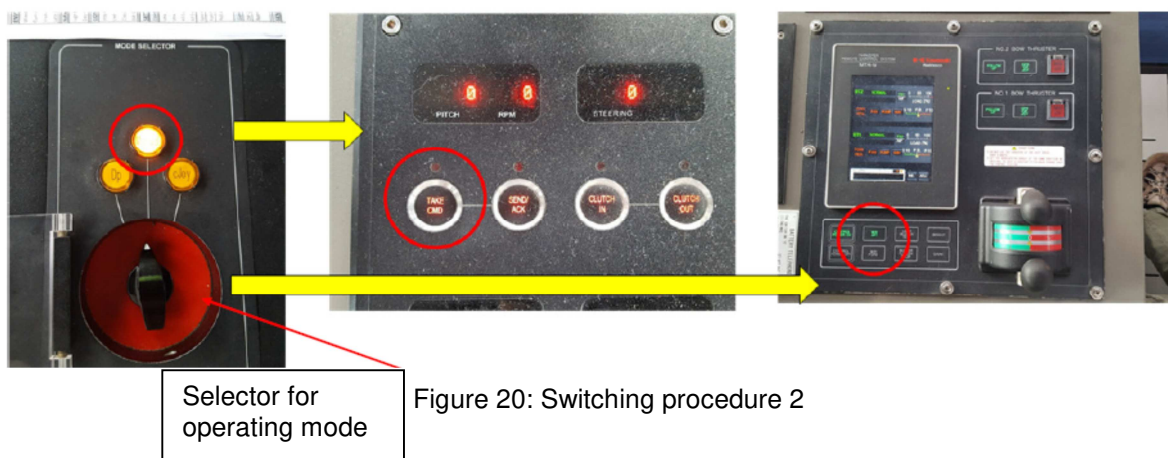
Figure 20: Switching procedure 2

1. Set DP selector to *Manual* (left image).
2. Apply switch over by pressing the *Take CMF* buttons on both azimuth levers on the aft control position (middle image).
3. Check the thrusters by making sure they respond to the levers on the aft control position (right image).
