## **Investigation Report 168/16**

### **Very Serious Marine Casualty**

**Fatal person-overboard accident involving a  
crew member of the fishing vessel  
PESORSA CUATRO  
150 nm west of Ireland  
on 17 May 2016**

18 February 2019

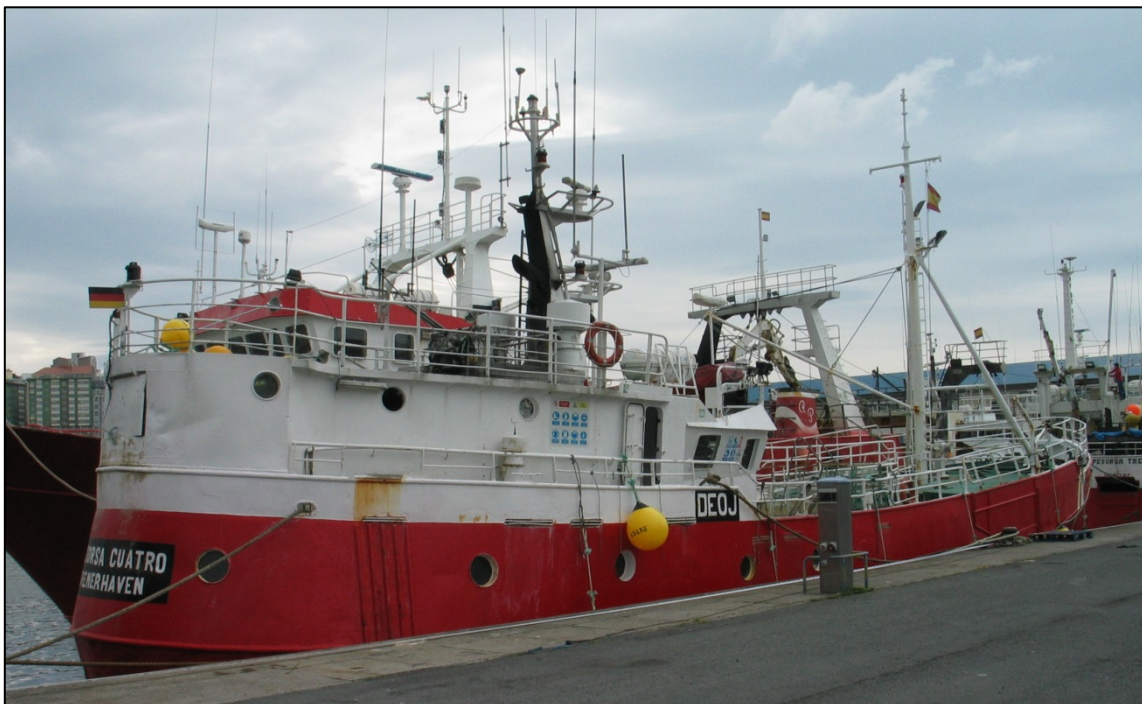
Figure 10: The PESORSA CUATRO at the time of the BSU's survey

The vessel in the port of A Coruña with pots and marker buoys stowed on deck.
