Bundesstelle für Seeunfalluntersuchung
Federal Bureau of Maritime Casualty Investigation
Federal Higher Authority subordinated to the Ministry
of Transport and Digital Infrastructure

Summary Investigation Report 20/17

**Failure of the main engine with subsequent
emergency anchor manoeuvre on the bulk carrier
MV CAPE LEONIDAS on 17 January 2017 in the area
of Kolmar on the River Elbe**

6 November 2019

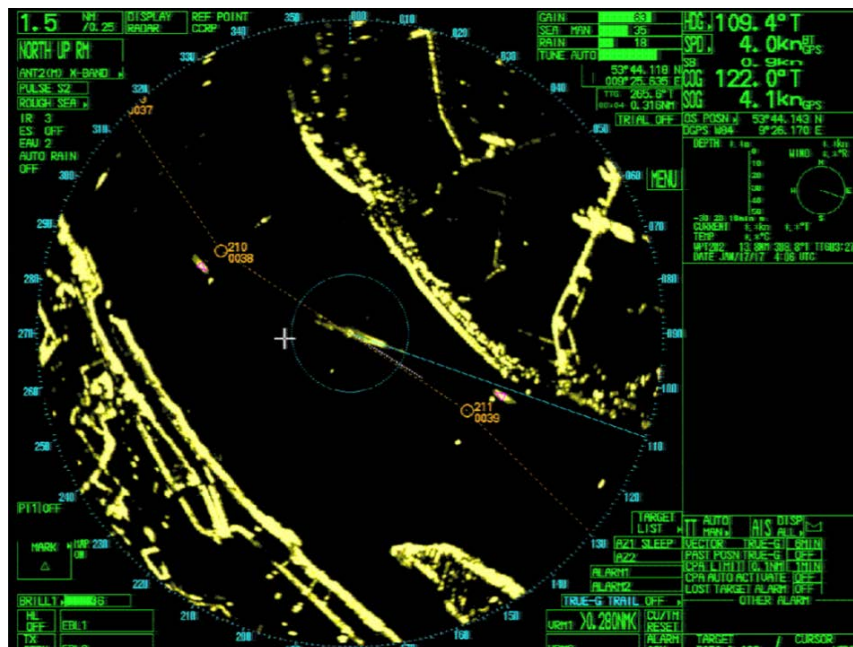
Figure 3: MV CAPE LEONIDAS – radar image at the time of the first emergency anchor manoeuvre³

The bulk carrier CAPE LEONIDAS (flag: Marshall Islands) was fully laden with ore and started to experience problems with her main engine at about **0330²** on **17 January 2017**. At this point, the ship was sailing toward Hamburg in calm winter weather on the River Elbe. She was manned by a pilot who was assisted in his advisory activities by a radar pilot at Vessel Traffic Service (VTS) Elbe. Due to her draught, the CAPE LEONIDAS was reliant on the maximum water depth, which was only available on the fairway for the entire length of the passage from Brunsbüttel to Hamburg during high tide. All efforts made on board to remedy the technical issues failed. The engine failed for the final time at about **0414** and could not be started again afterwards. Following that, the pilot notified the VTS at about **0420**, taking the precaution of requesting tug assistance in the process. A total of seven tugs from Brunsbüttel, Stade and Hamburg were deployed. The forecabin of the distressed vessel was manned and the starboard anchor made ready to drop. The ship was being sailed at about 12 kts when the engine failed. She inevitably lost speed gradually afterwards but was still easy to steer for some time, even without propulsion. The CAPE LEONIDAS's speed had slowed down to some 4 kts by about **0501**. Since the steering had deteriorated substantially, an emergency anchor manoeuvre was unavoidable. Accordingly, the starboard anchor was first lowered and then its entire length (13 shots) deployed at **0507** (see **Figure 3**).

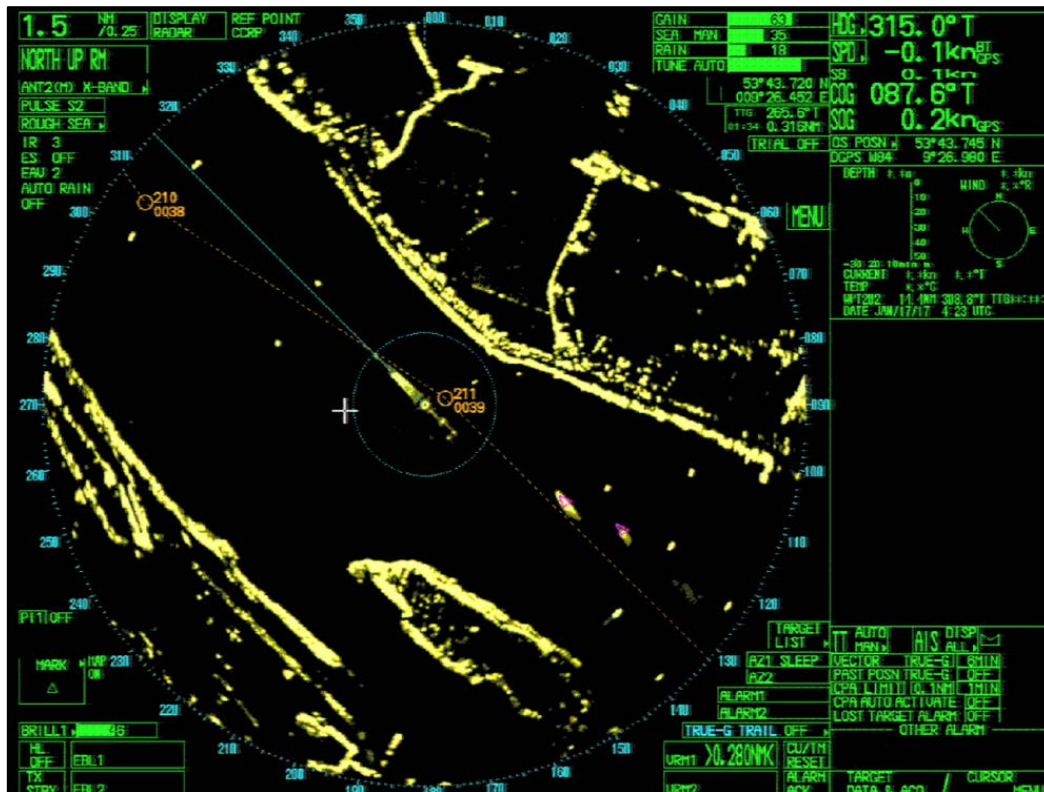
Figure 4: MV CAPE LEONIDAS at her first emergency anchorage (after swaying toward the sea)

This made it possible to stop the ship completely within about the following 15 minutes and hold her in a constant position from about **0523** onwards. In the meantime, the rising tide had caused the laid up vessel to sway about 180 degrees toward the sea port stem first (see Figure 4).

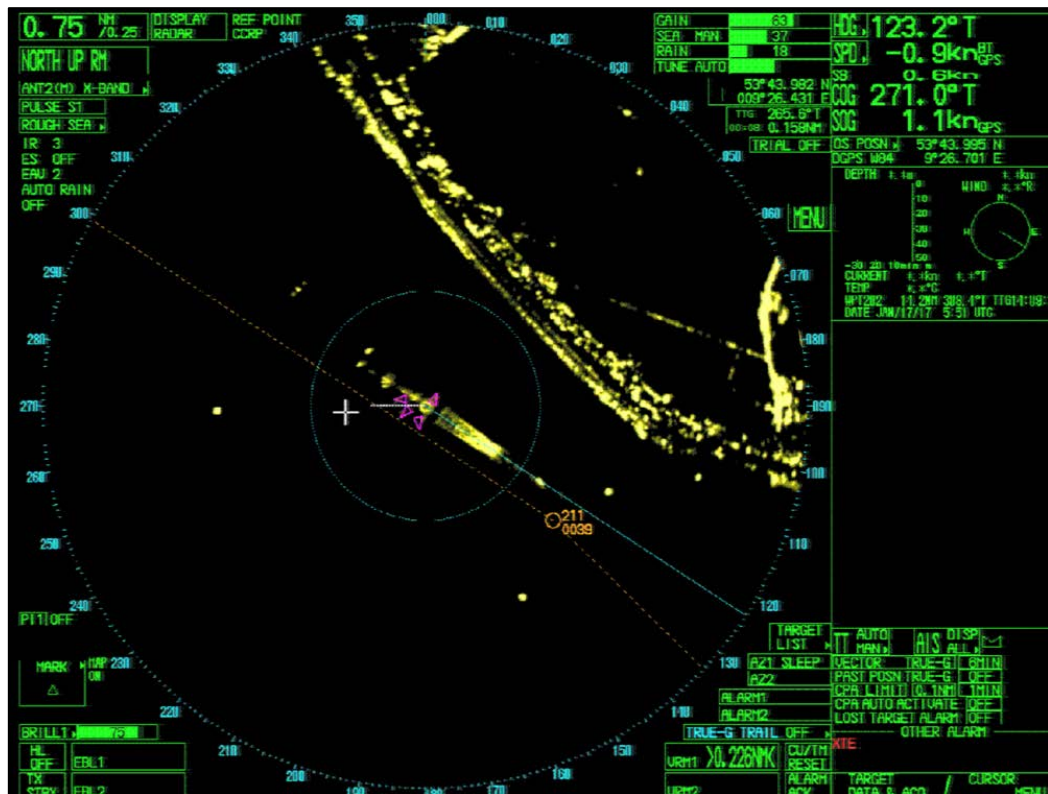
Figure 5: MV CAPE LEONIDAS after the turn required for shifting to her second anchorage

To execute this plan, they initially started to turn the distressed vessel 180 degrees in the fairway (i.e. in the direction of Hamburg) port stem first with tug assistance at about **0606**. Two tugs (BUGSIER 18 and WOLF) had already made fast aft for this purpose. The two other tugs were positioned fore and aft on the port side of the CAPE LEONIDAS to push and stabilise. During the turning manoeuvre, which was completed by about **0651** (see Figure 5), the distressed vessel hauled in several shots of her starboard anchor's chain cable, as planned.

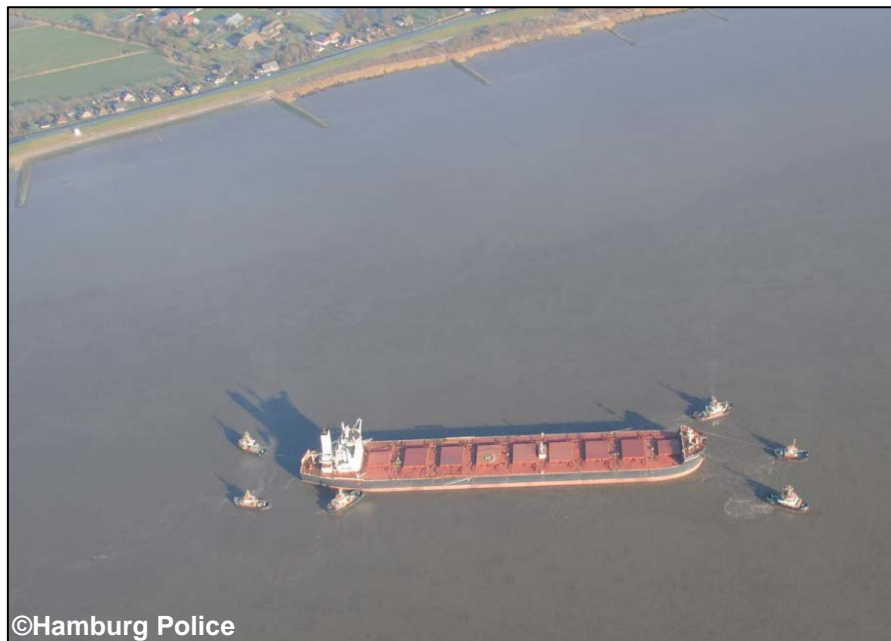
Figure 6: The MV CAPE LEONIDAS secured by tugs in her waiting position in the fairway on the River Elbe in the area of buoy 89, which had been pulled in

At **1017**, the tugs had towed the CAPE LEONIDAS to her final waiting position in the area of buoy 89, which had been pulled in. The distressed vessel then dropped her port anchor there and in the hours that followed was kept in line with the fairway with the continued support of the tugs. She was thus prevented from grounding or running aground.

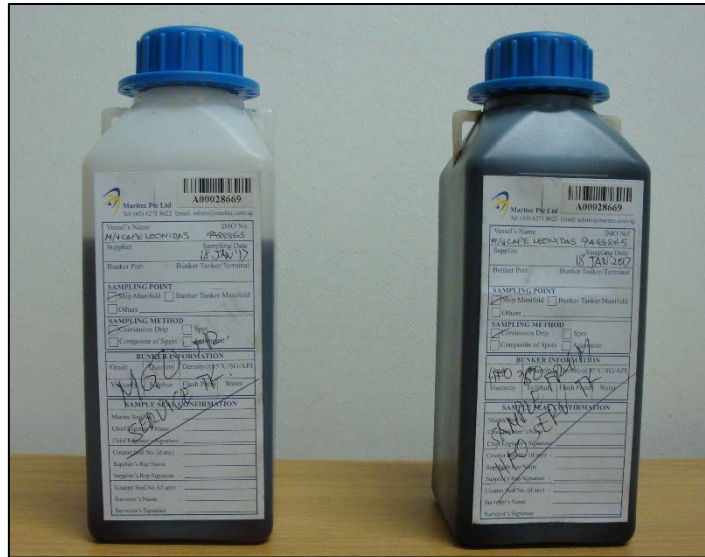
Figure 10: Fuel samples from the CAPE LEONIDAS's day tanks

*IFO and MGO samples were taken from the day tanks at the request of the expert. The chief engineer provided clean sample bottles (capacity of about one litre), which he filled with the corresponding fuels from the day tanks and then labelled (see **Figure 10** below). The samples were given to the expert for later analysis.*

The laboratory's analysis report dated 6 February 2017 indicated that none of the test results were conspicuous. This means that incompatibility of the fuels involved in the changeover can, with high probability, be ruled out as being partly or solely responsible for the incident. The cause of the solid deposits in the injectors (even though the IFO was fluid at ambient temperature) could not be clarified conclusively.

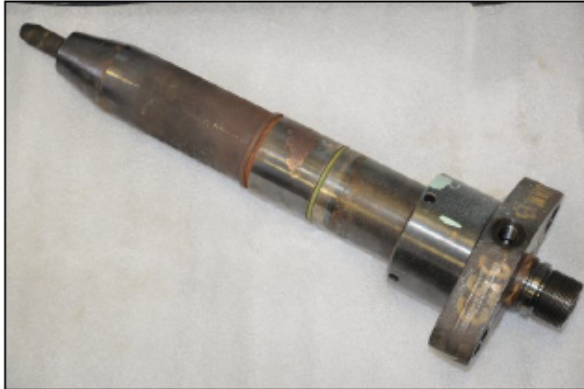
Labor_2017.02.01_0043

Anlieferungszustand

Kraftstoffeinspritzventil

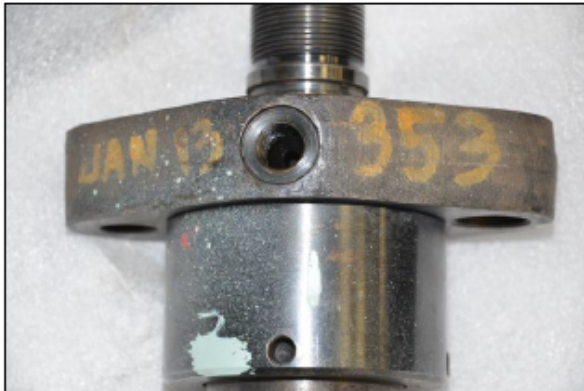
Labor_2017.02.01_0044

Markierung am Kraftstoffeinspritzventil

JAN13 353

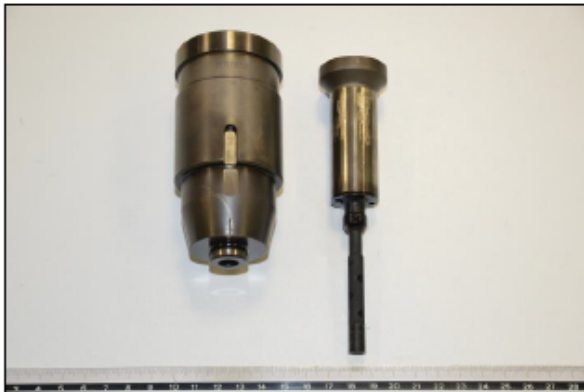
Labor_2017.02.01_0046

Einspritzventilkomponenten

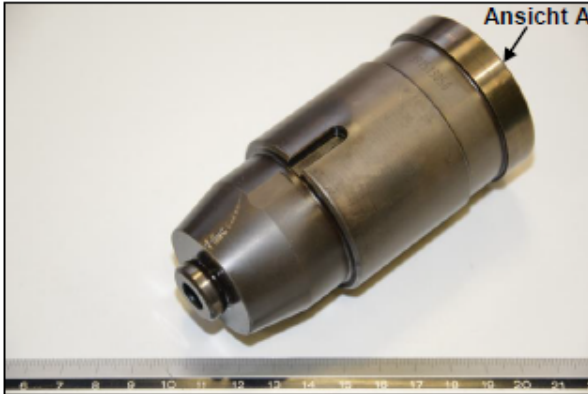
Labor_2017.02.01_0049

Düsenkörper

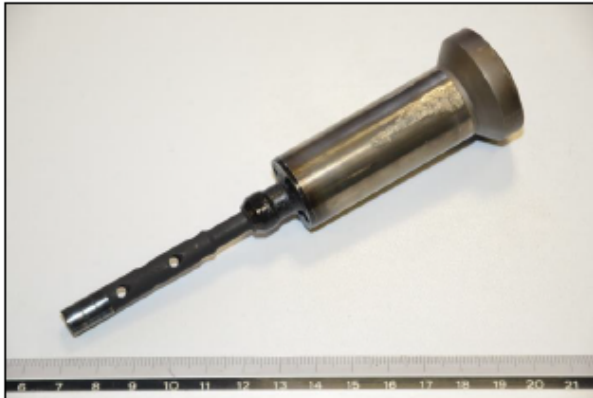
Labor_2017.02.01_0056

That initially explained why the nozzle failed to open/inject within the specified pressure range on the ship's test rig (pressing tool). The nozzle needle exhibited signs of surface damage but it was not possible to see inside the nozzle body to begin with.

Düsenadel

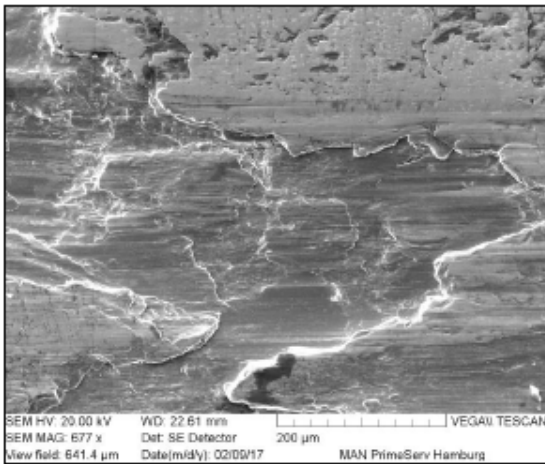
REM 1

Die Mantelfläche weist in diesem Bereich Fressspuren auf.

Detailvergrößerung
