Investigation Report 408/17

Serious Marine Casualty

**Grounding of the bulk carrier
MV GLORY AMSTERDAM
on 29 October 2017 about 1.6 nm north of the
North Sea island of Langeoog**

6 March 2019

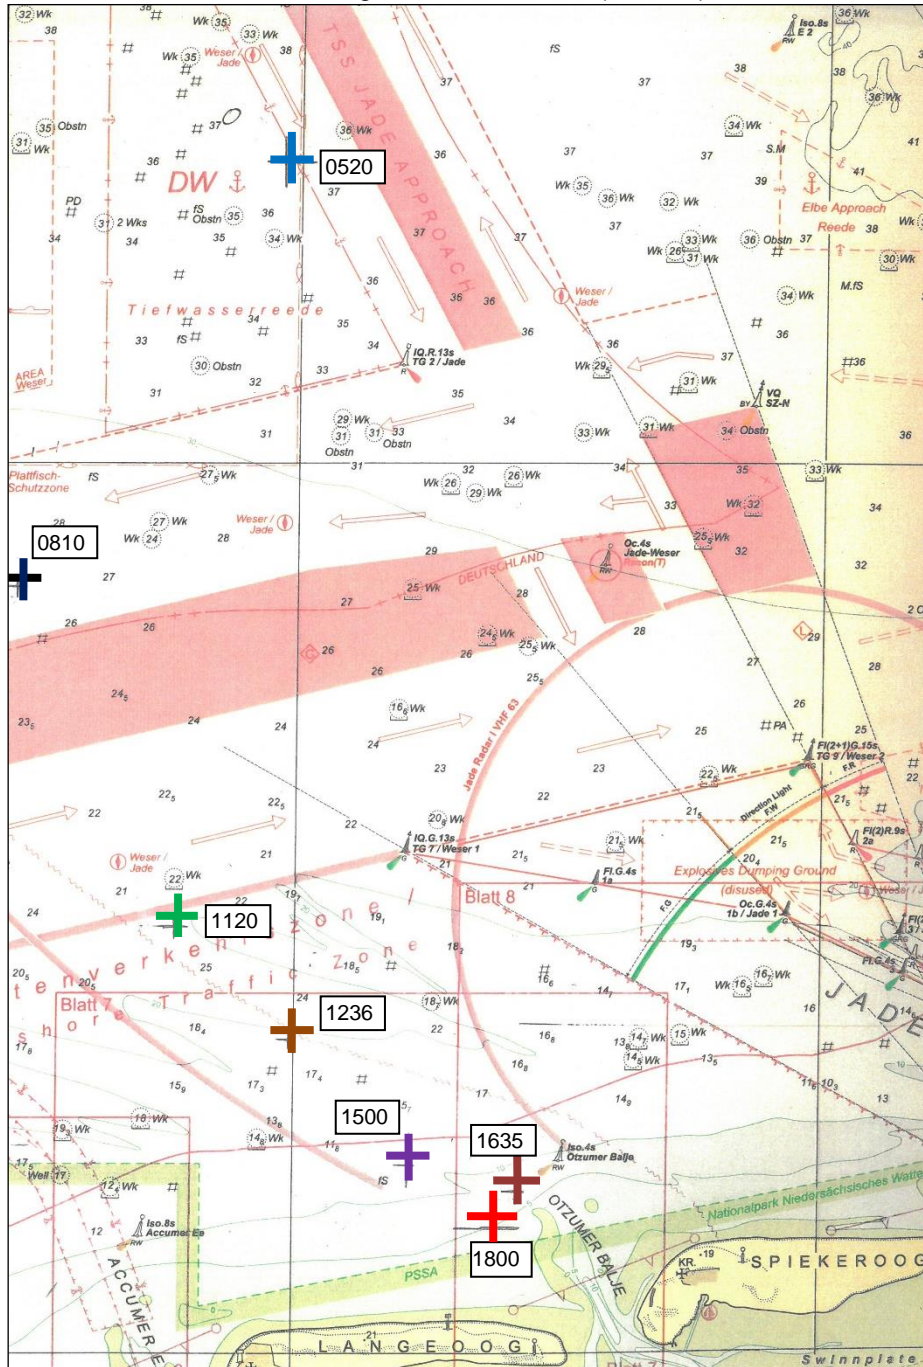
Type of accident:	Serious marine casualty
Date, time:	29/10/2017 at about 1800 CET
Location:	North Sea; 1.6 nm north of Langeoog
Latitude/Longitude:	Approximately ϕ 53°47.2'N λ 007°35.9'E
Ship operation and voyage segment:	Drifting from roadstead despite two anchors dropped
Consequences:	Grounding and rudder damage. No physical injuries or environmental damage

Figure 2: Scene of the accident

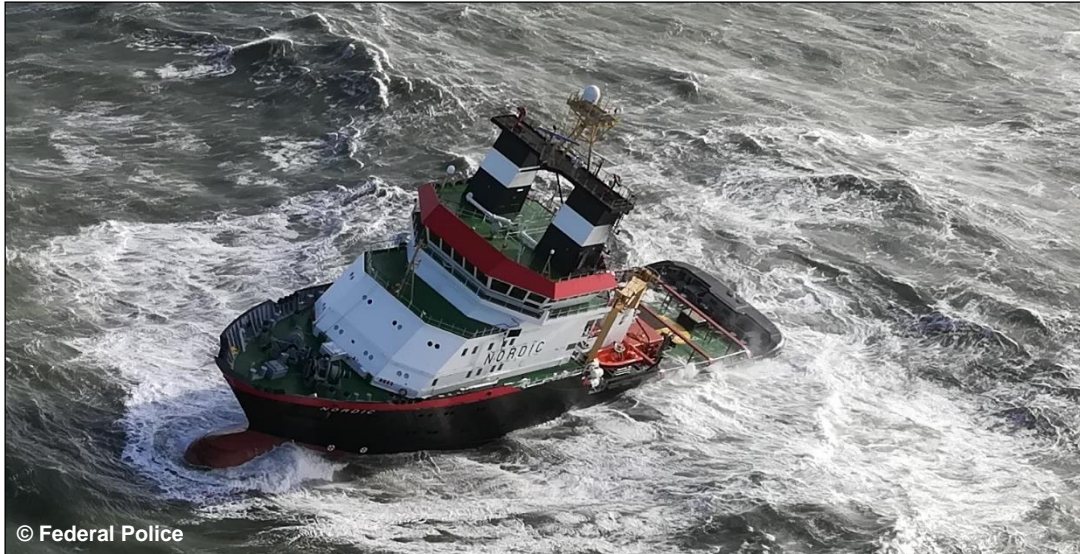
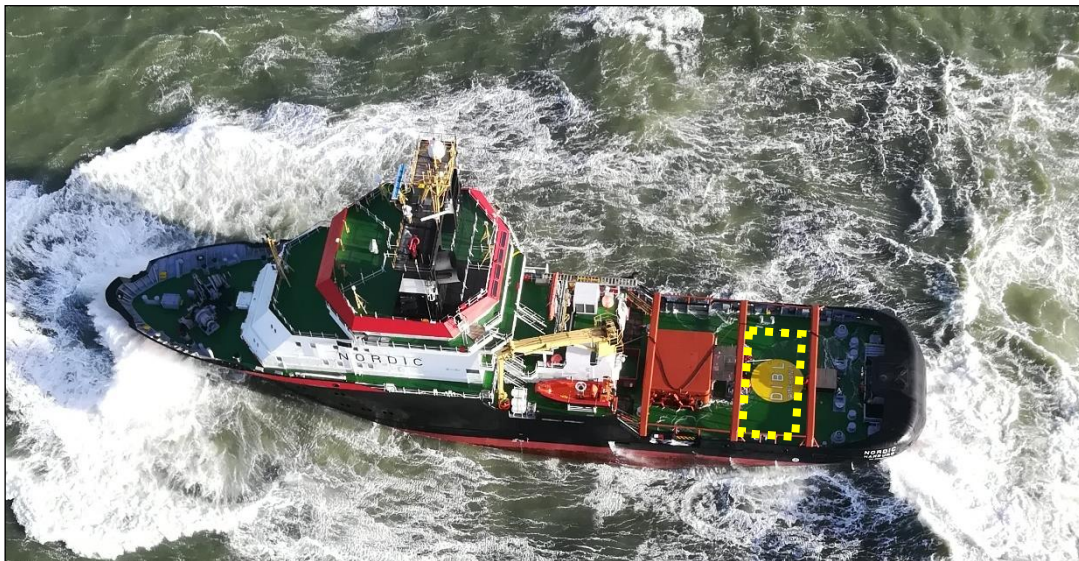
However, the corresponding efforts failed due to the extremely violent movements of the NORDIC in the stormy sea (see **Figures 5 f.** below). In addition to the resulting difficulties in lowering the winch hook down to the very limited area within reach of the tug's deck crew (see yellow marking in **Figure 6**), there was the particular danger that a person hanging from the winch hook could be hurled against components of the NORDIC, which was rolling and pitching violently in the swell, before reaching an uncritical height above the vessel.

Figure 5: ETV NORDIC heeling to port – seen from the Federal Police helicopter

Figure 6: ETV NORDIC pitching – seen from the Federal Police helicopter

For these reasons, the attempts to transfer BT NORDIC to the GLORY AMSTERDAM via helicopter were abandoned at 1137.

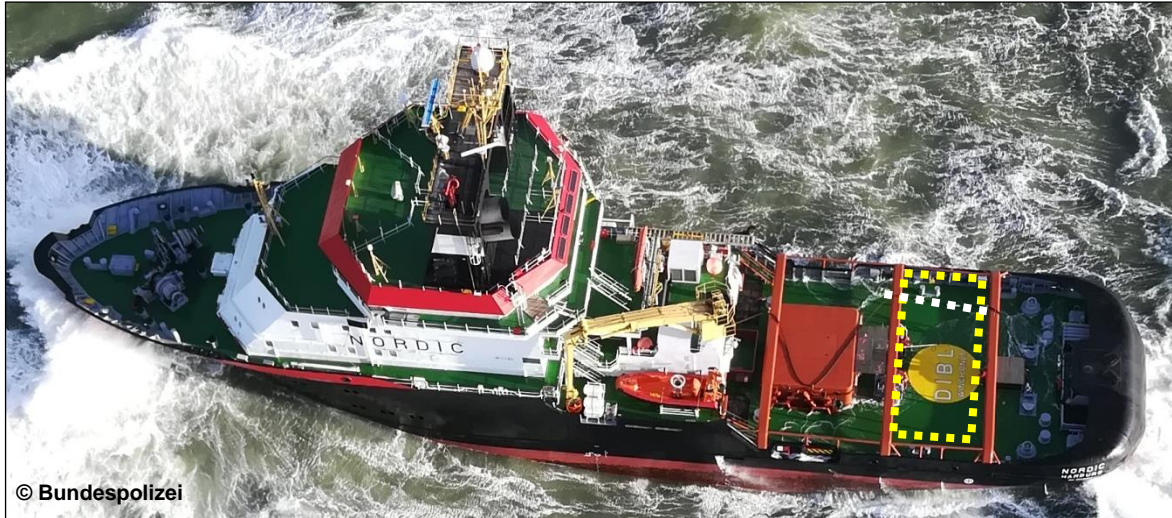
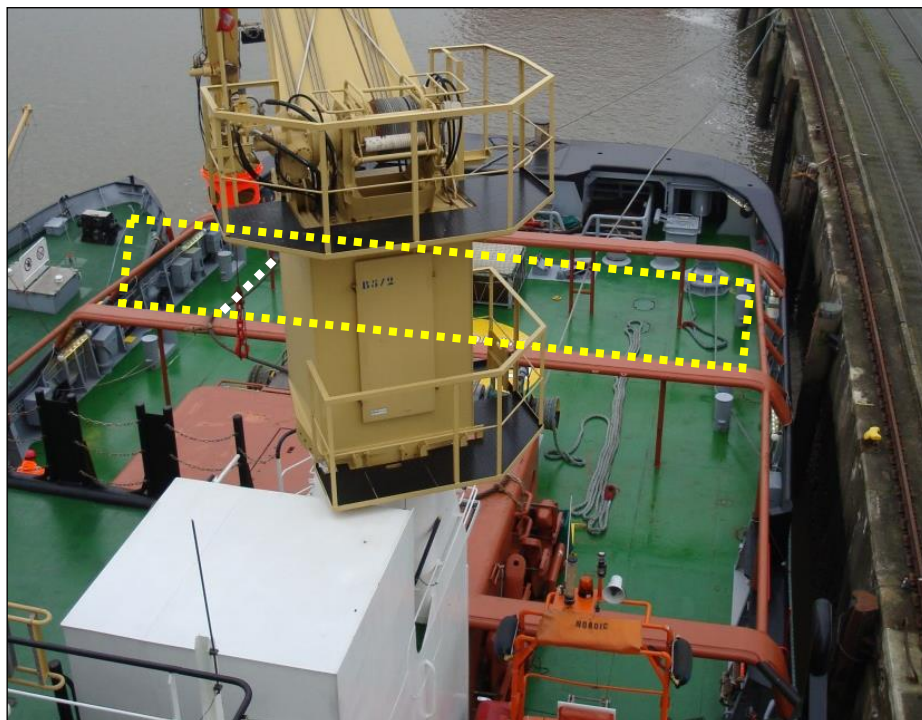
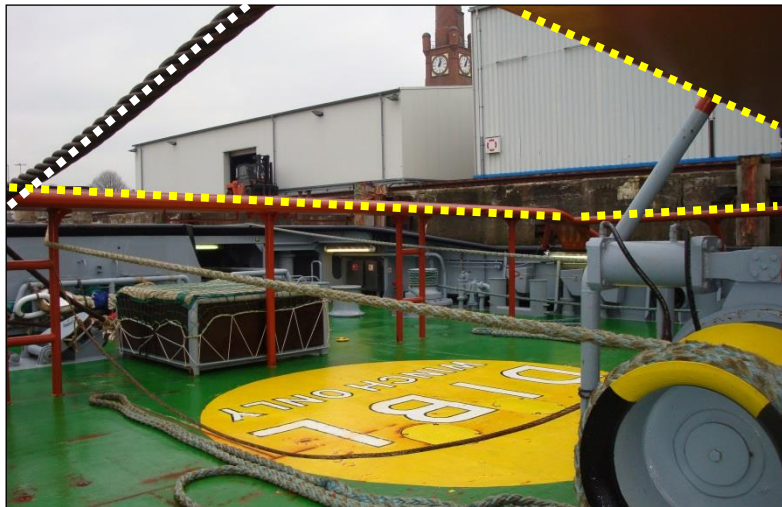
However, in several attempts on the day of the accident, it was actually not possible for the experienced helicopter pilot from the Federal Police to lower the winch hook (see red marking in **Figure 32** below) into the area within reach of the tug's deck crew, which was spatially bounded by two towing rails positioned athwartships (see yellow markings in **Figures 32 ff.** below) and a towing cable running in a longitudinal direction above the two rails (see white marking in **Figures 32 ff.**).

Figure 33: ETV NORDIC on the day of the accident (winch area marked yellow)

Figure 34: Lateral view of the winch area (bounded by steel towing rails and towing cable)

Figure 35: Winch area bounded by steel towing rails and towing cable (partial view)

The convincing accounts of the helicopter crew to the BSU and the impression of the particular structural conditions of the winch area on the NORDIC gained personally leave the BSU in no doubt that under the prevailing extreme weather conditions and taking into account the particular structural arrangement of the NORDIC's winch area, there was no reasonable option for the helicopter's crew other than aborting the winch manoeuvre. A continuation of these efforts would undoubtedly have involved a risk to the lives of the personnel waiting to be lifted and possibly even of the helicopter crashing.

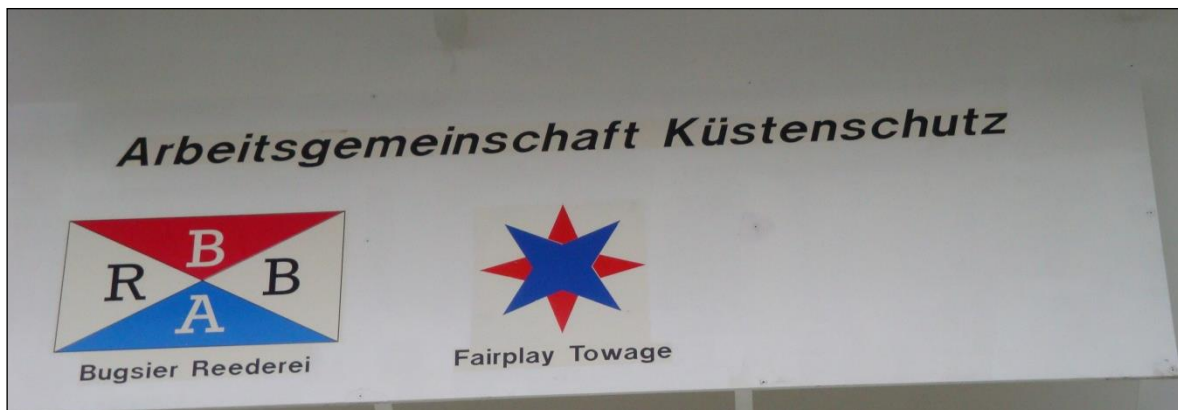
Although signs bearing the lettering 'Arbeitsgemeinschaft Küstenschutz' [coastal protection working group] and the logos of the owners Bugsier and Fairplay Towage (see **figures 37 f.** below) are mounted underneath the bridge deck on each side of the NORDIC, these signs are – especially because of the logos of the two owners – not a suitable means of illustrating that the vessel is operating on behalf of the authorities, but rather imply that she is a private salvage tug operating with commercial objectives.

Figure 38: Marking on the side of the NORDIC

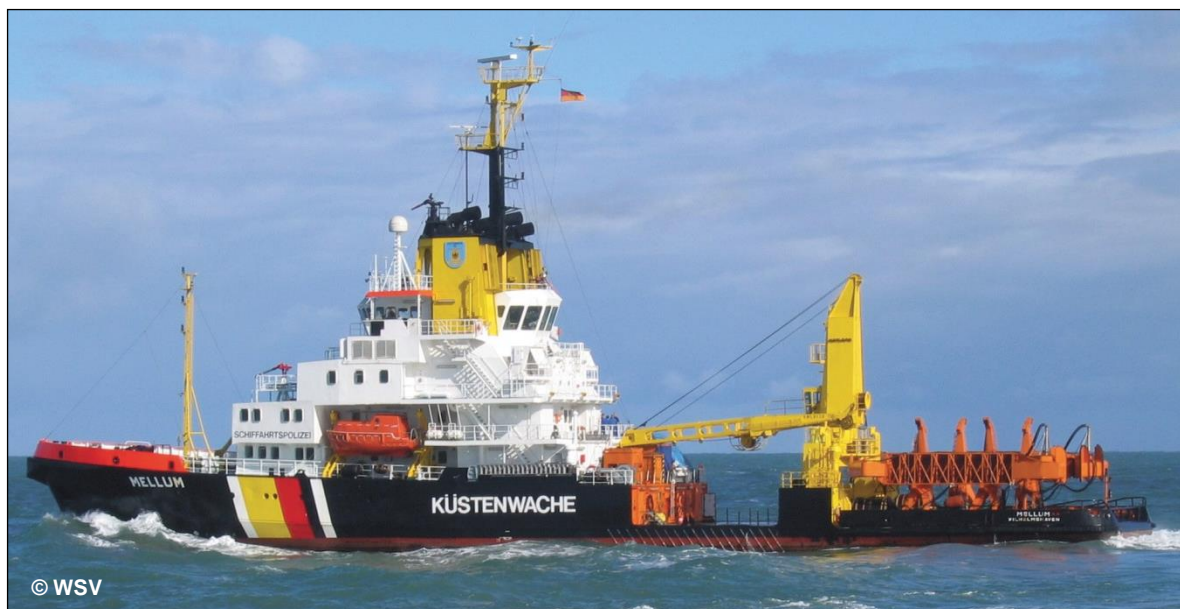
All in all, the MELLUM's master quickly realised that the actions crew members would have to perform on the main deck to establish a towing connection posed a risk to life and limb in the prevailing heavy swell due to the deck's low freeboard depth. **Figure 41** below shows the MELLUM with her extremely low working deck (aft of the superstructure, in particular) in very light swell and demonstrates that the master of the MELLUM's concerns were not unfounded in this regard.

Figure 41: Water pollution control vessel MELLUM

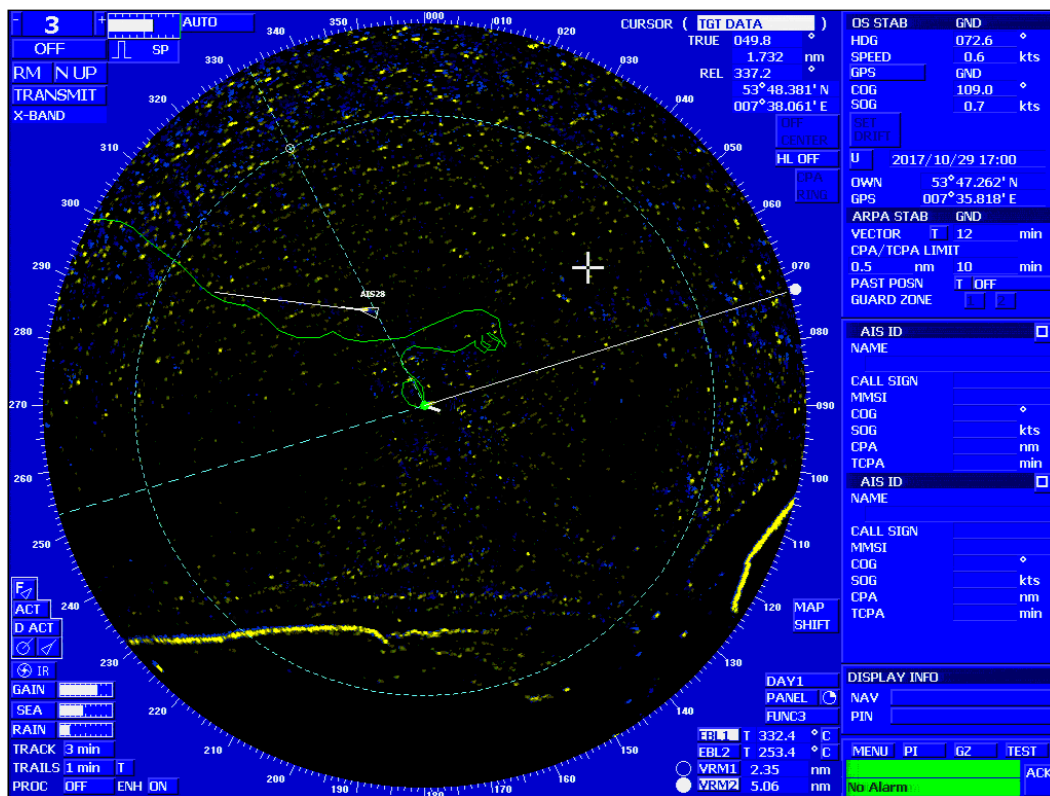
Figure 51: Radar image from the GLORY AMSTERDAM's VDR (time of grounding)

The recordings of the VTS, the AIS and the GLORY AMSTERDAM's VDR made it possible to unequivocally trace the chronological order of events leading up to and during the accident. Accordingly, it is established that at about **0520 on 29 October 2017**, the distressed vessel started to drift south from her anchor position (starting point of the accident) and ran aground at **1800** about 1.6 nm north of the North Sea island of Langeoog (see **Figure 51** below).

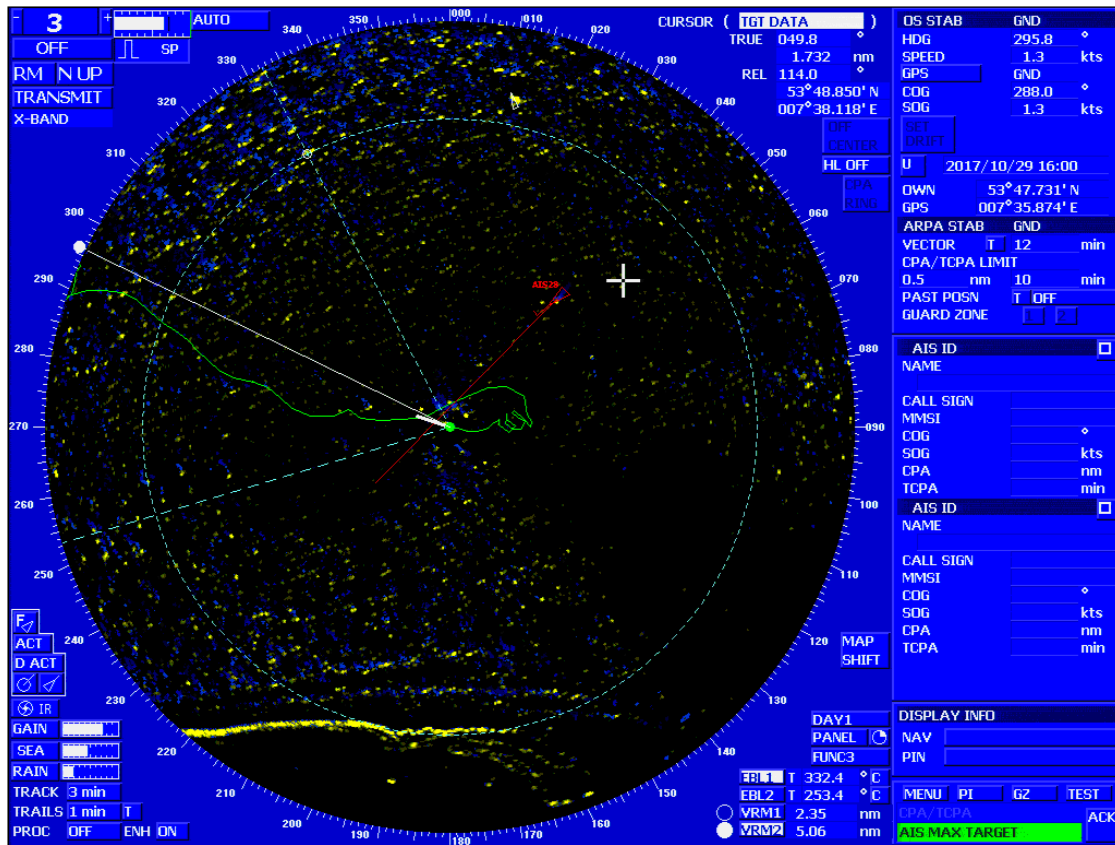
Figure 52: Radar image from the GLORY AMSTERDAM's VDR (one hour before grounding)

However, it is important to stress that the BSU is of the opinion that the crew of the NORDIC went to the limits of what was feasible in every respect given the technical and maritime constraints to assist the distressed vessel and that she was only 0.5 nm from the 5 m depth contour one hour before grounding, i.e. in a position that was beyond the limits of the ETV's regular operating capacity (see **Figure 52** below).

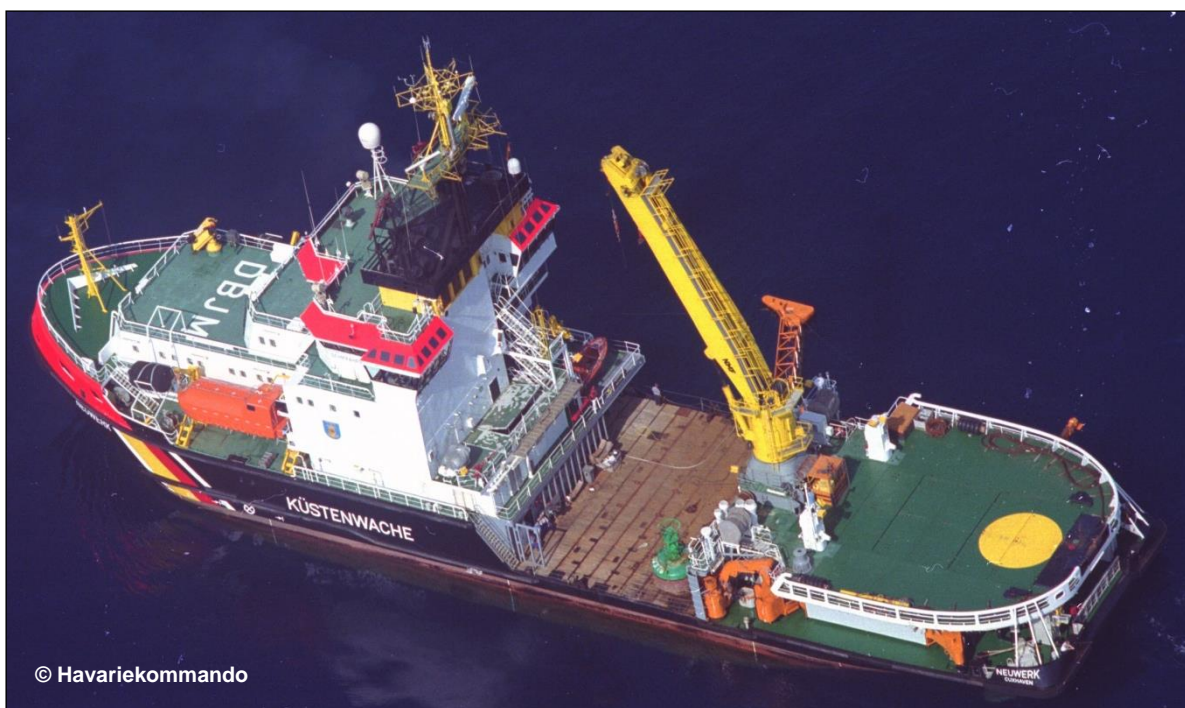
Figure 53: Water pollution control vessel NEUWERK

The BSU noted that unlike the structural conditions on the NORDIC, the raised working and towing deck on the NEUWERK has a much greater area available for carrying out unobstructed helicopter transfers, as well as for handling the lines and equipment required for establishing towing connections relatively safely and easily even under adverse external conditions (see Figure 53 below).

All in all, it became clear that unlike the MELLUM, the NEUWERK's special structural and technical conditions described above would most probably have enabled her to provide the NORDIC with effective support when the NORDIC attempted to establish an emergency towing connection with the GLORY AMSTERDAM.

However, the NEUWERK was out of service at the time of the accident due to scheduled maintenance and repairs. At the time of the survey (2 July 2017), the vessel had already been out of service for 13 months! Accordingly, even though she is also part of the emergency towing strategy (and an especially useful part at that), she was not available to the CCME.
