Bundesstelle für Seeunfalluntersuchung
Federal Bureau of Maritime Casualty Investigation
Federal Higher Authority subordinated to the Ministry of Transport
of Transport and Digital Infrastructure

Investigation Report 496/15

**Fire in the cargo hold of the
multipurpose ship VENTURA
off the canal locks
at Kiel-Holtenau
on 18 December 2015**

29 November 2019

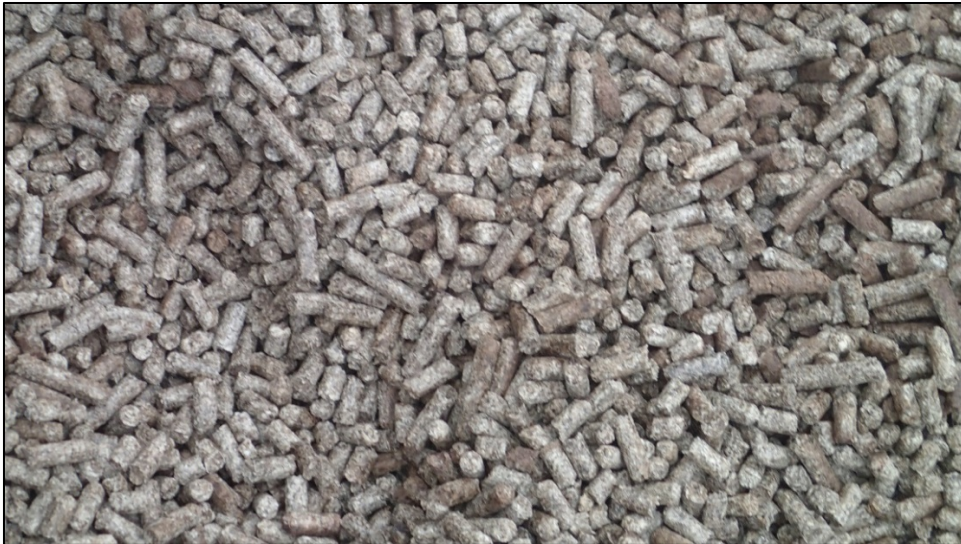
Figure 3: Sugar beet pulp in pellet form

The Antigua and Barbuda-flagged multipurpose ship VENTURA cast off from the port of Liepaja in Latvia at 1800 on 16 December 2015 to set sail for Casablanca, Morocco. The ship had 4,900 t of sugar beet pulp with no added molasses in pellet form stowed in her two cargo holds.

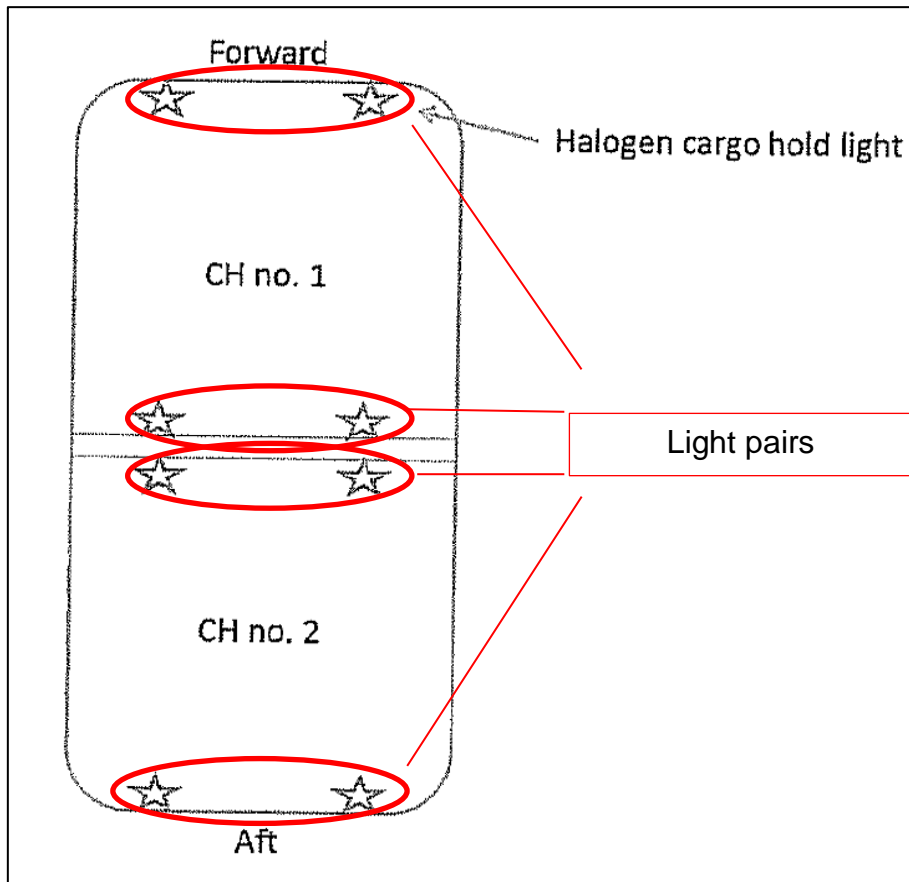
Figure 11: Position of the cargo hold lights

Each of the VENTURA's cargo hold hatches are equipped with four cargo hold lights (see Figure 11: Position of the cargo hold lights). The control panel is in the cargo office. The cargo hold lights can only be switched on or off in pairs using a key switch. A green indicator light shows the respective operating status. On the day of the survey by the BSU staff member, the position of the key switches of all four cargo hold light pairs was on zero, equal to off (see Figure 12: Control panel for the cargo hold lights).
