Bundesstelle für Seeunfalluntersuchung
Federal Bureau of Maritime Casualty Investigation
Federal Higher Authority subordinated to the Ministry
of Transport and Digital Infrastructure

Investigation Report 52/18

Serious Marine Casualty

**Allision of the container ship AKACIA
with a lock gate on the Kiel Canal in Kiel-Holtenau
on 19 February 2018**

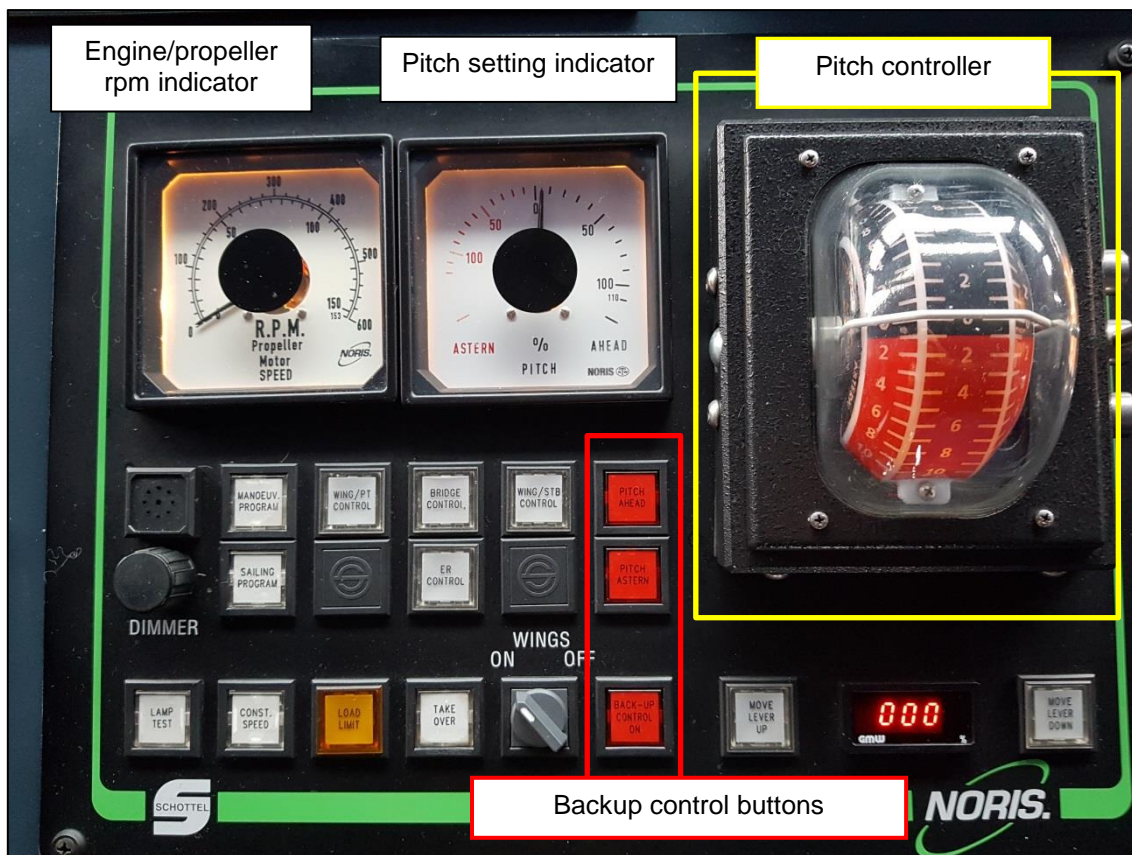
Figure 3: CPP system control panel

According to his statement, the master first tried, unsuccessfully, to cancel the given pitch by setting the control lever back to astern. He then pressed the button to enable the backup control. Although the illuminated push button indicated it was enabled, the master could not adjust the pitch using the PITCH ASTERN push button, which was intended for that purpose.

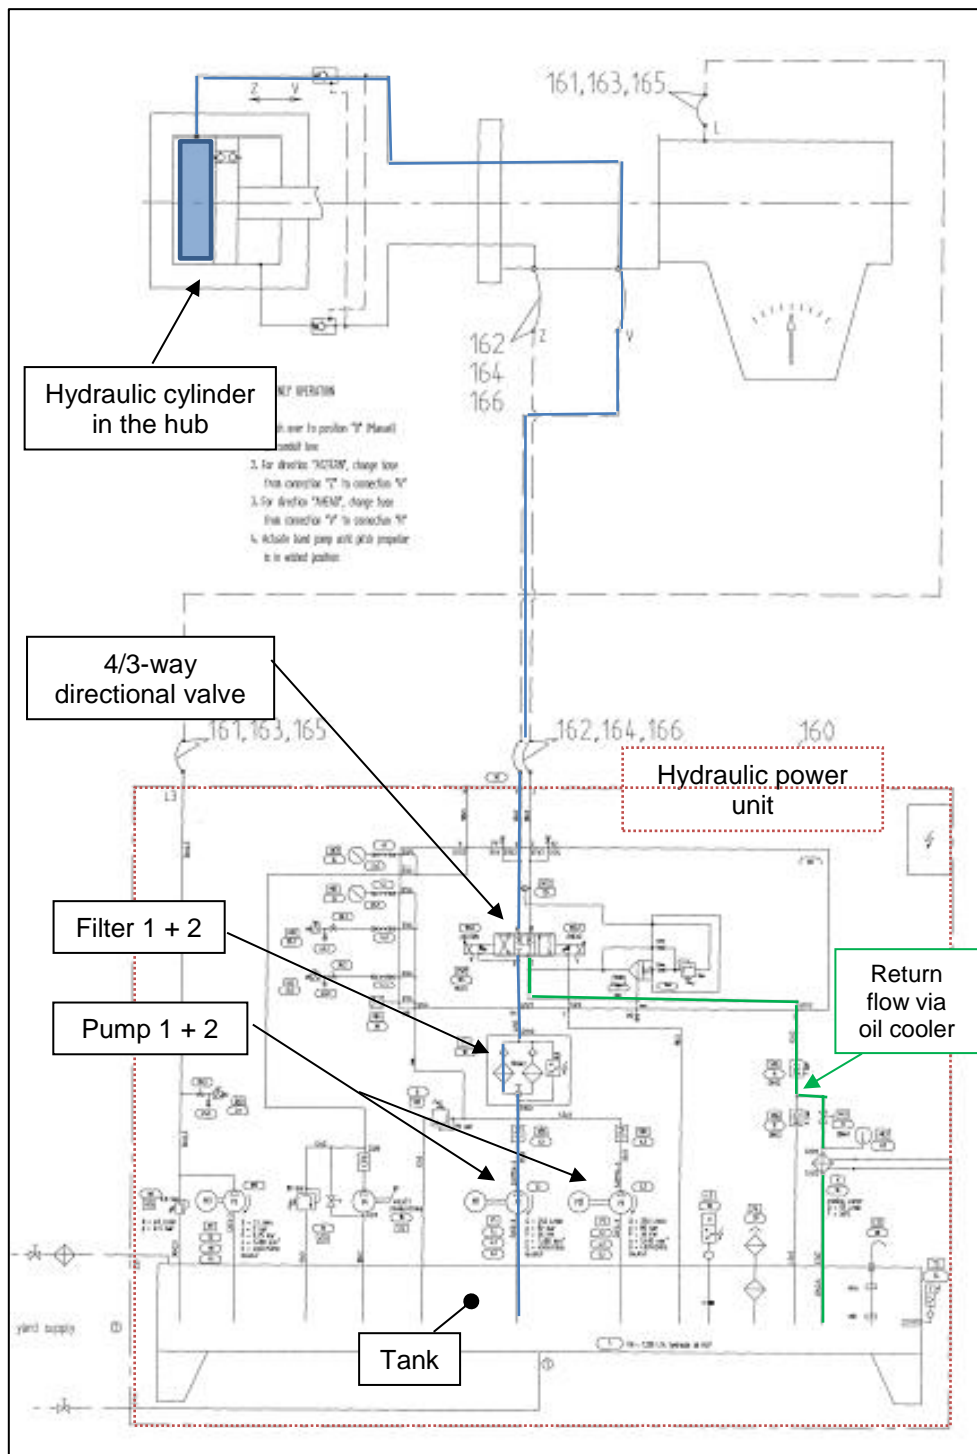
Figure 27: Schematic drawing of the hydraulic system¹⁸

The path of the hydraulic oil for an adjustment in the direction ahead is shown in blue. If no adjustment is made, the oil is returned to the tank (return flow; shown in green).

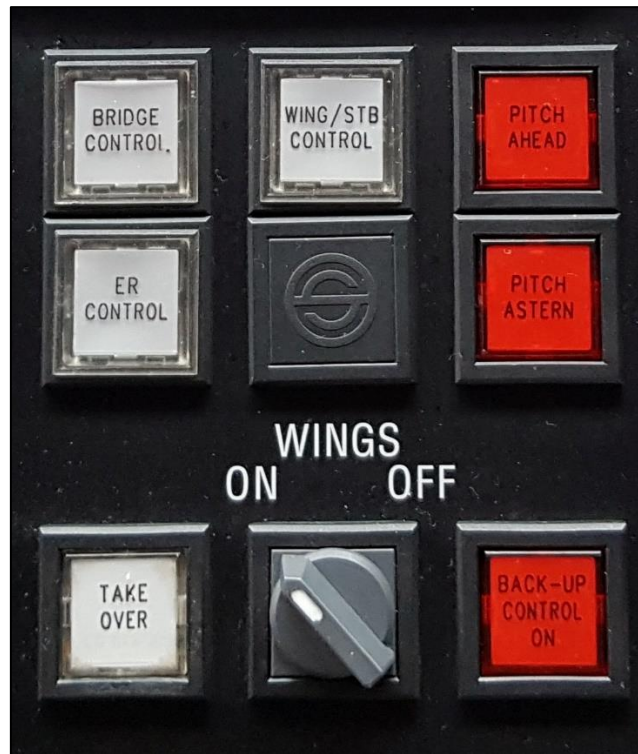
Figure 29: Detail of the CPP system's control panel at the bridge

The backup control is switched on by pressing the BACK-UP CONTROL ON button (Figure 29). The pitch is then adjusted by pressing the PITCH AHEAD or PITCH ASTERN button. During operation of the backup control, the TAKE OVER key flashes. This button is pressed to return the system to normal operation. The position of the operating lever and the actual pitch need not be the same for this purpose.

Main and backup controls are not designed to (and do not need to) detect whether there is a mechanical fault within the system, for example in the proportional valve. Therefore, switching to the backup control is possible as long as there is no electrical fault. An existing electrical fault that prevents switching would result in the "BACK-UP CONTROL ON" button not lighting up.

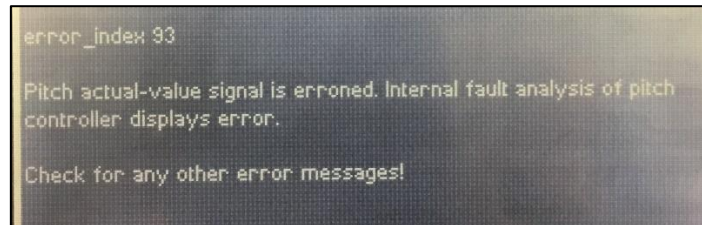
Figure 33: CPP system (meaning of error 00093)

The first error message occurred at 235042 (141733 + 9:33:09 hours) as stated above. The message (see Figure 31) indicated an error in the control system. The meaning of error message 00093 is shown in Figure 33. The error occurs when the difference between the pitch setpoint and actual pitch value exceeds a specified value. This error could not

be read on the bridge, where only an audible alarm was issued (235042). However, it did become apparent on the bridge that the pitch of the propeller blades was rising to 100% without the influence of the adjusting lever. The pilot brought this to the master's attention at 235047: "Captain, there is something wrong."

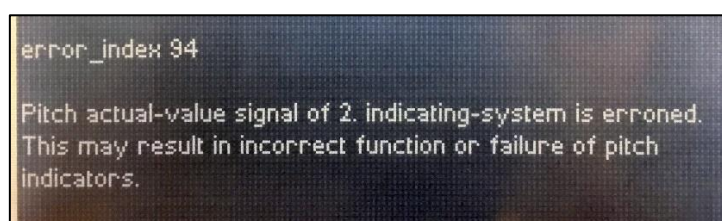
Figure 35: CPP system (meaning of error 00094)

The next error message was generated at 235101 (141752): '2. actual pitch signal back-up-system'. This error (Figure 35 (error 94)) occurs when the pitch display exceeds the set maximum value of 100%. The pitch reached 110%.

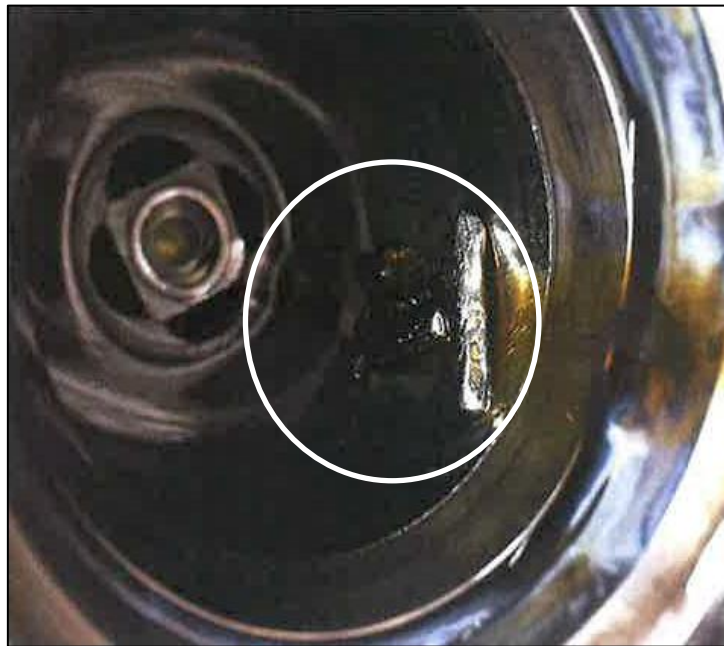
Figure 41: Location of the fragments shown in Figure 42²⁵

When the CPP system was further dismantled in the shipyard, the service technician found fragments of the support plate in the system.

Parts of the support plate in the area of the hydraulic oil line connection are shown here.

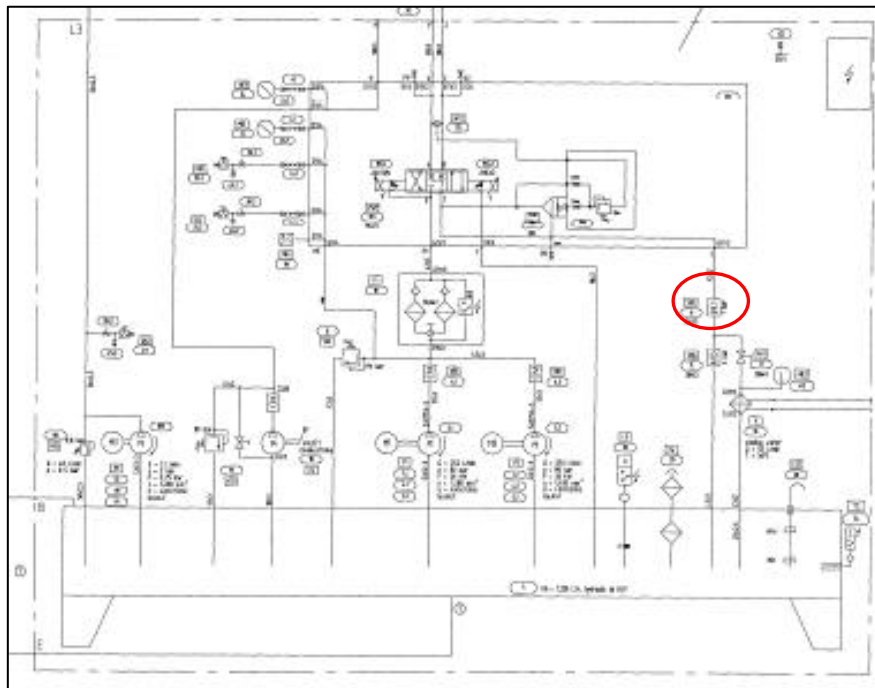
Figure 51: Extract from the diagram of the hydraulic system (see Figure 27)
Position of the non-return valve upstream of the oil cooler

The removed foreign bodies are parts of the retaining ring/circlip, the absence of which was detected during the dismantling of the valve body on 21 March 2018.

The size of the metal parts found in the non-return valve upstream of the oil cooler and in the actual oil cooler was such that they were able to pass through the hydraulic system from the propeller hub to the hydraulic power unit. The time required to pass through the hydraulic system is uncertain. Consequently, conclusions as to the triggering event cannot be drawn.

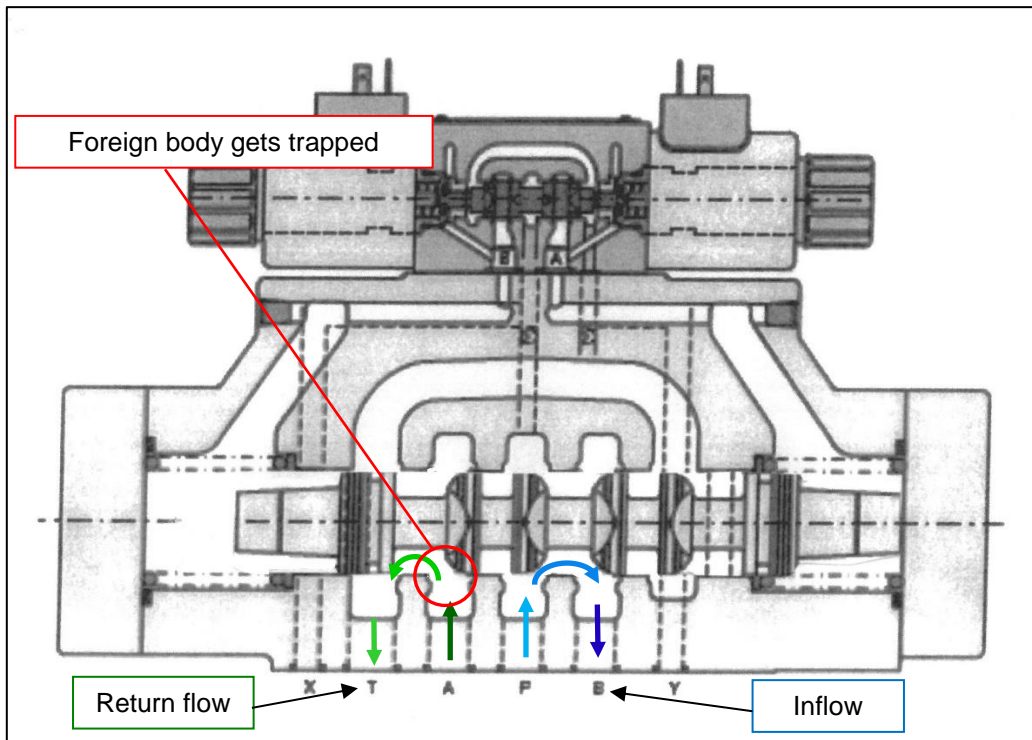
Figure 60: 4/3-way proportional valve

Smaller metal and plastic parts passed through the entire system from the propeller hub through the proportional valve to the tank probably without affecting the proportional valve. However, the investigators do believe that either the fragment found in the non-return valve or in the oil cooler resulted in a blockage of the proportional valve. Corresponding damage was found in the proportional valve when it was dismantled. The investigators also believe that the blockage took place when the pitch adjustment was made in the direction ahead, as this was the only way to make a pitch adjustment of 100% and above. The damage to the piston at the control edge from A to T found when the proportional valve was dismantled is an indication of this (see Figures 54 and 55). During the previous adjustment of the piston for the astern manoeuvre to the right a fragment seems to have been able to settle there (Figure 60). This fragment then blocked the piston during the subsequent adjustment to the left (pitch adjustment in the direction ahead), as shown in Figure 61. The usual deactivation of the hydraulic oil flow by moving the piston to the middle position when the required pitch is reached was prevented by the blockage. This allowed the pitch to rise to the maximum position because the oil flow in the direction ahead was not interrupted.

Piston for pitch adjustment in the direction astern shifted to the right

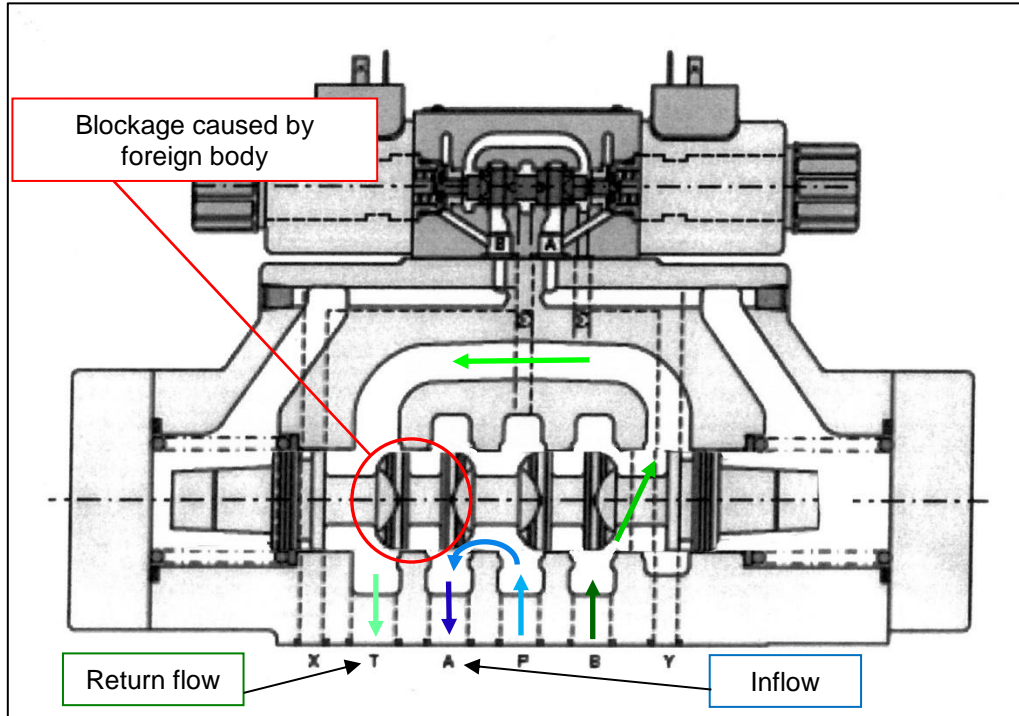
Figure 61: 4/3-way proportional valve

Piston for pitch adjustment in the direction ahead shifted to the left here. This causes trapped foreign body to block the piston. **P** – constant oil flow from pump through filter to proportional valve. **A** – oil flow through OD-box to propeller hub to set hydraulic piston in the direction ahead. **B** – return flow of hydraulic oil from hydraulic piston on the side not under pressure. **T** – return flow of hydraulic oil through oil cooler to tank.

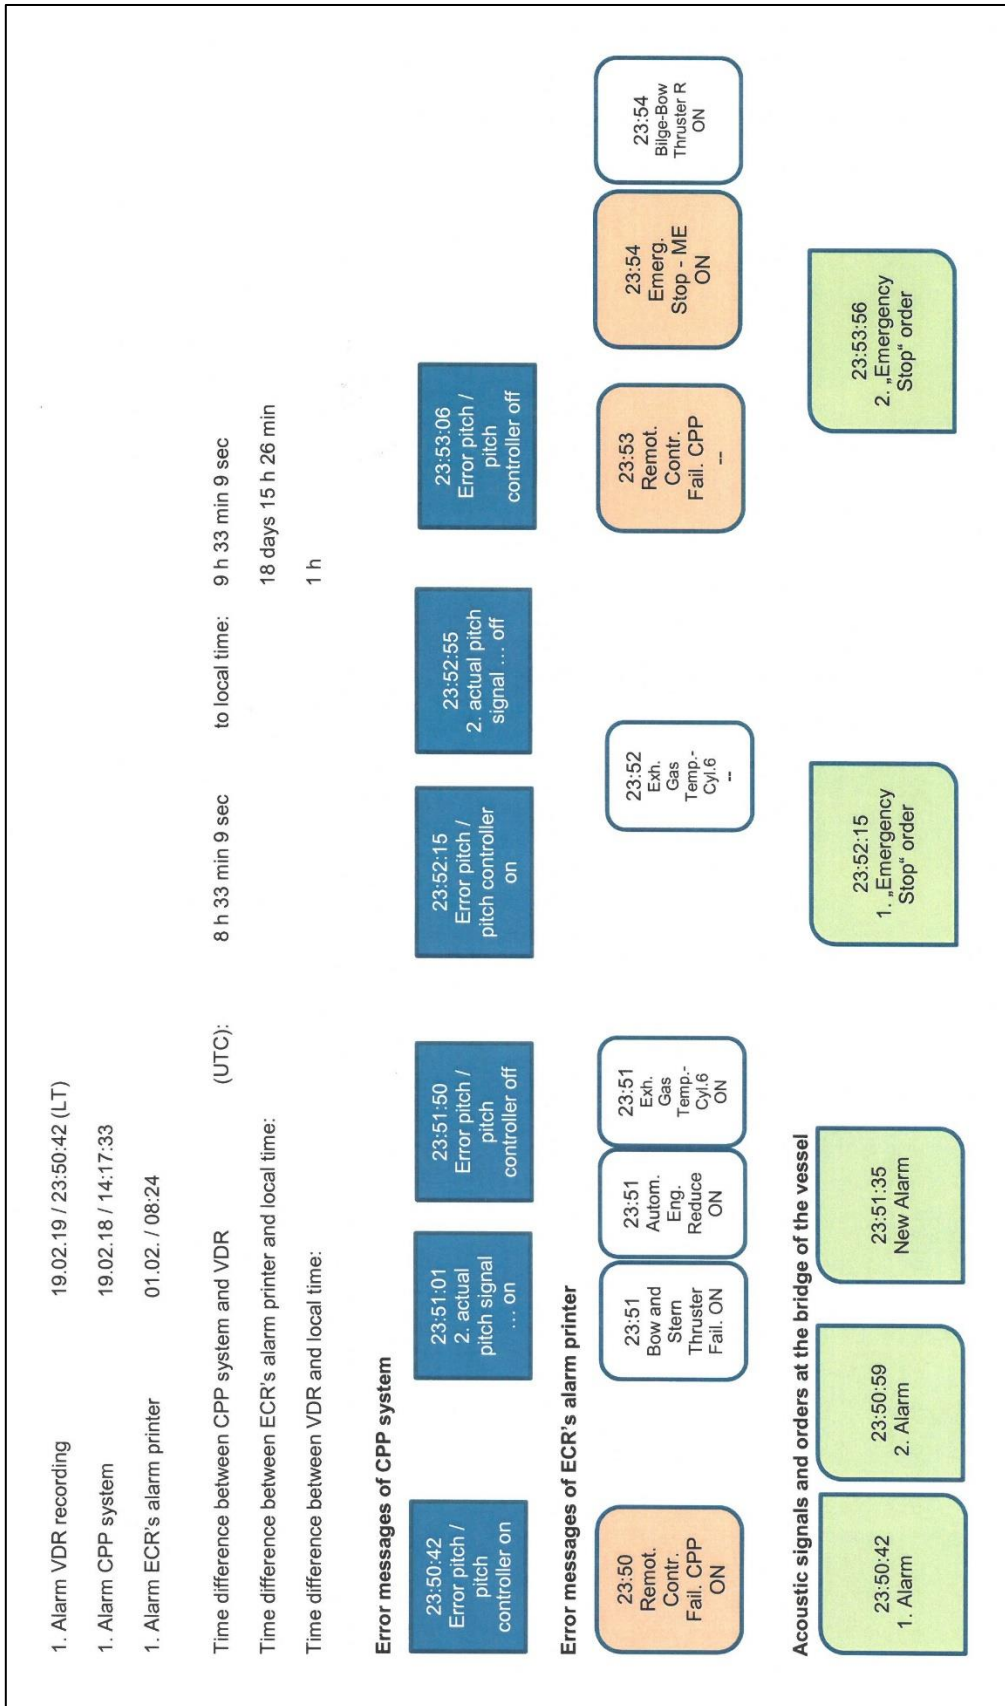
Figure 62: Overview of error messages and alarms

In the context of the investigation, it became apparent that the system times considered here differed from the ship's time. In particular, the difference in the time of the engine's alarm printer (18 days 15 hours 26 minutes) is remarkable.

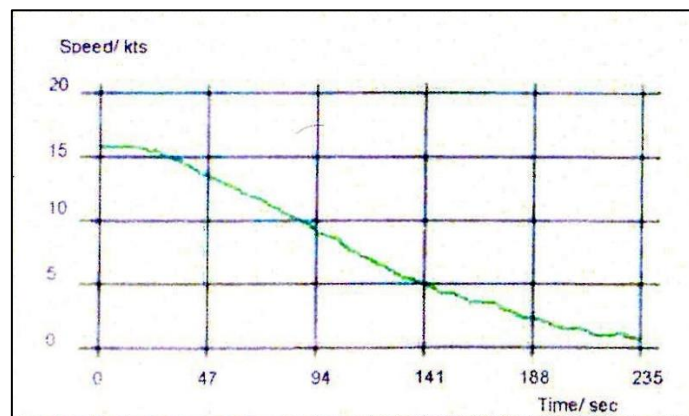
Figure 63: Speed-time-diagram for AHEAD FULL SEA to ASTERN FULL

Ignoring the fact, that neither an ASTERN FULL manoeuvre nor another adjustment of pitch would have been possible from 235042 on, due to the failure of the CPP, the following data could have been used for an ASTERN FULL manoeuvre.

Speed at Start:	15,70 kts
Speed at End:	0.0 kts
Speed Step:	Astern Full
Initial Heading:	90,7°
Final Heading:	183,2°
Time to Stop:	234s
Total Distance:	938,1m / 5,1 cbl / 6,7 S.L.

have presumably sufficed at an ASTERN FULL manoeuvre (only theoretically possible).

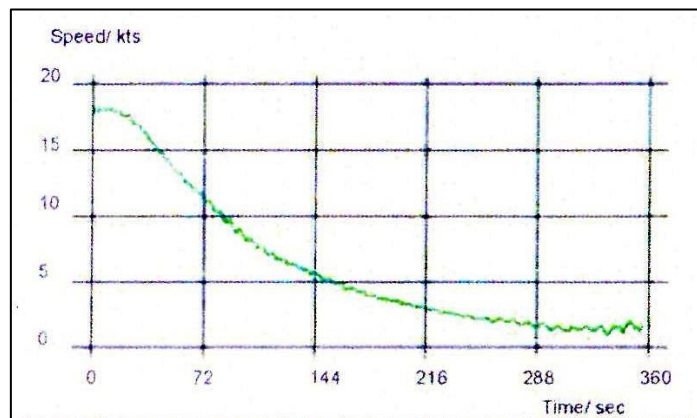
Figure 65: Speed-time-diagram for AHEAD FULL SEA to STOP

The question as to whether the stop distance would have sufficed, if an emergency stop of the main engine had been initiated immediately at the time in question, must remain open. The values for the “AHEAD FULL to STOP manoeuvre” were available for assessing the emergency stop of the main engine and the stop distance resulting from that. However, this trial was completed in an unloaded condition with a speed of 18 kts. The data sheet available does not allow a conclusion as to whether an emergency stop of the main engine carried out earlier would have prevented or at least weakened the collision. This is particularly due to the deviating loading and the test conditions. Here, the propeller rotating in zero-position probably resulted in a stronger and the open water presumably in a lower time delay.

Speed at Start:	18,00 kts
Speed at End:	1,90 kts
Speed Step:	Stop
Initial Heading:	310,5°
Final Heading:	247°
Time to Stop:	357s
Total Distance:	1170,8m / 6,3 cbl / 8,4 S.L.
