## **Investigation Report 71/17**

### **Very Serious Marine Casualty**

**Collision between the FV JAN MARIA and a fishing  
boat in the Mauritanian EEZ  
on 21 March 2017**

20 September 2019

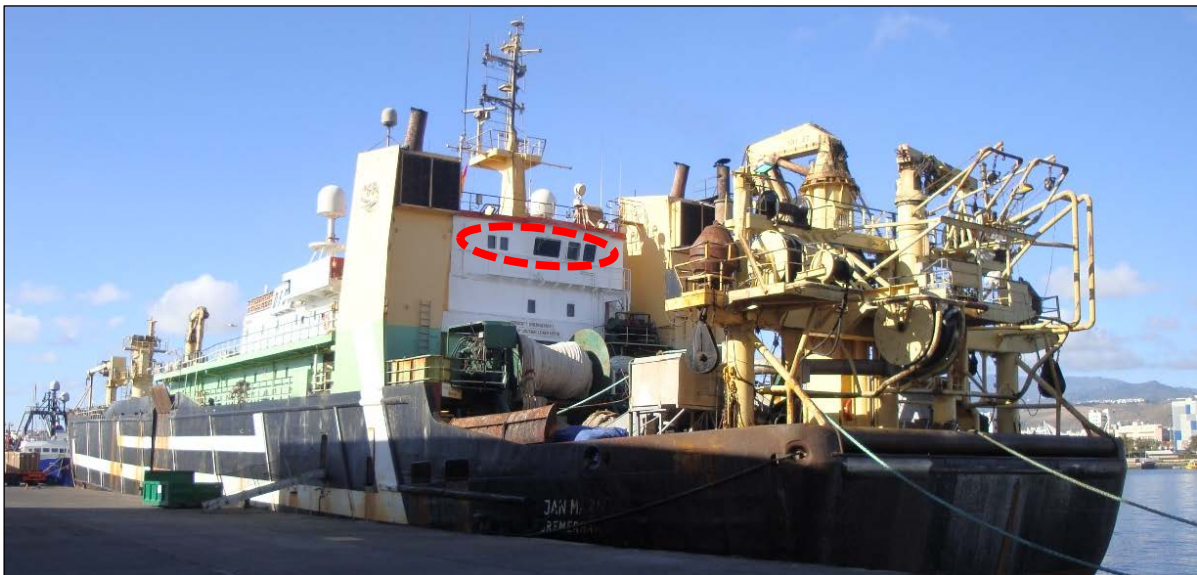
A few minutes later the officer heard excited cries, which included the English word 'canoe', coming from the JAN MARIA's aft section, i.e. from the direction of the fishing deck behind the superstructure (see **Figures 4 f.**).

Figure 4: View of the aft section of the JAN MARIA  
(bridge's aft windows marked red)

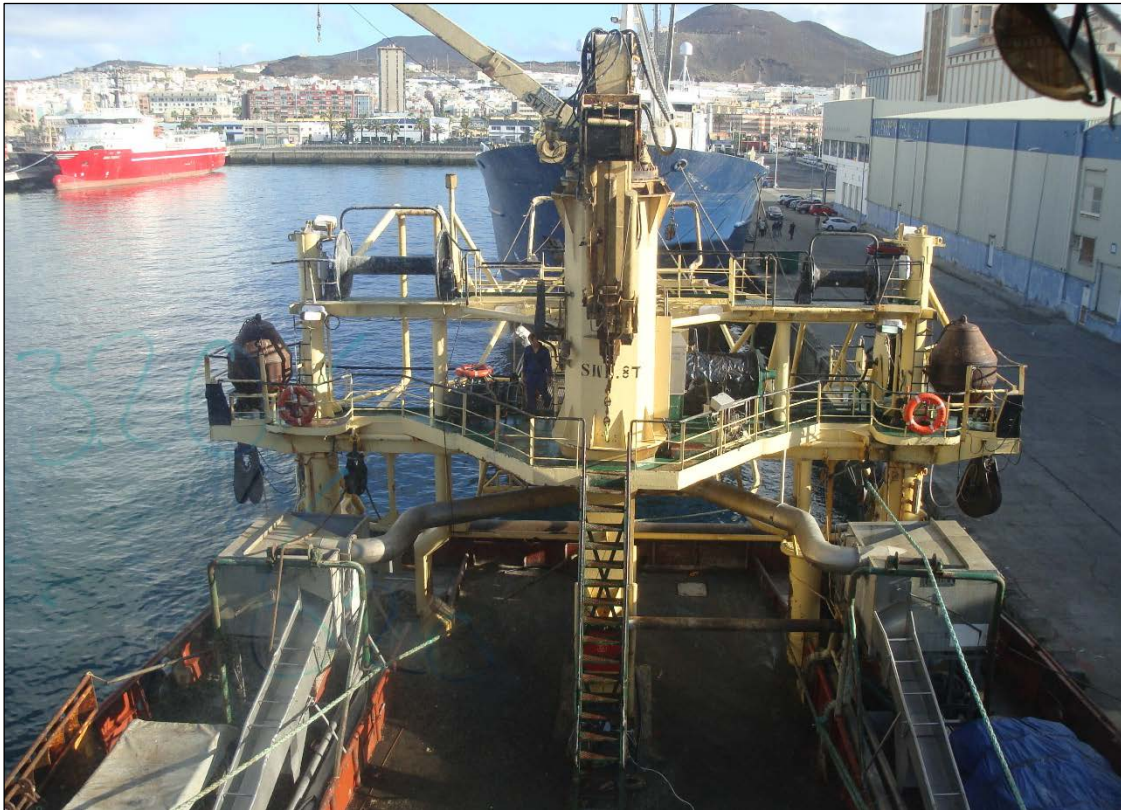
Figure 5: View of the fishing deck from the bridge's aft windows

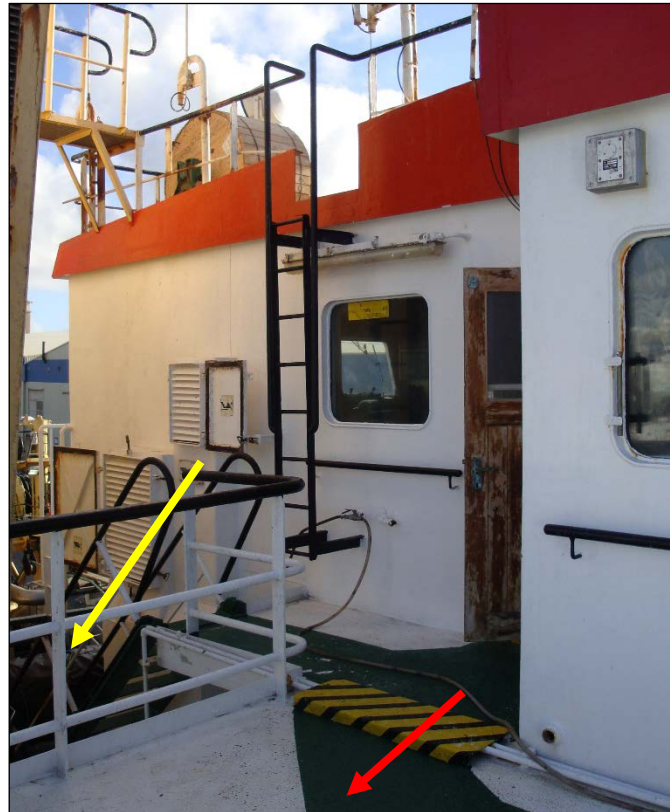
**Figures 6 ff.** show the position outside the bridge where the officer in charge of the navigational watch and the seaman (who reported the collision with the fishing boat) met, the position in the starboard wing from where they then looked for the object with which they had collided and the view from the position in question toward this object.

Figure 6: Area outside the JAN MARIA's bridge (starboard side) with companionway to the fishing deck (yellow arrow) and path to starboard wing (red arrow)

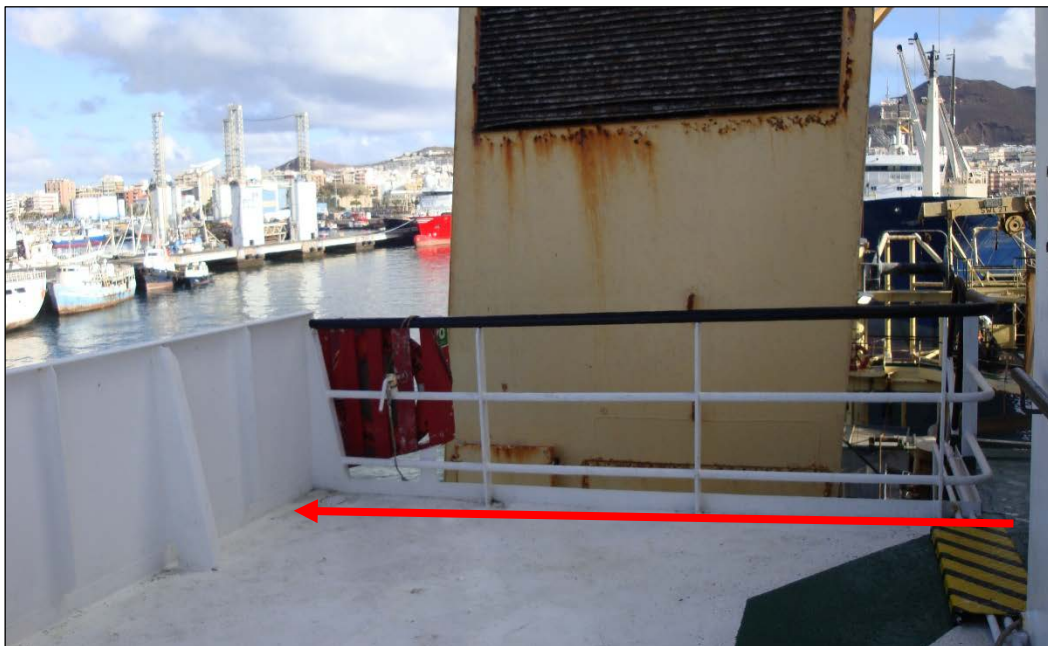
Figure 7: Starboard bridge wing (red arrow marks path to observation point)

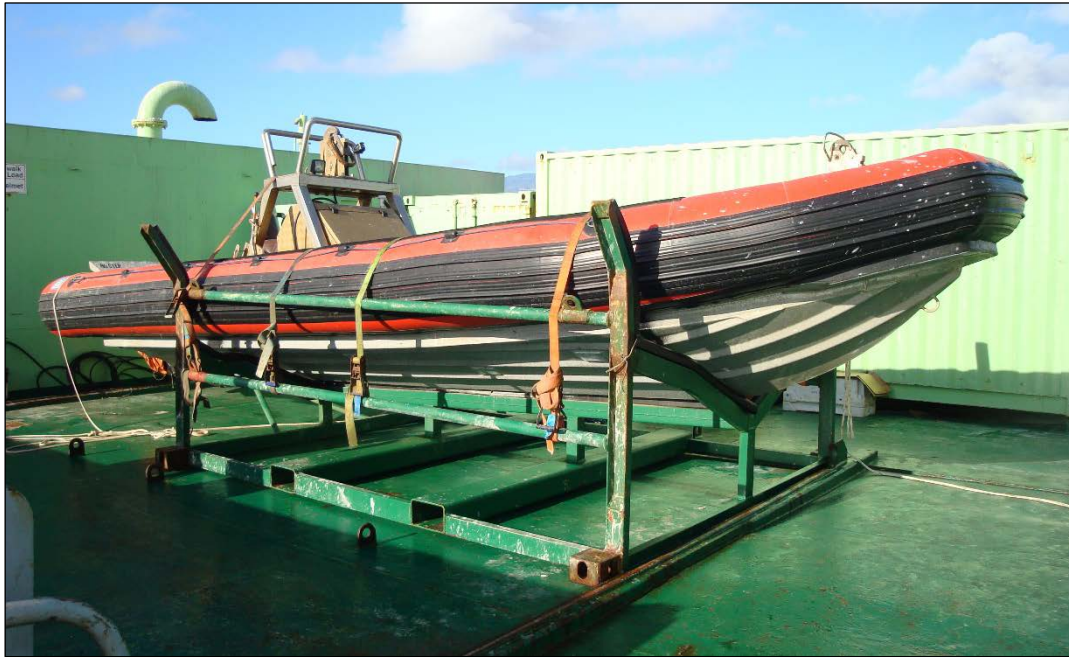
Despite a temporary increase in swell, a decision to lower the person-overboard boat to search for survivors was taken on board the JAN MARIA (see **Figure 11**). The boat was launched at about **0150** and began to search the sea within sight of the JAN MARIA for the missing fishermen.

Figure 11: JAN MARIA's person-overboard boat at her stowage position on the ship's main deck

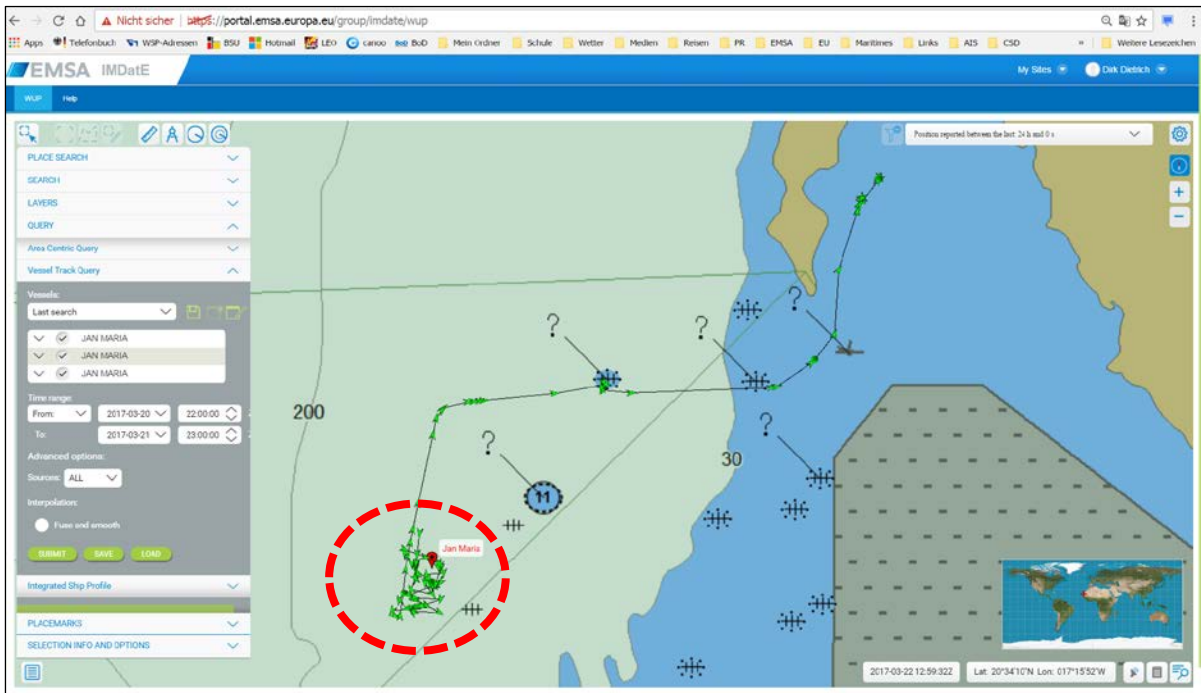
Figure 12: The JAN MARIA's SAT-AIS data on 20/21 March 2017  
(overview map; accident and search area marked in red)
