**Bundesstelle für Seeunfalluntersuchung**  
**Federal Bureau of Maritime Casualty Investigation**  
Federal Higher Authority subordinated to the Ministry  
of Transport and Digital Infrastructure

## **Investigation Report 12/16**

### **Serious Marine Casualty**

**Collision between the Rendsburg transporter bridge  
and freighter EVERT PRAHM with  
subsequent grounding  
of the EVERT PRAHM  
on 8 January 2016**

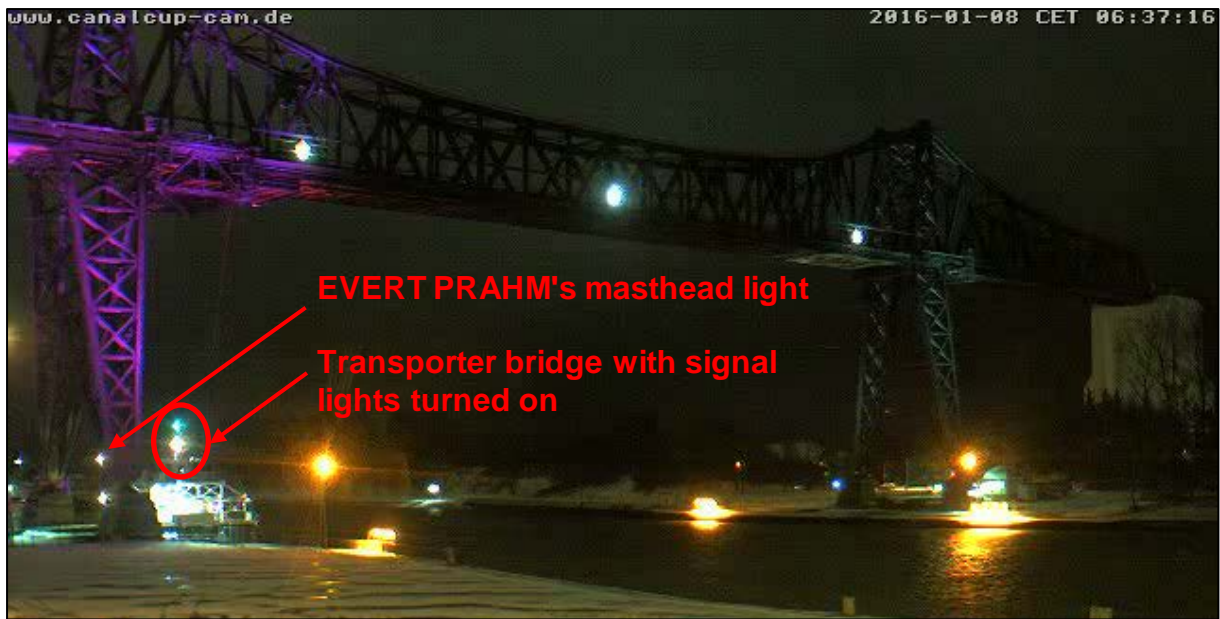
Figure 7: The transporter bridge turns on the signal lights (08/01/2016, 0637)

In addition to its operator there was also a passenger on the transporter bridge. The EVERT PRAHM kept to the middle of the fairway in accordance with the pilot's recommendation and was just short of the railway bridge when the transporter bridge's signal lights went on (Figure 7; see Subsection 3.4.9 below for information regarding the bridge pier's violet lighting).

Since the BSU was of the opinion that the transporter bridge was not a vessel for the purposes of the SeeSchStrO, it follows that lights displayed by the transporter bridge (see Figure 7) were a voluntary installation by WSA Kiel-Holtenau because they were not stipulated by the SeeSchStrO.

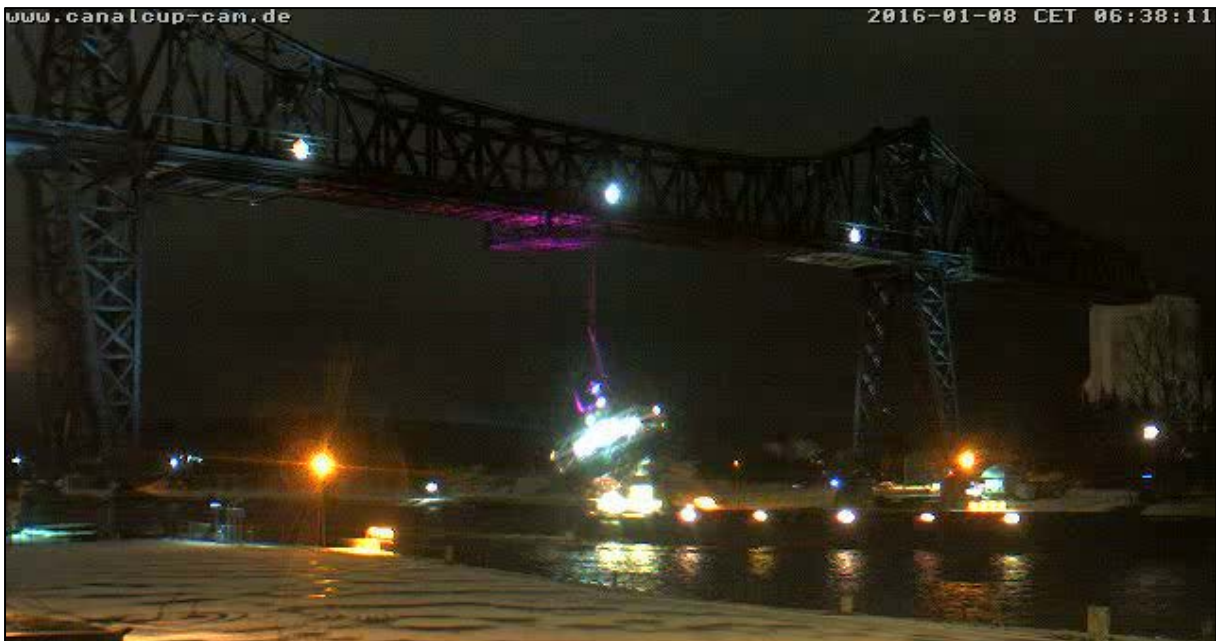
Figure 10: Transporter bridge catapulted upward (08/01/2016, 0638)

It then struck the starboard wing before scraping over the wheelhouse, dragging the antenna, part of the funnel and stern mast with it. At the same time, the transporter bridge was catapulted upward and swung violently (see Figures 10 and 11).

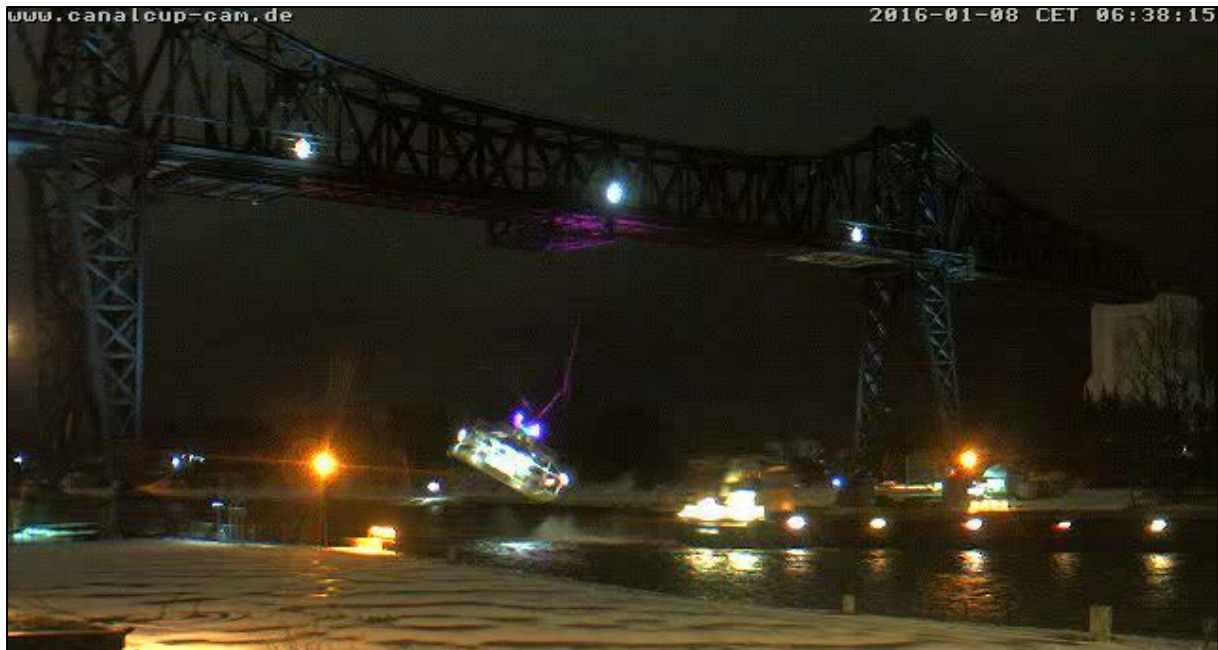
Figure 11: Transporter bridge swinging after the collision (08/01/2016, 0638)

The severely damaged transporter bridge was stuck over the middle of the Kiel Canal after the collision. The two people on the transporter bridge were injured during the accident. The transporter bridge's superstructure on the Rendsburg railway bridge was derailed but thankfully – given that a train crossed the bridge immediately after the accident at 063842 – did not project into the railway track.

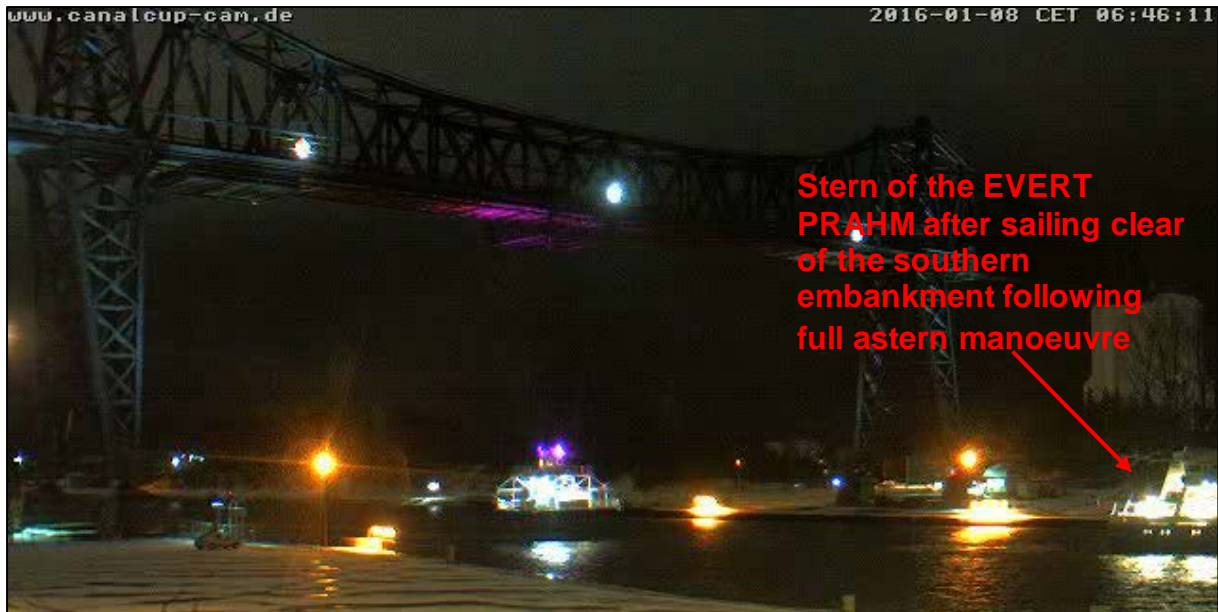
Figure 12: The EVERT PRAHM refloats after sailing onto embankment (08/01/2016, 0646)

The collision and hard to port manoeuvre caused the EVERT PRAHM to turn to port and she approached the southern embankment. Her crew and the canal pilot remained unharmed. The pilot recommended hard to starboard and then full astern, which the cadet executed. Despite this the EVERT PRAHM sailed gently onto the southern embankment at canal kilometre 62.5 at 0640. The chief officer stopped the engine. The vessel traffic service (VTS) was notified on VHF radio. Following that the chief officer put the vessel back to astern. The EVERT PRAHM refloated at 0646 (see Figure 12). The master went onto the bridge shortly after.

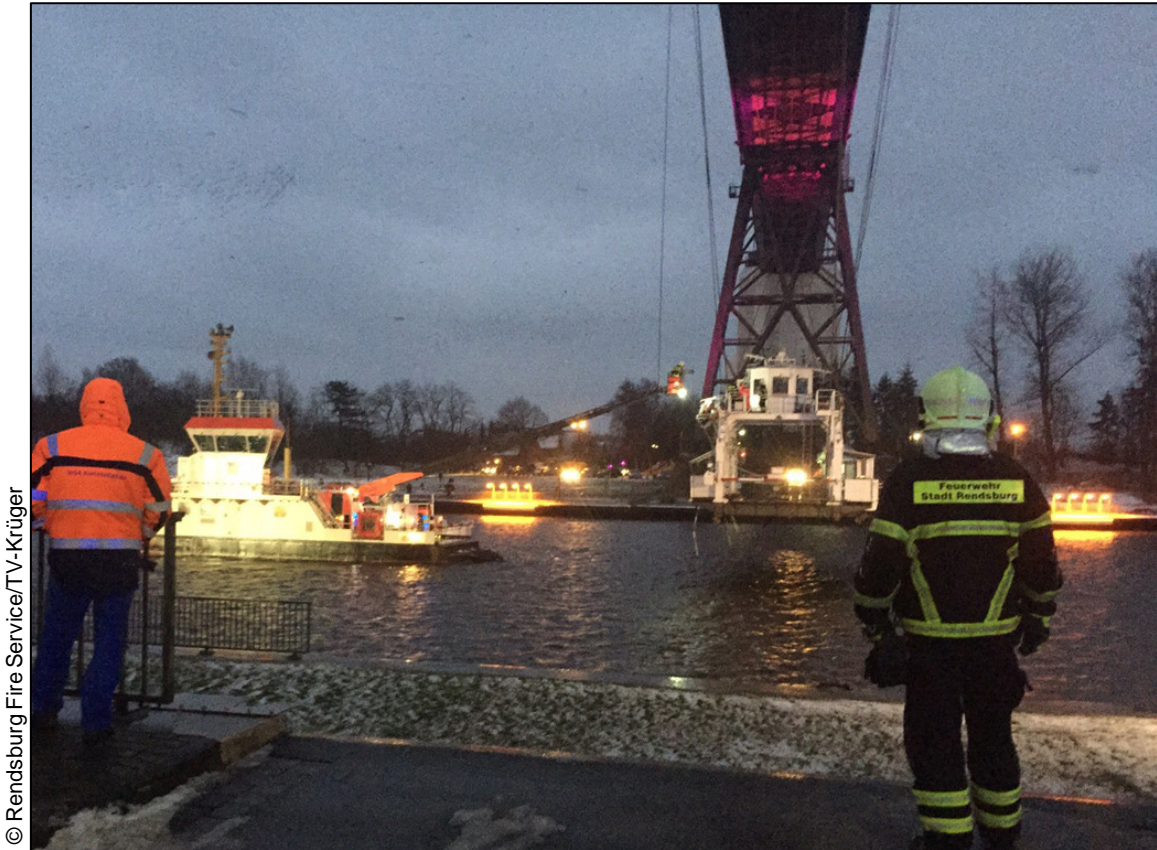
Figure 17: Rescue operation – emergency responders climb across to the transporter bridge

Two fire engines from Rendsburg Fire Service had been loaded onto the MEMEL in the meantime. At 0736 emergency responders were able to cross from the MEMEL to the transporter bridge on the turntable ladder of one of the fire engines and begin treating the casualties (see Figures 17 to 19). To begin with the strength of the wind

made it impossible to mount a ladder safely, meaning that although emergency responders could get onto the transporter bridge it was initially not possible to carry the transporter bridge's injured operator from it to the MEMEL safely.

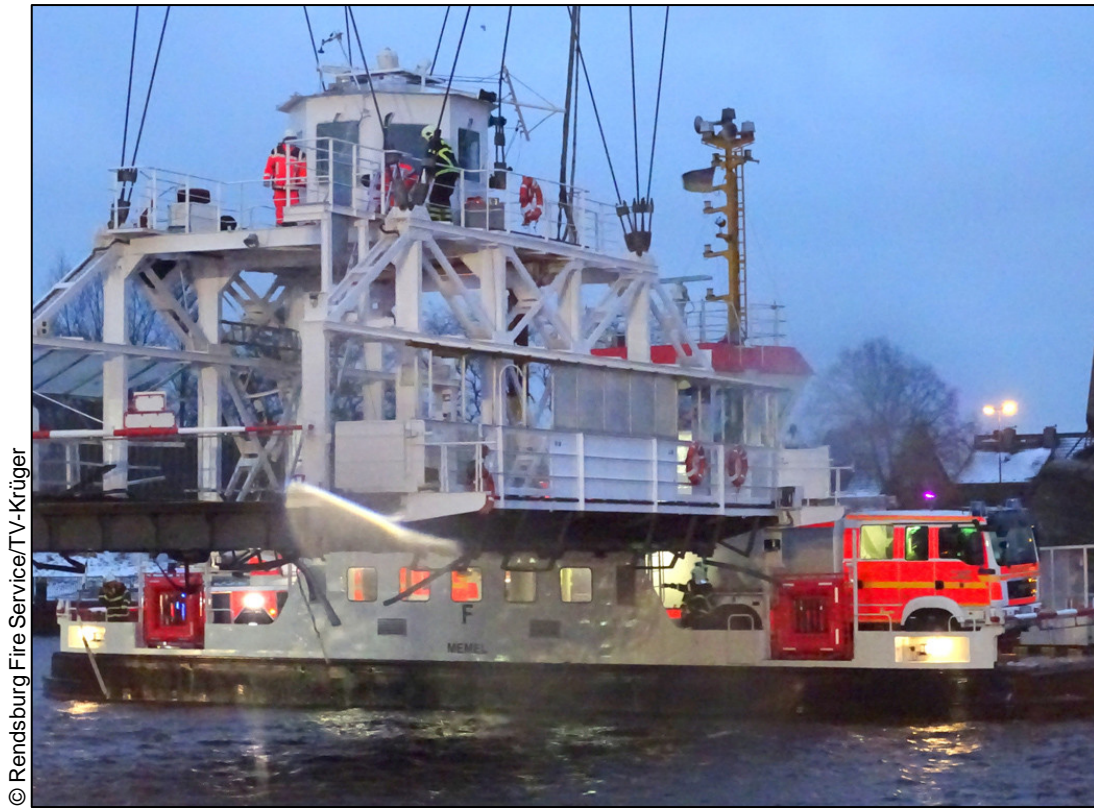
Figure 19: Rescue operation – Fire engines on the MEMEL and treatment of casualties on the transporter bridge

The injured passenger was able to leave the transporter bridge at 0739 via the turntable ladder. Rescuing the transporter bridge's operator proved difficult because the steps to his cabin had been so badly damaged by the collision that this route could not be used. The operation was complicated further by the transporter bridge's severed 400 V conductor line, which sprayed sparks on the upper deck and therefore had to be switched off ashore first so as not to endanger anyone.

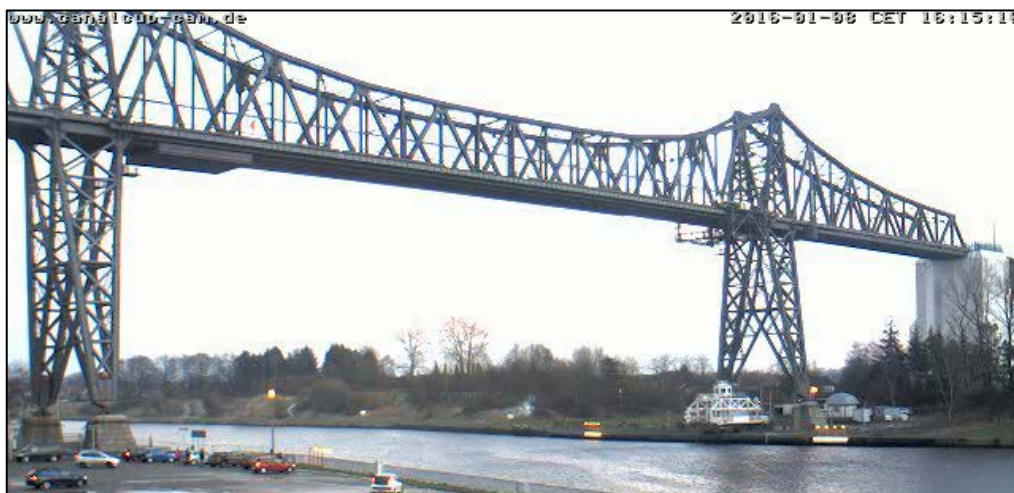
Figure 21: Recovery of the damaged transporter bridge (08/01/2016, 1615)

From 1318 onwards it was possible to pull the transporter bridge to the southern bank metre by metre. The recovery took just under three hours, after which the transporter bridge could be made fast on the southern bank and no longer posed an obstacle to navigation (see Figure 21).

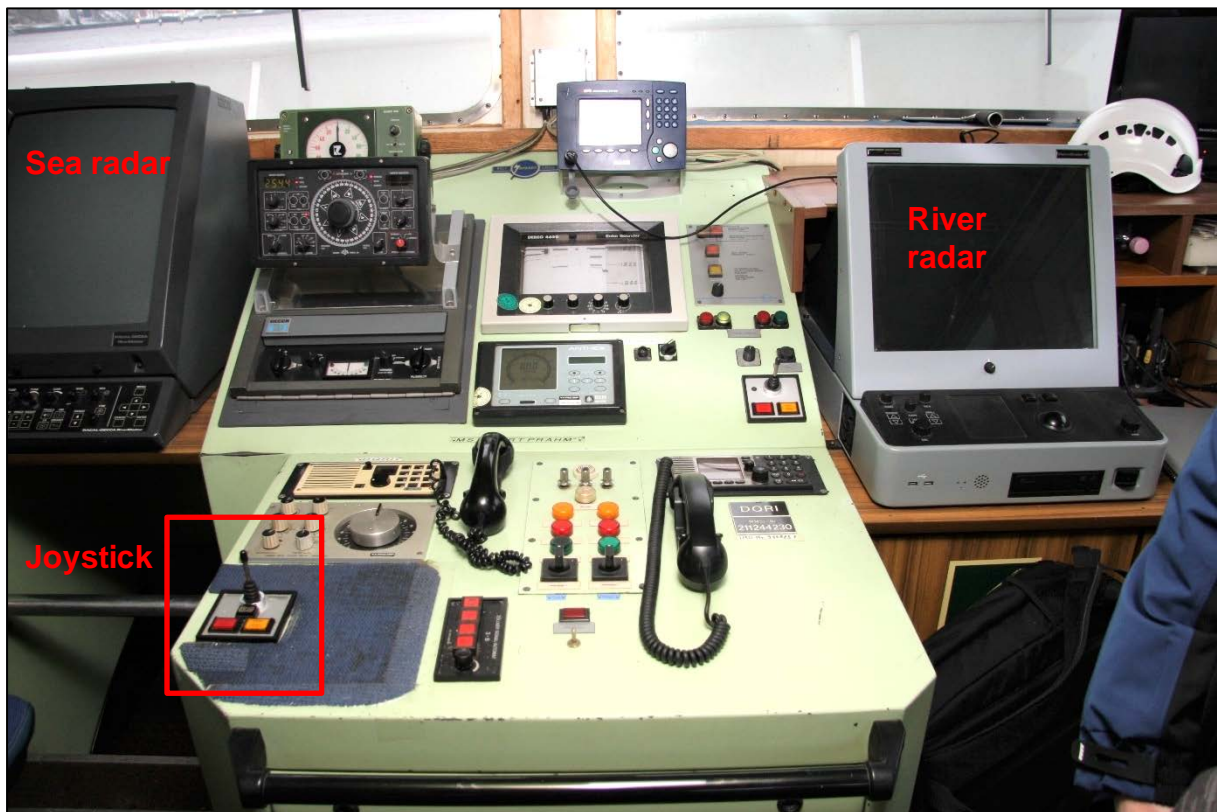
Figure 25: The EVERT PRAHM's control position, joystick control, taken on 08/01/2016

The cadet, who had the role of helmsman at the time of the accident, was completing his second work placement from the maritime school. He had been on board the EVERT PRAHM training in bridge service since 28 October 2015. At the time of the accident he was steering with the joystick (see Figure 25).

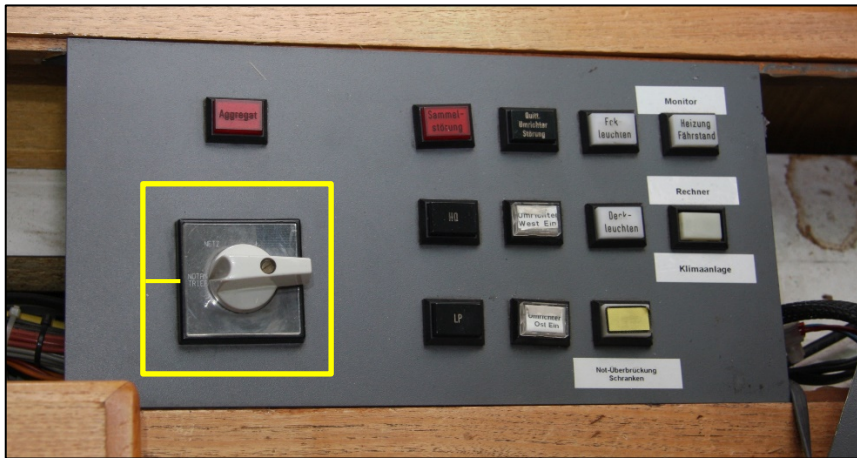
Figure 33: Mode selector switch set to emergency operation

Batteries were installed on the transporter bridge for the DC motors. They were activated by operating a switch for the power supply on the control panel. The switch

was set to emergency operation (see Figure 33) when the BSU and WSP Kiel surveyed the control position.

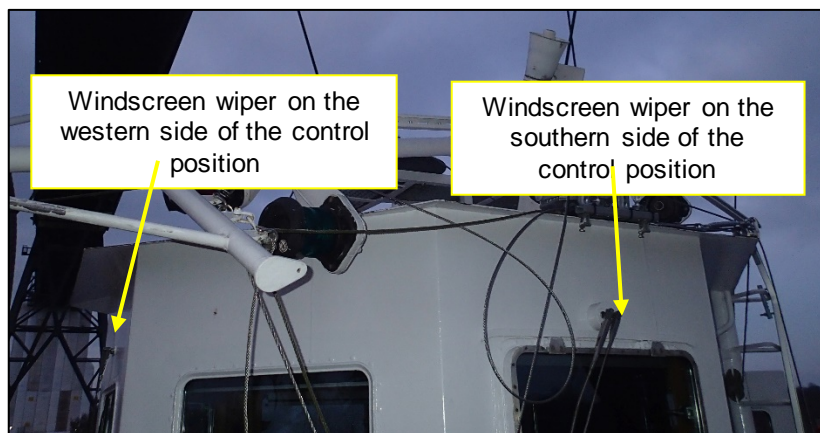
Figure 34: Windscreen wiper on the southern and western side

Windscreen wipers were installed on three sides of the octagonal structure. One windscreen wiper was installed on each of the windows in both directions of travel. In contrast to the straight pane on the western side, the straight pane on the eastern side does not have a windscreen wiper because of the entrance door located there (see Figures 34 and 35).

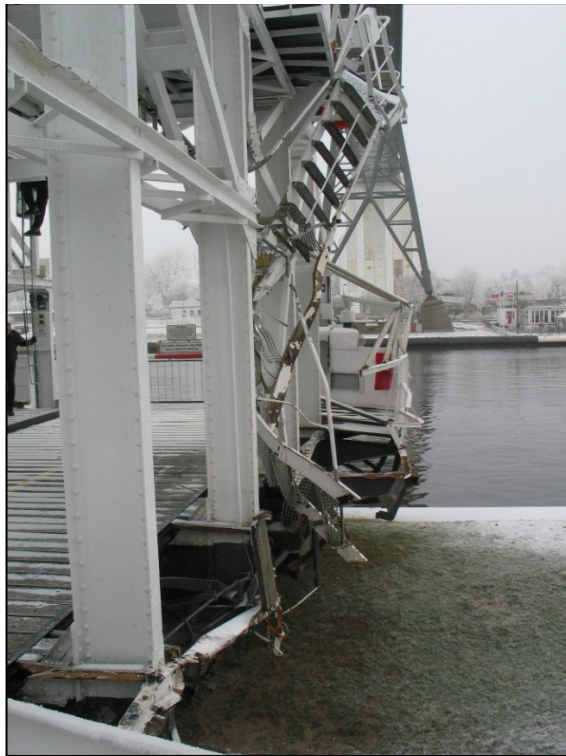
Figure 41: View of the destroyed passenger platform and steps to the control position

- the platform for the passengers and its roof was almost completely destroyed on the side of impact (eastern side);
- the steps to the control position were destroyed on the eastern side;
- the signal mast was broken;
- the transporter bridge's barrier on the southern side was destroyed, and
- the solid liferaft brackets below the platform were destroyed.

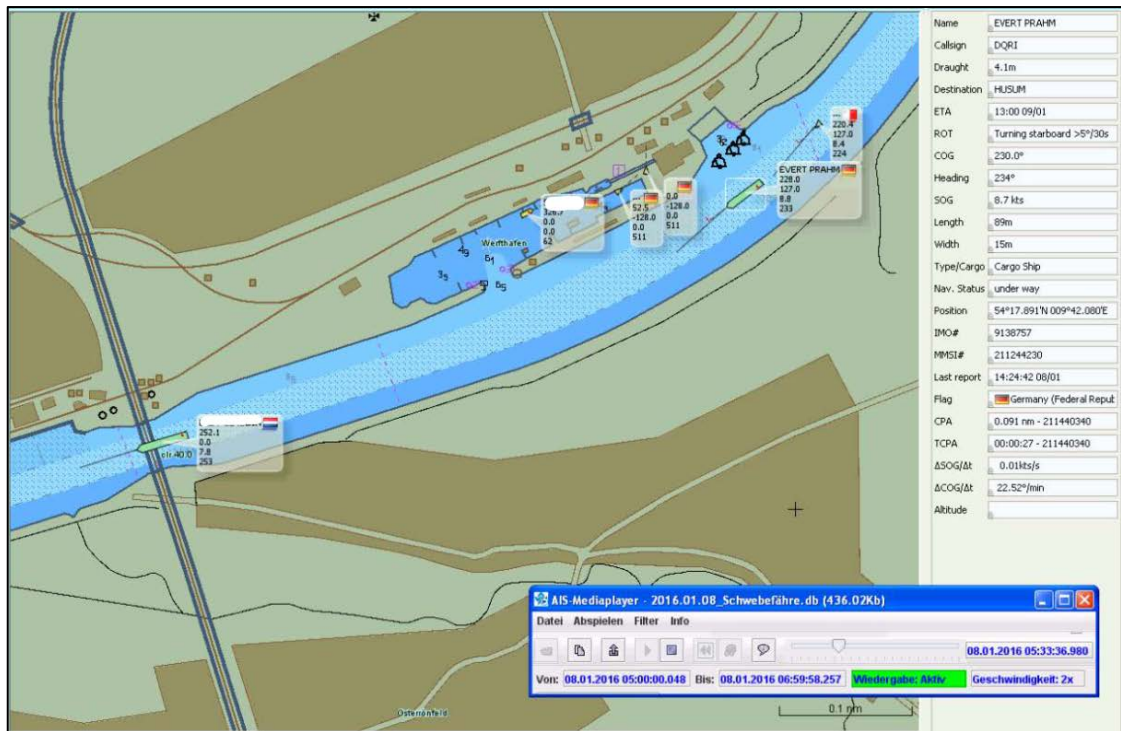
Figure 51: Ship A passes bridge before the accident (08/01/2016, 063336)

The first ship in the convoy, Ship A, passes the Rendsburg railway bridge at 0633 at a SOG of 7.8 kts<sup>7</sup> (see Figure 51). She was followed by the EVERT PRAHM (8.7 kts, course over ground (COG): 230.0°, heading (HDG): 234°) and the last ship in the convoy, Ship B, at 8.4 kts. The recording exhibits a synchronisation deviation in that the speed of the EVERT PRAHM is indicated as 8.7 kts in the detail bar displayed to the right, while the detail bar next to the ship symbol indicates 8.8 kts.

Irrespective of the general observation that such AIS data always involve minor deviations in the presentation (see Figure 51 – speeds of 8.7 kts and 8.8 kts displayed for the EVERT PRAHM in the same AIS plot), the recordings as a whole indicate that the EVERT PRAHM had exceeded the speed limit. However, the BSU's investigators believe this excess speed of 0.6 kts to 0.7 kts (corresponding to 0.36 m/s at 0.7 kts) had no effect on the collision. Stopping would not have been possible even if 8.1 kts had been maintained and the additional reaction time arising from sailing in compliance with the canal's speed limit would not have been sufficient for a promising evasion manoeuvre.

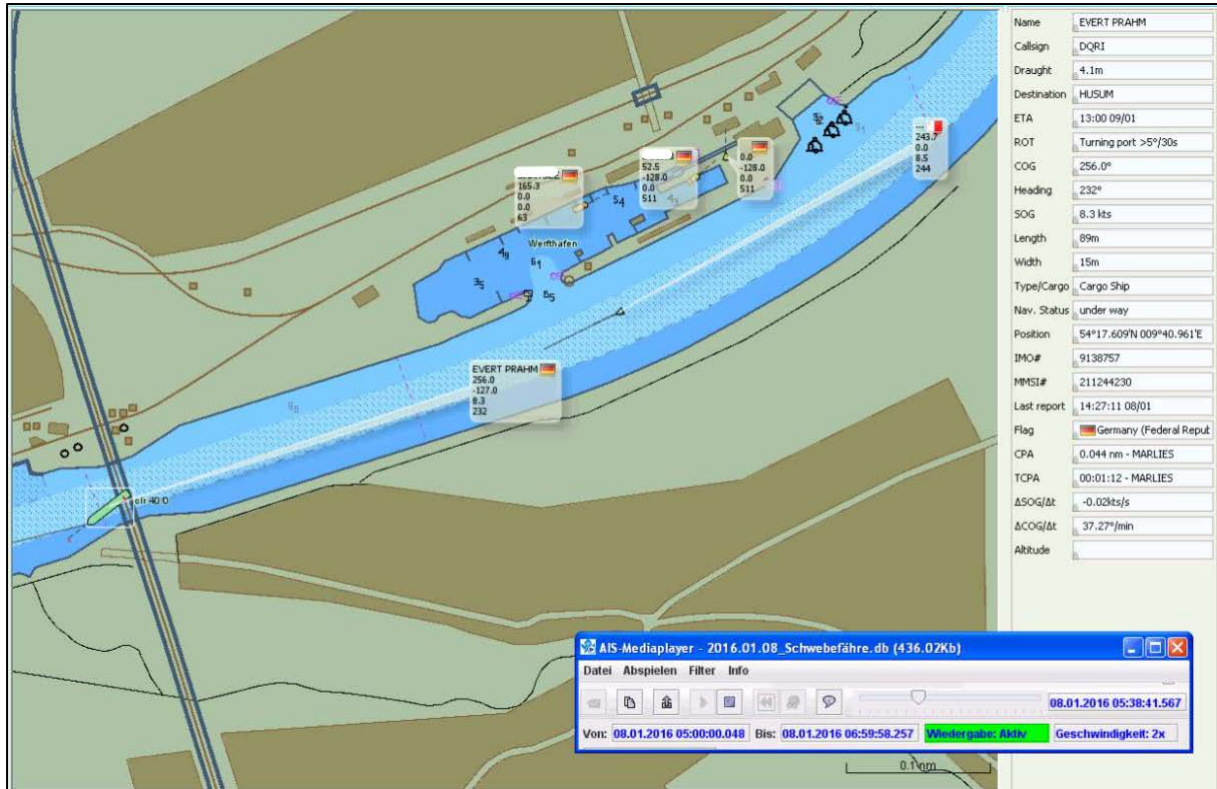
Figure 62: The EVERT PRAHM after the collision (08/01/2016, 063841)

The EVERT PRAHM's COG and HDG remain almost unchanged during the approach to the bridge crossing. The speed is also indicated at 8.8 kts immediately before passing beneath the bridge. The collision with the transporter bridge occurred between the previous and following figures.

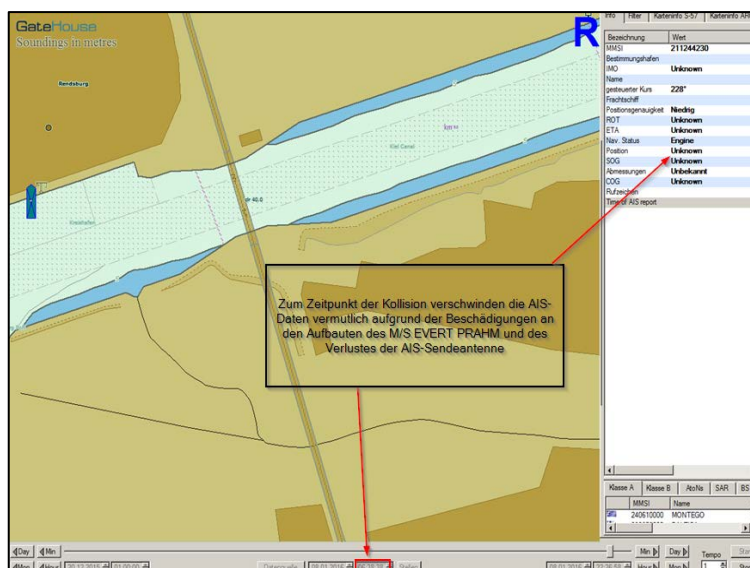
Figure 68: Interruption of the EVERT PRAHM's AIS signal (08/01/2016, 063838)

The WSP control centre also documented the interruption of the EVERT PRAHM's AIS signal after the collision with the transporter bridge (see Figure 68).

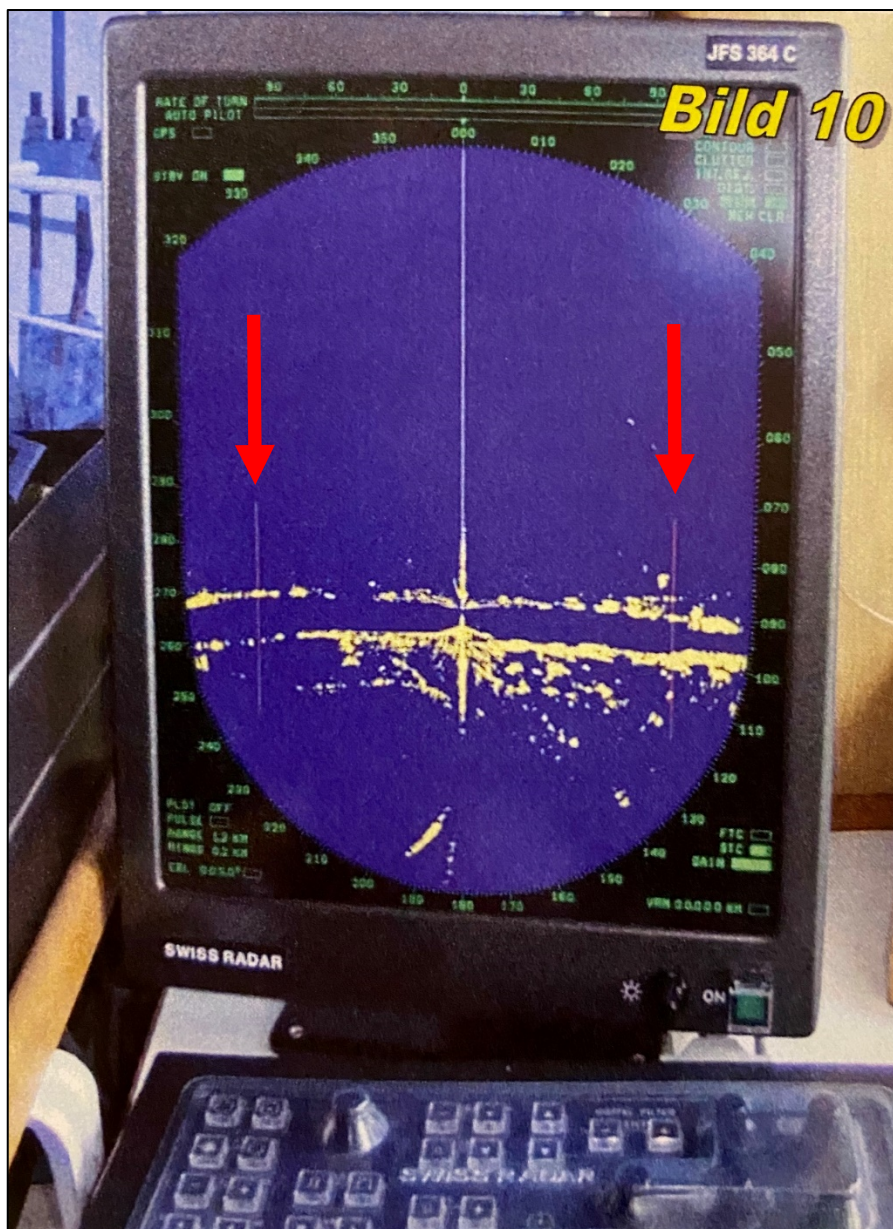
Figure 69: Transporter bridge's radar set (photograph taken on 20/12/2012, image from DNV GL's expert opinion on emergency stopping devices)

WSP Kiel tested the transporter bridge's radar set and found no indications of a malfunction.

The two distance markers of the safety area to be maintained from transiting shipping are clearly visible (red arrow markings) on the radar image used for illustration (see Figure 69). Since the radar set was found to be without power when the first survey after the accident was made, it was not possible to determine retrospectively whether it had been in operation on the morning of the accident.

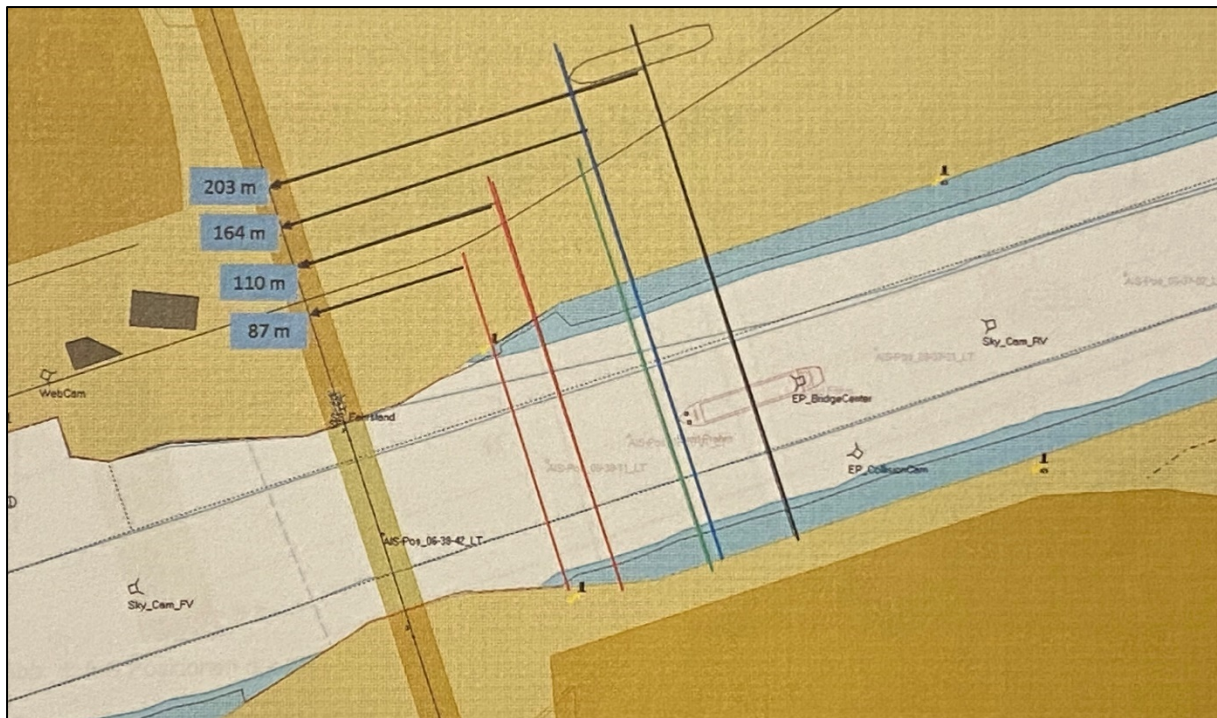
Figure 70: Manoeuvre points of the EVERT PRAHM from the GDWS opinion

In the opinion, two manoeuvre points are then derived from AIS position data and speed data from the EVERT PRAHM (see Figure 70).

The red line (manoeuvre point) at 87 m would therefore reportedly correspond to a reaction time of 12 seconds, while the red line at 110 m would reportedly correspond to a reaction time of 17 seconds. According to the opinion, the blue line indicates the position of the EVERT PRAHM's bow when the transporter bridge starts moving (164 m distance, 45 seconds before collision) and the green line the position two seconds after the transporter bridge starts moving.

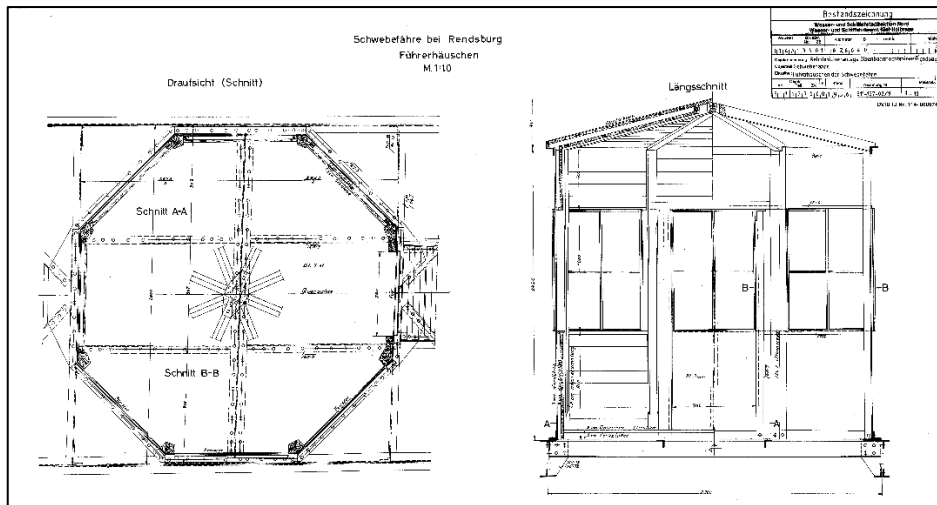
Figure 73: Floor plan of the transporter bridge operator's cabin

The operator's cabin has an octagonal floor plan (see Figure 73). Each of the eight sides has a window with the two windows in the immediate direction of travel being the largest (84 x 100 cm). Five other windows are only slightly smaller (77 x 100 cm). The smallest window is installed in the only door (48 x 60 cm).

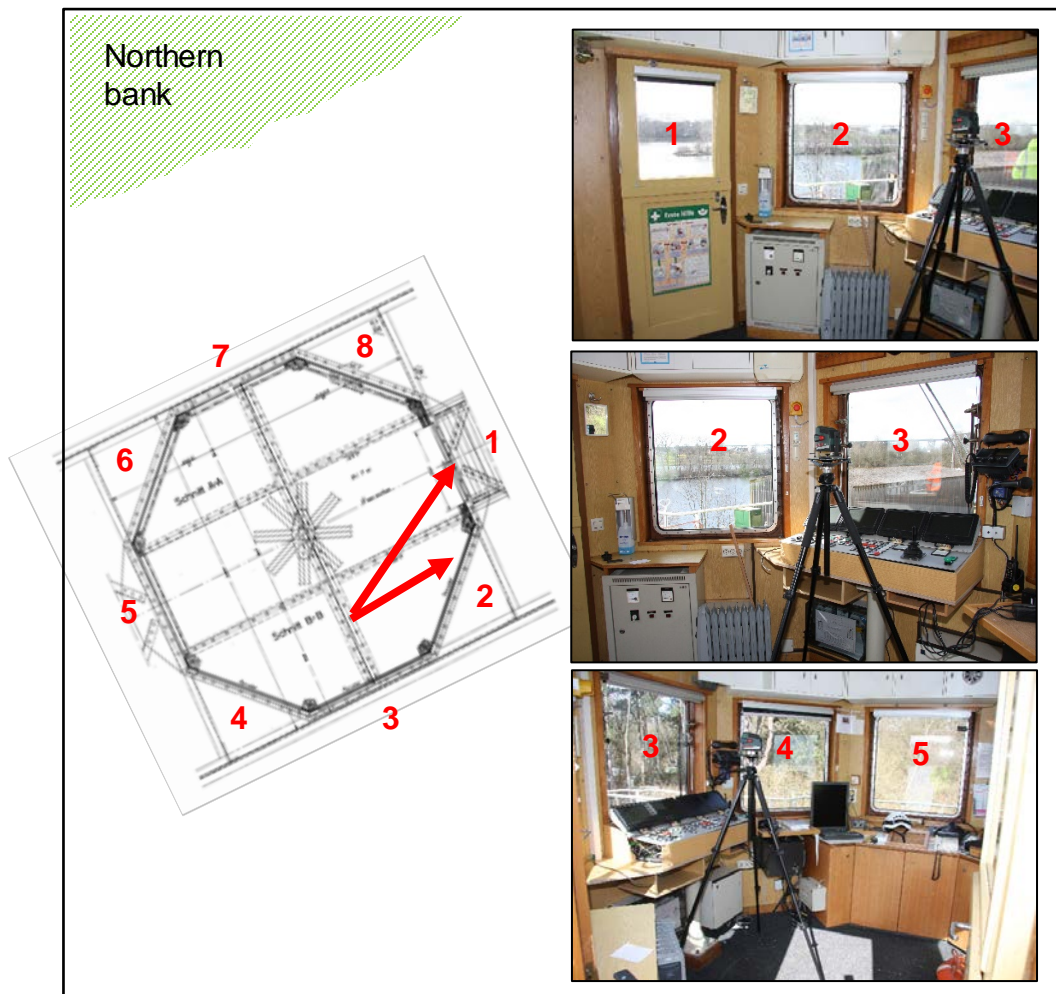
Figure 74: Window arrangement in the transporter bridge operator's cabin

There were only two windows (1 and 2, see red arrows in Figure 74) through which the approach of the EVERT PRAHM could theoretically have been observed. This statement does not take into account the weather on the night of the accident, as the measurement of the field of view only determines that permitted by the structural arrangement of the windows.

Windows 3 and 7 in the immediate directions of travel (see Figure 74: 3 for crossings to the southern bank and 7 for crossings to the northern bank), as well as 5 are each equipped with one windscreen wiper. A sun shield is fitted to the inside of each window. None of the eight windows has its own heating system with filaments.

The fact that only three out of eight windows are equipped with a windscreen wiper and none of them can be heated must be regarded as a handicap. On the night of the accident it had snowed and was icy. Following the analysis of the witness testimonies, the BSU concludes that even without winter weather conditions the view from the windows can be seriously impaired at times, especially during crossings at night by the bridge lighting and associated reflections. Visibility may be impaired to such an extent

when the windows are frozen that traffic observation is only possible by stepping out of the operator's cabin or looking at the radar. The BSU considers it appropriate to expressly draw the attention of prospective and existing transporter bridge personnel to these conditions or to remedy the situation in a new construction by making technical modifications, such as heated windows with a sufficient number of windscreen wipers.

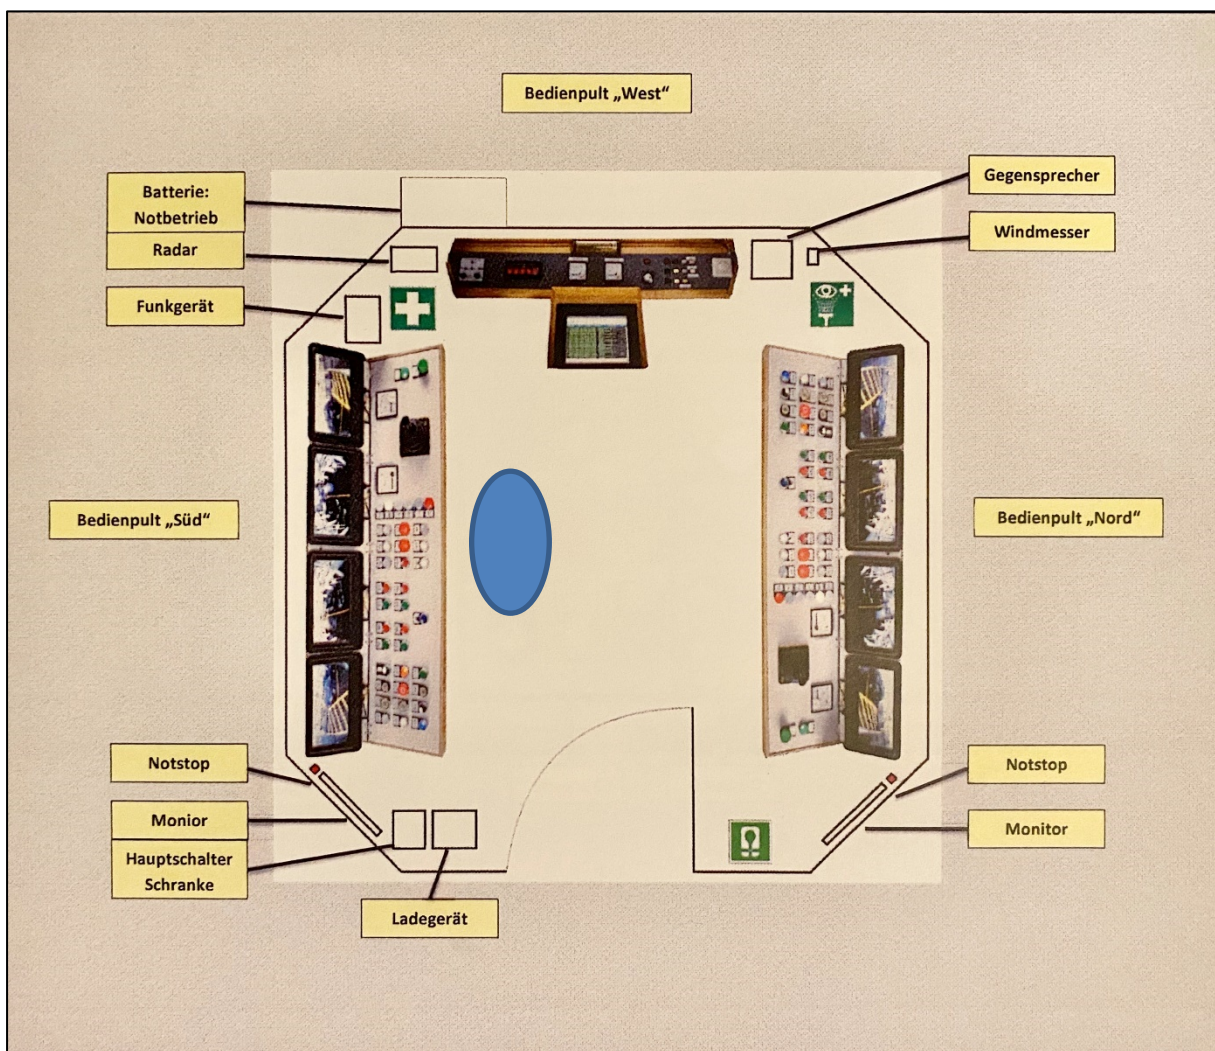
Figure 75: Arrangement of the control panels in the operator's cabin – taken from the operating manual

The measurement was based on the transporter bridge's operator being positioned in front of the control panel for the direction of travel from the northern to the southern bank. The control lever for the direction of travel or speed was located at an ergonomically appropriate distance (arm's length). Ultimately, this resulted in a position centrally in front of the southern control panel (see Figure 75, blue marking corresponds to the estimated position).

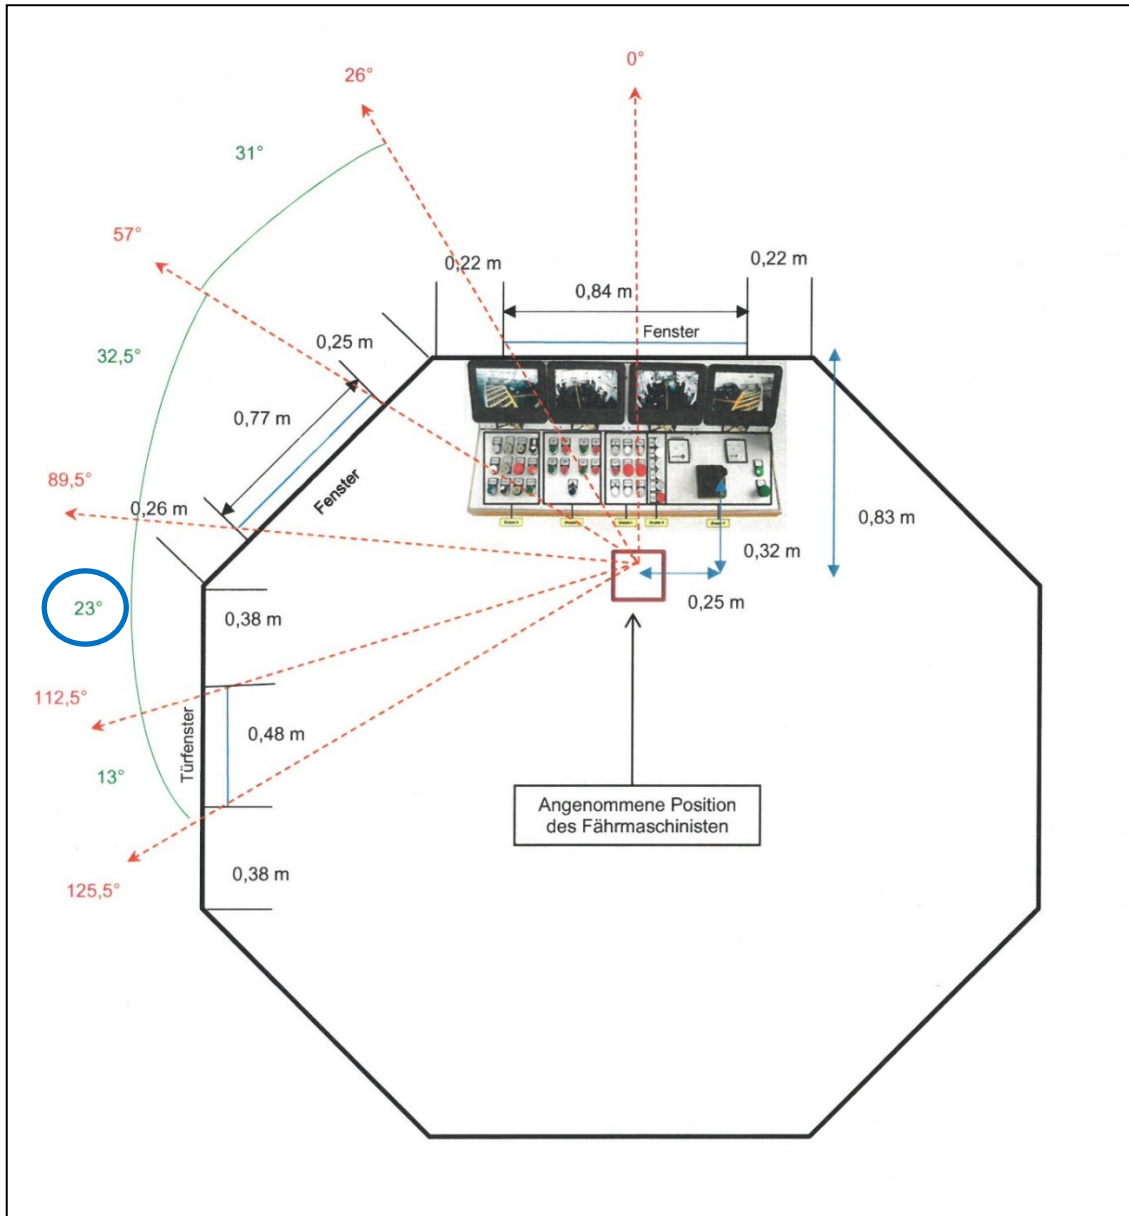
Figure 76: Viewing angles

The measurements were limited to the viewing angles relevant to the collision with the EVERT PRAHM. These were determined with the aid of a laser beam level and a 360° bearing plate mounted on a stand (see Figure 76).

The following figure transposes the measured angles to the navigational chart at the time at which the first ship in the convoy (Ship A, green dot in Figure 77) passes. The EVERT PRAHM is marked as a red dot and the ship following her in the convoy (Ship B) as a blue dot. The door frame and the wall between windows 1 and 2 create a blind sector of 23° (see blue circle in Figure 76).

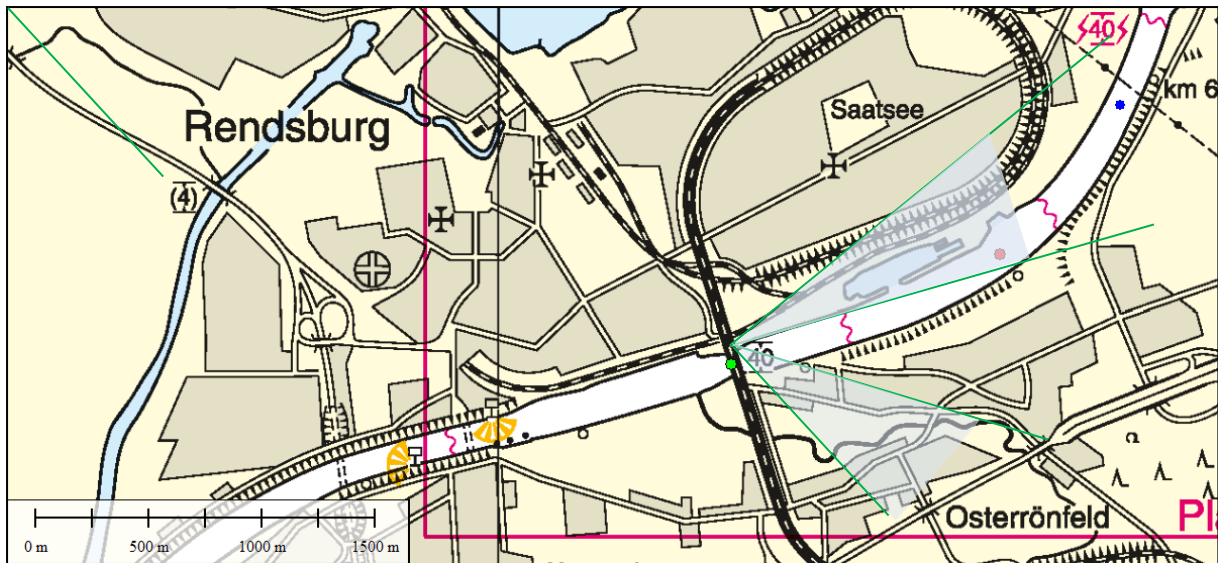
Figure 77: Viewing angle when the first ship in the convoy passed

The measurement of the field of view and determination of the viewing angle derived from that revealed that theoretically the structural conditions in the transporter bridge operator's cabin permitted a view of the EVERT PRAHM when the first ship in the convoy passed. However, it should also be noted that a large part of the Kiel Canal – the immediate vicinity of the transporter bridge when looking east-north-east, in particular – was in the blind sector if the position of the transporter bridge's operator remained unchanged.

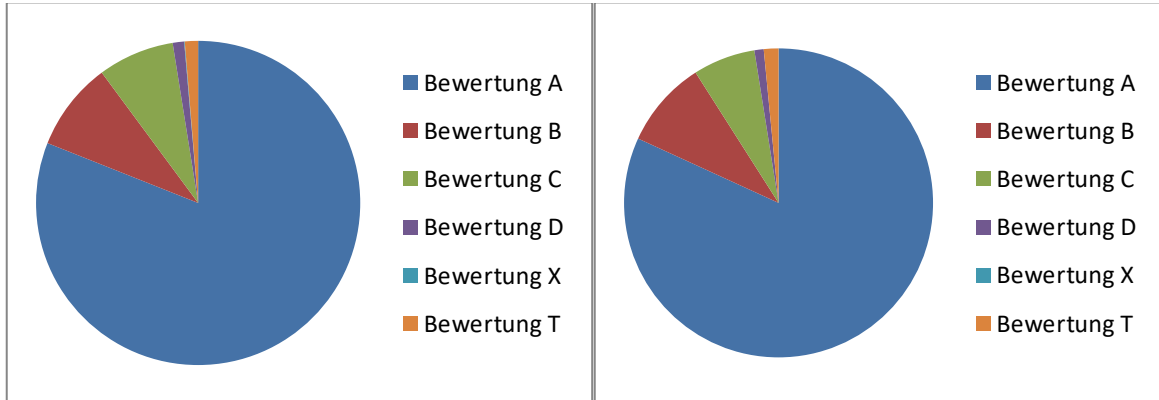
Figure 81: Comparison of operating behaviour – graphic evaluation

A total of 6,648 transporter bridge crossings made in the period 1 October 2015 to 9 January 2016 were analysed. Since the shift schedules of the transporter bridge operators deployed were taken into account in the analysis, it was possible to establish from a general view of operating behaviour according to the above categories that the transporter bridge operator's behaviour on the day of the accident did not differ from that of his colleagues (see Figure 81).

The chart to the left shows the operating behaviour of the transporter bridge operator on the day of the accident in the overall period analysed and the chart to the right shows that of his colleagues. The percentage analysis also reveals that the differences in cumulative operating behaviour are marginal at most (see Spreadsheet 5).

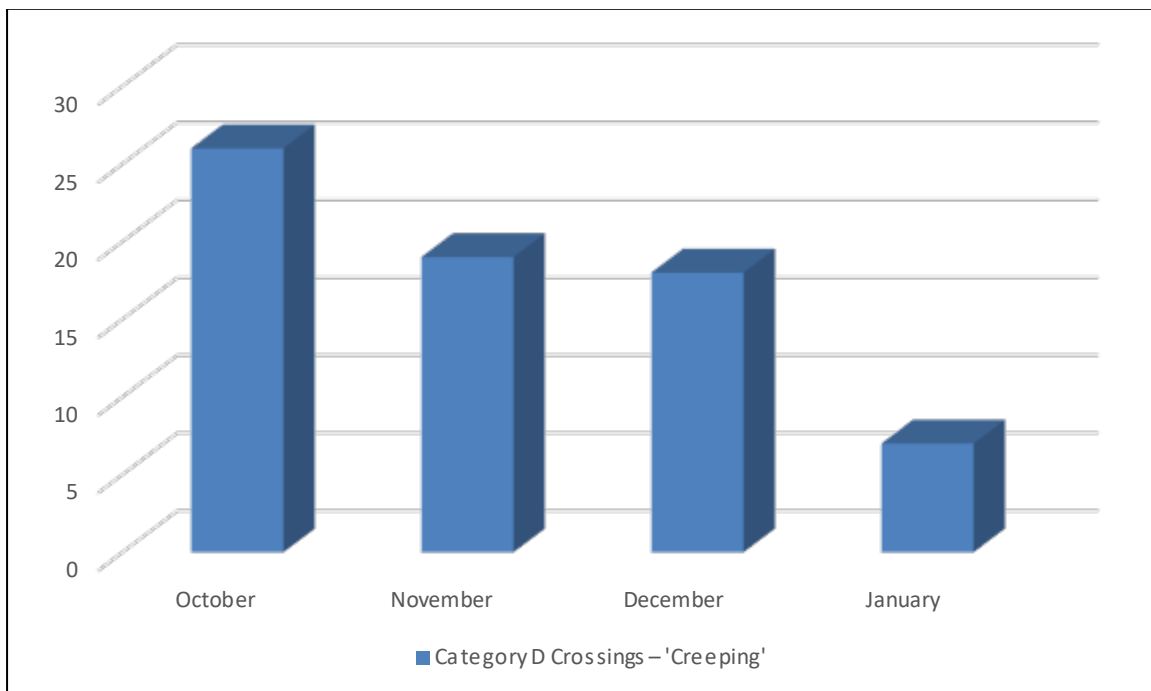
Figure 82: Transporter bridge crossings with a significant deficit in the safety distance

The analysis revealed that the operating behaviour described by the canal pilots questioned (Category D, 'Creeping') could be seen in about 1% of transporter bridge crossings. The transporter bridge departed despite the maritime traffic and headed for the ship so as to then cross to the other bank directly at the stern. Expressed in number of cases, the operator of the transporter bridge on the day of the accident displayed this operating behaviour 37 times and his colleagues 33 times. These very clear violations of WSA Kiel-Holtenau's instructions regarding safe distances to be maintained were spread over the respective month, occurring at different times of the day and night. This operating behaviour became something that could be observed in the Kiel Canal regularly, sometimes even on a daily basis (see Figures 82 and 83).
