**Bundesstelle für Seeunfalluntersuchung**  
**Federal Bureau of Maritime Casualty Investigation**  
Federal Higher Authority subordinated to the Ministry  
of Transport and Digital Infrastructure

## **Investigation Report 12/16**

### **Serious Marine Casualty**

**Collision between the Rendsburg transporter bridge  
and freighter EVERT PRAHM with  
subsequent grounding  
of the EVERT PRAHM  
on 8 January 2016**

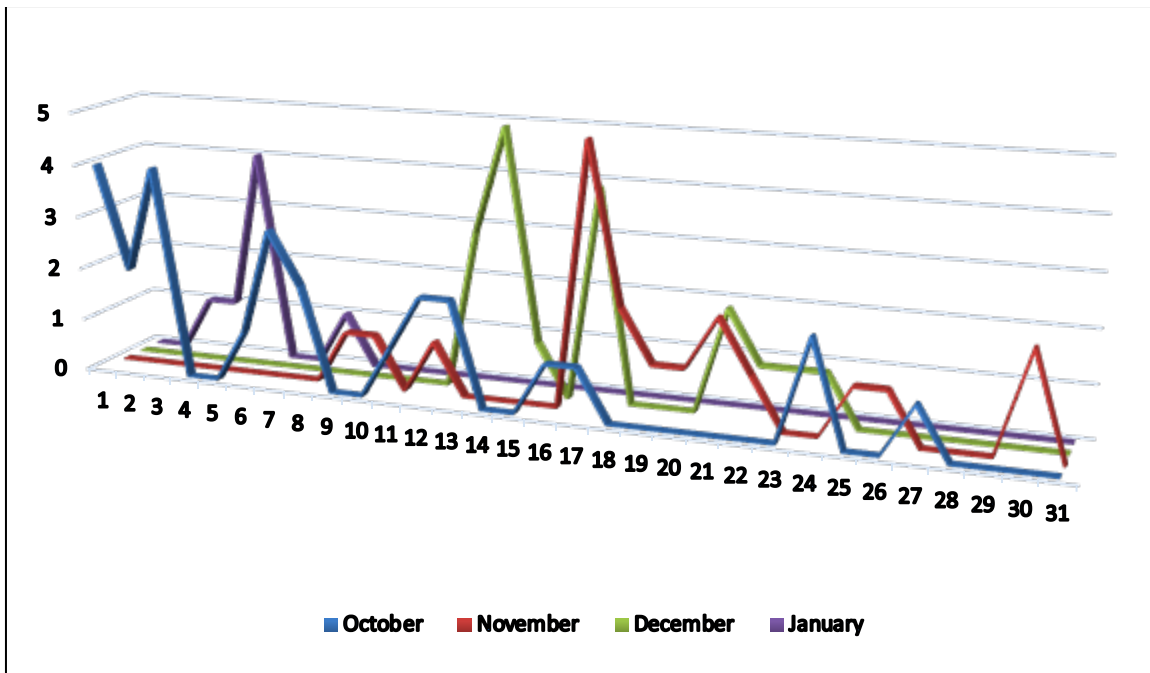
Figure 83: Distribution of infringements across the days of each month

Since the month of January 2016 was not fully recorded due to the accident being at the beginning of the month, there is only an apparent downward trend here.

In each case, crossings with a clear deficit in the safety distance were distributed across the whole month. There was no indication that deficits in the safety distance were more frequent on certain weekdays (e.g. Mondays) than on others. Based on these evaluations it can be stated that the transporter bridge's departure on the morning of the accident, despite the fact that maritime traffic was passing at the same time, was neither a novelty nor at least unusual. Parties transiting the Kiel Canal on a regular basis would be able to witness this operating behaviour by the transporter bridge sooner or later. The analysis therefore substantiates the testimony of the pilots on the EVERT PRAHM and the ship following her in the convoy, according to which the departure of the transporter bridge alone did not lead to the assumption of a risk of collision. Rather, the BSU assumes that the transporter bridge regularly crossed in such a conspicuous manner and that inasmuch an element of habituation may have developed among merchant shipping.

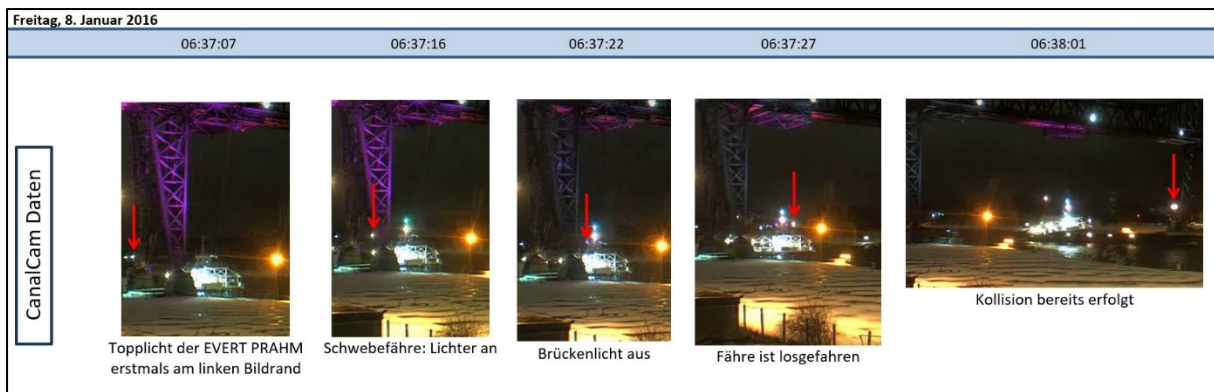
Figure 84: Video showing accident sequence

When the transporter bridge's operator docked on the northern bank on the morning of the accident after Ship A had passed, the EVERT PRAHM's masthead light was already visible in the video when the signal lights on the transporter bridge went on after the storm hook was released (see Figure 84: red arrow = EVERT PRAHM's forward masthead light). Within six seconds, the violet illumination of the bridge pier went out. Within another five seconds the transporter bridge moved away from the dock and thus directly toward the EVERT PRAHM.

demonstrated that the accident was mainly caused by the transporter bridge operator's failure to notice the EVERT PRAHM for reasons that remain unclear. The BSU's investigators regard the chronological sequence of the video showing the accident and the comments of the transporter bridge's operator after the accident on VHF

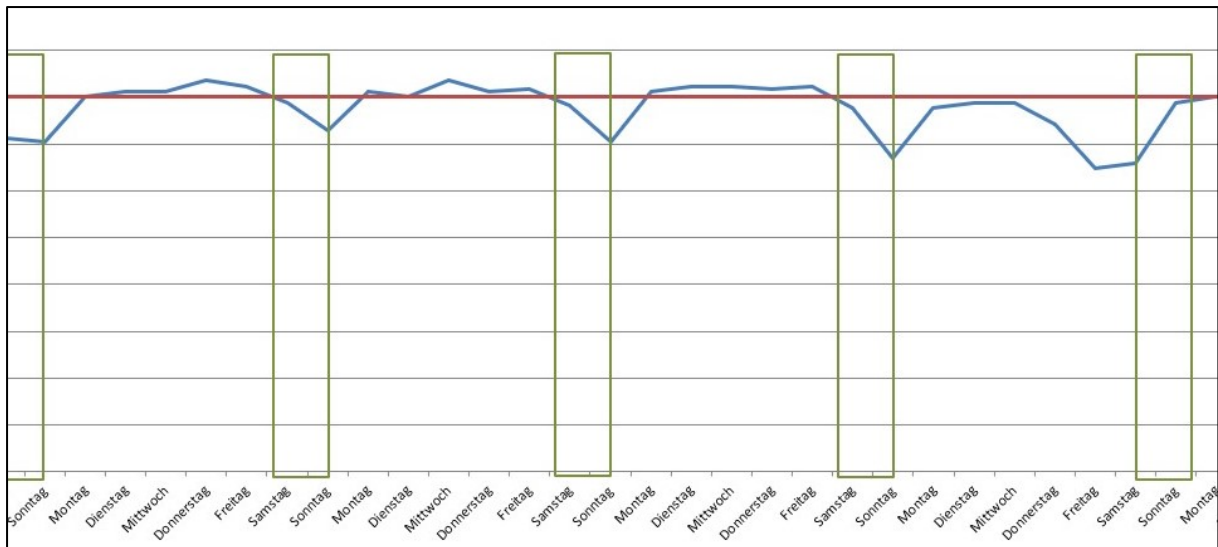
Figure 85: Extract from the analysis of the daily number of crossings by the transporter bridge

The analysis shows that although fewer crossings were always made at weekends than on weekdays, the eight crossings per hour target was consistently met. The arithmetic mean of all crossings in the months analysed is a constant eight crossings per hour (see Figure 84 – the red line represents the mean of eight hours per day).

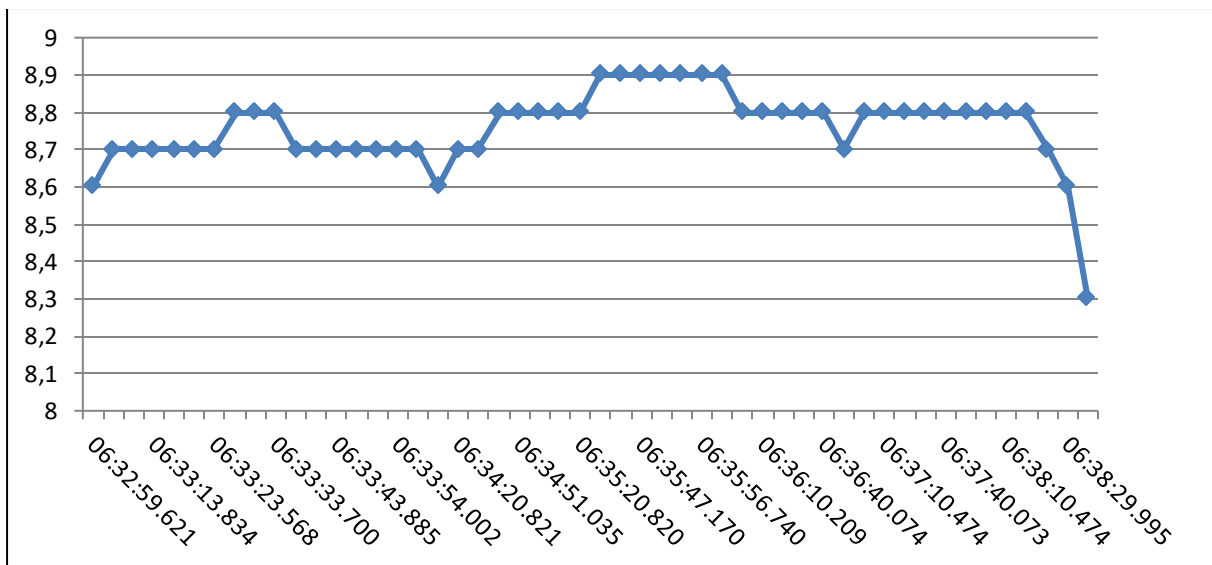
Figure 86: AIS velocity profile for the EVERT PRAHM

Due to her draught of 4.1 m, the EVERT PRAHM was classed as a TG 3 ship on the day of the accident and thus subject to a speed limit of 15 km/h or 8.1 kts. The ships ahead and astern of the EVERT PRAHM in the convoy were also classed as TG 3. The BSU created a velocity profile for the EVERT PRAHM based on the AIS data (see Figure 86).

Irrespective of the general observation that such AIS data always involve minor deviations in the presentation (see Figure 51 – speeds of 8.7 kts and 8.8 kts displayed for the EVERT PRAHM in the same AIS plot), the recordings as a whole indicate that the EVERT PRAHM had exceeded the speed limit. However, the BSU's investigators believe this excess speed of 0.6 kts to 0.7 kts (corresponding to 0.36 m/s at 0.7 kts) had no effect on the collision. Stopping would not have been possible even if 8.1 kts had been maintained and the additional reaction time arising from sailing in compliance with the canal's speed limit would not have been sufficient for a promising evasion manoeuvre.
