Bundesstelle für Seeunfalluntersuchung
Federal Bureau of Maritime Casualty Investigation
Federal Higher Authority subordinated to the Ministry
of Transport and Digital Infrastructure

Investigation Report 15/19

Serious Marine Casualty

**Fire in the area of the deck cargo
on board the container ship
YANTIAN EXPRESS
in the Atlantic Ocean
on 3 January 2019**

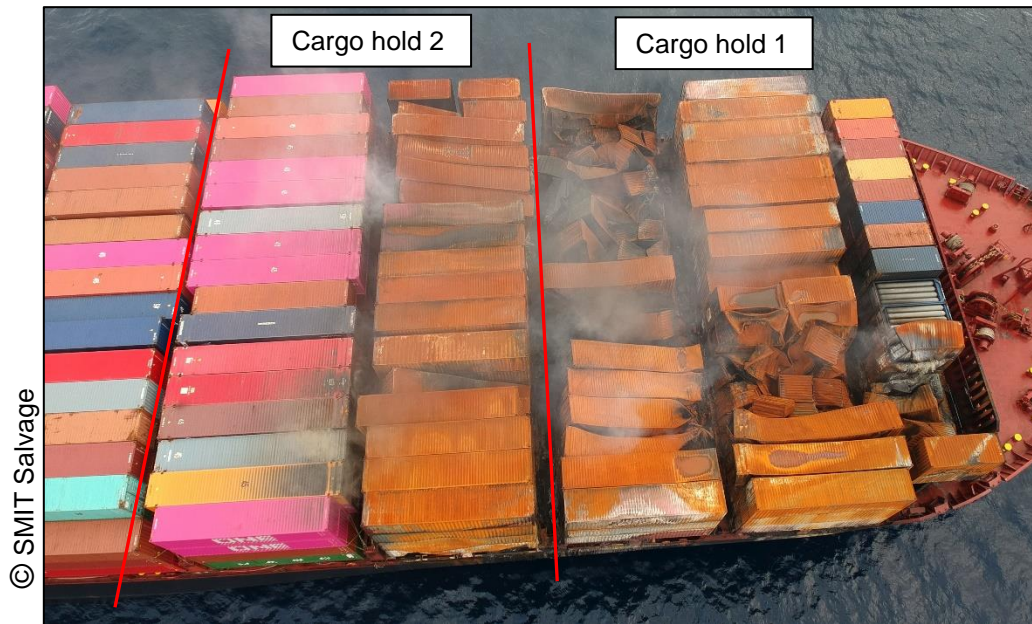
Figure 16: Fore ship of the YANTIAN EXPRESS on 12 January 2019

With regard to the cargo, the shipping company announced that four containers in cargo hold 1 and one container on the deck (161584) supposedly contained 'Titanium Sponge Granules + 10 mesh'²¹. The name in the manifest was 'Granules/Crushed Stone'. Although titanium sponge is not classified as a dangerous good, the data sheet indicates that it has a tendency to explode if it is heated or comes into contact with water. This information was important because a large amount of water had been and was being used to cool down the dangerous goods containers in bay 1. After the announcement, all cooling and firefighting measures around cargo hold 1 were initially stopped.

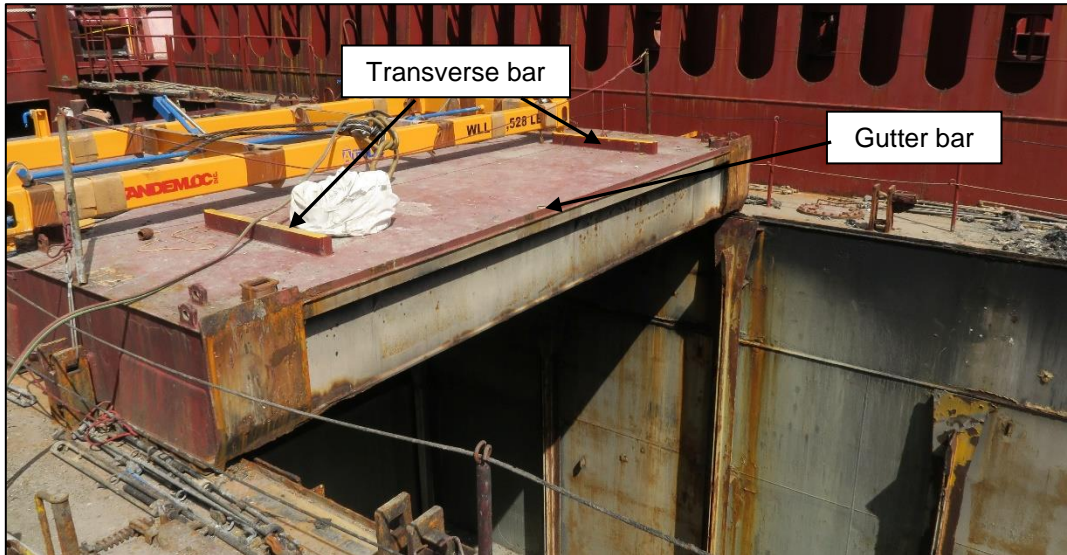
Figure 19: Cargo hold 1, bay 1, gutter bar and transverse bar

The hatch covers on the YANTIAN EXPRESS only form a partially watertight closure at the top of the cargo hold. This approved design is known as a non-weather-tight type hatch cover. Due to the design, a larger gap remains open between the individual lids.²⁸ The gap on this ship is ≤ 5 cm. A metal strip (gutter bar) welded to the edge of the cover on the side of the gap is intended to prevent rainwater or spray on the surface of the cover from entering the cargo hold as the ship moves (see Figure 19).

The chief officer also explained that the use of firefighting water beneath the containers was obstructed by the container feet located on the hatch cover and especially by the transverse bars welded onto them (see Figure 19).

The crew reported that the transverse bars on the hatch covers (Figure 19) obstructed the active cooling and extinguishing measures underneath the containers. Although the distance between cover and container is relatively large (see Figure 56), the transverse bars reduced the space available.

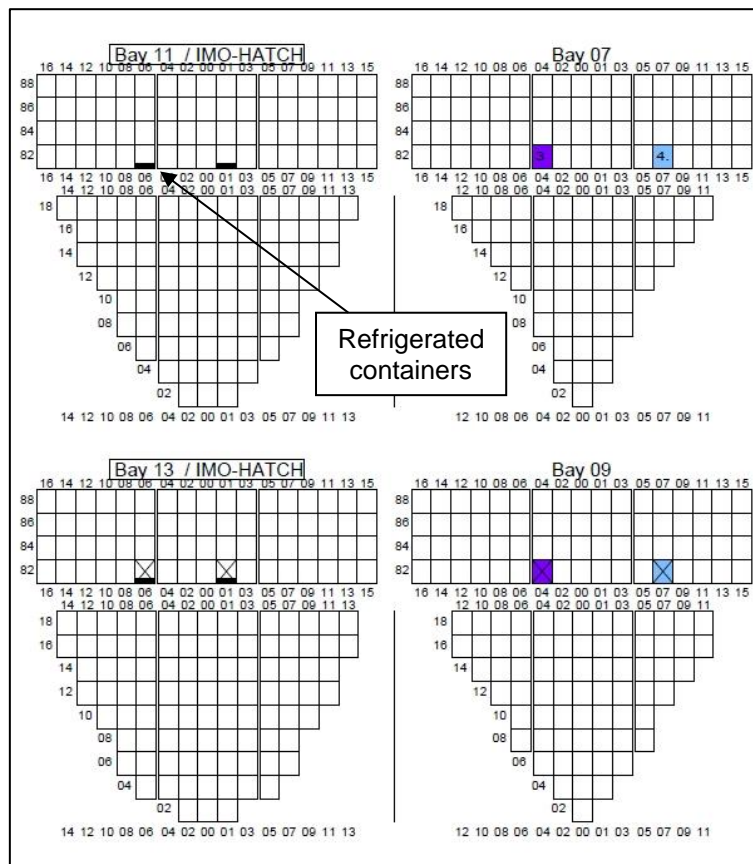
Figure 20: Dangerous goods and refrigerated containers in bays 7 to 13

Bays 11 and 13 were fully loaded across four tiers on the deck. 20' containers could also be found there. A total of 76 containers were thus transported on the deck. A total of 93 containers were transported in the cargo hold at bays 11 and 13.

The distribution of dangerous goods and refrigerated containers in bays 7 to 13 is shown in Figure 20.

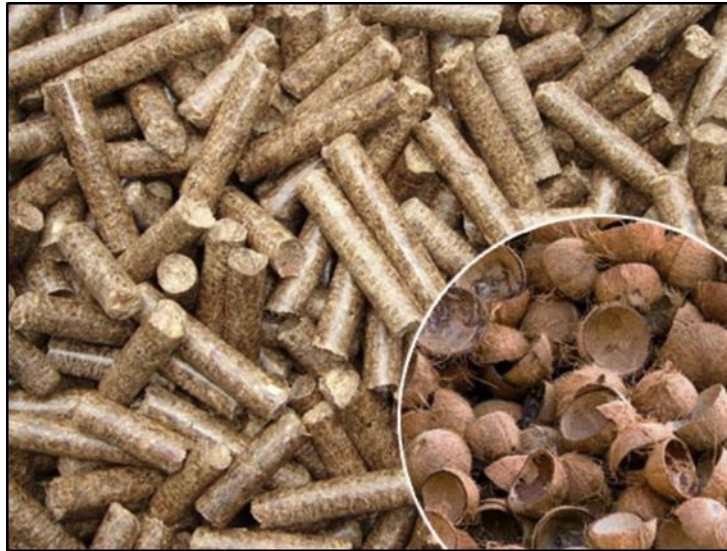
Figure 41: Coconut pellets³⁰

Coconut charcoal rather than the coconut pellets specified in the cargo documents was in container UACU5272502 at slot 120782. The difference between coconut pellets (see Figure 41) and the pyrochar shown in Figure 33 is clear. Coconut pellets are produced by grinding coconut shells and used as fuel for furnaces. In addition, coconut

shells or their fibres are processed into fish feed pellets or into a basic material for plantations. Chemically, coconut pellets are completely different from coconut charcoal.

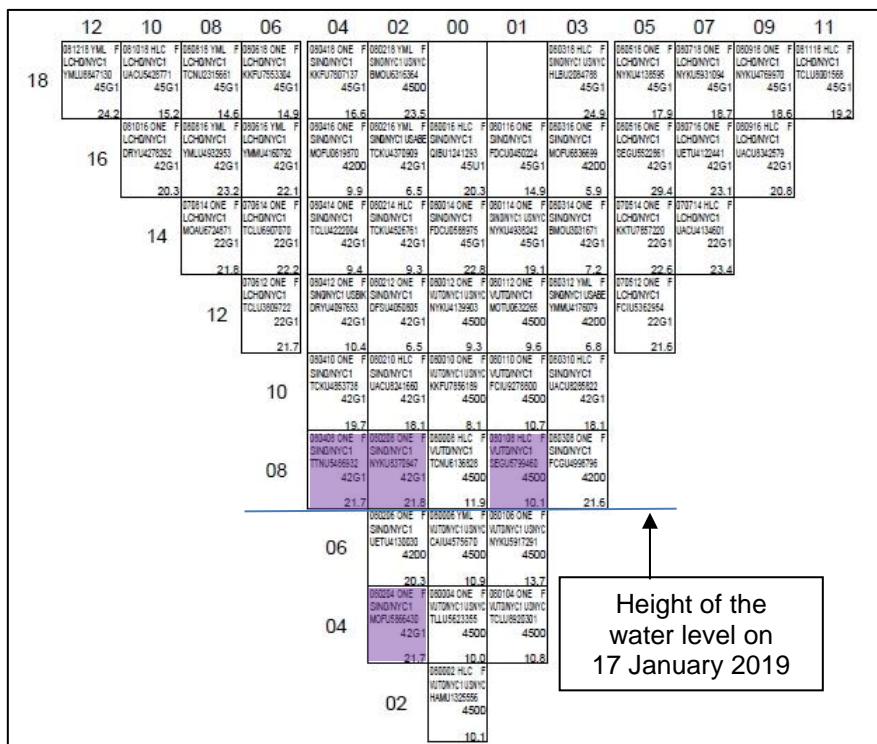
Figure 49: Cargo hold 1, bay 8, 40' container with titanium sponge

According to the shipping documents, seven 40' containers with titanium sponge were on board the YANTIAN EXPRESS. Four of them were transported in cargo hold 1, bay 8. Another container was in bay 16.

The safety data sheet provided to the BSU by the shipping company contained the following text: "Keep away from heat, sparks, open flames, heated matters and other ignition sources. Keep in a cool place and avoid sunlight. Container may explode on heating. May react drastically or explosively on contact with water. May decompose explosively when heated or involved in a fire." The prohibited firefighting agents indicated included water, CO₂ and foam extinguishing agents.

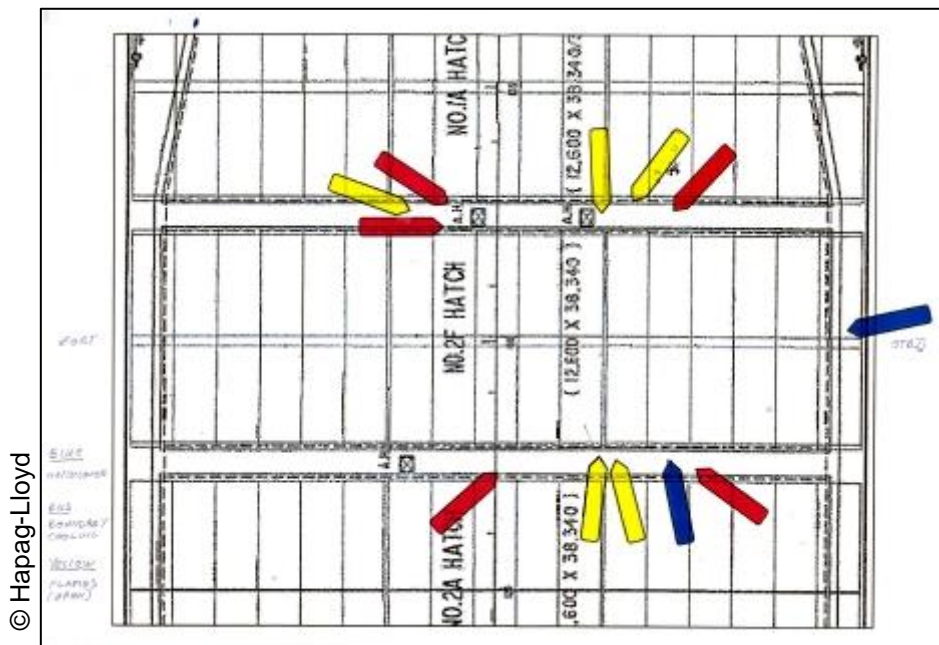
Figure 52: Firefighting by the crew at bay 12

Viewed from the top. The blue arrows indicate the use of water between hatch cover and container floor. The yellow arrows indicate the extinguishing of open flames. The red arrows indicate the cooling down of the environment.

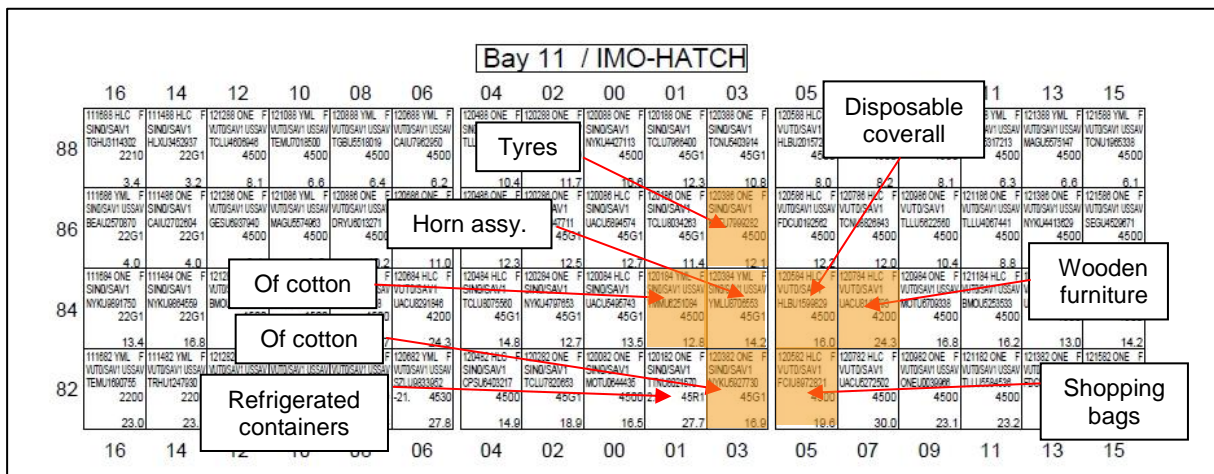
Figure 58: Bay 11 stowage plan

The cargo in the containers first affected is once more shown below (see also Figure 3 and subsection 3.2.6).

Reference samples of the in figure 58 listed cargoes were not available to determine specific fire hazards, except for the container with “horn assy”. This is because the contents had been essentially consumed by the fire and it was therefore not possible to determine what was in the containers pre fire based upon the remains alone. The investigators do assume that none of these goods posed a particular risk of spontaneous combustion under normal circumstances, however. With that said, however, the investigators cannot rule out any undeclared or misdeclared cargo in these containers.

The containers at slots 120382 and 120582 were identified as being the first containers to catch fire at about 0040 on 3 January 2019. The container at slot 120582 was fully loaded with polypropylene shopping bags (PP Woven Shopping Bag) and put on board the YANTIAN EXPRESS in Vũng Tàu. The investigators found no evidence to suggest

The cargo documents indicated that only two loads may have contained a source of ignition. One was the refrigerated container at slot 120182 and the other was the container loaded with horns (Horn Assy) at slot 120384. The investigators consider it unlikely that the refrigerated container was the cause of the fire. Firstly, the container was loaded with pineapples, which do not pose a fire hazard. Secondly, no traces of fire indicating a fire inside the unit could be found on the refrigerating unit (see also Figure 34). The container loaded with horns contained only the horns and no associated power sources. Their packaging was obviously flammable, however.
