Bundesstelle für Seeunfalluntersuchung
Federal Bureau of Maritime Casualty Investigation
Federal Higher Authority subordinated to the Federal Ministry
of Transport and Digital Infrastructure

Investigation Report 19/19

Less Serious Marine Casualty

**Accident involving a person
on the multi-purpose vessel MARFAAM
at the Rüsterbergen pilot station
on the Kiel Canal (NOK)
on 13 January 2019**

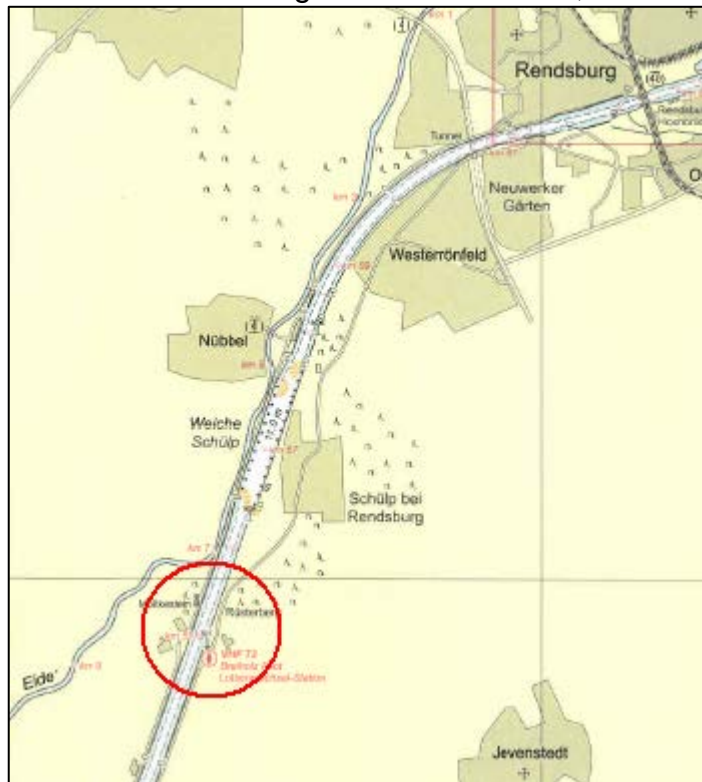
Figure 3: Scene of the accident; NOK km 55 (Rüsterbergen pilot transfer station)

Type of marine casualty:	Less serious marine casualty ³ ; accident involving a person
Date, time:	13/01/2019, 0657
Location:	NOK km 55 (northern side); Rüsterbergen pilot transfer station at Schülp, near by Rendsburg

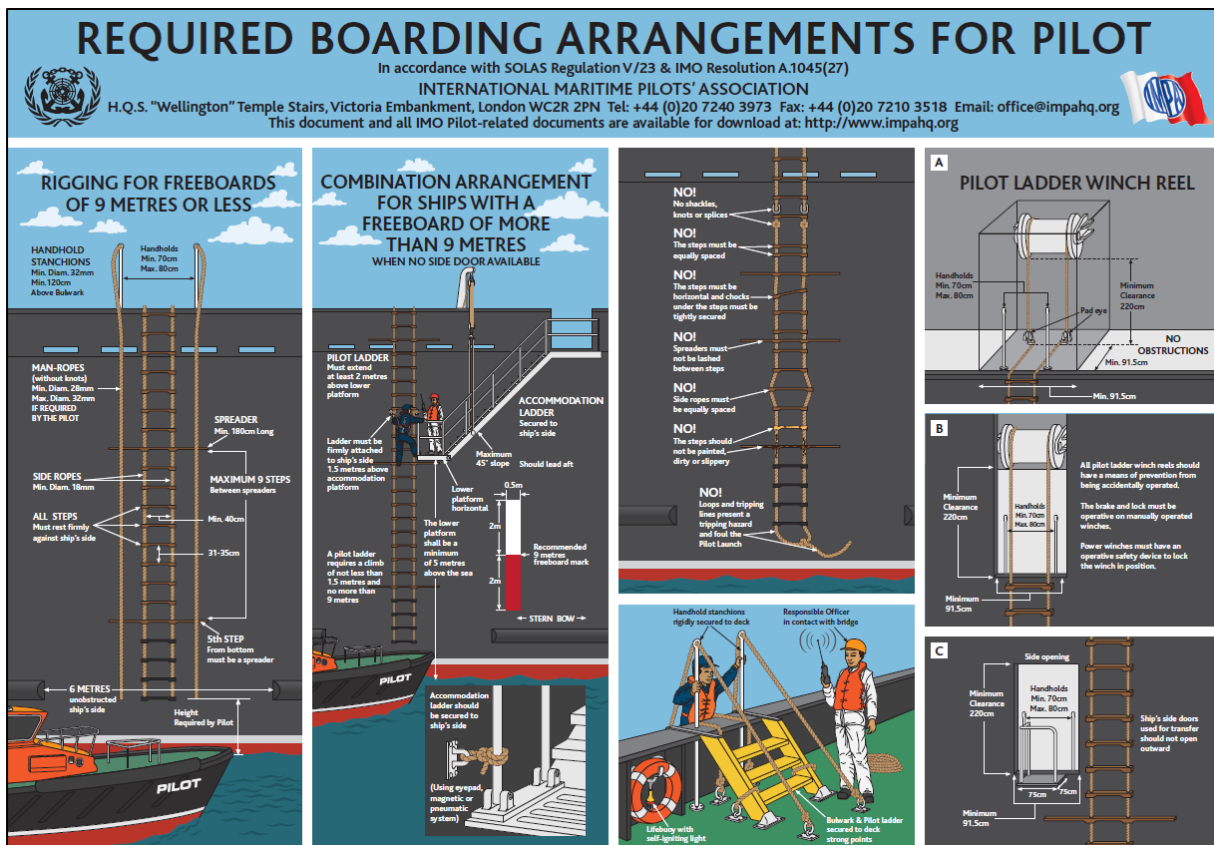
Figure 9: MSC.1/Circ.1428 of 28 May 2012 (larger version in Annex III)

The Maritime Safety Committee provided an updated version of the poster to IMO Member States for distribution to pilots, seafarers, shipowners, ship operators and any other person involved in pilot transfer (see Figure 9 and Annex 9.3) on 28 May 2012 in MSC.1/Circ.1428.

As a rule, only the poster most recently published can be found on relevant websites, such as that of the IMPA¹⁵, even though the older poster (see figure 8) is still valid in principle, e.g. for ships built before 30 November 2011 and on which no structural changes have been made to the pilot embarkation point after that date.

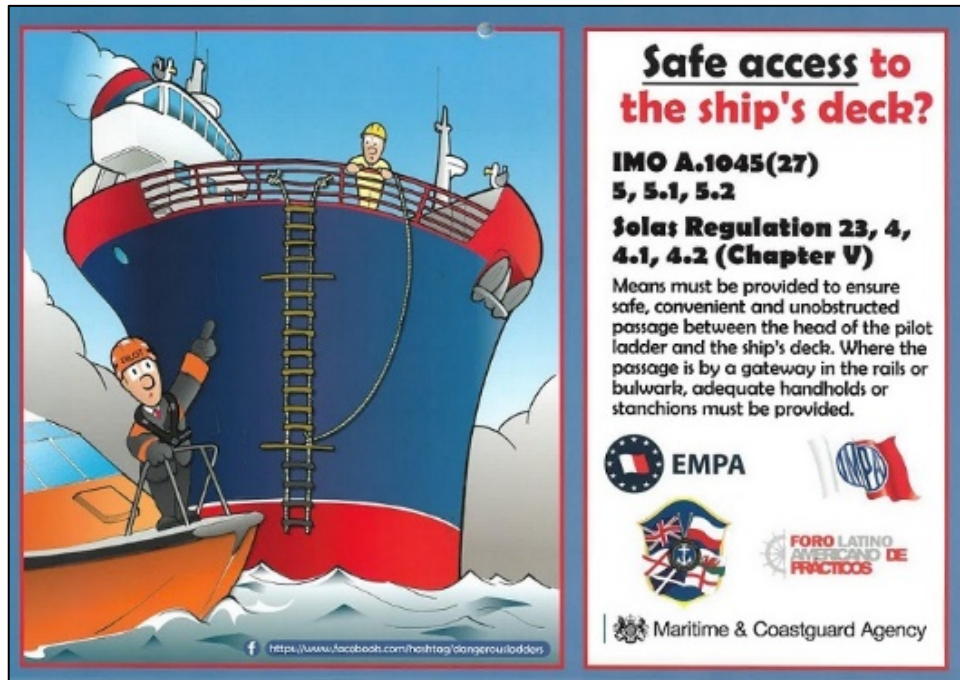
Figure 11: IMPA calendar page for October 2020

Inter alia, sturdy footwear, vest, gloves and an orange helmet are visible. These pilots do not carry a rucksack or bag. Figure 11 of the investigation report shows the calendar picture for the month of October, which deals with Regulation 23, paragraph 4 SOLAS (Access to the ship's deck). The calendar pictures for other months each deal with different SOLAS violations.

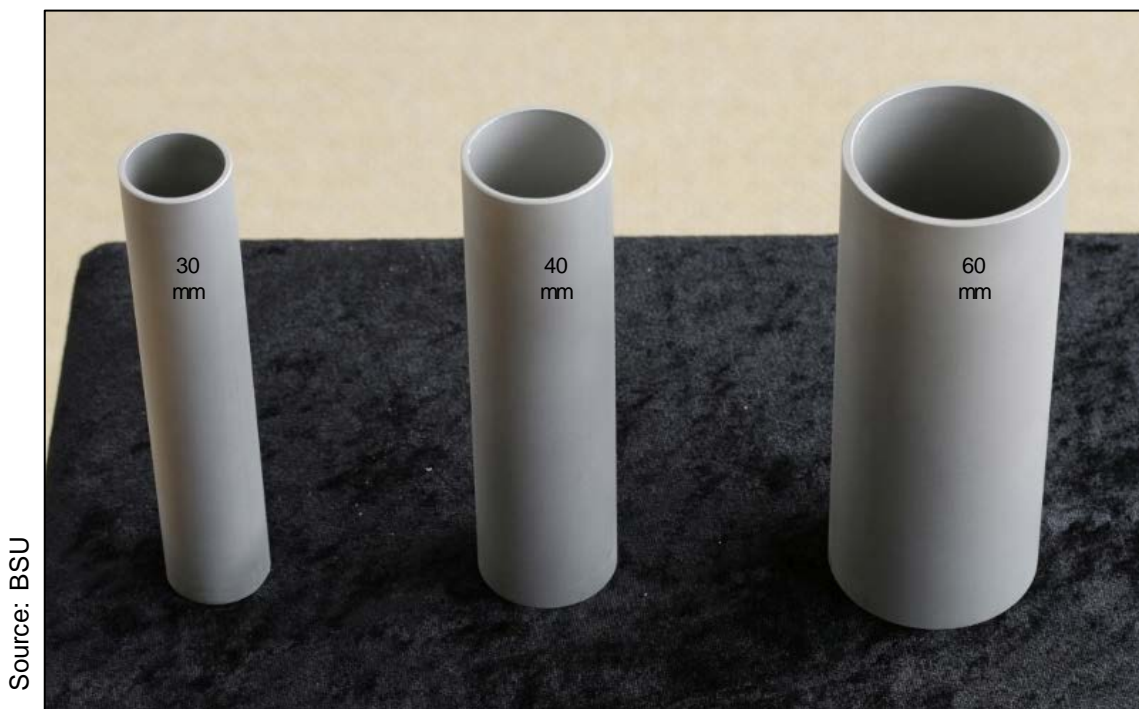
Figure 18: Tubing examples of 30⁴⁵/40/60 mm in diameter

The Maritime Safety Committee published criteria for adequate handholds as a recommendation in Resolution A.1045(27), as amended by A.1108(29). Handholds must have a minimum diameter of 32 mm and be rigidly secured to the ship on both sides at or near their base and also at a higher point at a distance from one another of between 0.7 m and 0.8 m.

⁴⁵ Standard tubing was used for the photograph. At 30 mm, the diameter of the tubing is 2 mm thinner than that permitted by SOLAS.

The replies of the classification societies (which check if pilot transfer arrangements comply with requirements on behalf of the flag State) questioned show that no other flag State requirements for the adequacy of handholds are known about. The recommendations of the Safety Committee are complied with as a general principle. One class recommends that its customers use a diameter of between 40 mm and no more than 45 mm, thus ensuring the handholds are adequate and meet SOLAS requirements.
