Investigation Report 241/18

Serious Marine Casualty

Grounding of the motor tanker PAZIFIK off Indonesia on 9 July 2018

23 January 2020

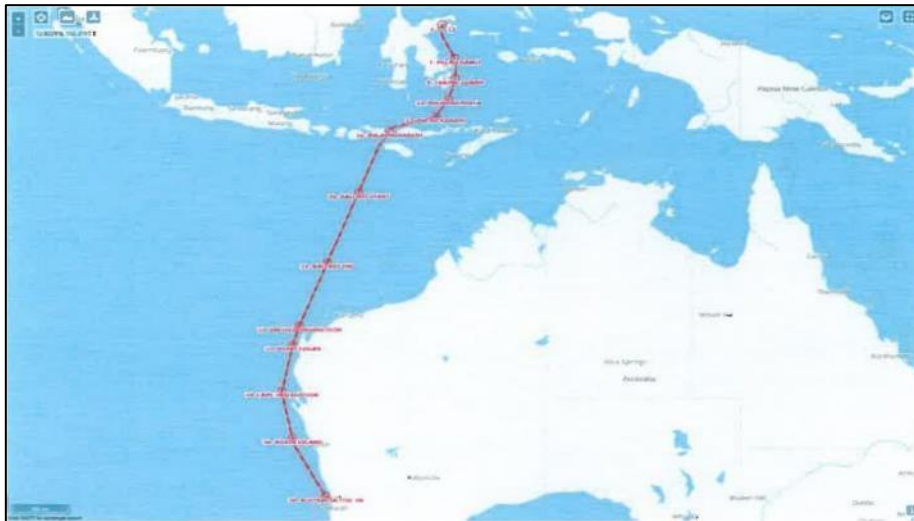
Figure 3: Voyage planned using ChartCo

The ChartCo software proposed a route via Selat Sape, passing between the islands of Banta and Komodo. The master and the second officer discussed this route. The route that the master is familiar with, through the more westerly Lombok Strait, was not chosen because it entailed an additional distance of more than 200 nm.

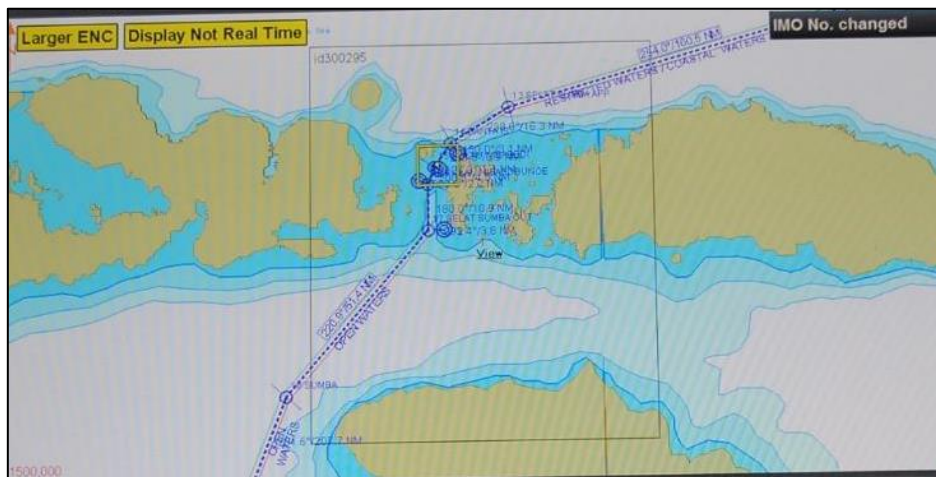
Figure 4: Passage planned using ChartCo

The master and the second officer agreed to follow the Selat Sape route proposed by the system with one modification. The route proposed by the PassageManager passed between the islands of Nisabedi and Lubuhtare. The distance between the two islands is only about 1.5 nm. The passage between the islands of Nisabedi and Banta, which was then used, is about 2.5 nm.

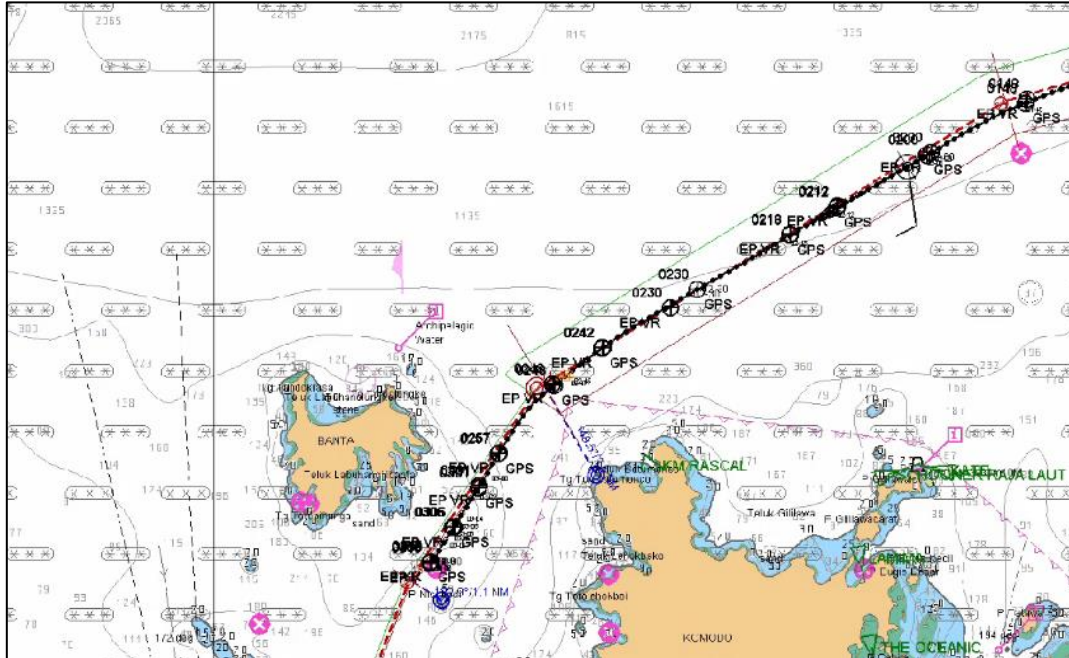
Figure 11: Voyage according to route planning

The course of the voyage is recorded in the ECDIS and statements of the crew are consistent with the recordings.

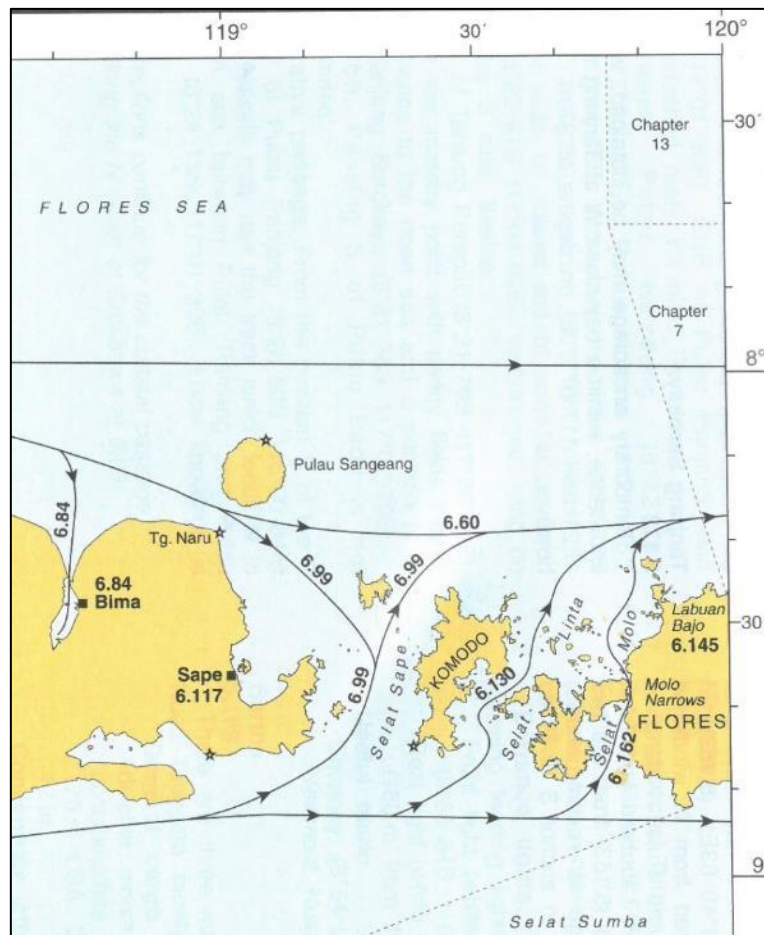
Figure 14: Chart p. 138 UKHO Sailing Directions NP 34

"The passage E of Pulau Banta is navigable but is seldom used, other than by ferries and other local craft, as tidal streams are strong and fewer anchorages are available [...]."

"A drying rock, 1 mile farther NNW, is small and dangerous; the breakers on it being indistinguishable from the normal overfalls and sea conditions in the area."

This account corresponds entirely with the situation found at the place of grounding.
