Bundesstelle für Seeunfalluntersuchung
Federal Bureau of Maritime Casualty Investigation
Federal Higher Authority subordinated to the Ministry
of Transport and Digital Infrastructure

Investigation Report 421/18

Occupational accident on board the MV SVENJA at the pier in the port of Rostock on 31 October 2018

18. June 2020

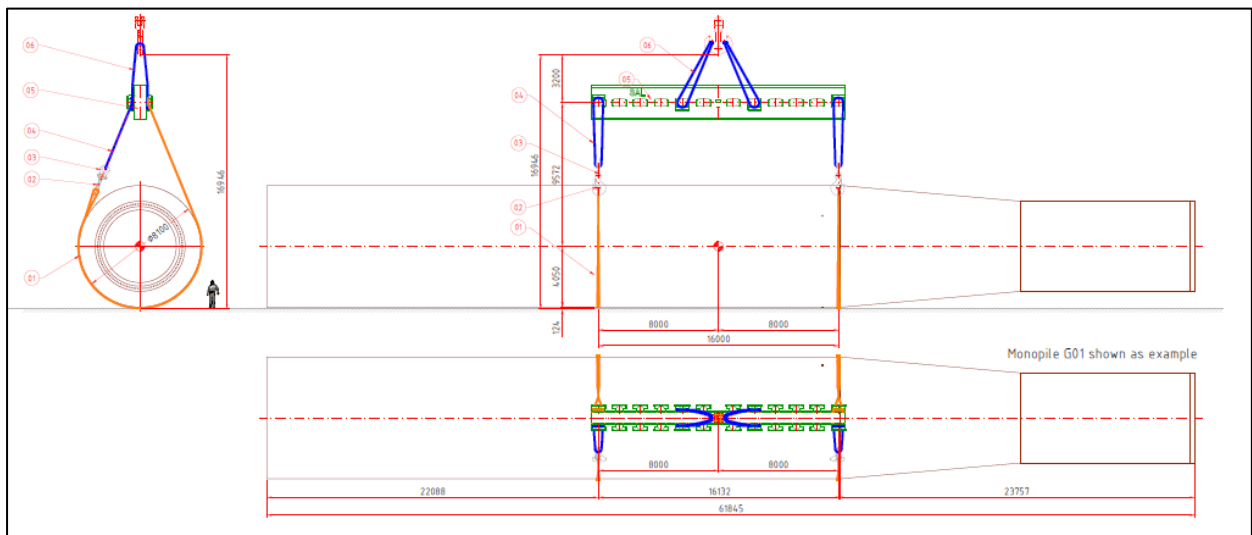
Figure 6: Configuration of the loading gear (overview)

The cargo gear consists of a traverse (green), which is 16 m in length and suspended from the crane hook with wire ropes (blue). Depending on the MPs being moved, two Dyneema ropes/slings (orange) of about 27 m in length are attached to one end of this traverse with a wire rope (blue). The maximum distance between the slings is 16 m (see below example of the cargo gear).

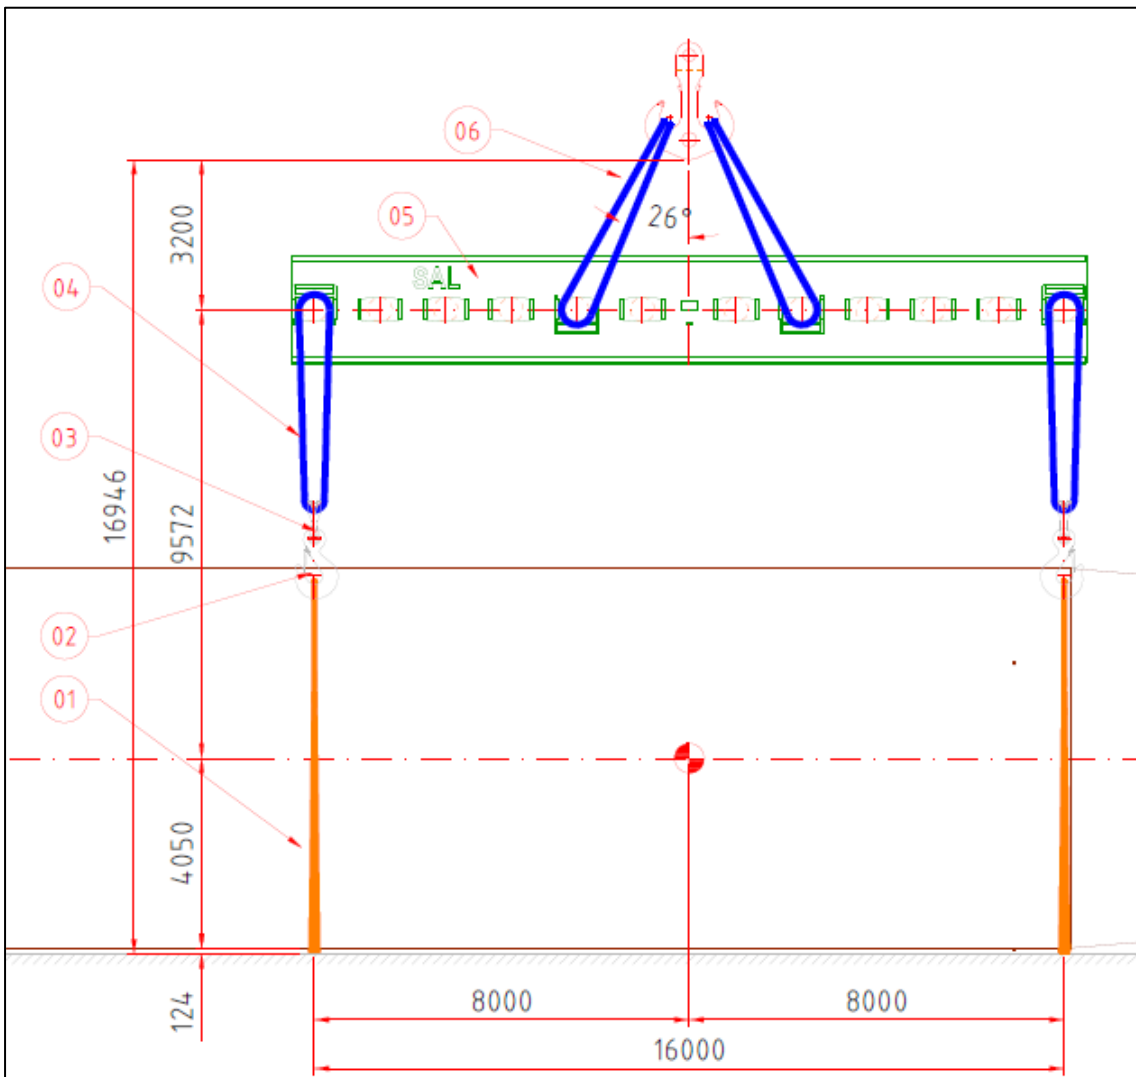
Figure 8: Centroidal distance

Attachment of the ropes 16 m apart from one another to the traverse for lifting with one crane started at 1830. The chief officer had inspected the loading gear to ensure it was properly certified and approved it beforehand. The ropes were positioned at the markings measured from the centre of gravity (figure 8) according to the lift plan and the positions were checked after the ropes had been tensioned with a load of 20 t on the crane hook. The cables belonging to the two tugger winches were attached to the crane traverse for fixing and tensioned slightly.

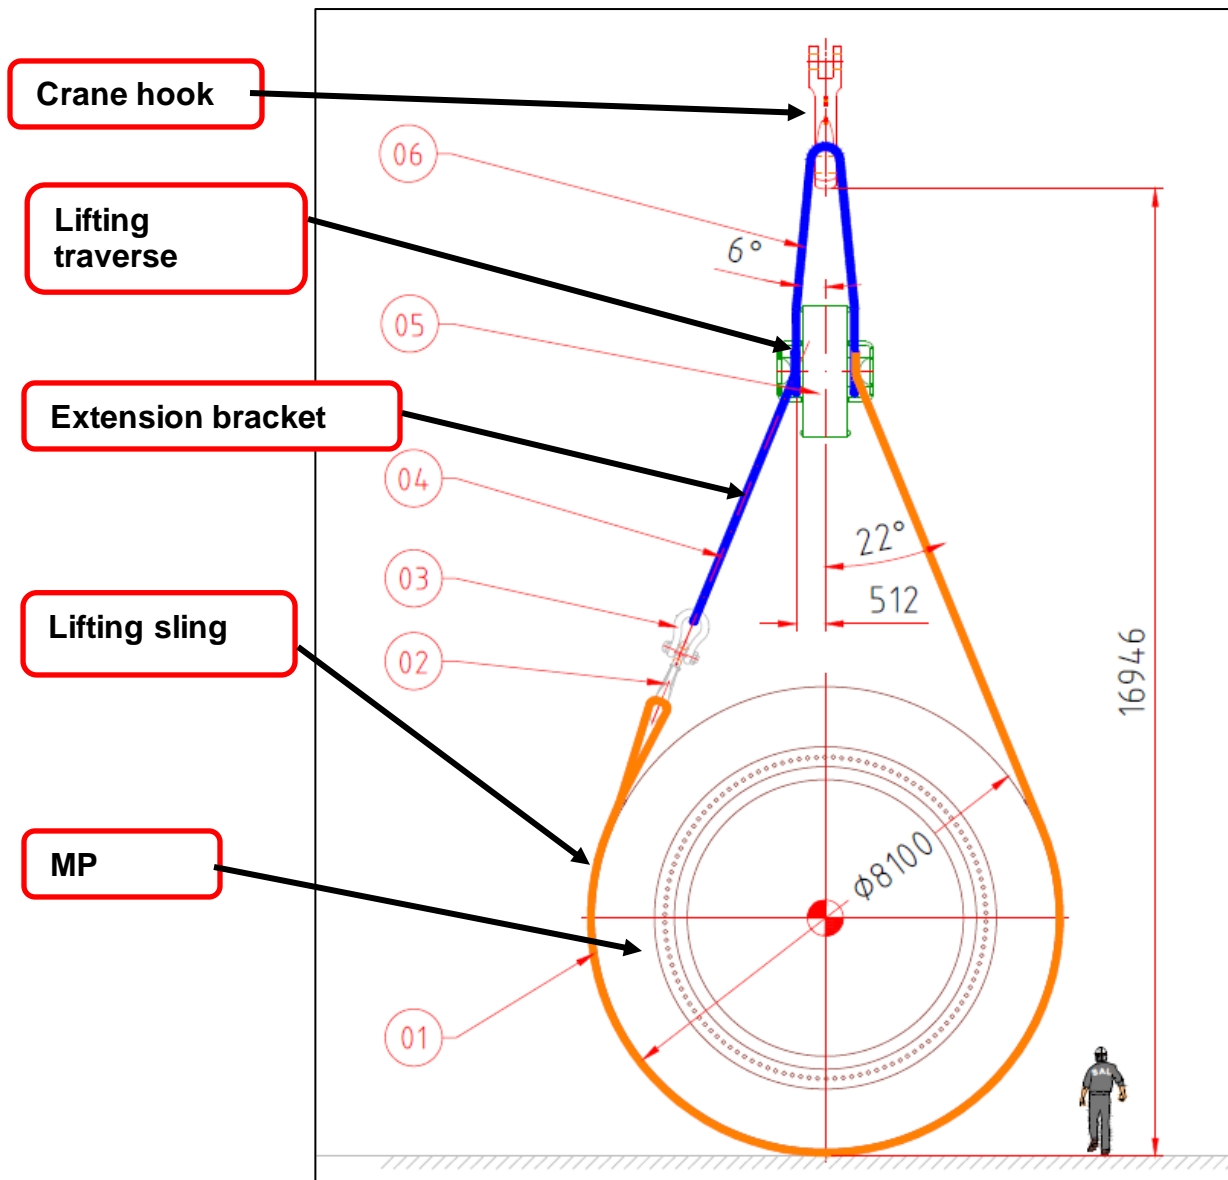
Figure 9: MP enlacement

The complete arrangement of the lifting traverse and lifting slings is shown in Figure 9. One ring on the 27.5 m-long lifting sling made by GeoGleistein is hung directly into the traverse, while the other ring is attached to an extension bracket, which is also hung directly on the traverse, by means of a shackle. The spacing between the slings on the crane traverse for single-crane operation can vary between 11.8 m and 16.0 m. The 16.0 m spacing for this lift was required for structural reasons due to the bulge of the earthing brackets on the MP, as well as due to the bearing blocks on the SPMT and the deck.

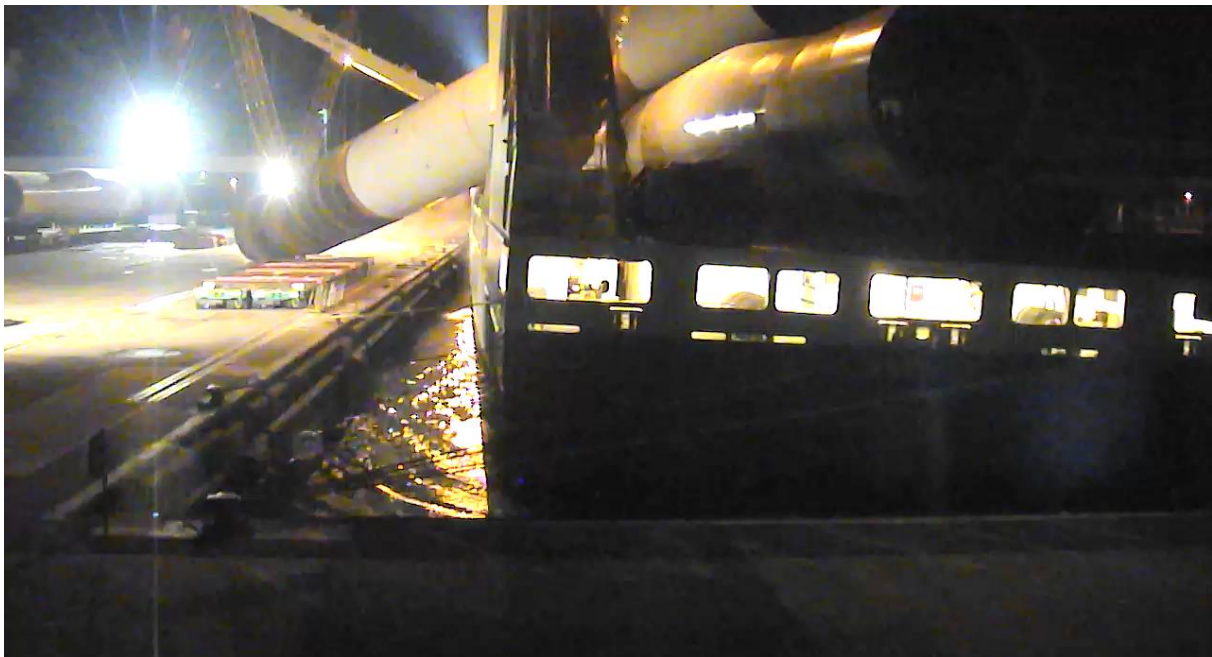
Figure 17: Still image of video recordings

The port operator's video recordings, which are triggered by motion detectors, were available for the investigation of the accident. The lift/swing operation cannot be seen in its entirety and continuously because this camera is only triggered when people or vehicles are in motion. No jerky or rapid rotational movements can be seen in the recordings or calculated from the running timeline of the recordings, however. The recordings were analysed with the involvement of representatives of the owner. The lift/swing operation was executed without any jerky movements, which is also confirmed by witnesses.
