# Loss of containers overboard from MSC ZOE

1-2 January 2019

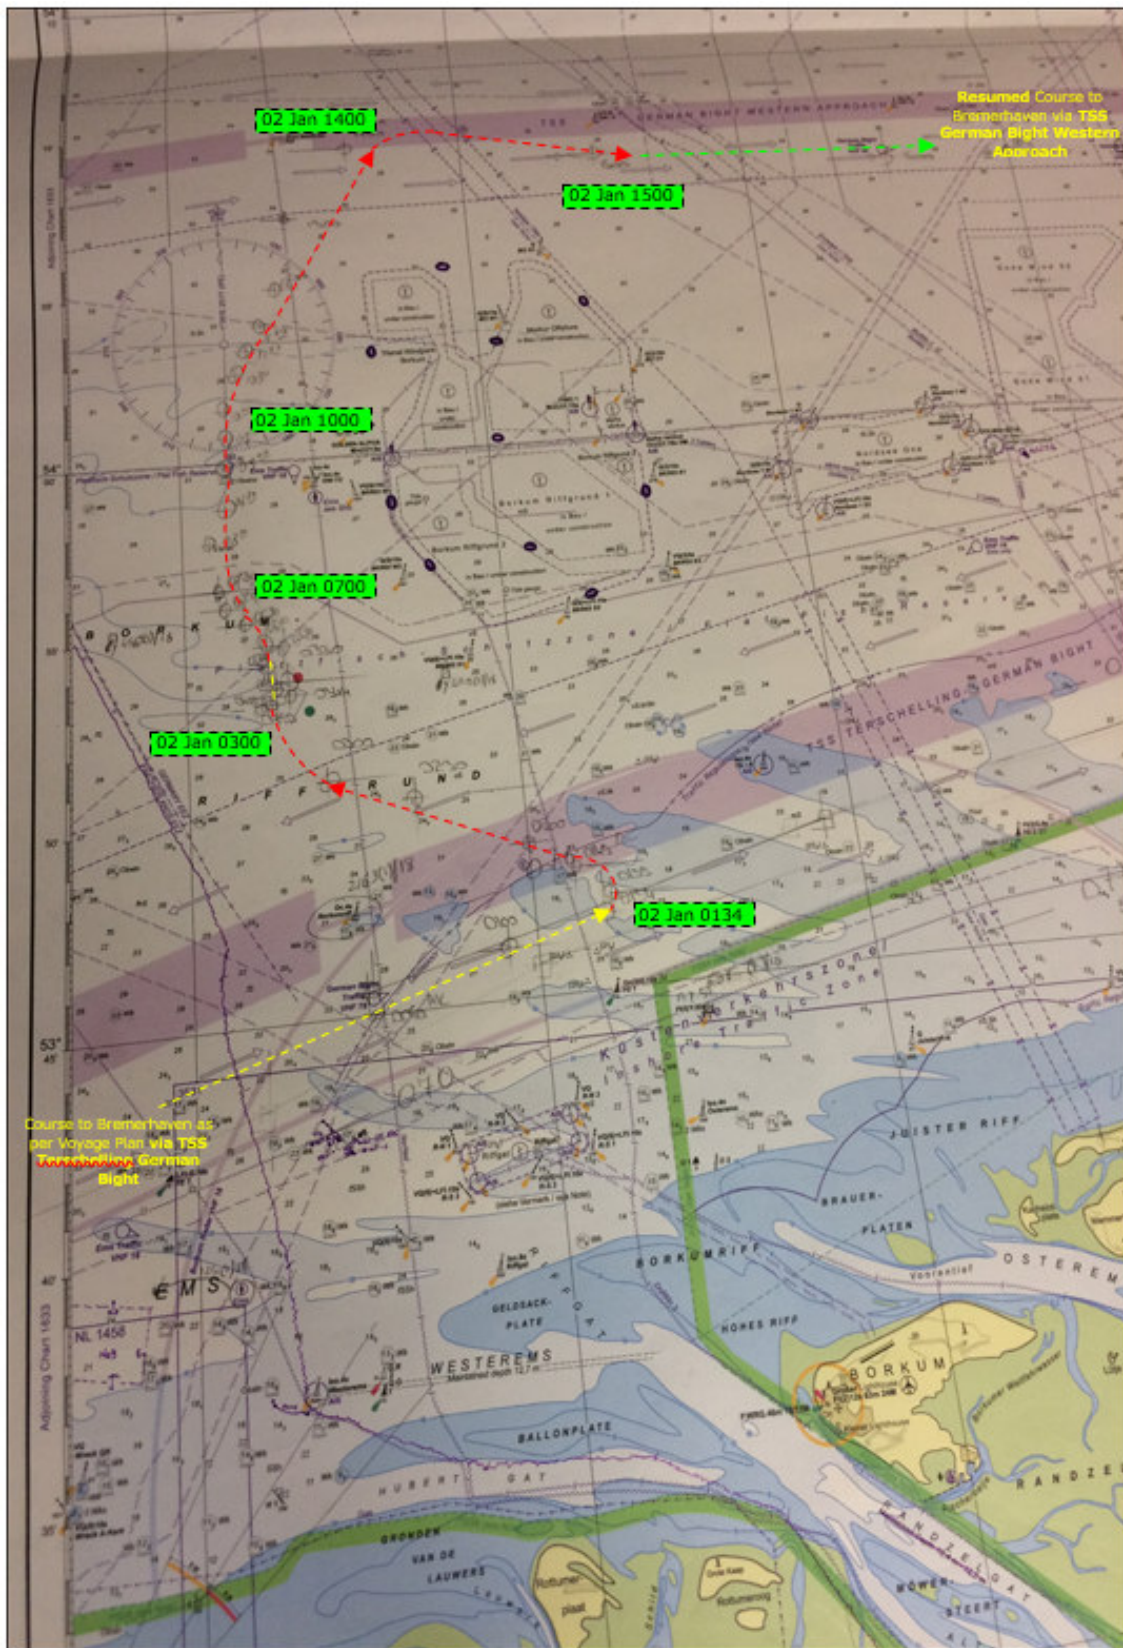
Figure 4: Track of the MSC ZOE after altering course to the north following the detection of the container loss. (Source: Paper chart MSC ZOE)

At around 14.00 hours in the afternoon of 2 January, the MSC ZOE reached the more northerly TSS German Bight Western Approach (see figure 4), and at around 15.00 hours following a turn to starboard, the vessel entered the southern lane in order to continue its journey to Bremerhaven. At 19.15 hours, the pilot came on board, to guide the ship into port. The MSC ZOE moored in Bremerhaven, at 01.00 hours in the morning of 3 January 2019.

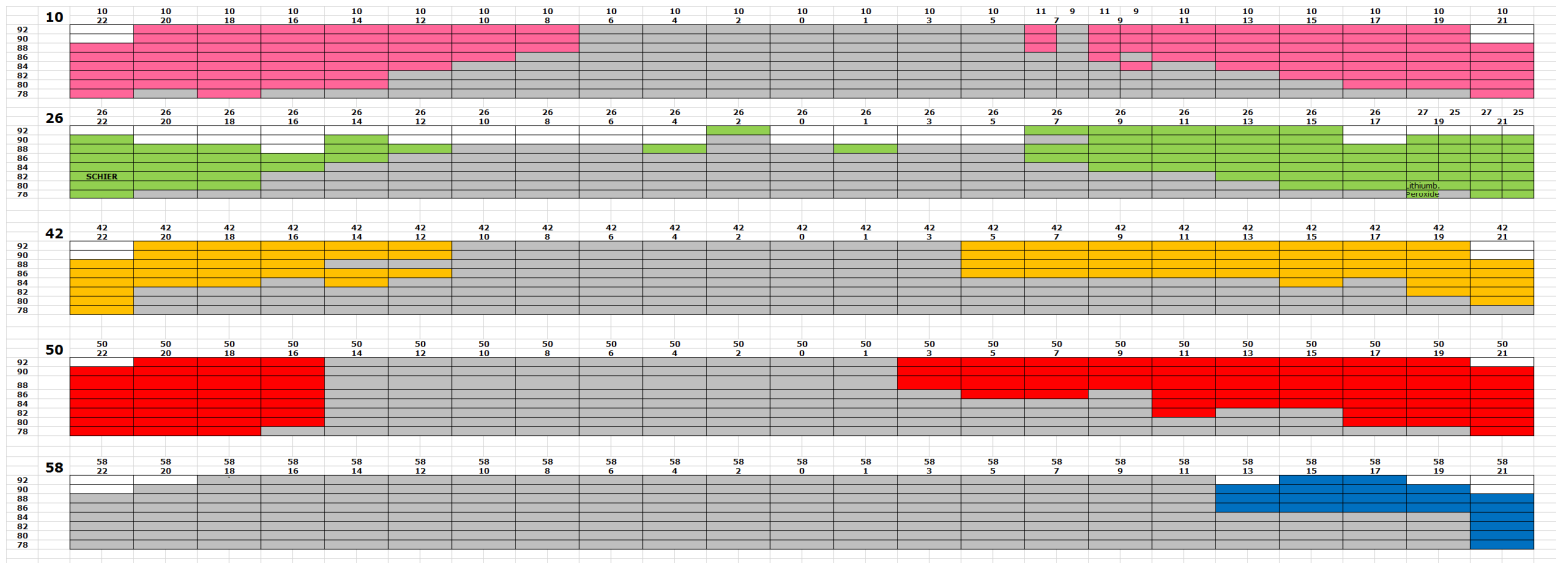
Figure 22: Cross section view of lost containers per bay. (Source: Based on data provided by Rijkswaterstaat).

The first containers were lost shortly before 20.00 hours (blue dots in figure 20). At that time, the MSC ZOE was located to the north of the most easterly point of Vlieland. These containers originated from bay 58, in the middle of the ship (see figure 21). The most notable element of this initial loss moment was that all the containers fell over the starboard side (see figure 22).

The second loss of containers occurred between 21.05 and 21.20 hours (pink dots in figure 20). At that time the MSC ZOE was located to the north of Terschelling. These containers originated from bay 10 at the bow of the vessel (see figure 21). Approximately the same number of containers fell overboard from both sides of the vessel (see figure 22).

The third loss occurred at around 22.20 hours. A number of additional containers fell overboard from bays 58 and 10. In total 21 containers were lost from bay 58, both at the first and third loss. It is impossible to determine exactly how many containers from this bay were lost at the first or third loss. Only the cumulative number of containers lost from bay 58 at those two points is known. The same holds for containers from bay 10 (9/11), which were lost during the second and third loss. In total 93 containers were lost from bay 10 (9/11) (see figure 22).

The fourth loss of containers took place at around 23.20 hours (orange dots in figure 20). At that time, the MSC ZOE was located to the north of the most easterly point of Ameland. These containers originated from bay 42, situated behind the bridge (see figure 20). Slightly more containers fell overboard from the starboard side, than from the portside. A number of containers from the middle of the bay also went overboard. Eventually 65 containers from bay 42 fell overboard (see figure 22).

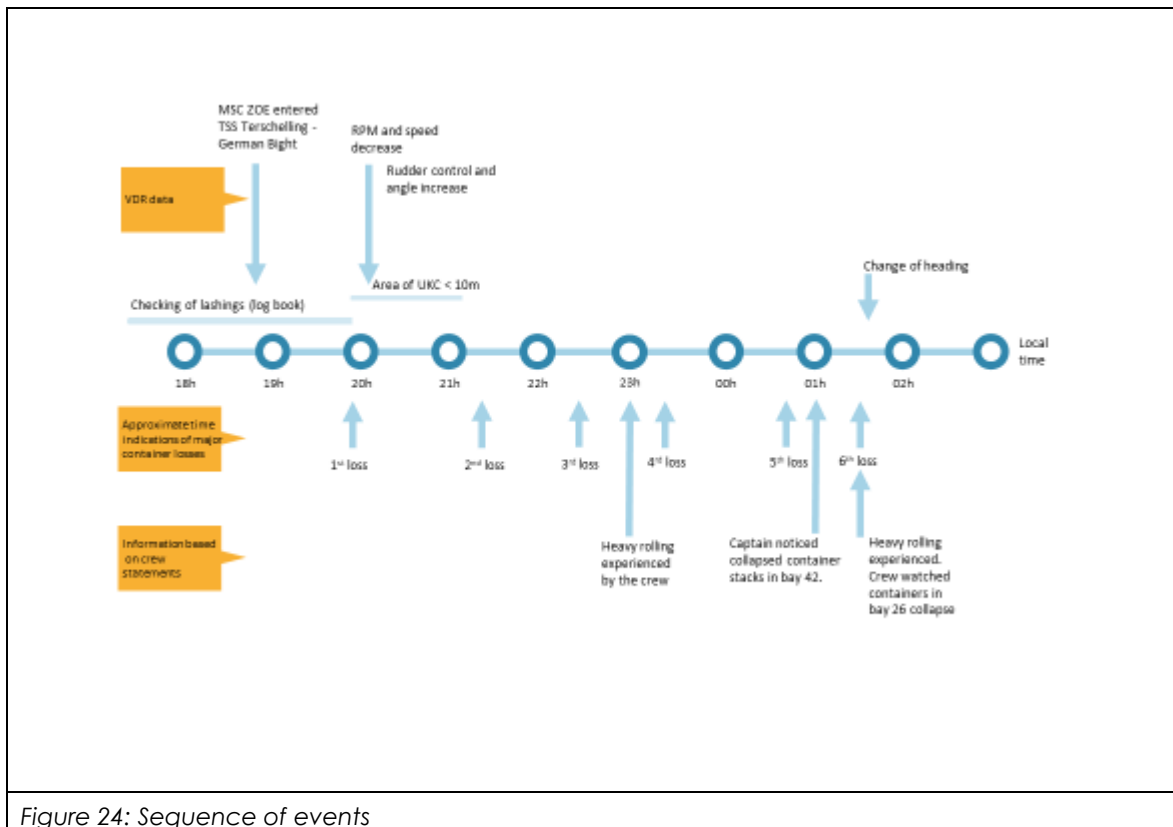
Figure 24: Sequence of events

Figure 24 summarizes the sequence of events and combines the data from the VDR, the information based on crew statements regarding the perceived ship motions and the major container loss moments based on the container recovery data.

According to crew statements, the MSC ZOE experienced in the TSS Terschelling – German Bight continuous rolling movements of 5 and 10° with occasional moments of heavier rolling of 15° up till 30° peaks. The VDR data confirms that when the MSC ZOE entered the TSS Terschelling – German Bight the ship started to roll continuously.

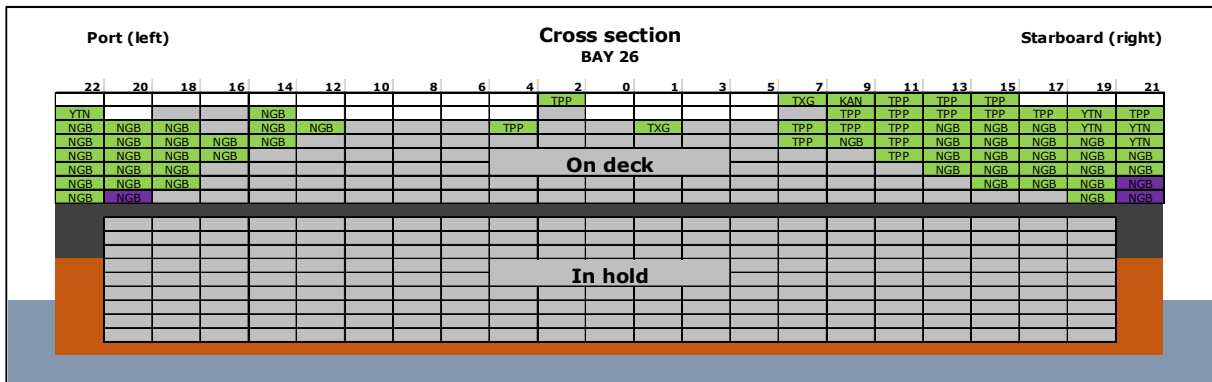
The containers lost from bay 26 were loaded in all Asian ports except Shanghai and destined for Gdansk. Bay 26 contained 3 containers with dangerous goods, coloured purple. The two containers on starboard were lost; the one on port side remained on board but lost some of its content.

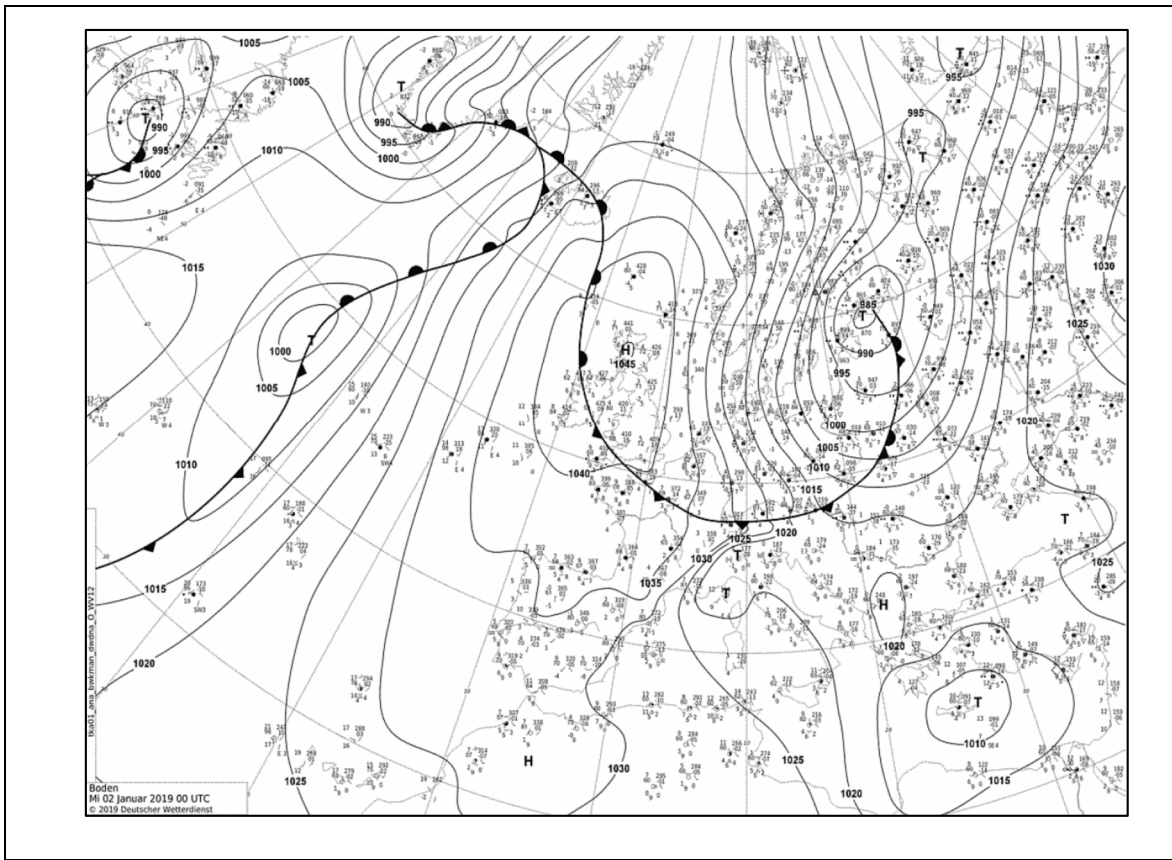
The weather on the night of 1-2 January 2019 was affected by a hurricane-force depression of 985 hPa over the Gulf of Finland, which slowly tracked south-east, see the weather chart in figure 36. This was countered by an extensive high of 1045 hPa over Great Britain, which spread to Morocco with a wedge of 1030 hPa. This triggered the development of a brisk north-westerly air flow over the North Sea.

Figure 36: Weather chart: Ground pressure and frontal analysis of the DWD at 0000 UTC on 2 January 2019 (Source: DWD)

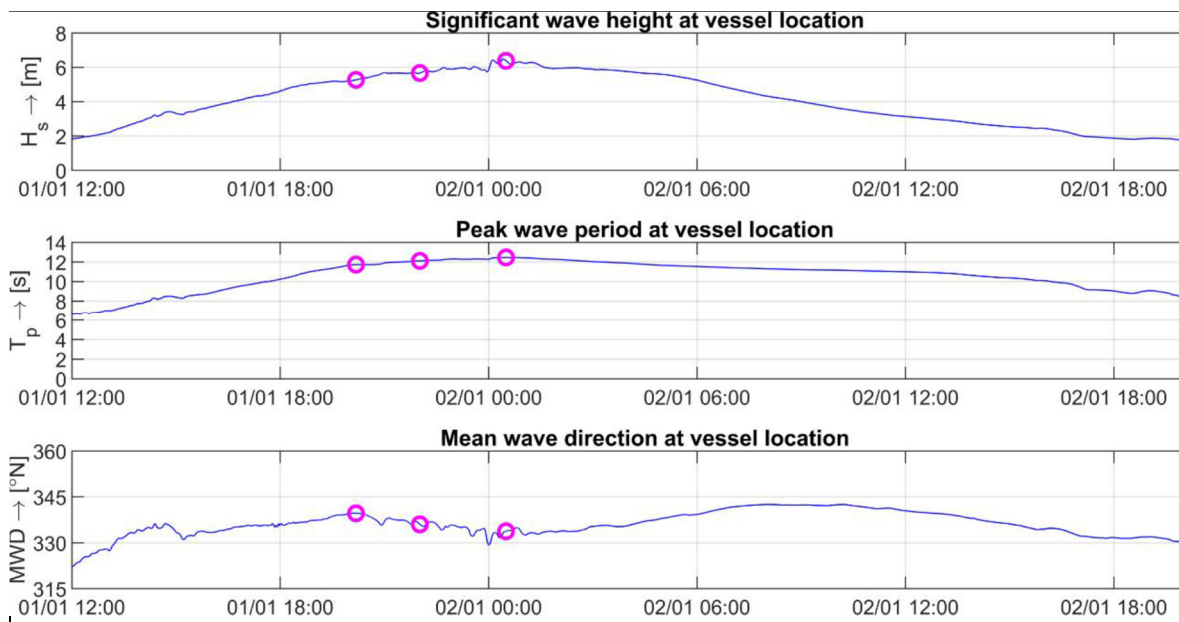
Deltares modelled the wave conditions encountered by the MSC ZOE when it was sailing in the TSS Terschelling – German Bight based on, among other sources, information of three wave buoy and five offshore platforms, see figure 40. The wave height that the MSC ZOE encountered developed with the increasing wind speed. On January 1 at around 15.00 hours LT, at the time that the ship was sailing along the Dutch west coast, the significant wave height ( $H_s$ ) was 2.5 meters. Five hours later, at 20.00 hours, the significant wave height ( $H_s$ ) was around 5.2 meters. The ship experienced the largest waves with a significant wave height of 6.5 meters at approximately 01.00 hours on January 2, after passing the island of Schiermonnikoog. The peak wave period ( $T_p$ ) experienced during the moments of container loss (between 20:00 hours and 01:30 hours LT) were between 11.8 and 12.5 seconds.

Figure 40: Wave conditions along the route of the MSC ZOE.

The waves approached the MSC ZOE from abeam. This wind direction allows the waves to build up as there is a long fetch length available on the North Sea. Significant wave height increased from 5 m to 6.5 m at the peak of the storm. The maximum wave height during this time reached up to around 11 meters. The peak wave period encountered was approximately 11.8 - 12.5 seconds. The wave conditions are neither very extreme nor exceptional for this part of the North Sea.

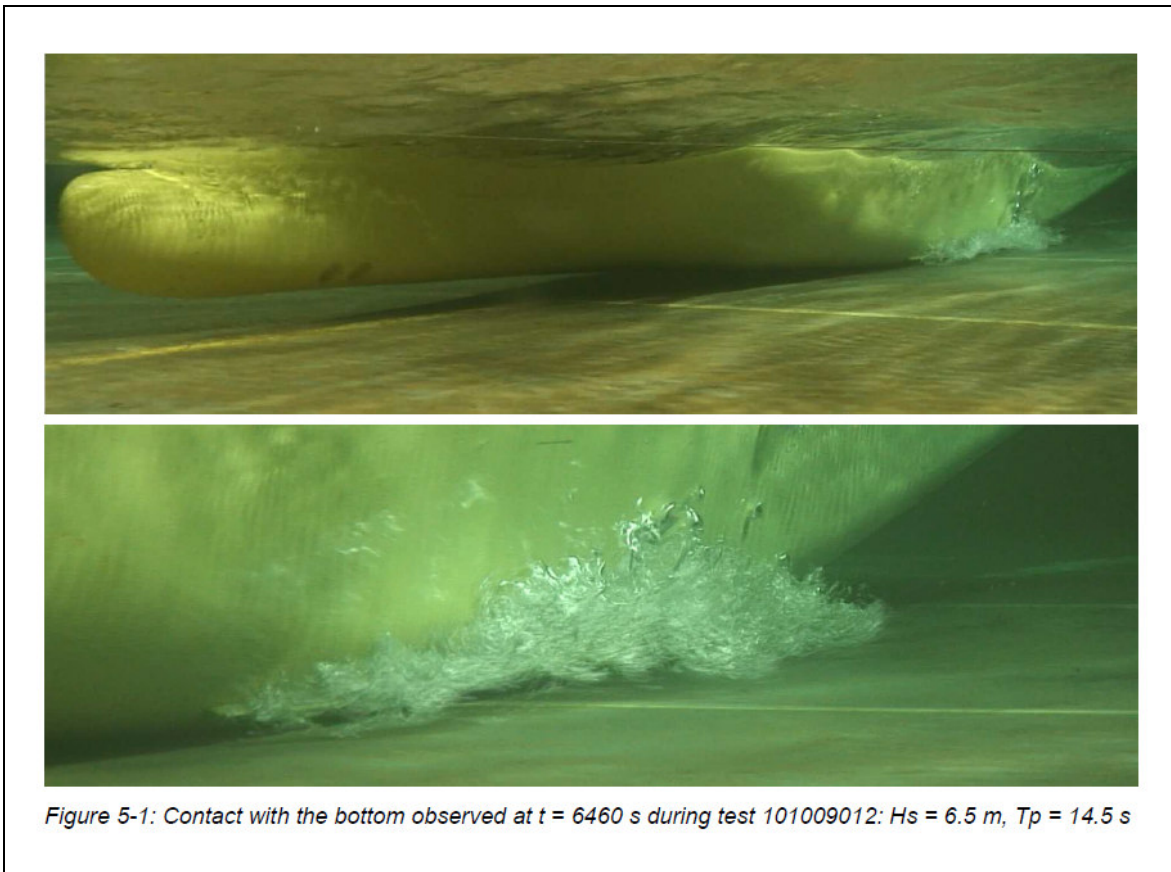
During the tests in the basin, contact or near contact of the model ship with the floor of basin was observed (see figure 51). The frequency of this varied with the wave and ship conditions. During the tests with short-crested waves contact with the basin floor was observed at a water depth of 21.3 m and a wave height of 6.5 meters and above and a peak period of 14.5 meters. The analysis by MARIN of the ship's motions shows that the model can touch the basin bottom when a large vertical heave motion is combined with a large roll motion at the same time in the passage of a group of relatively high waves. The ship also makes a transverse sway motion at that time.

Figure 51: Underwater images of the model ship at the moment of bottom contact (water depth 21,3 meter,  $H_s=6.5m$ ,  $T_p=14.5s$ ,  $V_s=0kn$ ). (Source: MARIN)

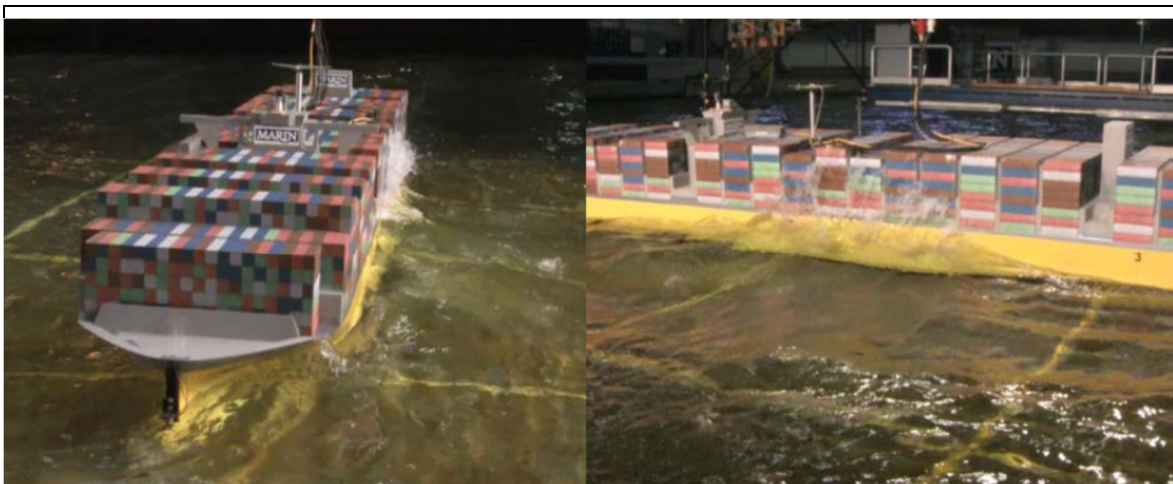
For a container ship, green water has the effect of exerting direct force from the wave on a container. The upwardly directed water can reach above the deck of the ship and can hit the bottom of the lowest containers above the gangway. This can lead to several problems: the bottom containers can be damaged themselves, or containers can be lifted causing damage to the lashings. If one container is damaged or has broken lashings, a whole stack of containers can fall over. The green water can also cause a lateral force on higher-lying containers, so that the container pushes against the container in the next row. This can lead to (part of) a row of containers falling over like a domino.

Figure 52: Images of the ship model and green water effects (source MARIN).

During the basin tests, green water effects were visually observed (using video recordings) for the tested shallow water conditions. Considering the cumulative number of events as observed during the three test conditions, green water was mostly concentrated on six container bays around the wheelhouse (bays 26 to 46). As shown in figure 53, this is in this area where most of the containers on the MSC ZOE were damaged or lost. Although no green water load measurements have been taken in the present tests, this suggests that green water can play a role in the loss of containers in the tested conditions.
