Summary Investigation Report 182/20

Less Serious Marine Casualty

**Deflagration
on the
Danish sail training ship DANMARK
off Fehmarn
on 30 June 2020**

9 December 2020

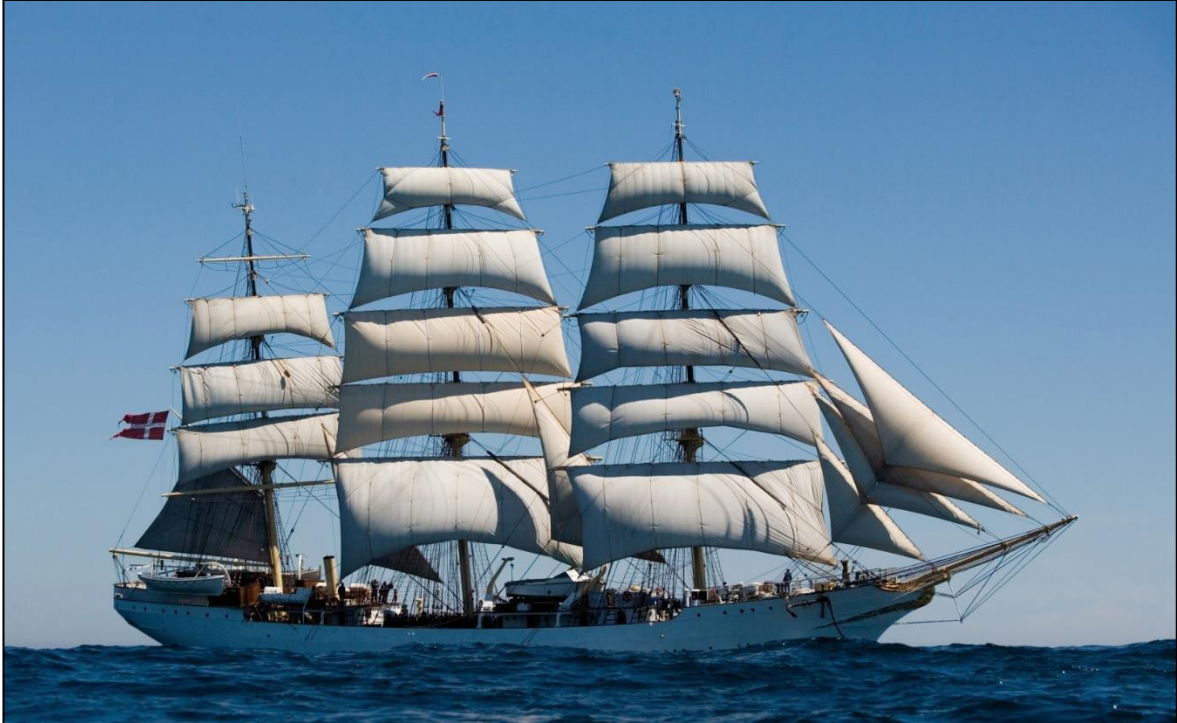
Figure 1: Training ship DANMARK

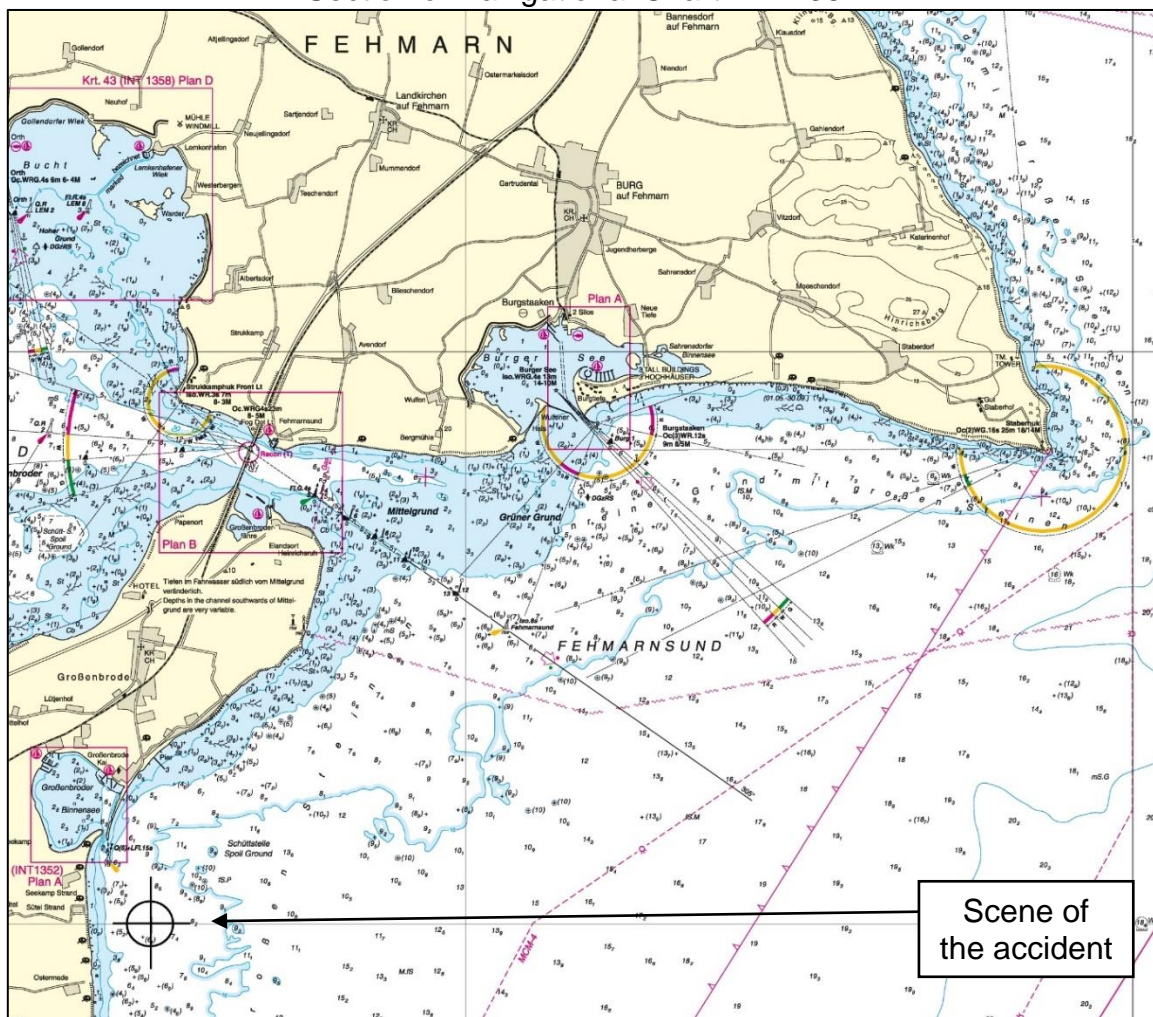
Type of marine casualty: Less serious marine casualty acc. to Article 1a(1a) SUG
 Date, time: 30 June 2020 at about 0950¹
 Location: South of the island of Fehmarn (abeam Großenbrode)
 Latitude/Longitude: $\varphi = 54^{\circ}20.0' N$ $\lambda = 011^{\circ}05.3' E$
 Ship operation and voyage segment: Return leg of a training voyage to the Orkney Islands and back. Port of departure/destination: Frederikshavn, Denmark.
 On 30 June 2020, after crossing the southern Sound (Øresund), the anchor was dropped south of the island of Fehmarn (abeam Großenbrode) to shelter from strong winds. The DANMARK was at the anchorage when the accident happened

Figure 2: Scene of the accident

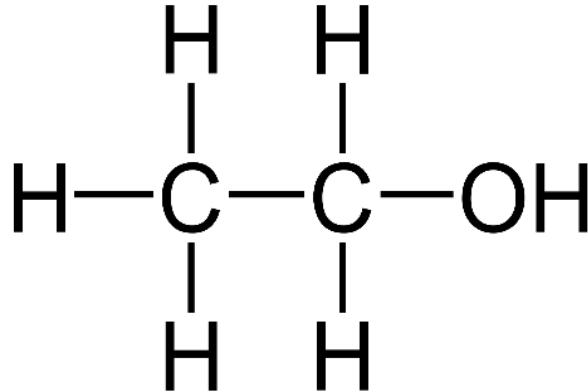
Figure 4: The molecular structure of ethanol

A mixture of ethanol vapours and air is explosive between 3.5 and 15 % (vol.). Although it has an auto-ignition temperature of 455 °C (at 1,013 hPa), ethanol is not classified as explosive because an ignition source is required to cause a combustion reaction under ambient conditions.
