Summary Investigation Report 283/16

Less Serious Marine Casualty

**Water ingress in the RoPax ferry BERLIN's forepeak
after an allision with the fender system in the port of
Gedser (DK) on 30 July 2016**

11 December 2020

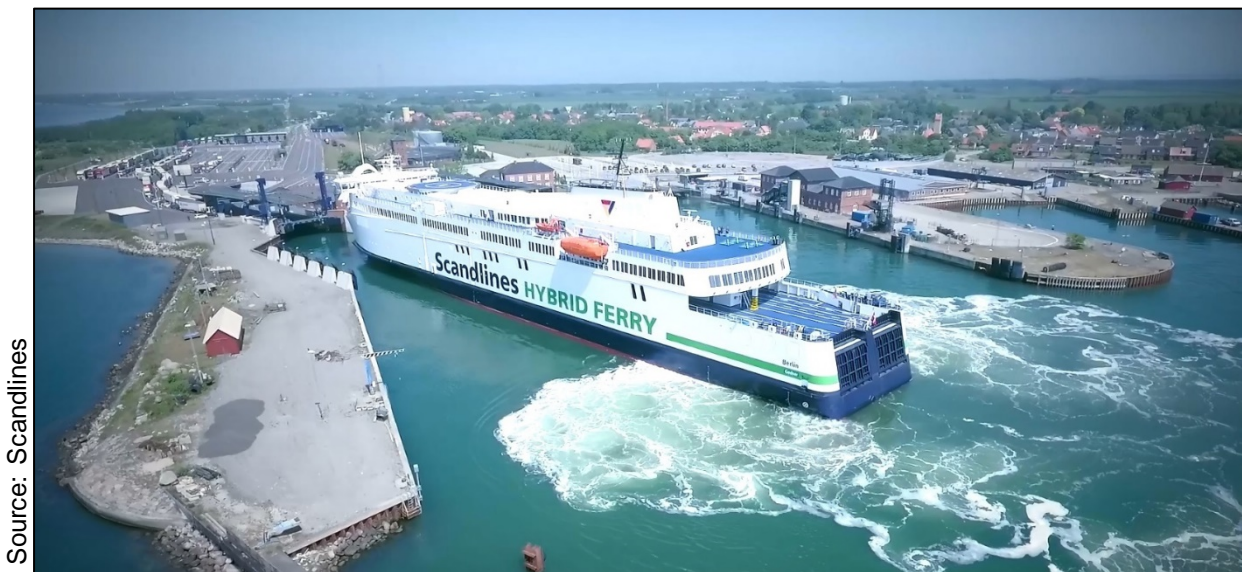
Figure 5: The BERLIN docking in Gedser

As they were passing the jetty with the speed reducing further to 7.5 kts, the stern veered eastwards (to starboard) at 1.3 kts due to the current. As a countermeasure, a further reduction in speed was initiated with the port Azipull and the stern was pushed to port simultaneously with the starboard Azipull. After the ship's bridge wing had passed the central pier, the two Azipulls were stopped at a speed of 5 kts. The two bow thrusters were operating in a starboard direction. Immediately afterwards, the chief mate set the two bow thrusters to hard to starboard to counteract the increasing rate of turn to port. Against all expectations, the ship's speed reduced only very slowly.
