## **Summary Investigation Report 310/16**

### **Less Serious Marine Casualty**

**Fire in the vicinity of the combined boiler  
with two injured crew members  
on board the tanker WEICHSELSTERN  
in the Neue Weser Nord Reede roadstead  
on 19 August 2016**

30 July 2020

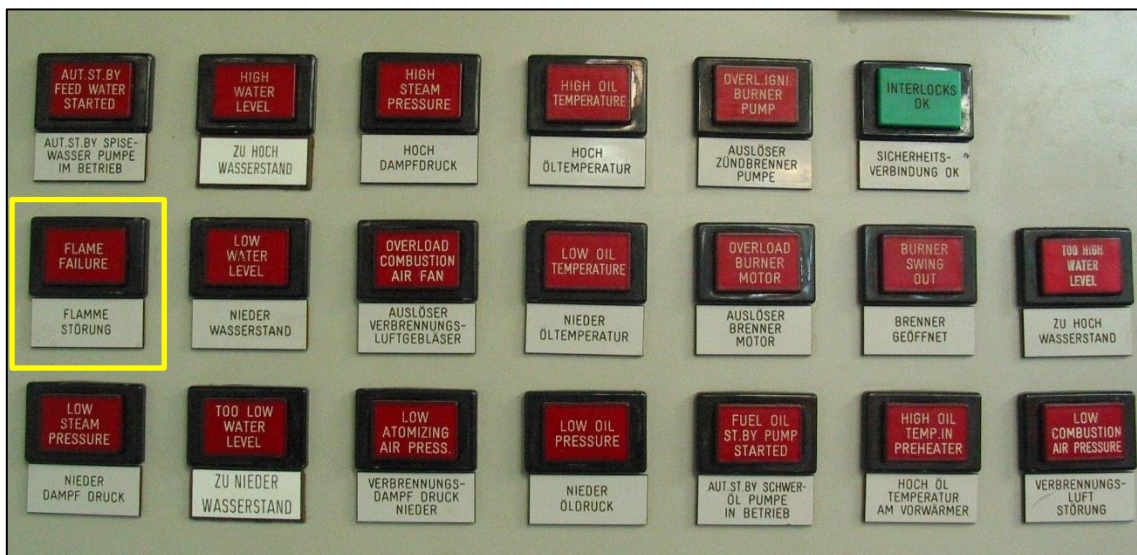
Figure 5: Area A: Alarm panel (extracted from Figure 4)  
 Flame Failure/Flamme Störung indication outlined in yellow.

The monitoring system registered the alarm as **Comb. Boiler Burner Stop 222943 (ON-Time)** (see Figure 3). A signal light on the switch cabinet was triggered and identified this alarm as a *Flame Failure*. The 2nd Eng acknowledged the alarm at **223101 (OFF-Time)**, when he pressed the reset button. This reset the boiler's control system and cleared all alarms (Figure 6). A system restart would not have been possible before this happened. The 2<sup>nd</sup> Eng then went to the boiler to check the condition there. A flame was not visible anymore through the boiler room's sight glass. He then returned to the engine control room (ECR) and phoned the 3<sup>rd</sup> Eng to ask about the boiler's last service because the boilers fell within the latter's area of responsibility. The 3<sup>rd</sup> Eng was also asked to go to the ECR.

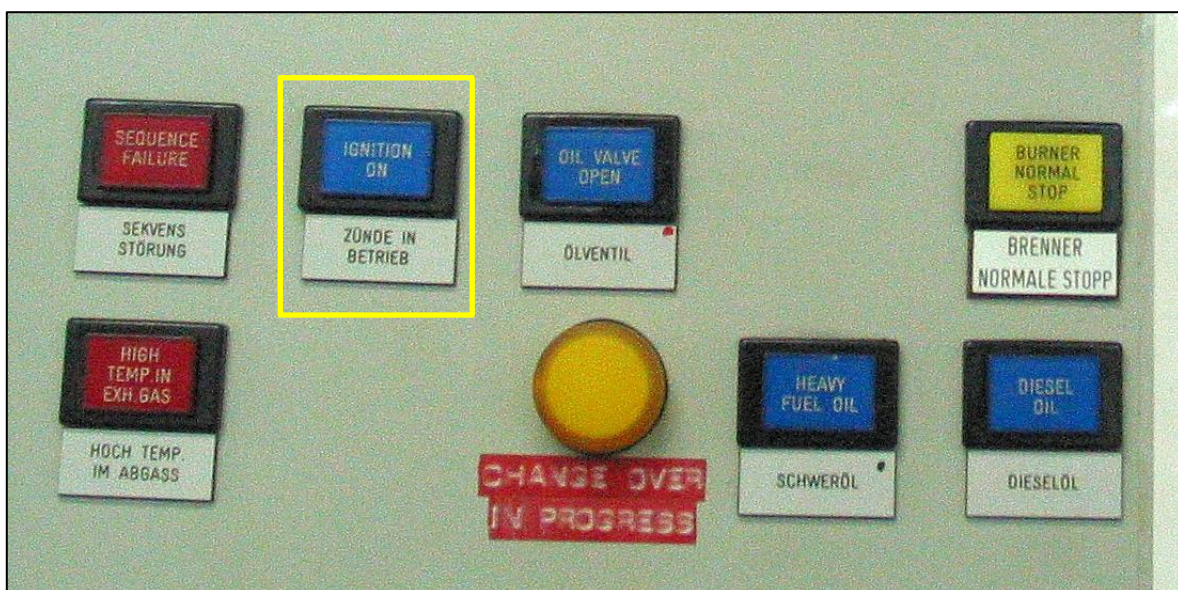
Figure 7: Area **C**: Ignition On/Zünde in Betrieb indicator light outlined in yellow

The boiler was then started automatically in the ECR. This involved pressing the *Burner On* button. The 2<sup>nd</sup> Eng stated that the main burner's *Ignition On* indicator light failed to illuminate afterwards.

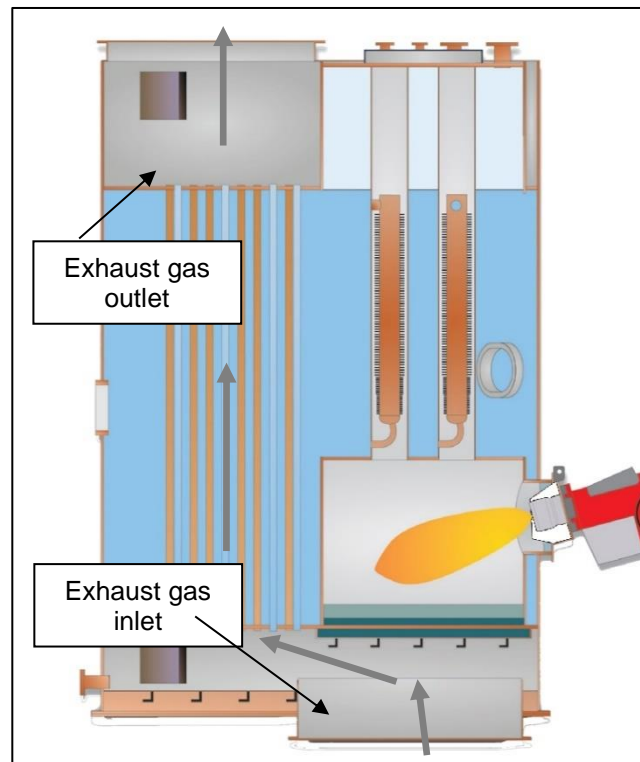
Figure 8: Schematic of the combined boiler installation<sup>8</sup>

The combined boiler is installed vertically. The basic design is shown in Figure 8.

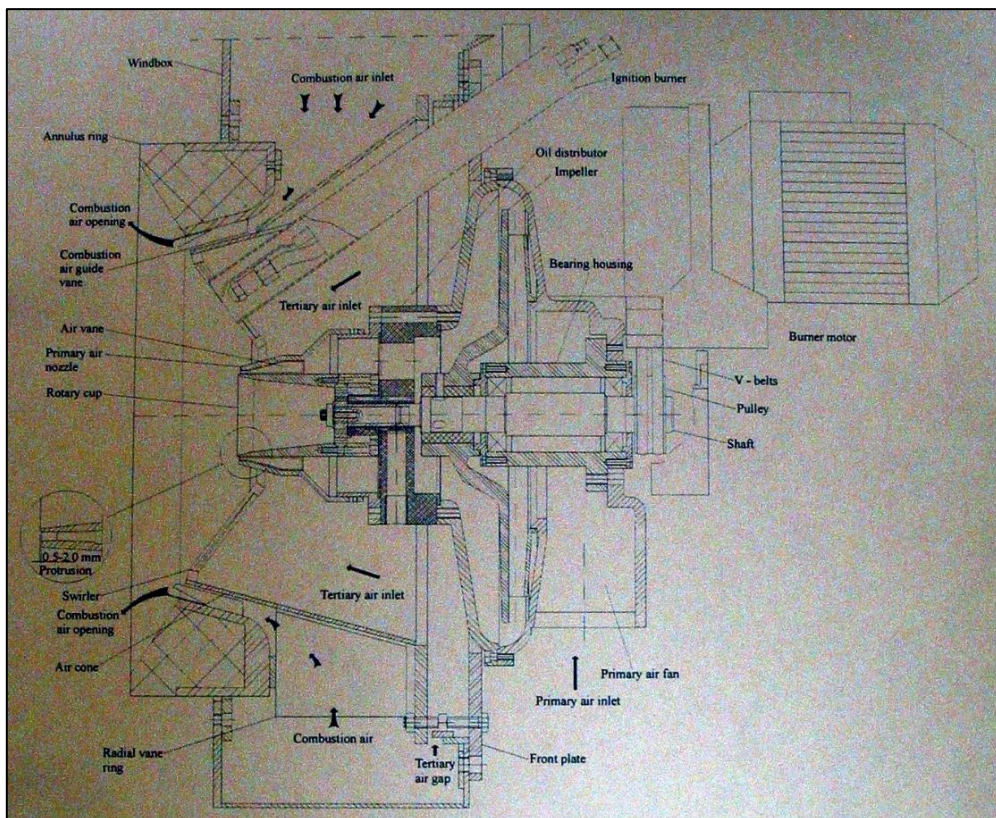
Figure 10: Basic design of burner, windbox and air supply<sup>10</sup>

During the survey of the windbox (Figures 10, 11 and 16) it was found that the ignition burner was not fully inserted into its guide tube (Figure 16). The ignition burner is usually secured in the guide tube with a wing screw. During the investigation it could

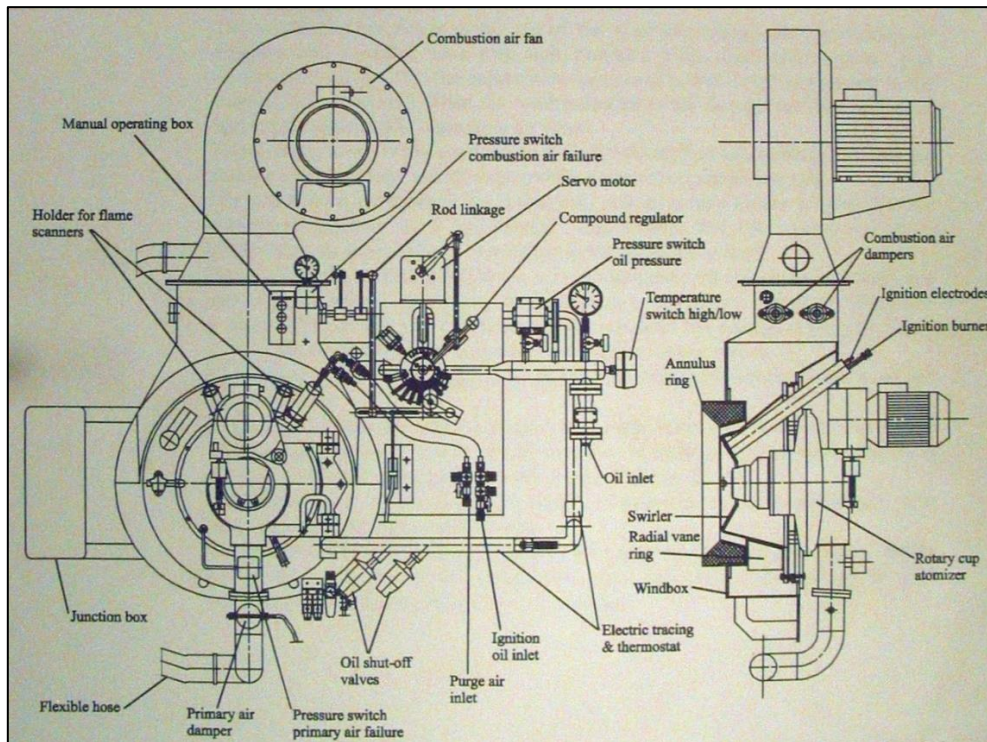
Figure 11: Rotary atomiser burner and associated components<sup>11</sup>

In burner operation, the supplied fuel is finely sprayed by the rotation of a rotary atomiser burner and an air nozzle, mixed with air (primary air), and blown into the combustion chamber. A separate ignition burner is responsible for ignition. This is also supplied with fuel (diesel), which is ignited electrically. To achieve optimum combustion, a blower forces more air (secondary air and tertiary air) through the windbox into the combustion chamber, where it is swirled on entry by a swirler (a ring with fan-shaped plates). The amount of air is controlled by an actuating system and the controlled amount of fuel injected thus adapted (see also Figures 9, 10 and 11).

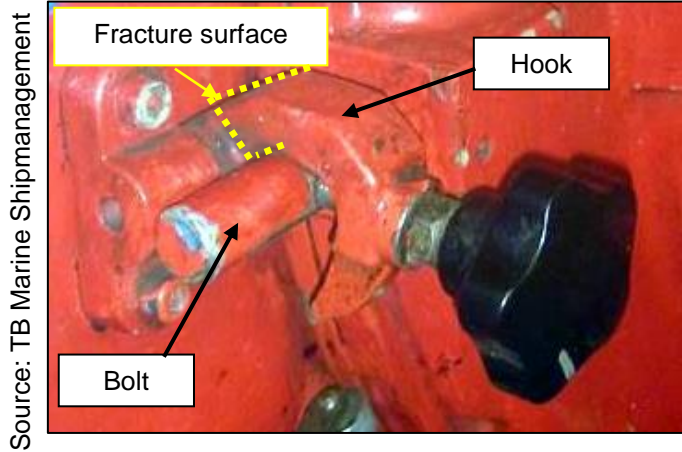
Figure 14: Similar component from a sister ship

It was found during the investigation that the burner door's locking mechanism was broken. "*The burner door is locked mechanically by a rotatable hook mounted on the boiler, which includes a bolt in the burner door [Figure 14]. The hook also comprises a locking screw with hand wheel, which creates a frictional connection between the hook and bolt.*"<sup>12</sup> The fragment of the door's locking mechanism was found. The BSU secured the entire door locking mechanism. As can be seen in Figure 12, the hook had been welded.

With regard to the door's locking mechanism, it was also found that the original bolt, which is the mating part of the hook on the burner door (Figure 15), had been replaced by a threaded rod on the WEICHSELSTERN. It was not possible to establish the reason or when this happened, either. However, the investigators believe that the replacement did not restrict functionality or safety.
