## **Investigation Report 20/20**

### **Very Serious Marine Casualty**

**Fatal person-overboard accident  
involving a crew member  
of the fishing vessel HELEN MARY  
in the North Atlantic  
on 30 January 2020**

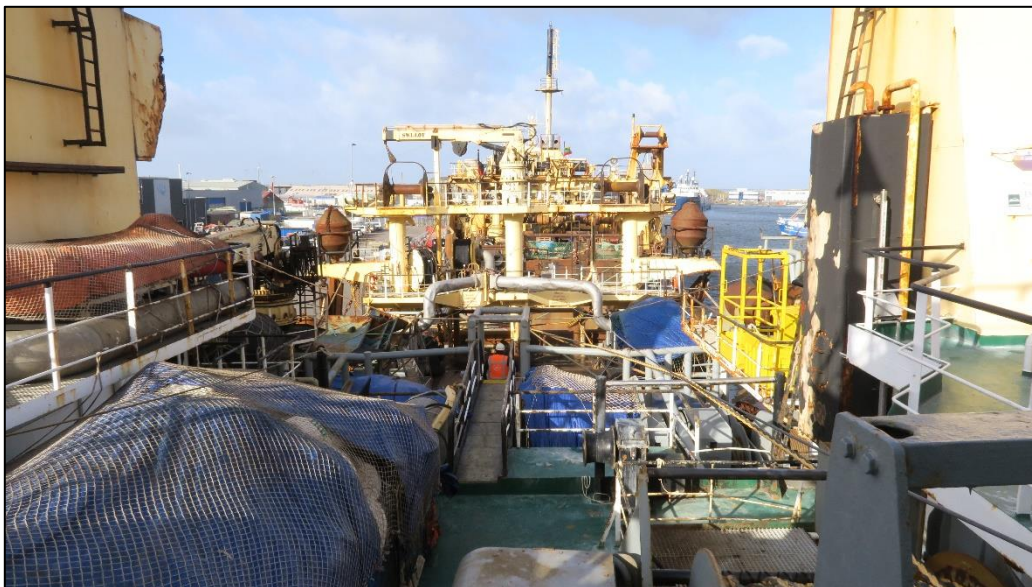
Figure 7: View of the stern from the level of the winch console

The investigators believe that the scene of the accident cannot be seen from the bridge (the winch console, in particular). A direct view of the work area on each side of the stern is not possible due to the hardware installed and the equipment stored on the sides (see Figure 7). However, the view of the middle of the stern is also limited due to the considerable distance, as well as partially obscuring protective tubes and other objects. As a consequence of this, the winch console on the bridge is equipped with large screens. In addition to fishing-related information, these also display images from cameras installed on board (Figure 21).

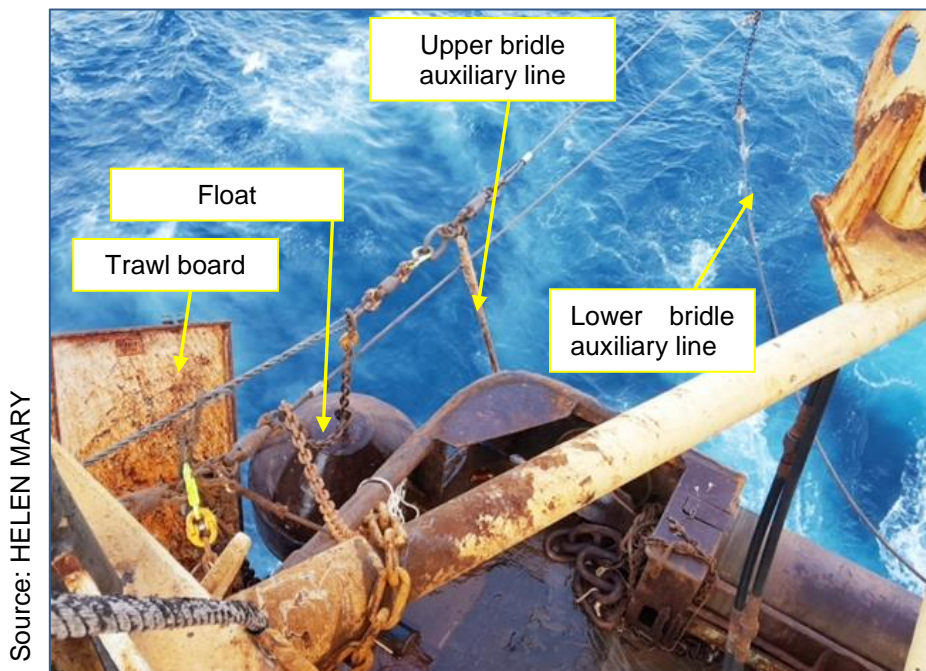
Figure 13: Starboard workstation at the stern

Both auxiliary lines are visible in Figure 13. At about 14 m in length, the lower bridle auxiliary line is already connected to the line coming from the net winch.

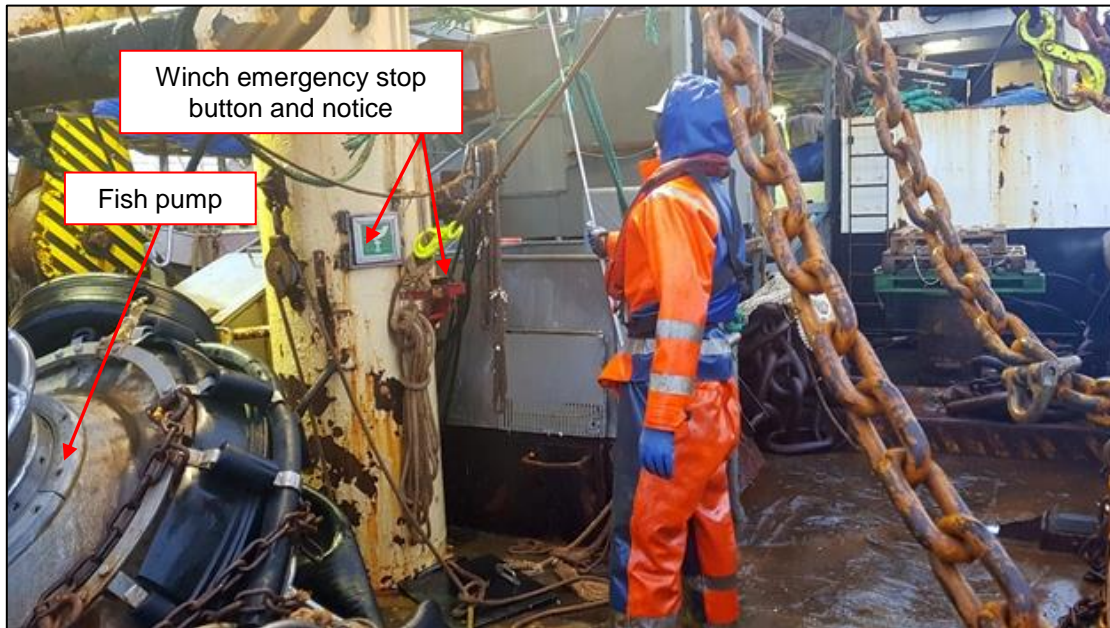
Figure 16: View from stern to bow

After use, the fisherman hung the metal pole back on its stowage position (Figures 16 and 17).

The shipping company had provided a waterproof jacket and waterproof trousers for every fisherman working on the deck (see Figure 16). The equipment issued for working on the deck also included work boots, wellington boots and gloves. Every fisherman was also equipped with a protective helmet. The full helmet type of the bosun was only used by this individual on the HELEN MARY.

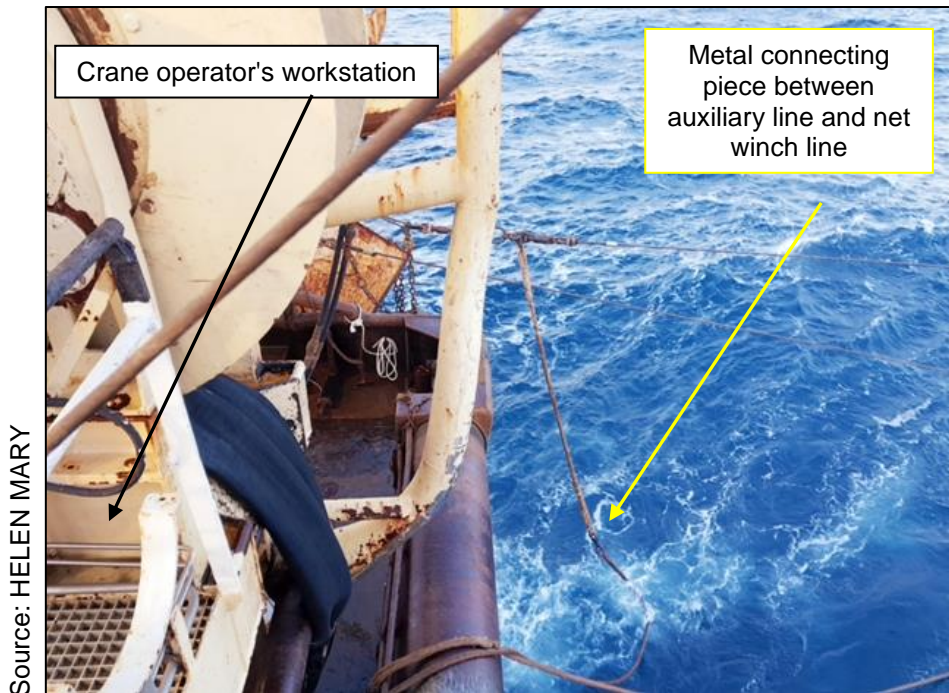
Figure 18: View from lower platform to stern

Figure 18 shows the configuration when both auxiliary lines are connected to the lines coming from the net winch. The bridles are then lowered and the net winch hoisted so that the load is transferred from one winch to the other. When the net winch is supporting the entire load, the bridles are released from the fishing gear. After that, there is no connection from the warp winches to the net.

A connection is established with both auxiliary lines. The warp winches are still supporting the load.

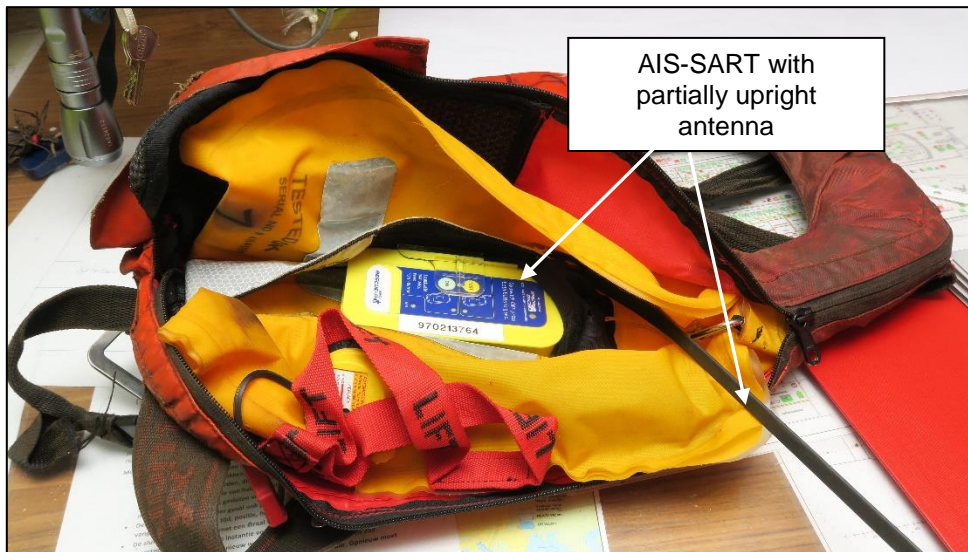
Figure 23: Inflatable work vest with integrated AIS-SART

To guarantee that a person who has fallen overboard can be quickly recovered, each vest was equipped with a PLB<sup>11</sup> (AIS-SART<sup>12</sup> – see Figure 23). This AIS transmitter (type: easyRESCUE-Automatic) is made by Weatherdock AG and activates upon contact with water. When the inflatable work vest opens up, the transmitter's antenna also straightens up. The device has an integrated GPS receiver so that the current position is communicated with the alarm signal. The AIS signal then appears on the ship's electronic navigational chart and a direct course can be set for the person overboard's position.
