Bundesstelle für Seeunfalluntersuchung
Federal Bureau of Maritime Casualty Investigation
Federal Higher Authority subordinated to the Federal Ministry
of Transport and Digital Infrastructure

Investigation Report 211/19

Very Serious Marine Casualty

Collision between traditional vessel N° 5 ELBE and container vessel ASTROSPRINTER on the River Elbe on 8 June 2019

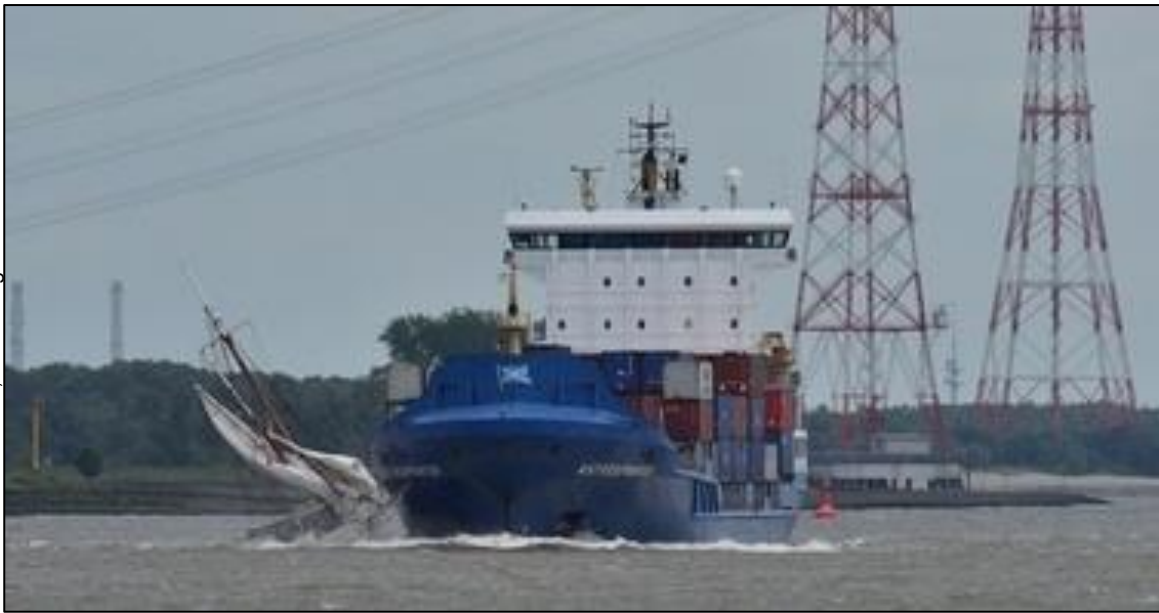
Figure 4: Collision

To prevent or at least reduce the damage caused by the looming collision, the pilot turned the ASTROSPRINTER to port. There was too little time for any meaningful intervention, however.

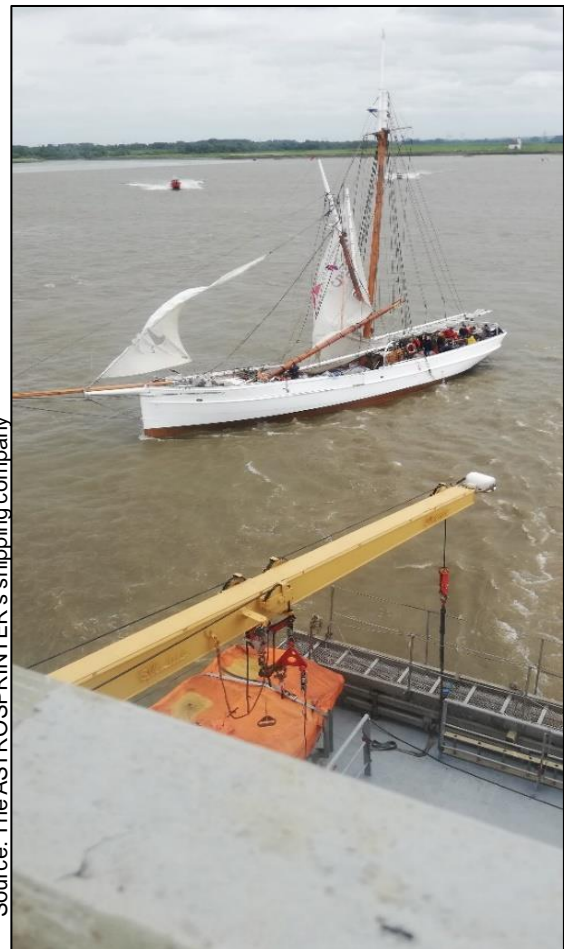
Figure 5: After the collision

Seconds later the 2nd NO called him and informed him of a collision. He hurried to the bridge immediately and asked his officer and the pilot what had happened. He went into the starboard wing and could see from there how the traditional vessel was drifting astern. He saw people sitting and standing on the deck of the sailing vessel. No one seemed to have fallen overboard and he gained the impression that immediate assistance was not needed. He also noticed two lifeboats quickly moving toward the sailing vessel. He asked the pilot to maintain contact with the VTS, which the latter acknowledged.

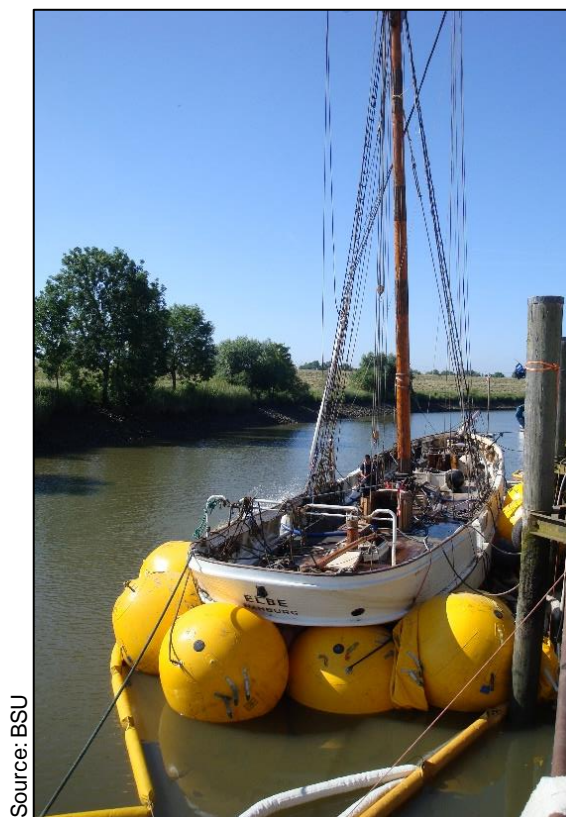
Figure 9: The N^o 5 ELBE – upright and floating

The salvage specialists took advantage of the low tide at about 2300 on Sunday 16 June 2019 and righted the N^o 5 ELBE by pumping air into the lifting bags while at the same time pumping out water that had accumulated inside the ship.

On Monday morning, two investigators from the BSU surveyed the traditional vessel, which was now afloat again. Evidence was secured, photographs were taken and those present were interviewed.

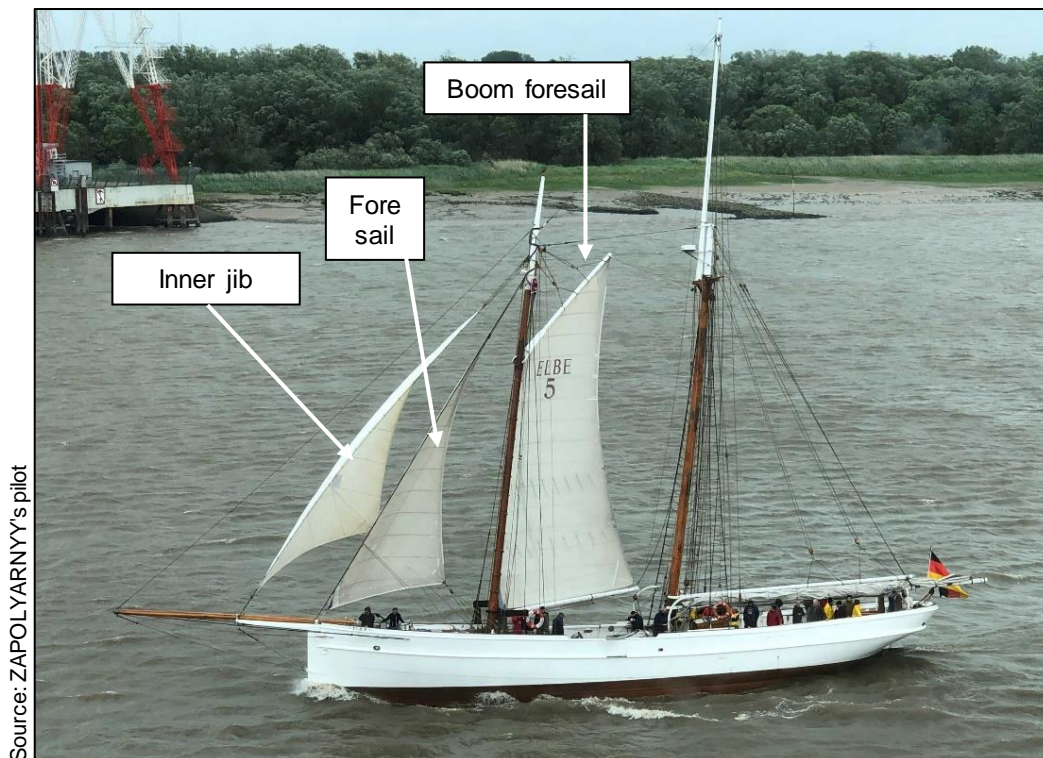
Figure 10: № 5 ELBE's sail configuration on the day of the accident

The sail configuration chosen reached or was within an adapted sail area that corresponded to the wind force expected by the skipper. However, the safety manual gives no indication as to whether the recommended maximum sail configuration is based on the average wind or on gusts. According to the nautical officer's statement, gusts of up to 8 Bft were also expected. Consequently, if the maximum sail area was based on the wind force during gusts, then it should not have exceeded 70 m².

The sail area chosen on the day of the accident, which was in the forward half of the vessel, suggests that the vessel had a lee helm¹⁴ and responded well to bearing away from the wind with the sheets open. The investigators assume that the sail area was easy and safe to handle with the numerically strong crew. The nautical officer's statement indicated that she responded to course alterations extremely well for a traditional vessel.

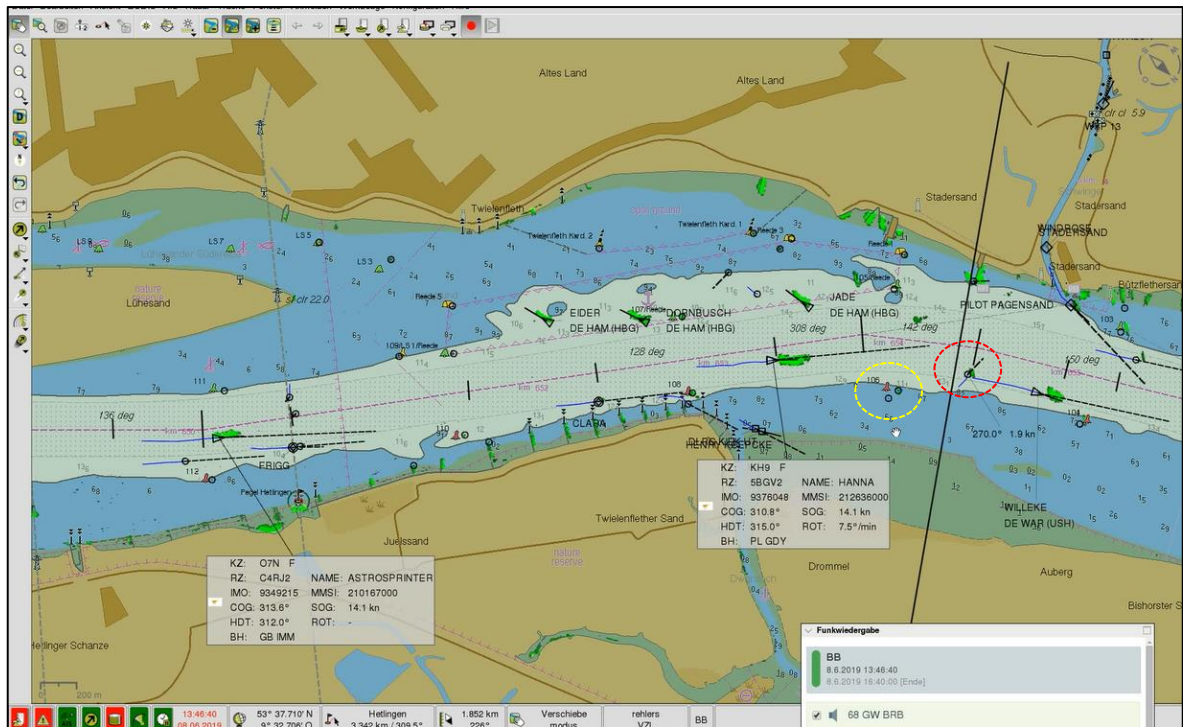
Figure 13: VTS recording at 134640

The N^o 5 ELBE, which is approaching the HANNA, is not visible either as a radar or AIS signal. It is possible that the schooner is still just outside the range set on the radar. For comparison and to facilitate a better understanding, a recording of the VTS is shown in Figure 13. Here, the yellow circle also highlights buoy 106 and additionally the N^o 5 ELBE in the red circle.

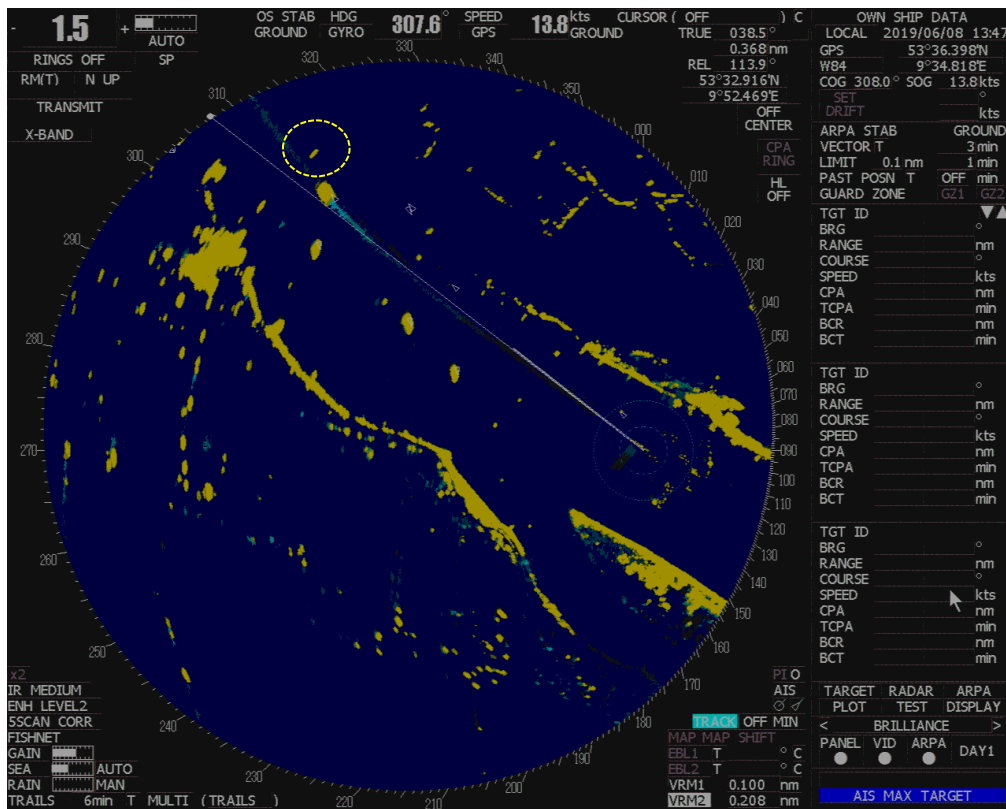
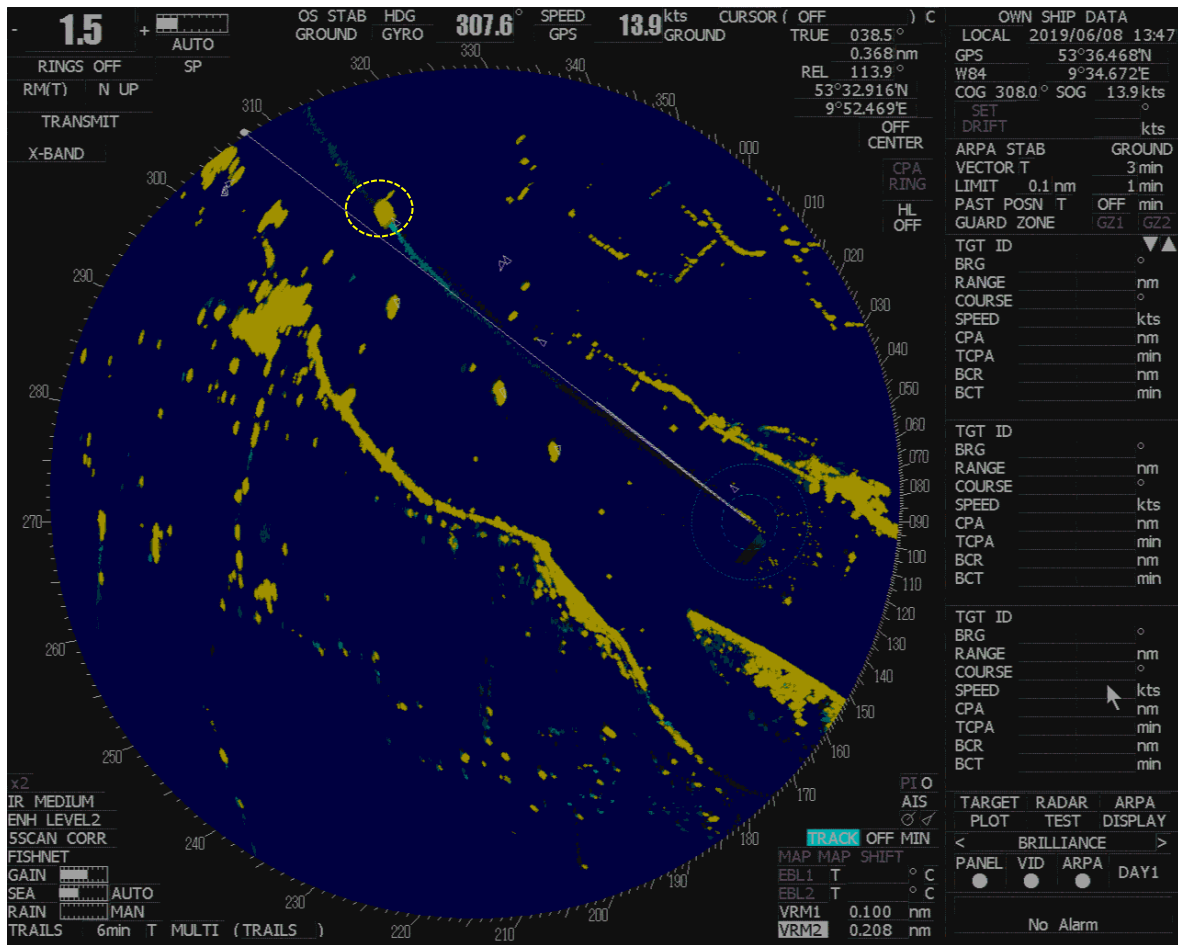
Figure 14 and Figure 15 show clearly how the HANNA alters course to starboard and sails past buoy 106 (in the yellow circle) in close proximity. The N^o 5 ELBE is still not visible on these radar images.

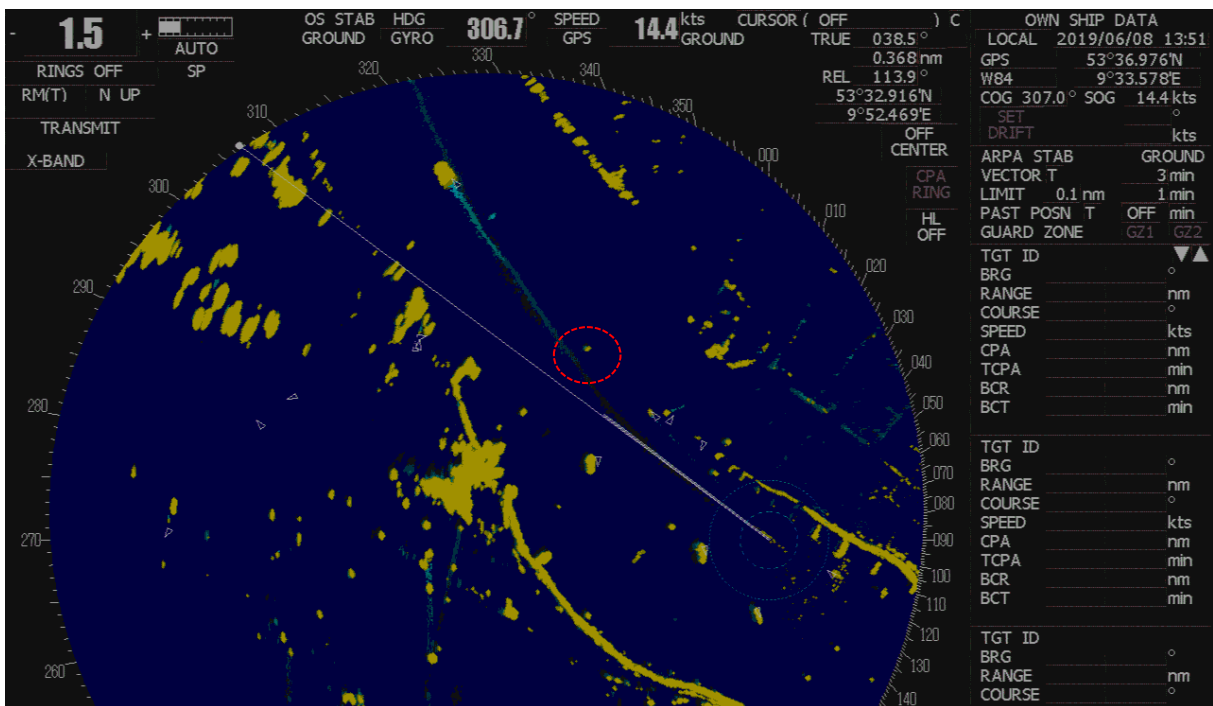
Figure 19: 135131 – buoy 106's radar echo with no further AIS symbol

At times, the AIS symbol disappears completely or two radar echoes are displayed next to each other for a brief period.

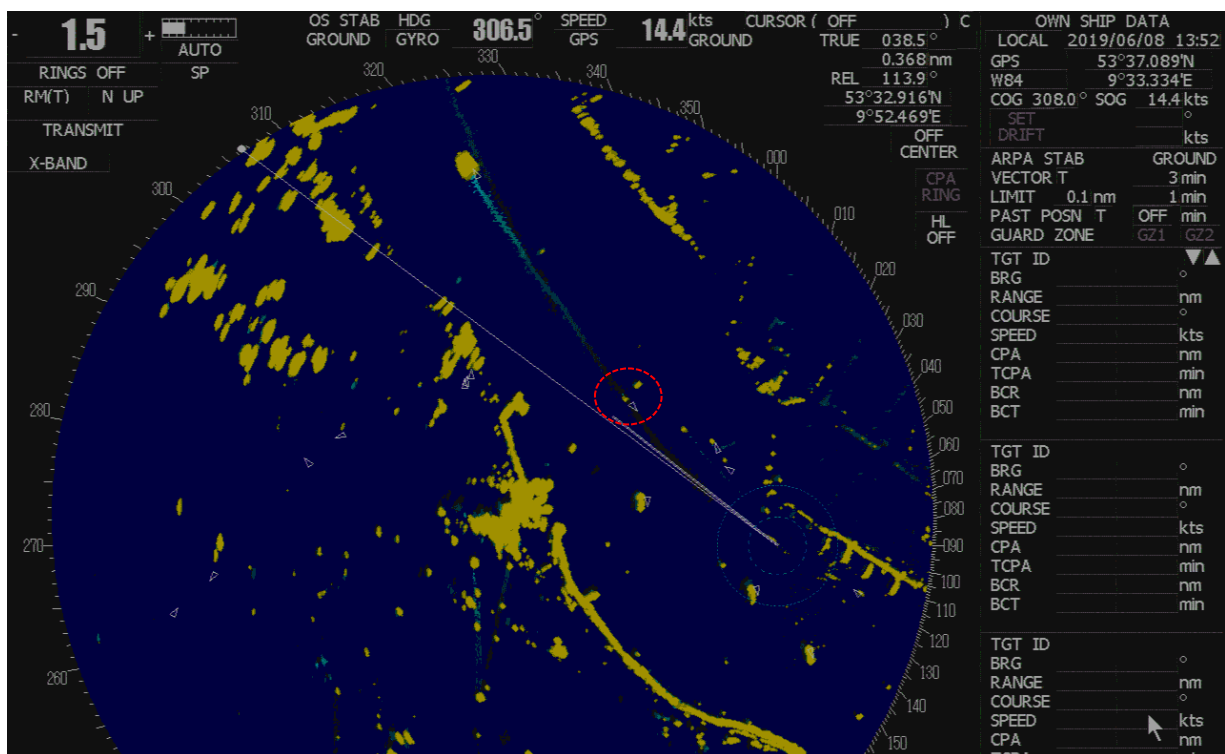
Figure 21: 135216 – two radar echoes with an AIS symbol

Figure 21 shows AIS symbols in the vicinity of the ASTROSPRINTER, too, at 1352. These are the sailing yacht CLARA, which happens to be passing by, as well as the KIEK UT and HENRY KÖPCKE hurrying to provide assistance.

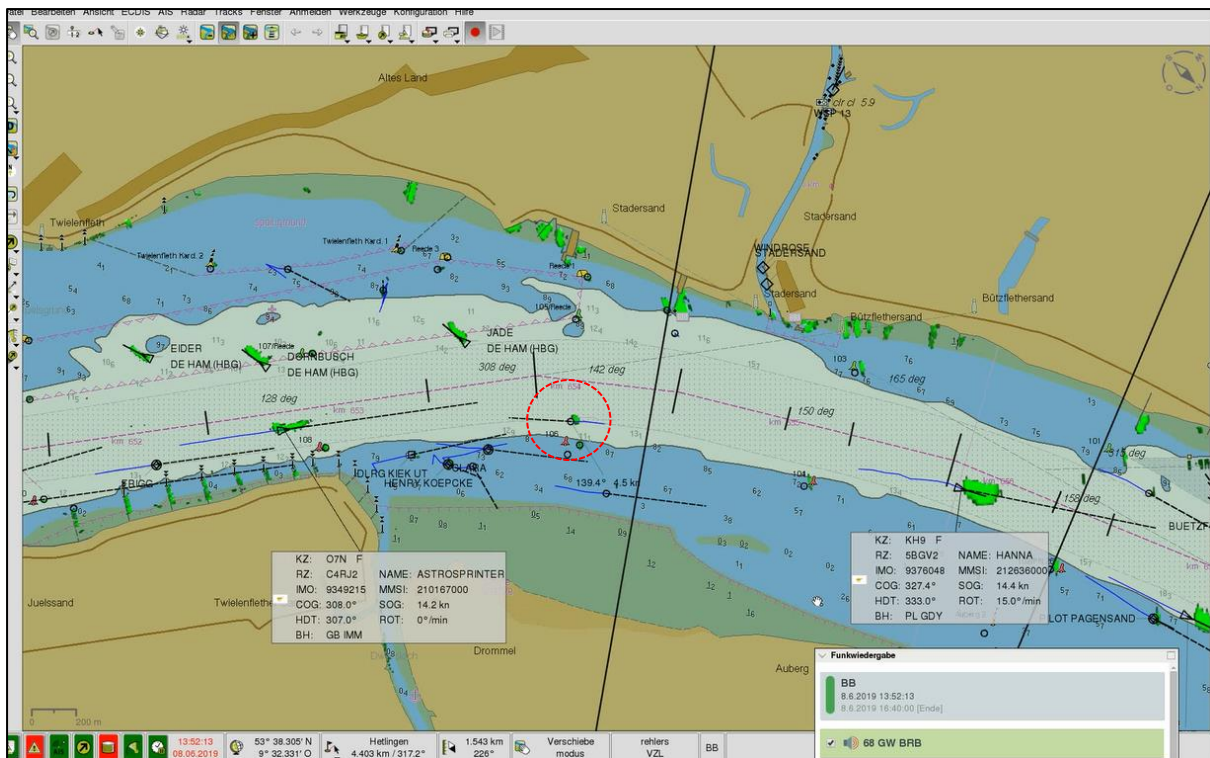
Figure 22: VTS recording at 135213

The № 5 ELBE remains on the starboard side of the ASTROSPRINTER (Figure 22).

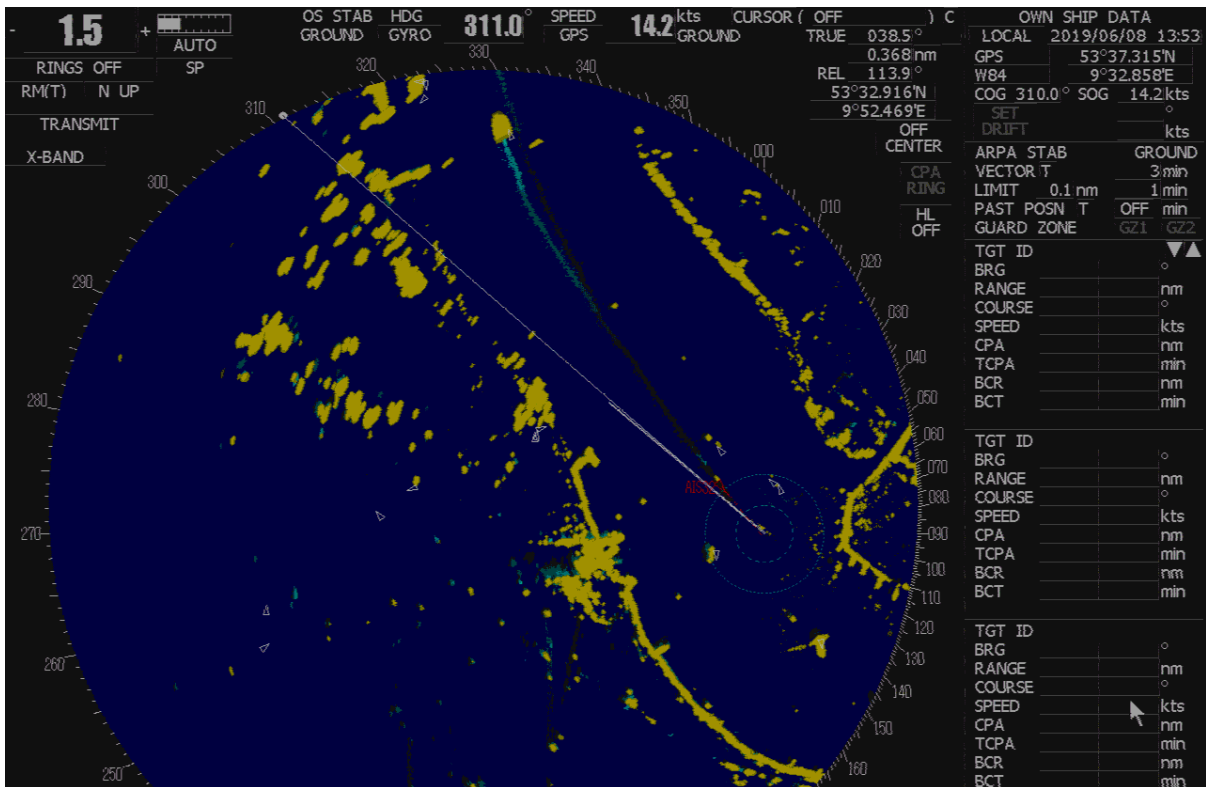
Figure 24: 135346 – seconds before the collision

The risk of collision comes to a head one minute later. Figure 24 shows the AIS automatic proximity alarm on the radar at 135346.

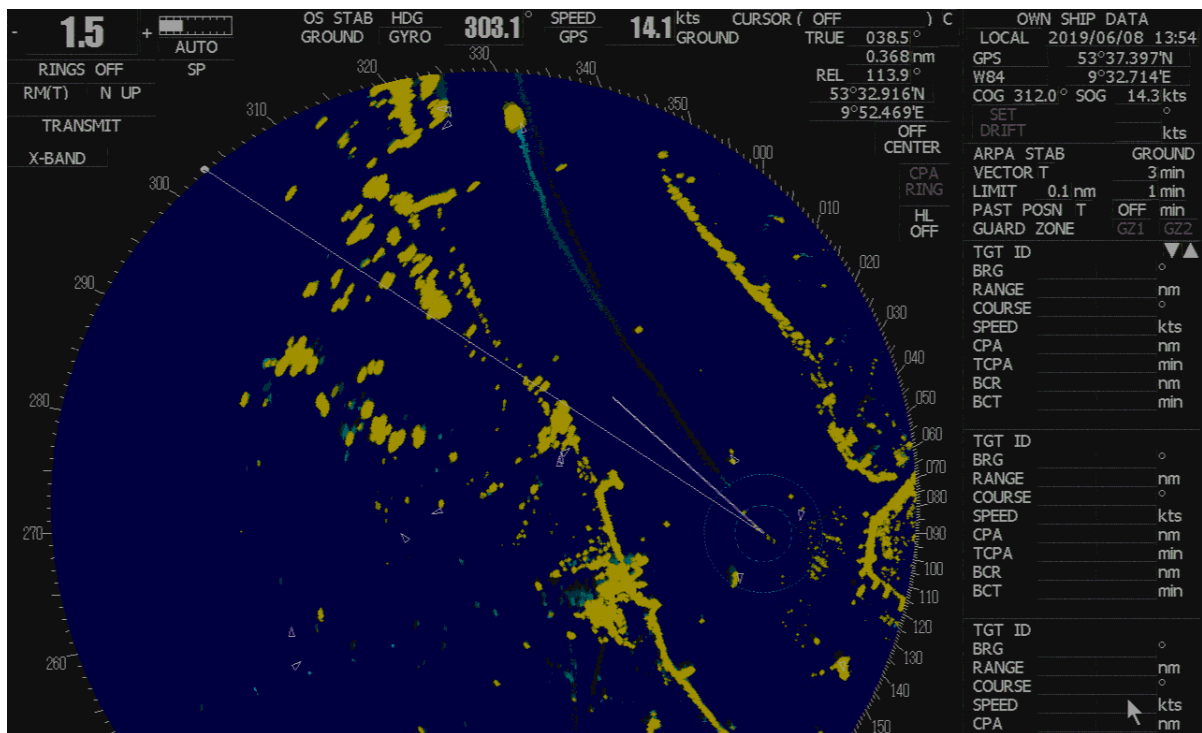
Figure 26: 135416 – collision

When the collision happened at 135416, the No 5 ELBE's radar echo is shown very faintly and no AIS symbol is displayed. To illustrate this, the VTS's recording made at the same time is shown again in Figure 27.

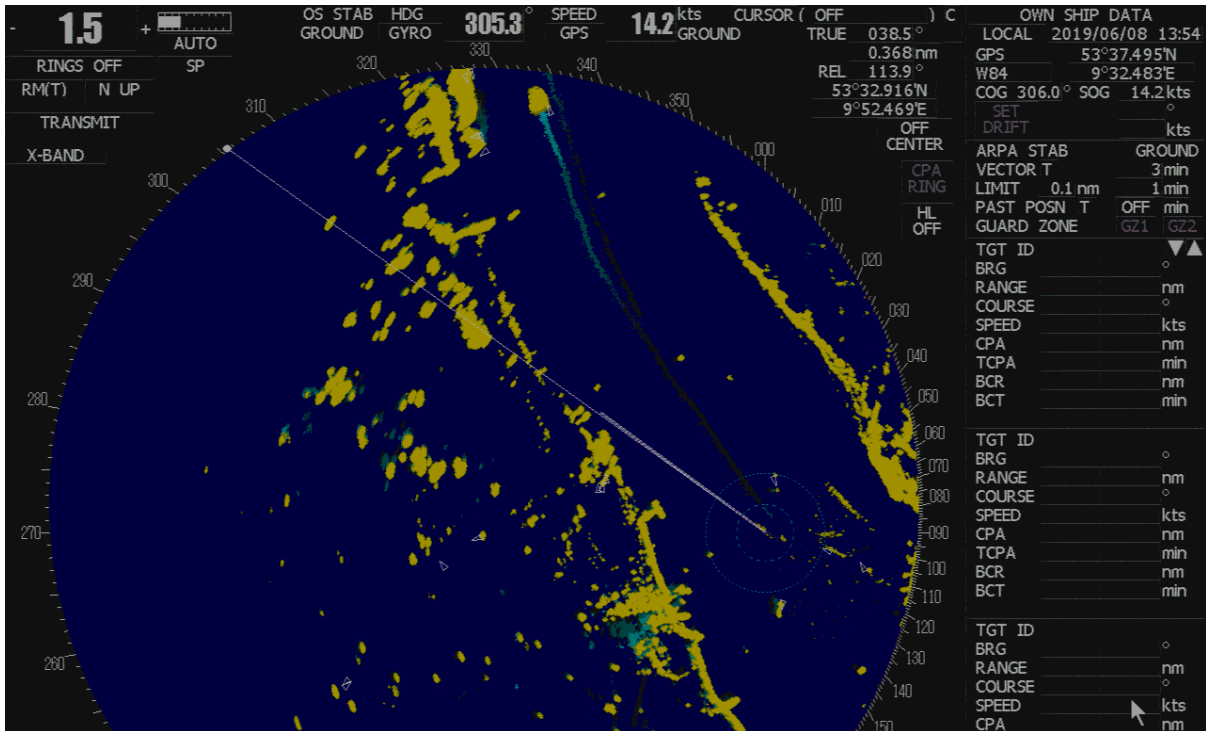
Figure 28: 135501 – the vessels part

Figure 28 shows how the vessels part again at about 1355.

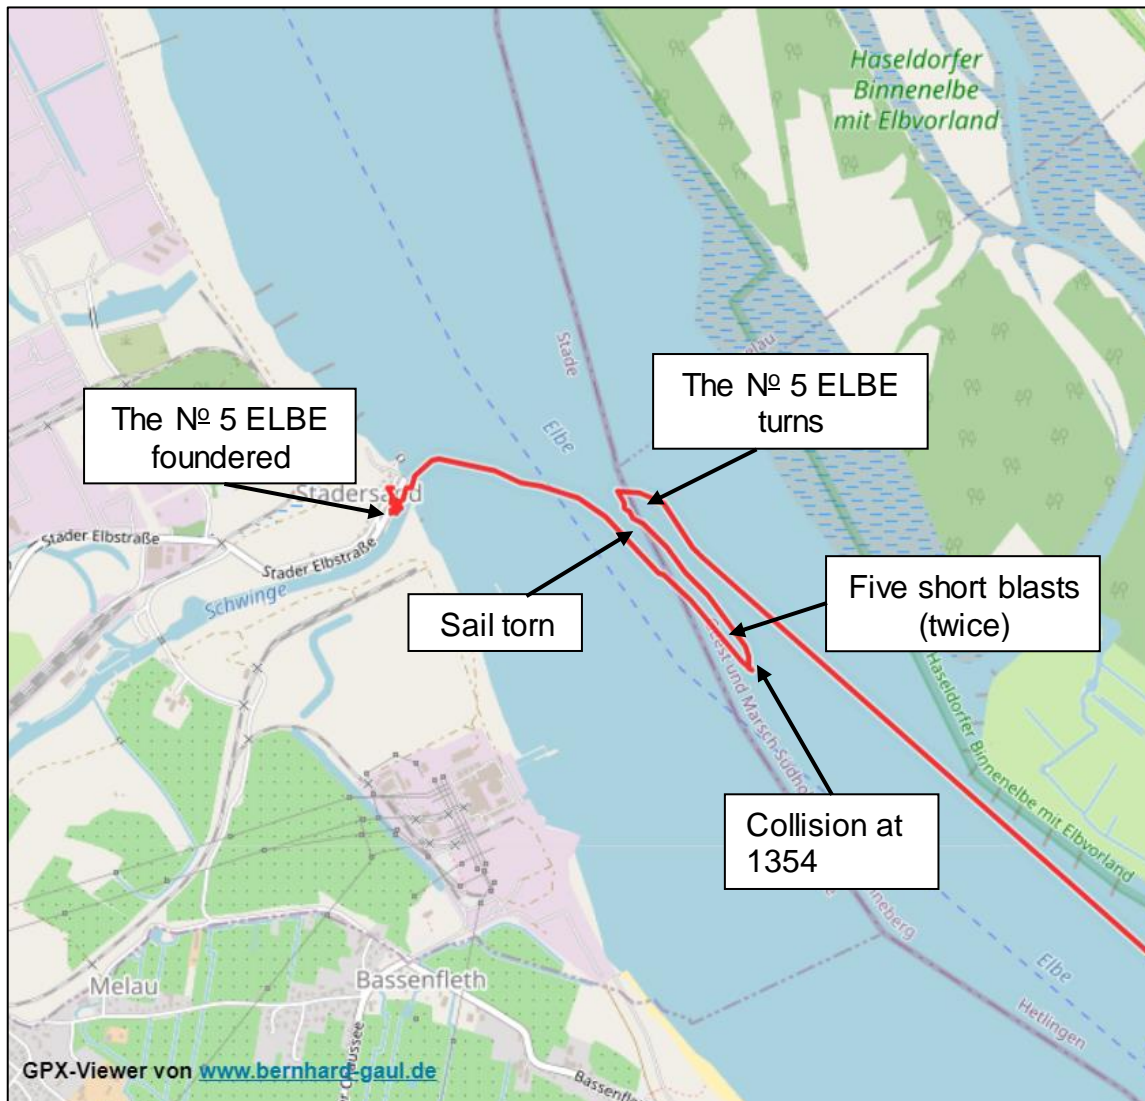
Figure 31: GPS track from a passenger on the N° 5 ELBE

A passenger happened to have a GPS tracker with her and provided the data to the BSU (see Figure 31)²⁰. Unfortunately, it was not possible to integrate the data into a navigational chart. With all possible inaccuracies, it is the only technical representation

of the course of the voyage from on board the N° 5 ELBE shortly before the collision. Figure 31 has been included here for illustrative purposes only.

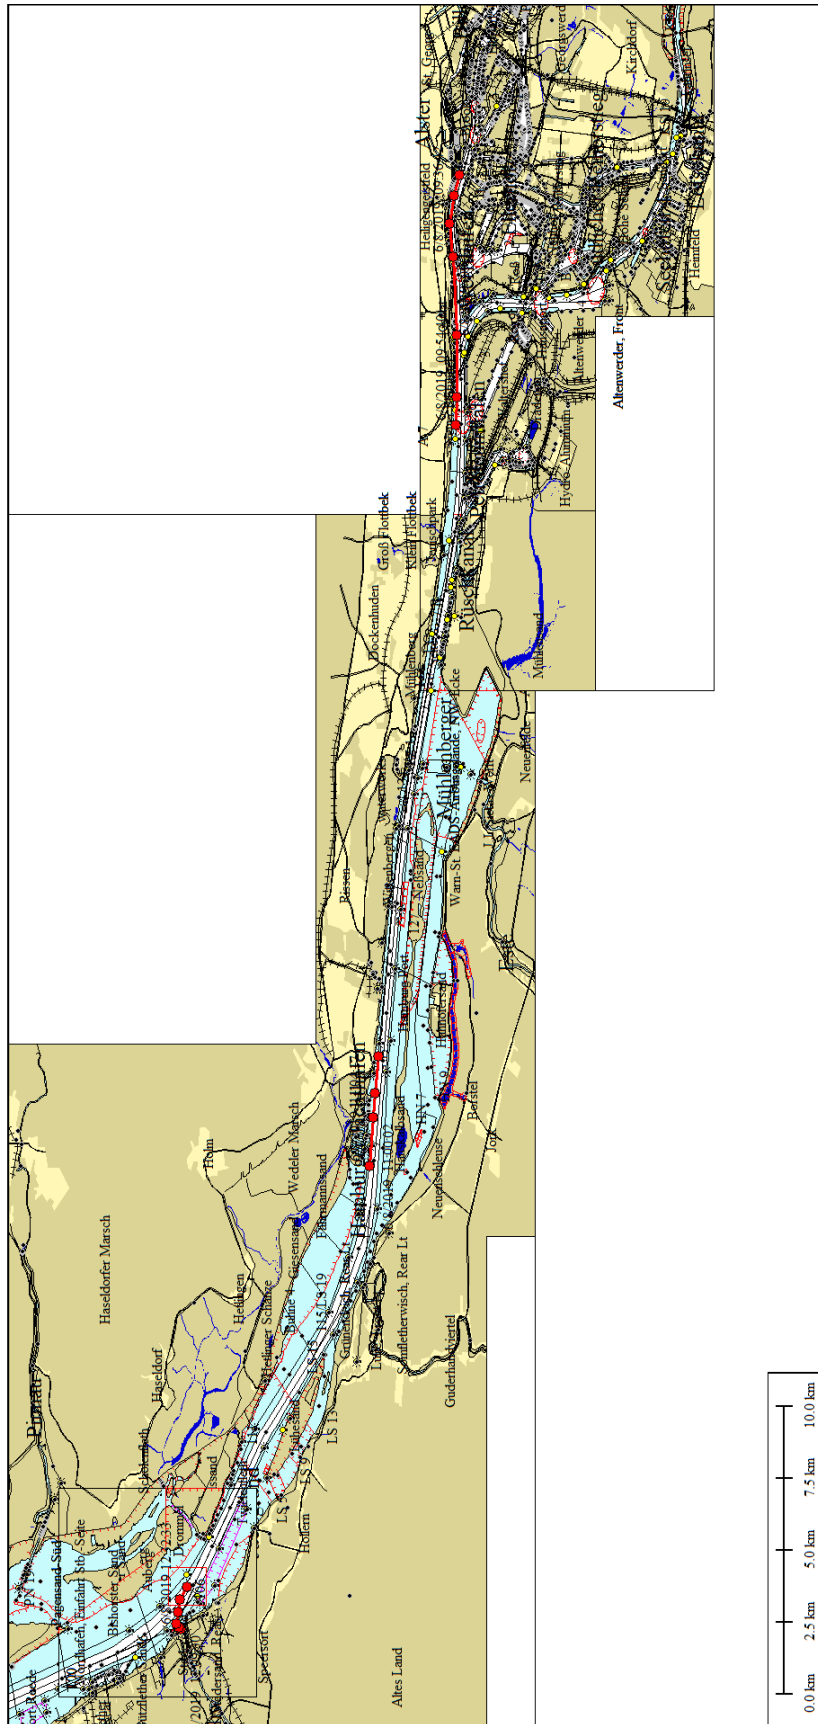
Figure 37: Overall course of the voyage

Showing the overall course of the N^o 5 ELBE's voyage from the port of Hamburg to the mouth of the River Schwinge, Figure 37 clearly illustrates that it was not possible to receive the traditional vessel's AIS signal continuously.

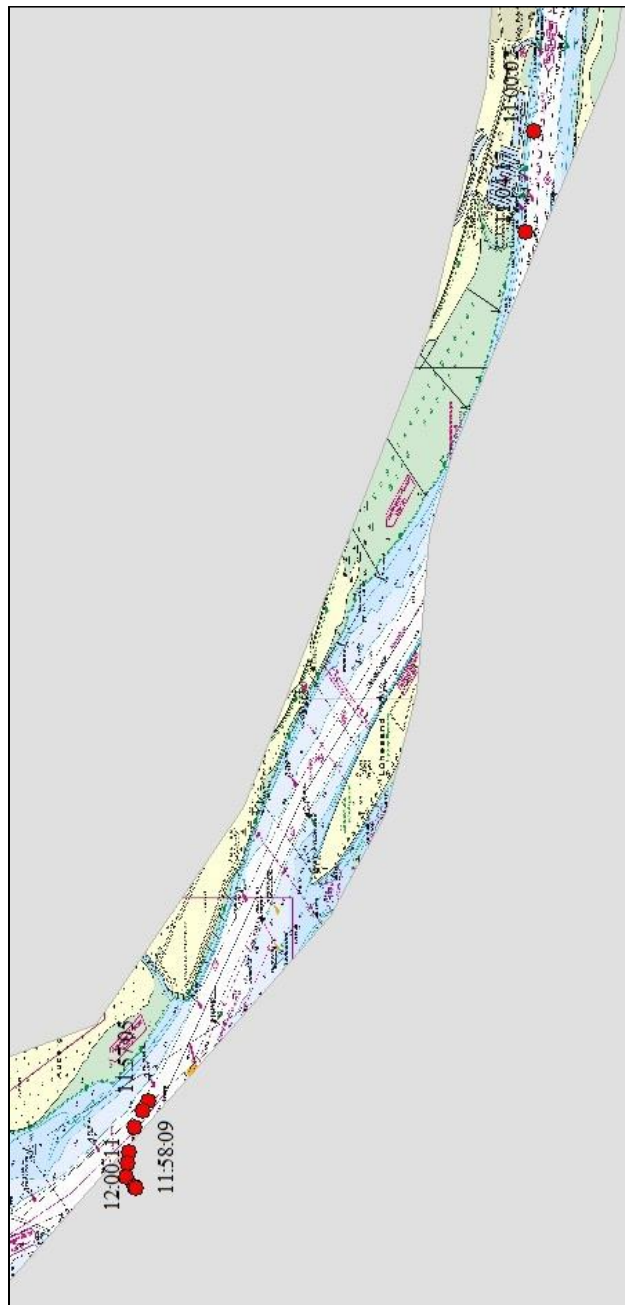
Figure 38: Representation of the AIS data from MSG

Data from the same period were obtained from another provider for verification. The Made Smart Group (MSG) from the Netherlands provided data for the period 1100 to 1300 UTC, which also form the basis for an expert report commissioned by SHM to demonstrate that the N^o 5 ELBE's AIS had been constantly switched on and reportedly transmitting. The BSU has presented these data graphically in Figure 38. It can be seen clearly that the N^o 5 ELBE did not record any data between 110417 UTC and 115705 UTC.

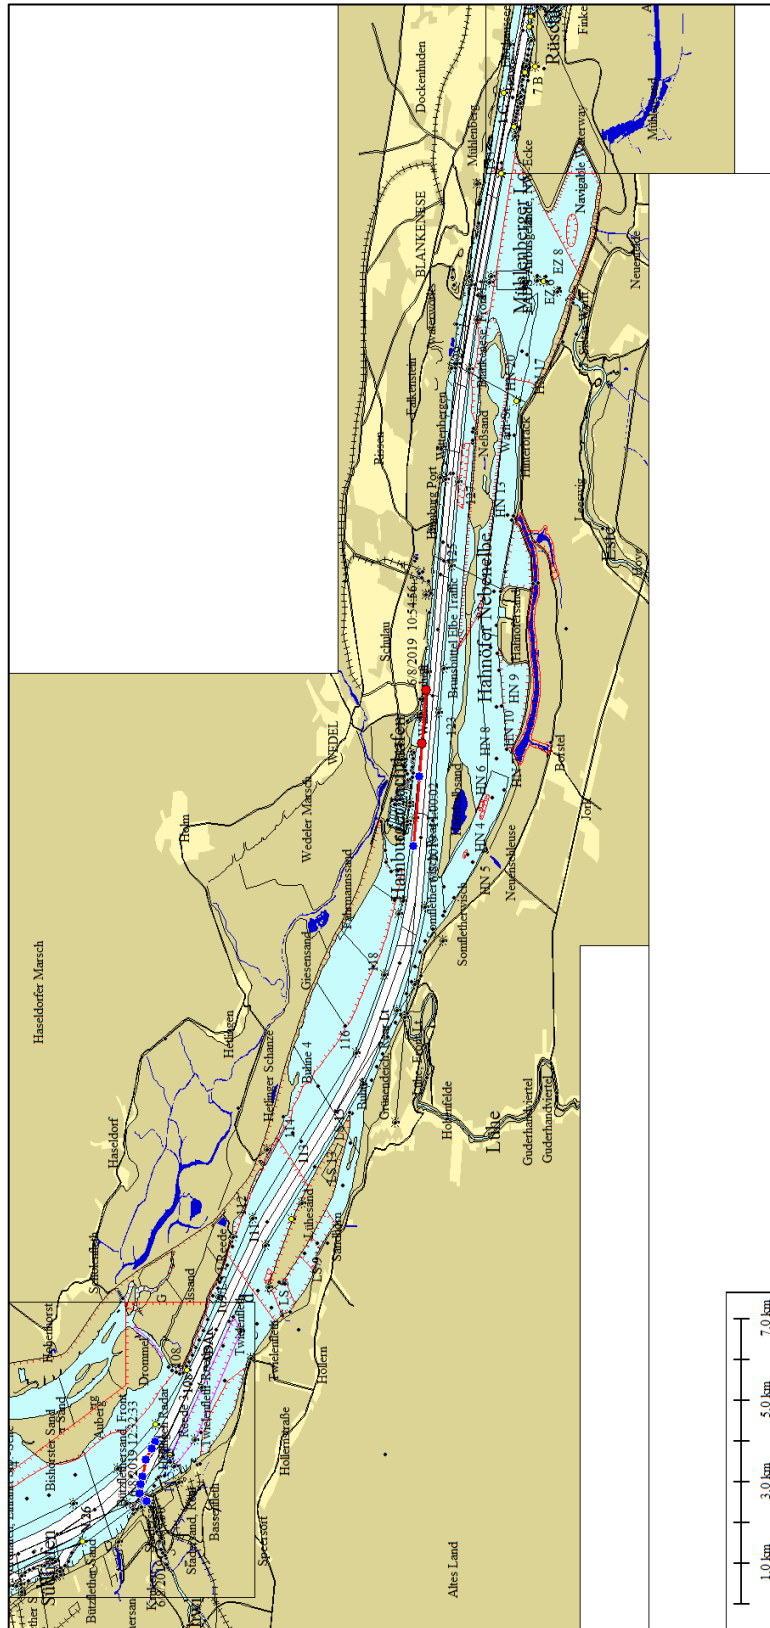
Figure 39: Superimposed AIS data from MarineTraffic and MSG

The AIS data from Marine Traffic and MSG were superimposed in Figure 39 to illustrate that the gap is virtually identical.

The following two tables show the numerical values on which the above graphical representations are based. Not only are the actual data identical but also the gaps in the recordings. After the last position was transmitted at about 110417 UTC (130417 LT), no transmission was received until after the collision.

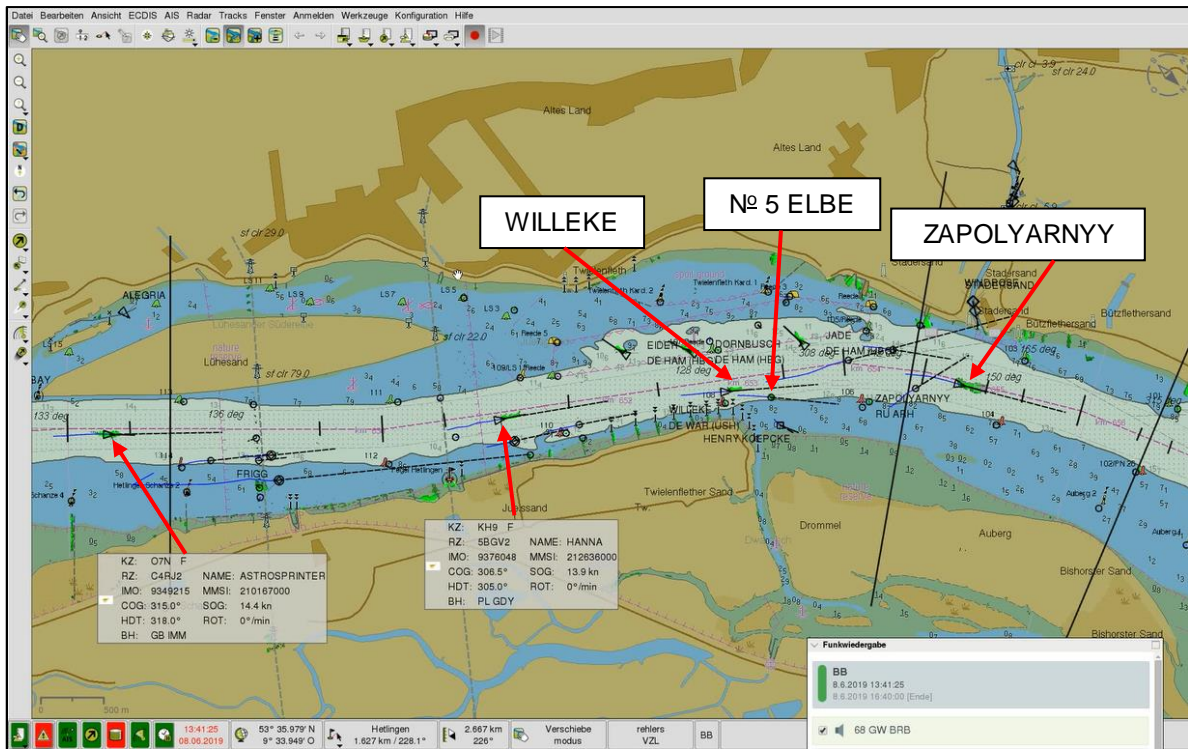
Figure 40: Initial situation at 1341

The order of the ships involved, constituting the initial situation, can be seen in Figure 40. The ASTROSPRINTER is on the far left of the image (since the image is not facing north, to the east²¹), in front of her the HANNA, in front of her the WILLEKE and lastly the ZAPOLYARNYY as the first ship.

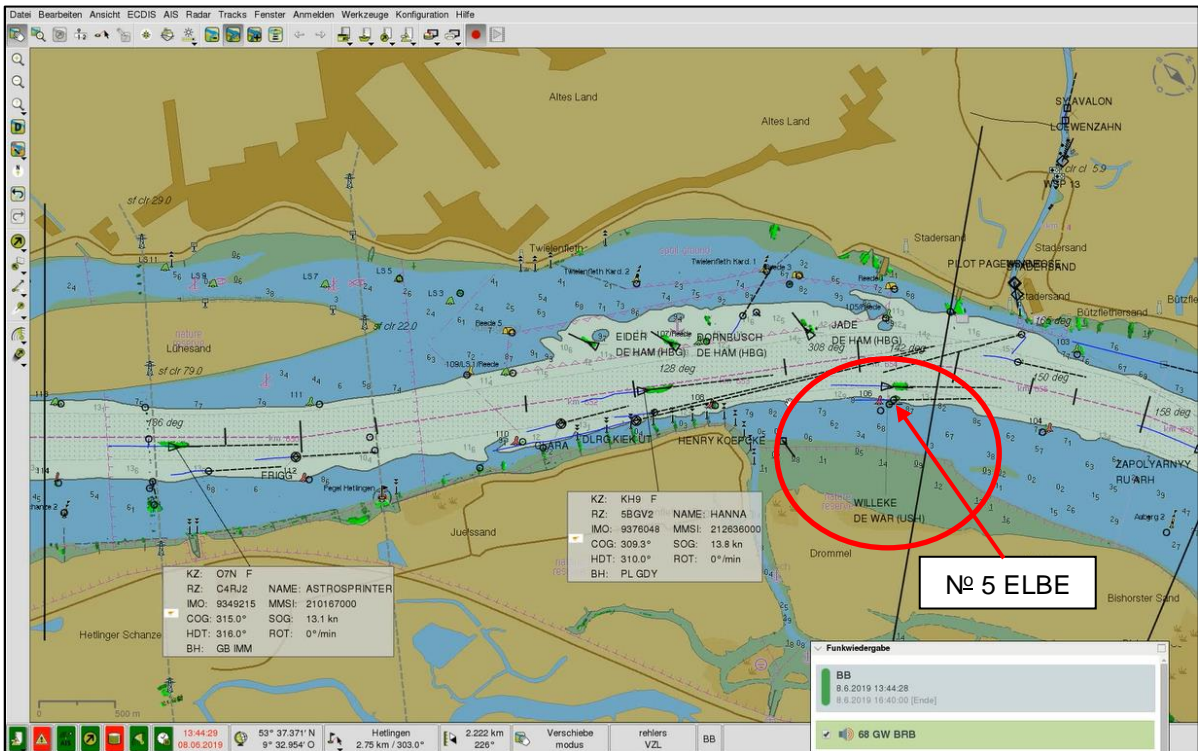
Figure 41: The WILLEKE passes the № 5 ELBE at 1344

Figure 41 shows the WILLEKE overtaking the № 5 ELBE. Her radar echo is extremely small and visible below that of the WILLEKE. The № 5 ELBE begins to turn after this pass is completed (Figure 42).

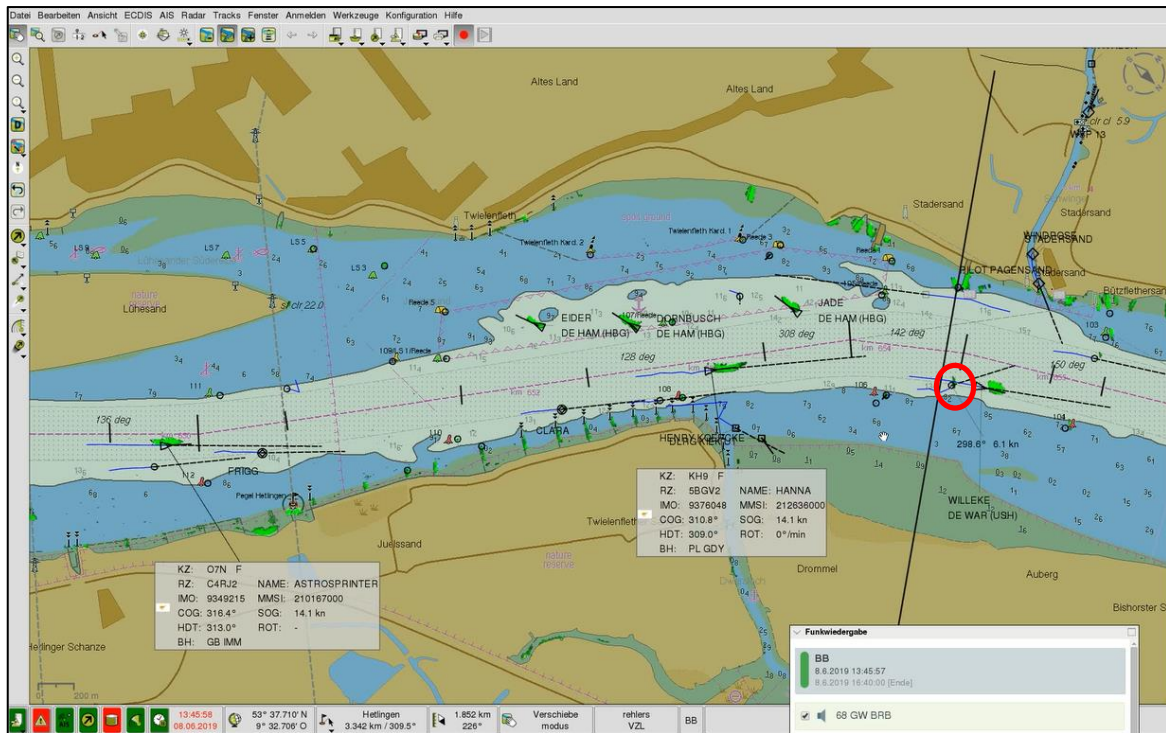
Figure 42: The № 5 ELBE begins to turn at 1346

The distance to the HANNA is about 1,200 m, which means that she still has about three minutes before she reaches the № 5 ELBE.

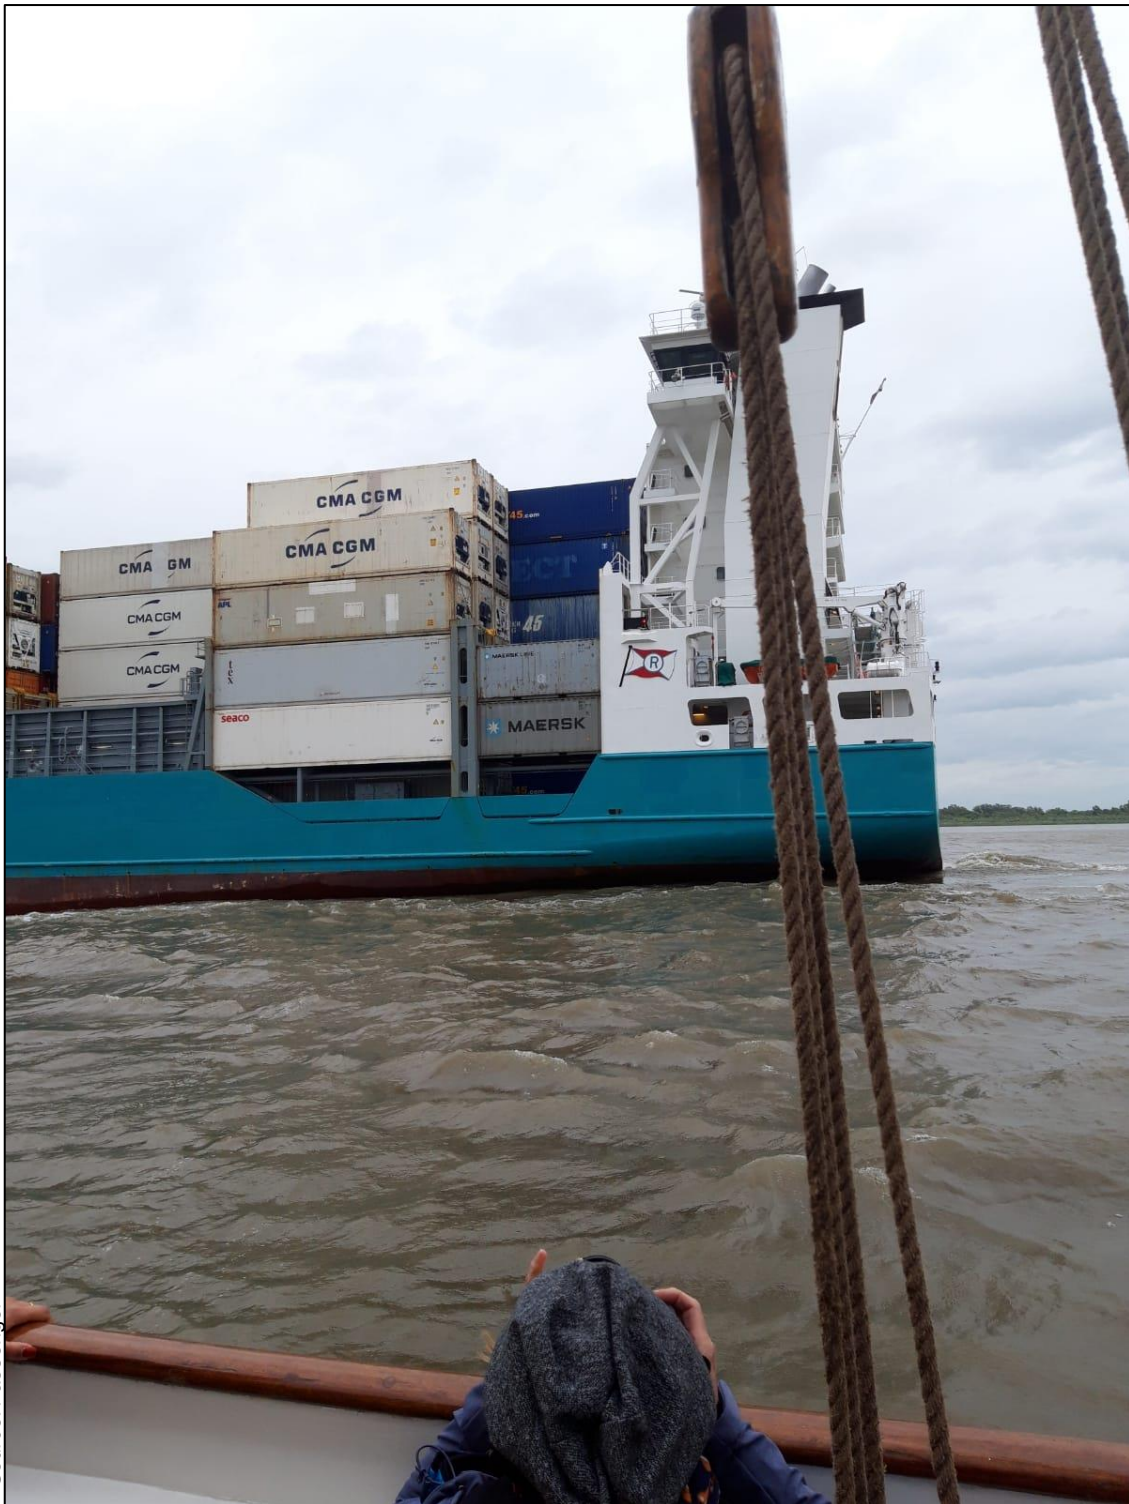
Figure 46: Photograph used for the distance calculation

The pilot of the HANNA estimated a distance of 20 m. To substantiate this statement, the BSU instructed the Institute of Photogrammetry and GeoInformation (IPG) at the Leibniz University Hannover to calculate the closest point of approach (CPA) by means of photogrammetry using a photograph that a passenger had taken by chance as the two ships were passing (see Figure 46). The thus calculated CPA between the two vessels stood at 32.1 m.

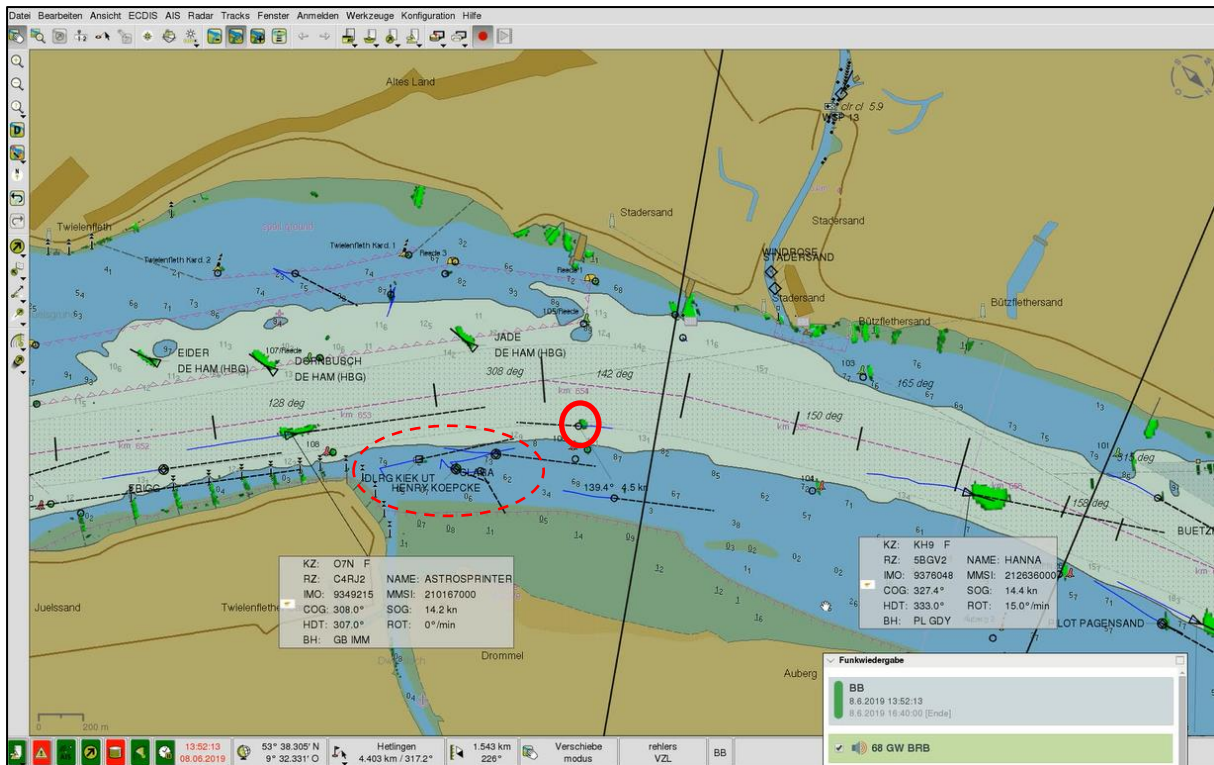
Figure 48: The N° 5 ELBE stays on the wrong side of the fairway

Figure 48 shows that the № 5 ELBE stays on the northern side of the fairway and sails directly for the oncoming ASTROSPRINTER. For that reason, the ship's command of the ASTROSPRINTER had to assume that a green-green encounter was intended, i.e. that the two ships would pass each other on the starboard side.

The ASTROSPRINTER has finished overtaking the FRIGG (Figure 48). The DLRG and fire brigade vessels are operating to the north of the fairway (dotted circle).
