Bundesstelle für Seeunfalluntersuchung
Federal Bureau of Maritime Casualty Investigation
Federal Higher Authority subordinated to the Federal Ministry
of Transport and Digital Infrastructure

Investigation Report 211/19

Very Serious Marine Casualty

Collision between traditional vessel N° 5 ELBE and container vessel ASTROSPRINTER on the River Elbe on 8 June 2019

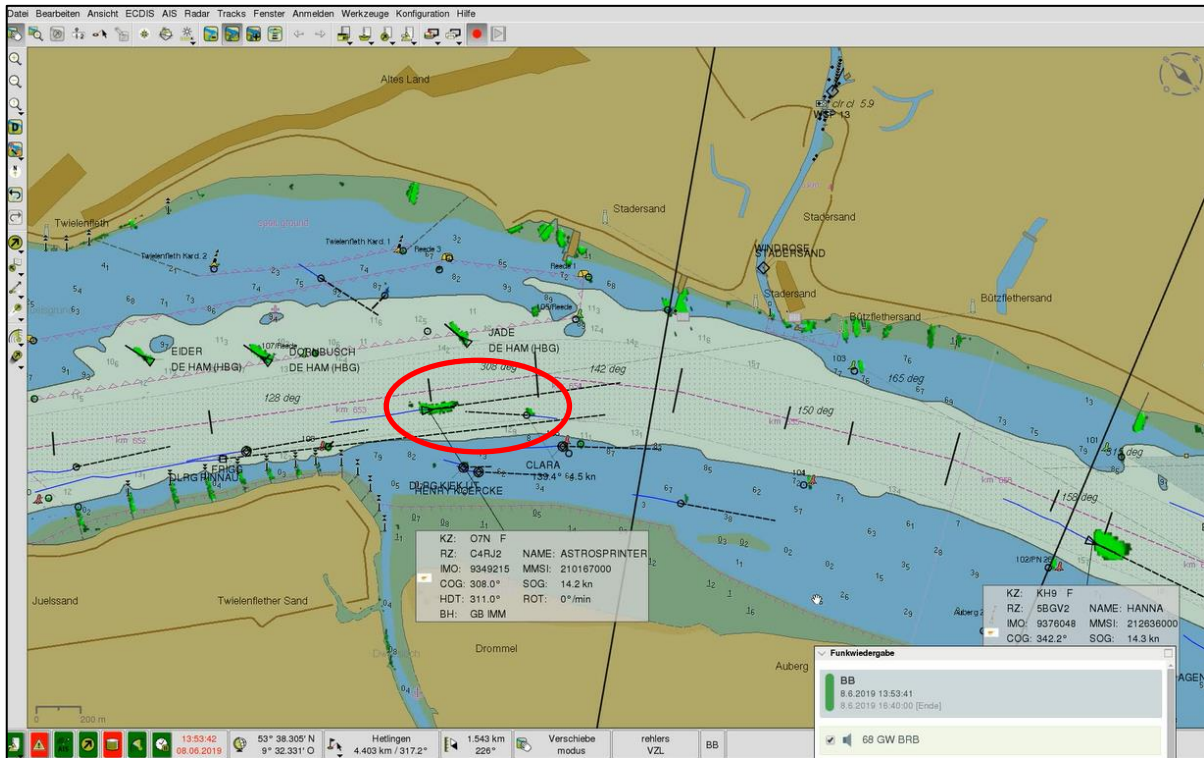
Figure 49: 135342 – risk of collision re-emerges

Figure 49 shows how the N° 5 ELBE and ASTROSPRINTER move ever closer²³. A further risk of collision emerges after the near collision with the HANNA. Figure 50²⁴ and Figure 51²⁵ show the two vessels collide at 1354.

²⁵ During the consultation phase, the GDWS commented in support of the VTS:
 "A significant course alteration by the N° 5 ELBE is evident. The collision is imminent. In less than two minutes, a seemingly safe situation develops into a collision. The absolute risk of collision is still not even apparent in Figure 49 (23 seconds before Figure 50). The room for manoeuvre in such close-quarters situations is simply too short for the VTS to intervene meaningfully in any form."

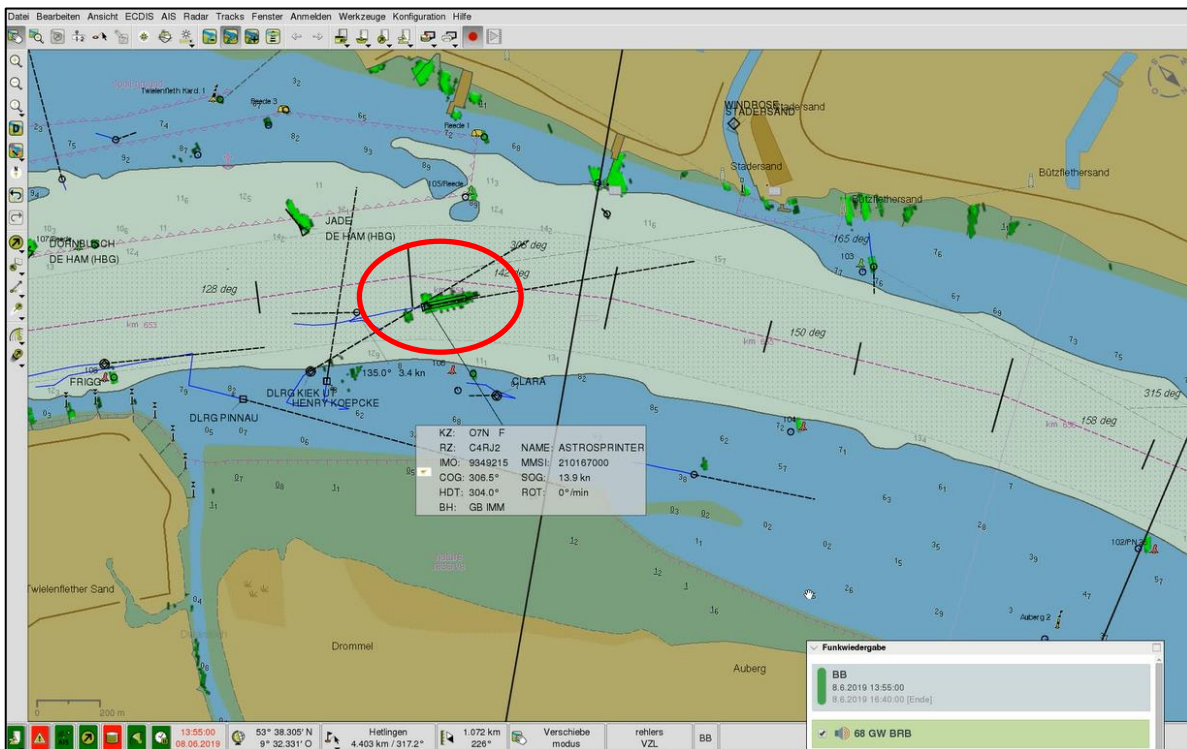
Figure 52: The ships have separated again. The KIEK UT is heading for the distressed vessel
 Just one minute later – at 1355 – the two vessels have separated. Figure 52 shows how the DLRG's motor lifeboat KIEK UT is already sailing to the scene of the accident.

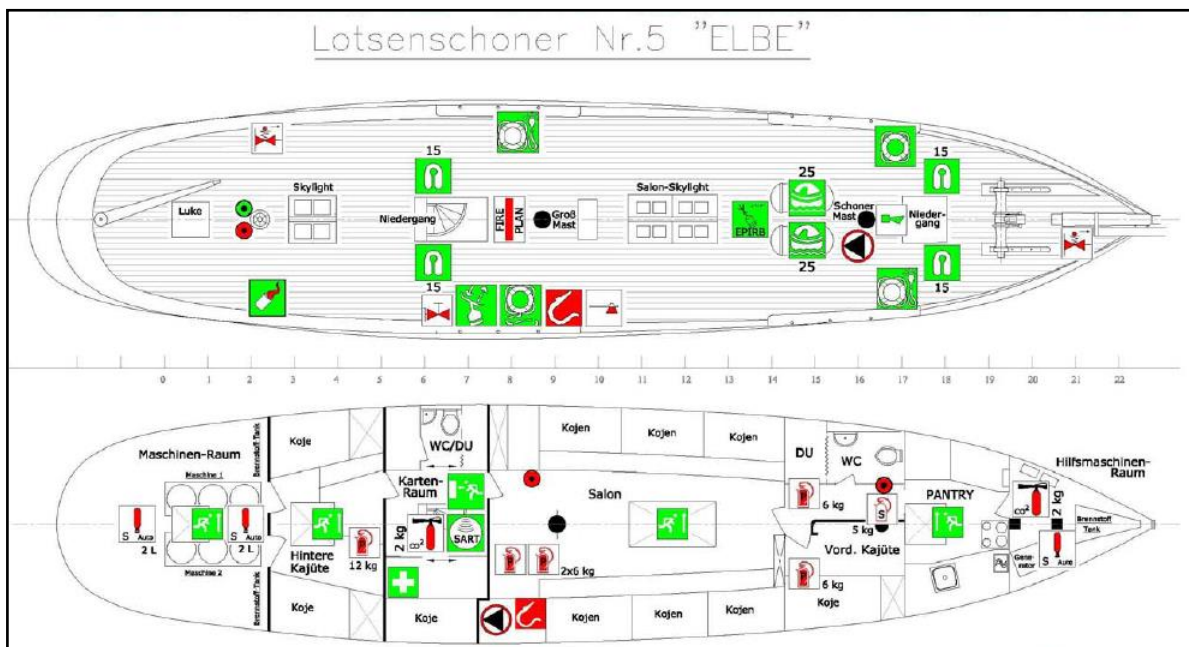
Figure 62: Top view from the fire control and safety plan

The № 5 ELBE has several mandatory and designated emergency exits. On 20 September 2019, two investigators went back to Wewelsfleth to survey the aft exit, which up to that point had been defined as an emergency exit. A hatch is located above the engine room, meaning it has a second exit in case of emergency. The cover, which is folded upwards, is so heavy that only two people were able to remove it from the deck. There was no handle inside it. The tiller would be in the way and above the hatch if it were not moved outwards (hard-over rudder angle) beforehand, making it difficult for someone who wanted to open the cover from inside. However, even at a hard-over rudder angle, the tackle (which is usually attached to the tiller) can cause an obstruction. It would certainly be more practicable to install the cover by means of a sliding mechanism. In addition, there would need to be a ladder inside because otherwise it would not be possible to get out of the hatch.

In this context it became apparent that ladders would also be needed at the skylights marked as emergency exits.

The Ship Safety Division (BG Verkehr) will impose a requirement to revise the fire control and safety plan."

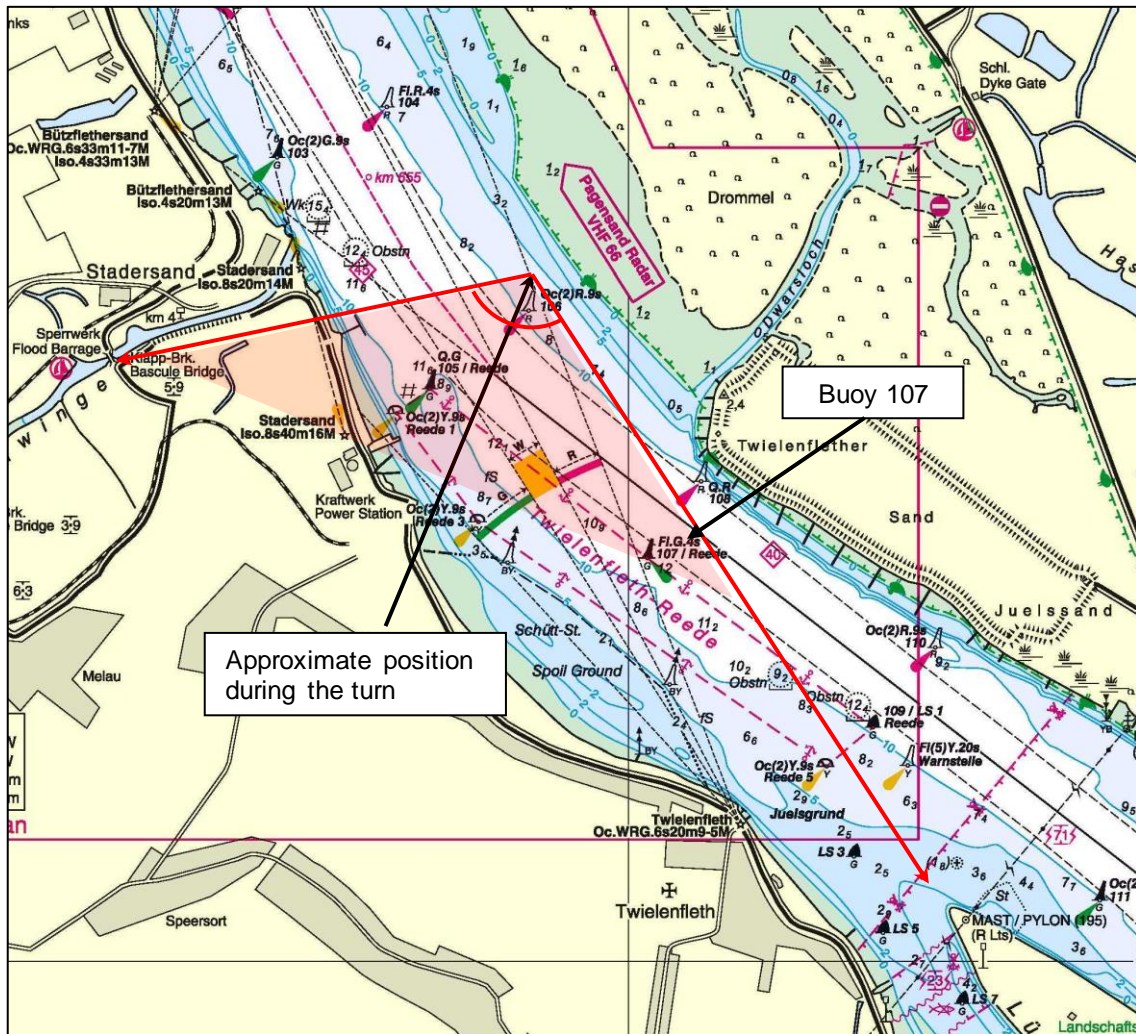
Figure 66: Turning angle of the N^o 5 ELBE in relation to buoy 106

Area not navigable without turning with wind direction SSW (202.5°) and assumed turning angle of 110°.

The area navigable by the N^o 5 ELBE under sail is shown in Figure 66. It becomes clear that it would have been possible to reach the correct side of the fairway even without turning, i.e. by luffing or sailing close to the wind.

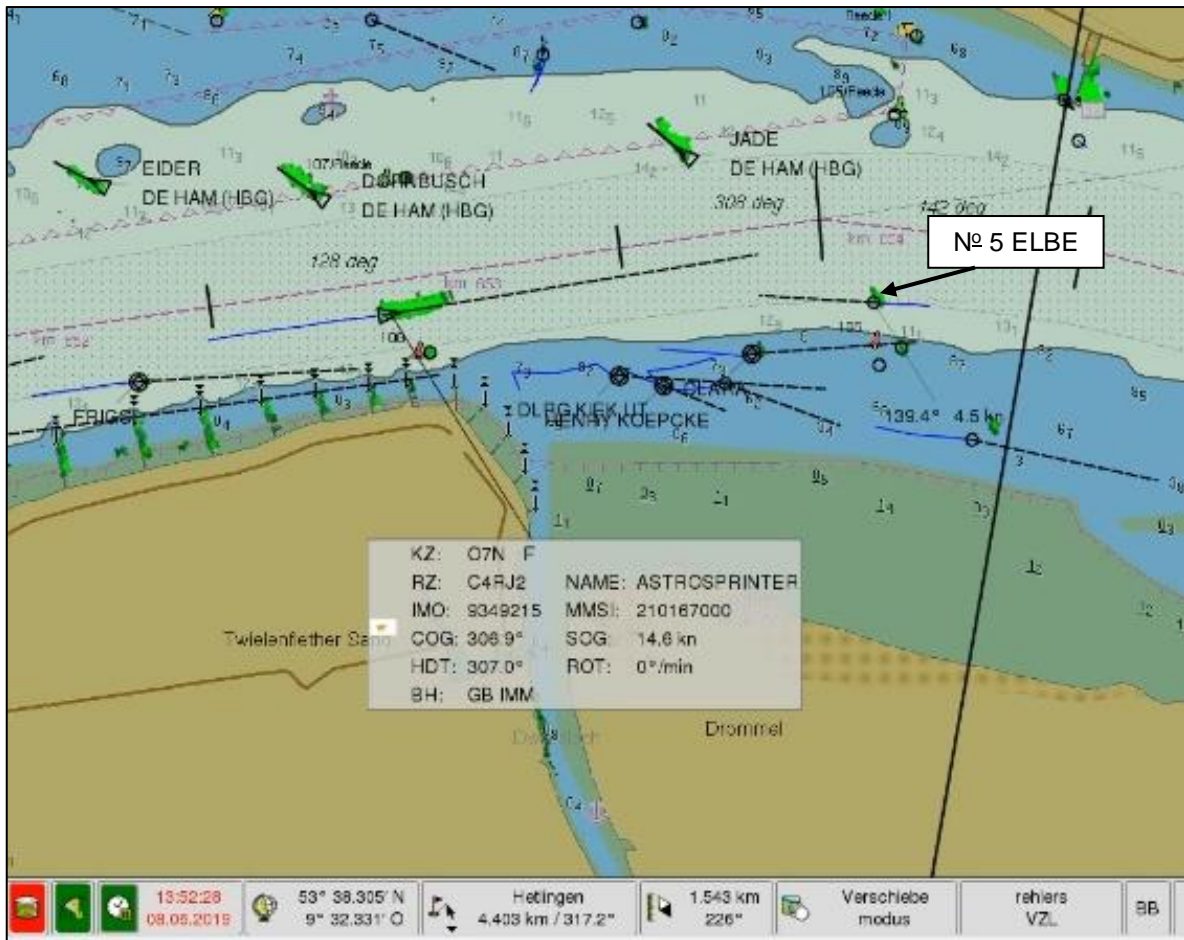
Figure 68: VTS Brunsbüttel radar image at 135228

The corresponding radar image (Figure 68) at this point shows the N^o 5 ELBE on the northern edge of the channel (dotted area of the fairway). Buoy 106 has just been passed on port beam. The ASTROSPRINTER has buoy 108 on starboard beam.

The respective vector in front of a craft indicates the craft's position two minutes later if speed and COG remain the same. It is evident that the two vessels will be abreast at about 135428.

It can be seen from figures 68 and 69 that the N° 5 ELBE was still a long way from the middle of the fairway at 135228 and continued to sail parallel with the course of the fairway (chart course of the fairway 142°) in the next minute. It was not until the bend in the fairway at buoy 105 (chart course 128°) that a significant gain in distance covered in the direction of the middle of the fairway (upstream on the River Elbe) was possible.

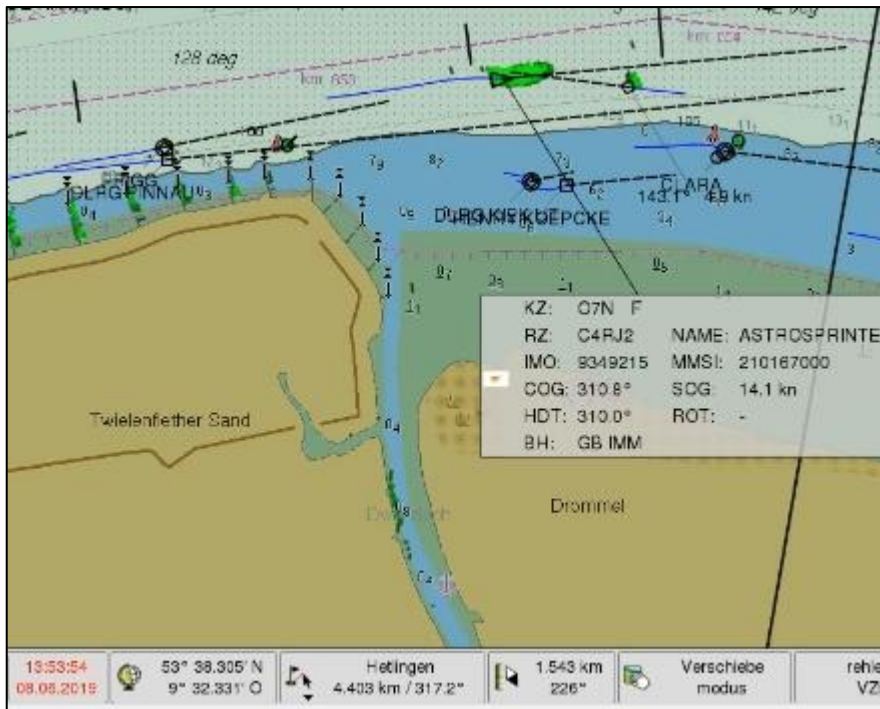
Figure 71: VTS Brunsbüttel radar image at 135354

The ASTROSPRINTER's COG had adjusted accordingly (310.8°) at 135346. The N° 5 ELBE began her sudden course alteration to starboard at about 135354 at the latest (Figure 71), which led to the turn directly in front of the ASTROSPRINTER's bow (Figure 72). It can be seen that the N° 5 ELBE had not significantly reduced the distance to the middle of the fairway by this point in time.

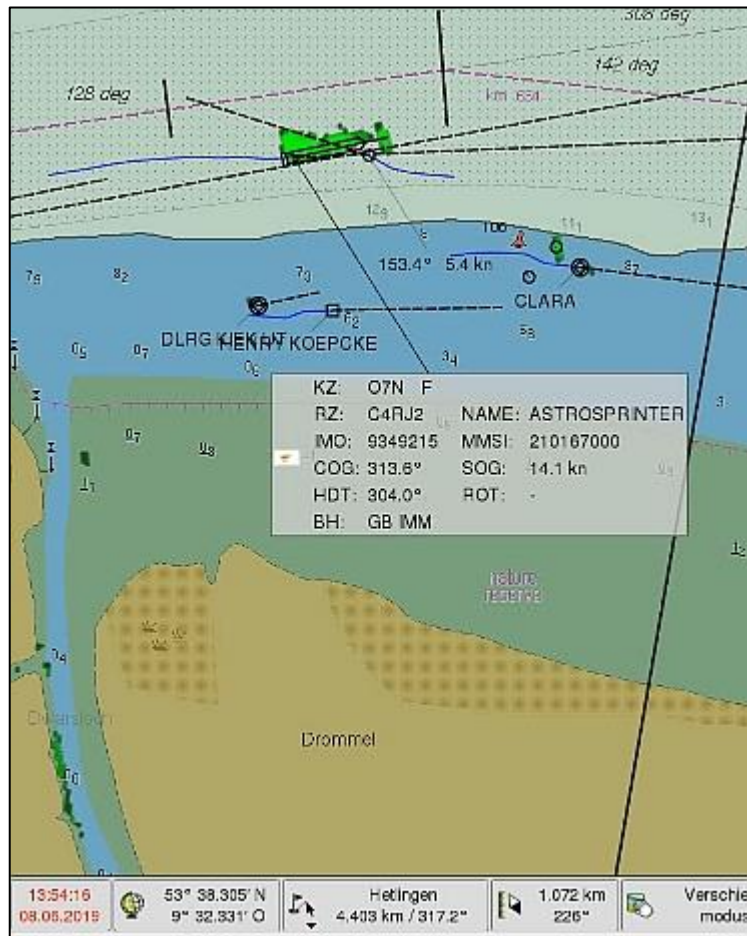
Figure 72: VTS Brunsbüttel radar image at 135416

- The ship's command of the N^o 5 ELBE initiated a turn in the direction of the ASTROSPRINTER. This manoeuvre took the traditional vessel in front of the ASTROSPRINTER's bow (Figure 72).

- The blue lines behind each vessel in Figure 72 show the respective COG. The BSU assumes that without the N^o 5 ELBE luffing and ultimately altering course ("the bearing away"), there would merely have been a very tight pass between the two vessels.

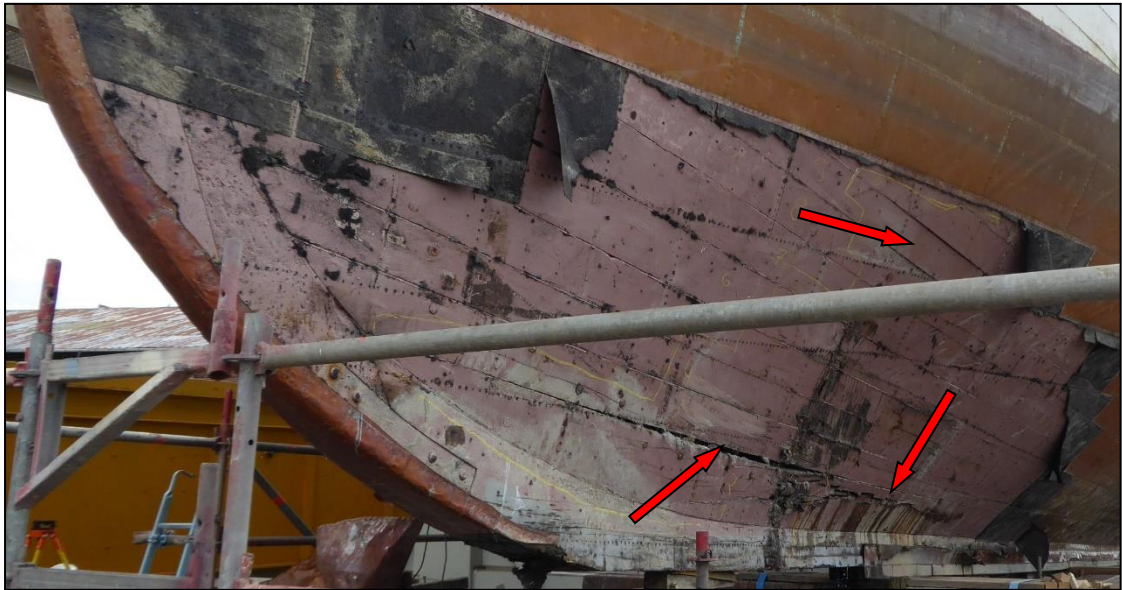
Fig. 8

Nach dem weiteren Entfernen der Kupferbeplattung wird ein größerer Schaden der Außenbeplankung sichtbar. Die erste Panke oberhalb des Kiels ist im hinteren Bereich eingerissen. Auch oberhalb der Schleifspuren durch den Wulstbug sind Planken gelöst und sicherlich nicht mehr wasserdicht gewesen.

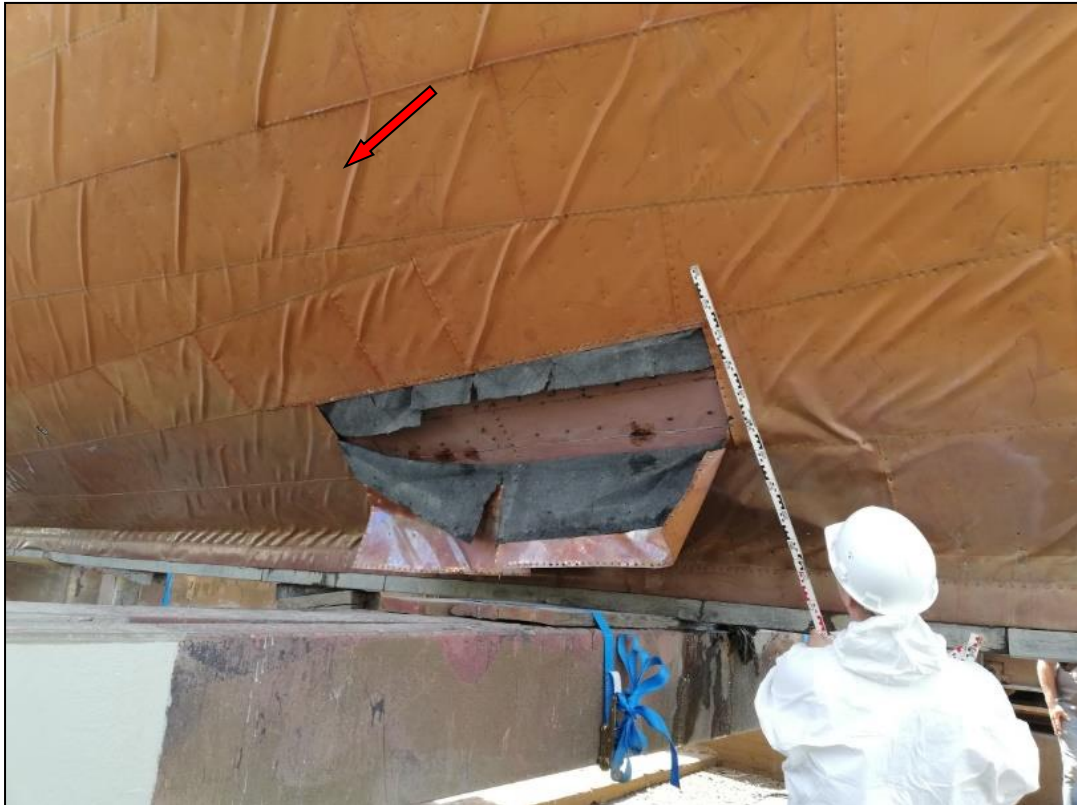
Fig. 10

An B.B. Seite ist die Kupferbeplattung ebenfalls großflächig gewellt.

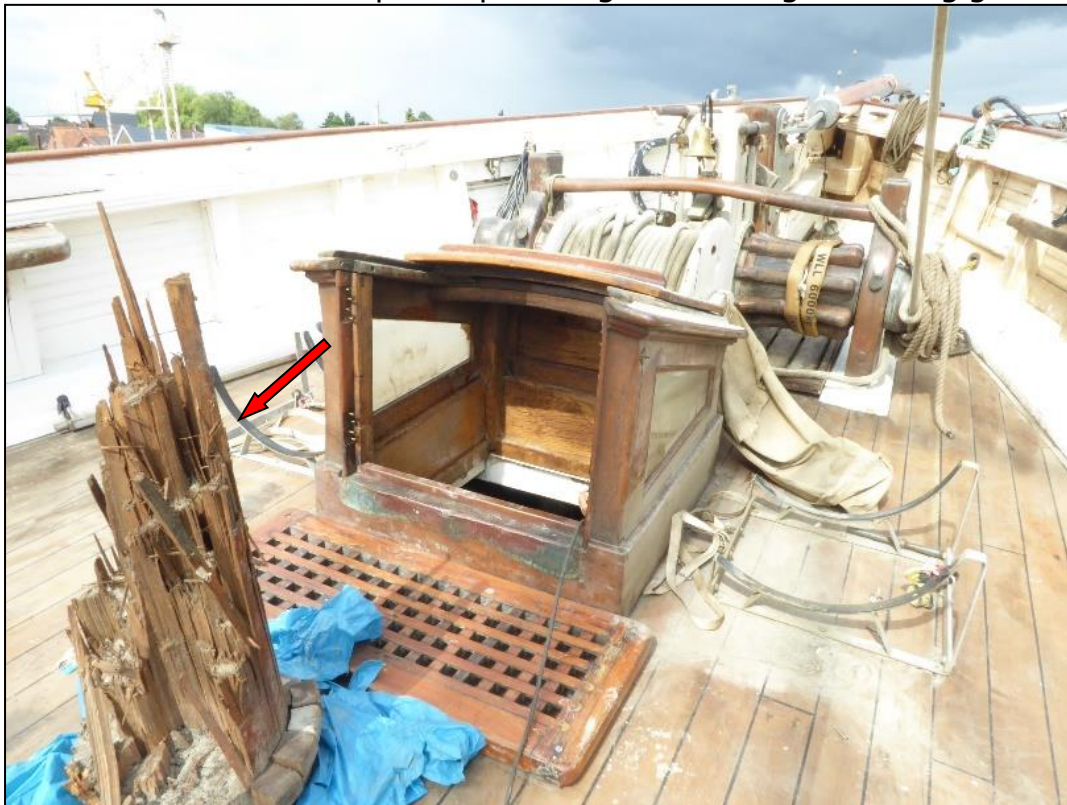
Fig. 11

Der vordere Mast mit Takelage ist oberhalb des Decks stumpf abgebrochen. Auf diesem Foto sind auch die Fundamente der beiden

Rettungsinseln zu erkennen.

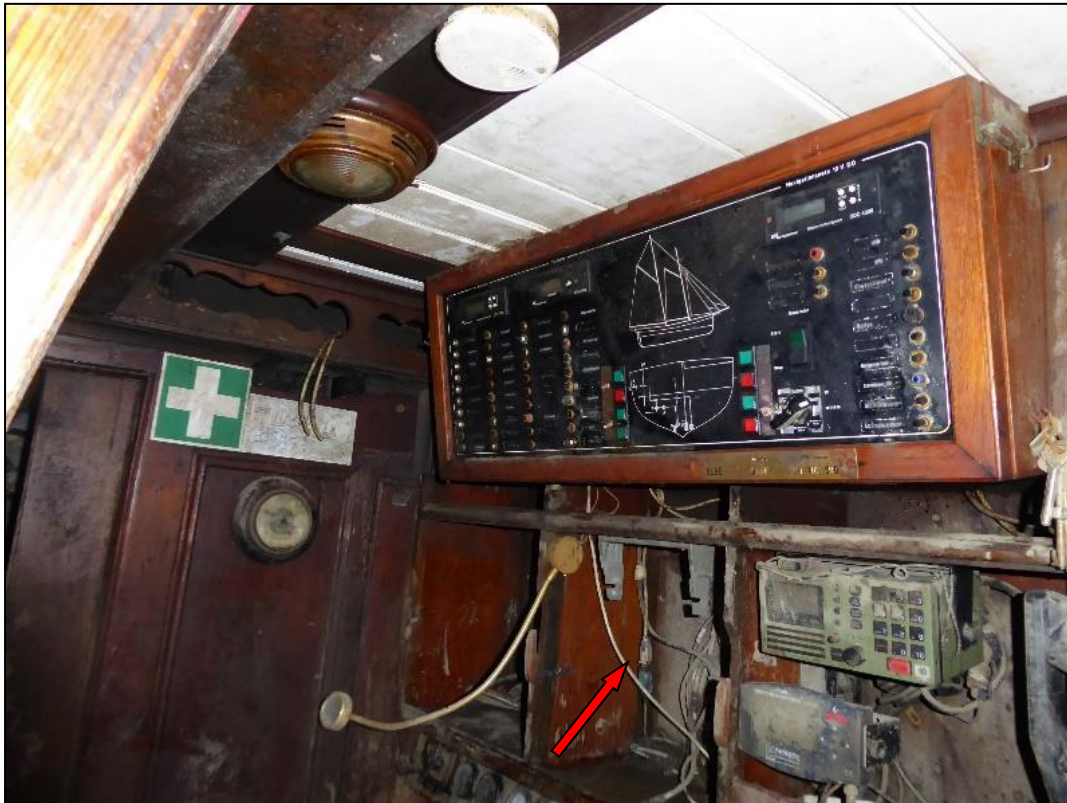
Fig. 12

Im Schiffsinnen ist die gesamte Technik sowie der Holzinnausbau durch das Sinken stark in Mitleidenschaft gezogen worden. Viele Komponenten der Elektrik als auch der Technik sind als Totalschaden anzusehen.

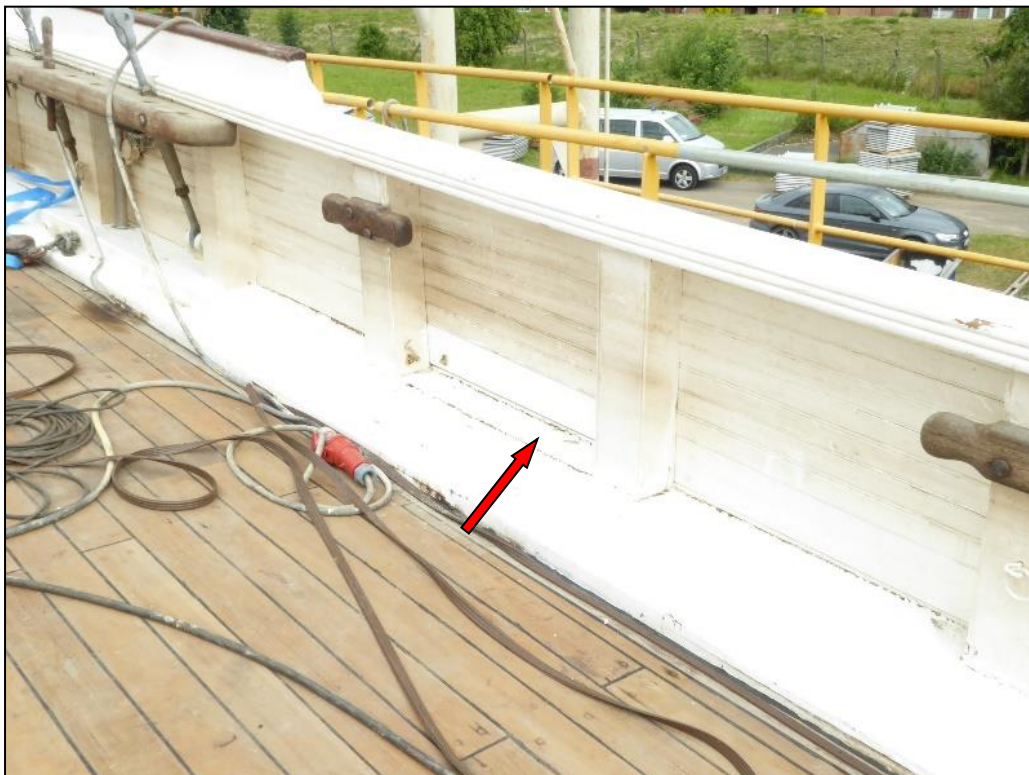
Fig. 14

Risse im Bereich des Holz-Dollbordes auf beiden Seiten im Vorschiffs- und Mittschiffsbereich

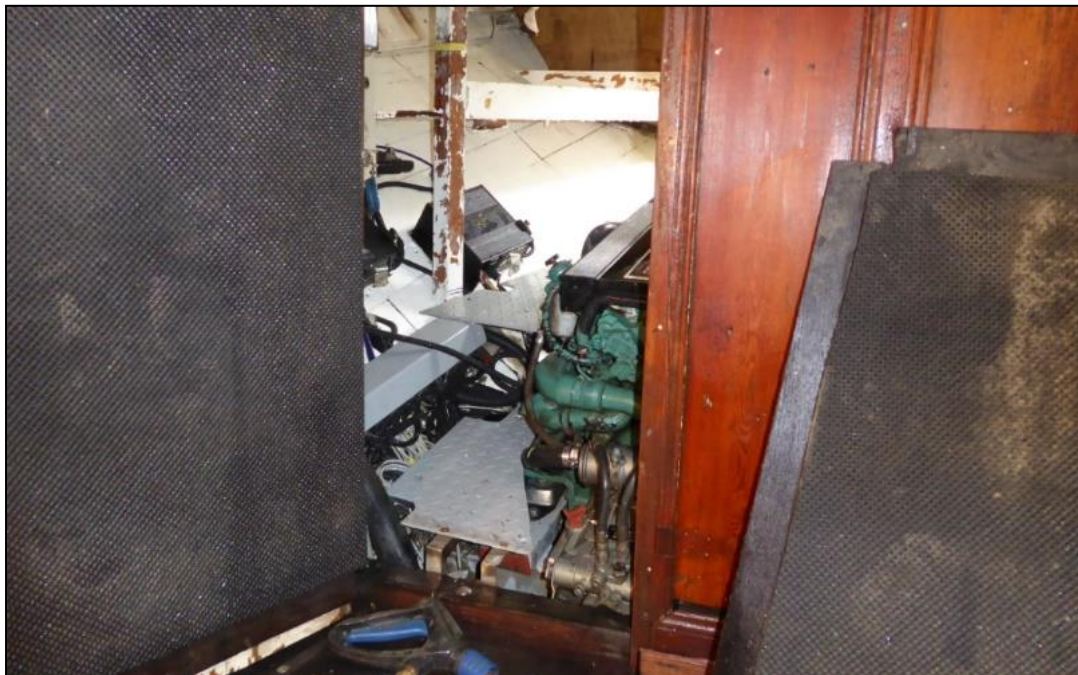
Fig. 23

Hintere Motorraumabtrennung: kein wasserdichtes Schott

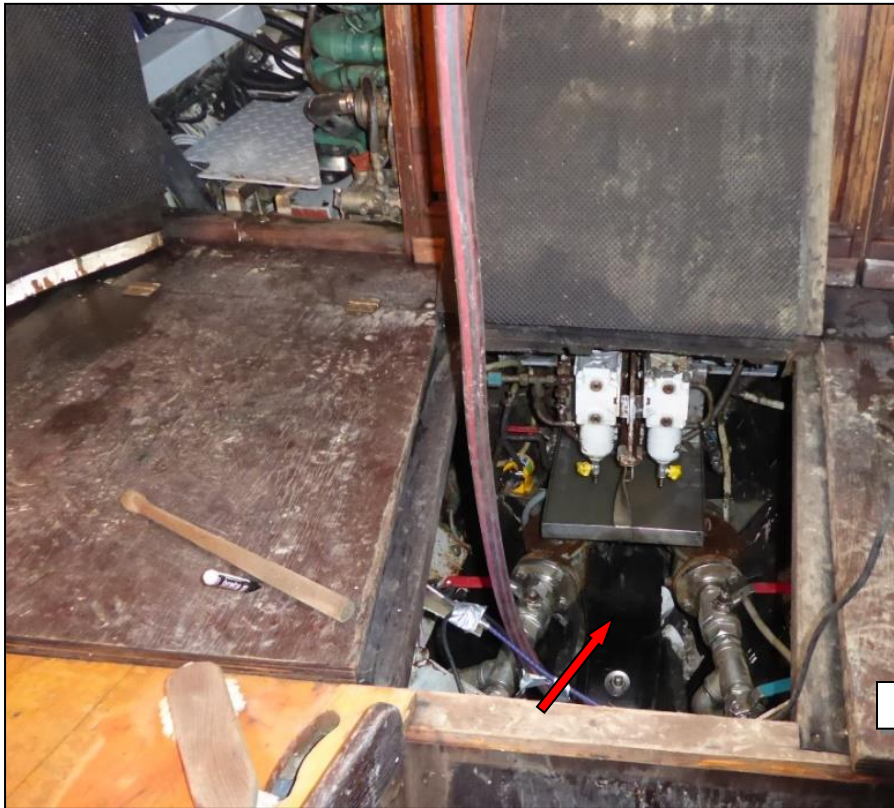
Fig. 24

Tank für Generator im Vorschiffsbereich. Kein Kollisionsschott vorhanden:

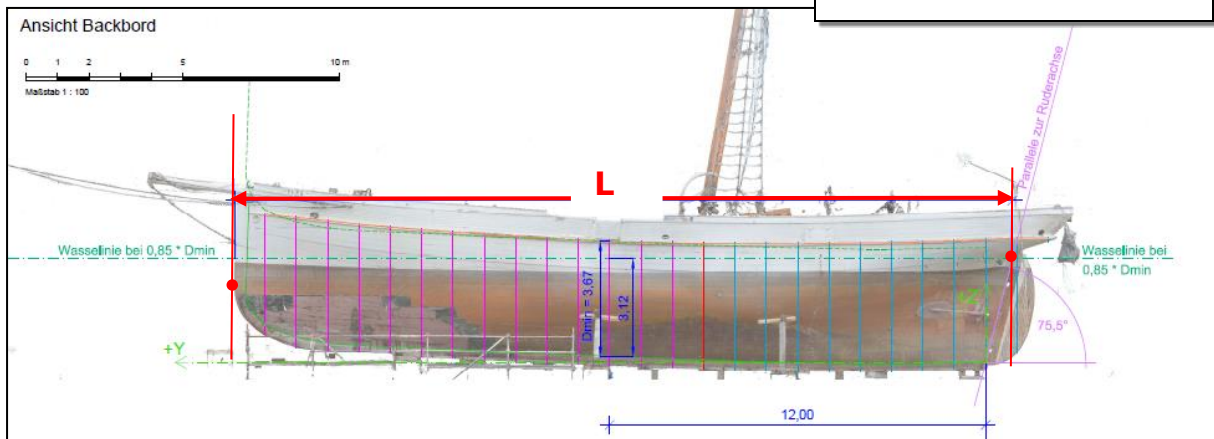
Fig. 38: Ermittlung der Länge L2

$$L2 = \mathbf{24,83 \text{ m}}$$

Die Länge **L2 = 24,83 m** ist die größte Länge und größer als 24,00 m. Daher ist diese Länge L2 für die Bewertung der Richtlinie (s. 4.1.III) heranzuziehen

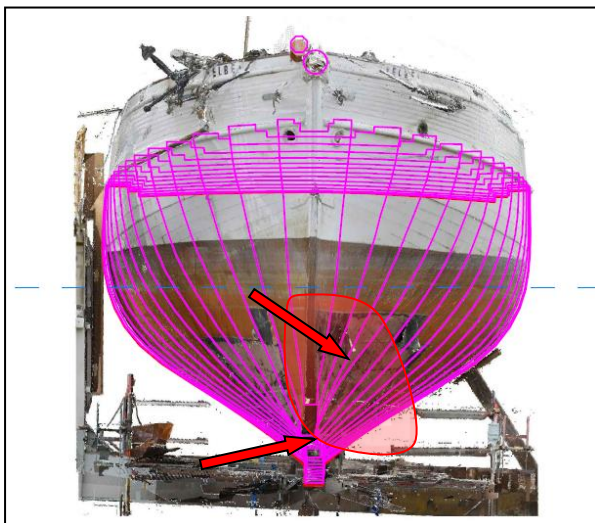
Fig. 39: Bereiche der größten Verformung an B.B

Bei der Betrachtung der eingescannten Kontur wird eine deutliche Verformung der Form des Vorschiffes an B.B.-Seite in den Bereichen Spt.18-23 festgestellt. Es wird eine asymmetrische Verformung von bis zu 170 mm im Bereich des Spt. 20 gemessen.
