Bundesstelle für Seeunfalluntersuchung
Federal Bureau of Maritime Casualty Investigation
Federal Higher Authority subordinated to the Federal Ministry
for Digital and Transport

Investigation Report 23/20

Less Serious Marine Casualty

**Cargo-related accident
(loss of two mobile cranes)
on the
JUMBO VISION
at berth in the port of Rostock
on 31 January 2020**

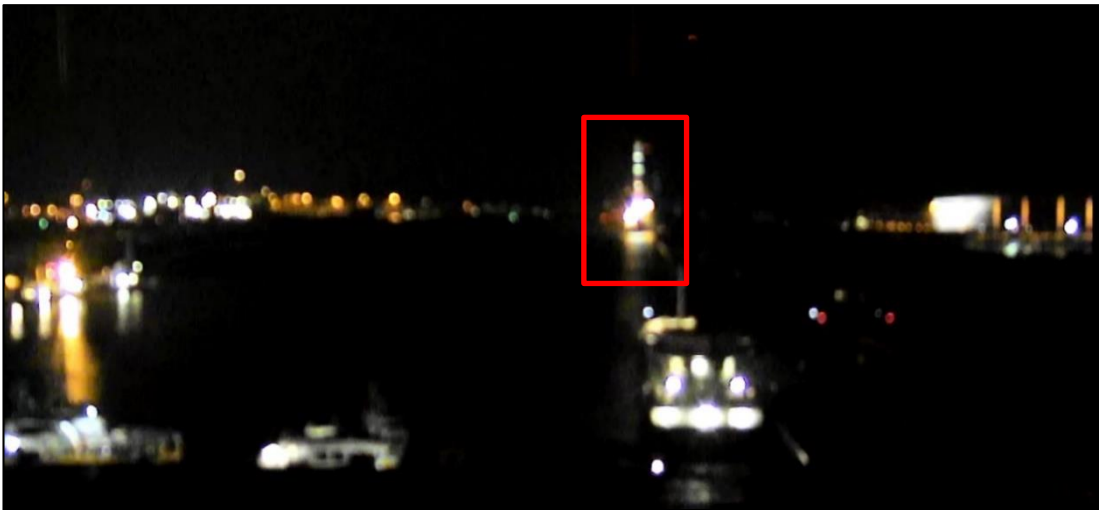
Figure 24: Screenshot: surveillance camera directly before accident

It is also evident that the JUMBO VISION was not heeling significantly before the accident (see Figure 24). This corresponds to the values of the inclination angle signal from the data chip analysis (see Figure 20). The same is true for the witnesses' statements.

Accordingly, the ship was not heeling on the seaward side at the time of the accident. On that day, the inclination sensor evidently correctly indicated the inclination of the surface on which the crane was moving. Possibly the orientation of the crane's tower is not automatically an indication of the inclination sensor's measurements.

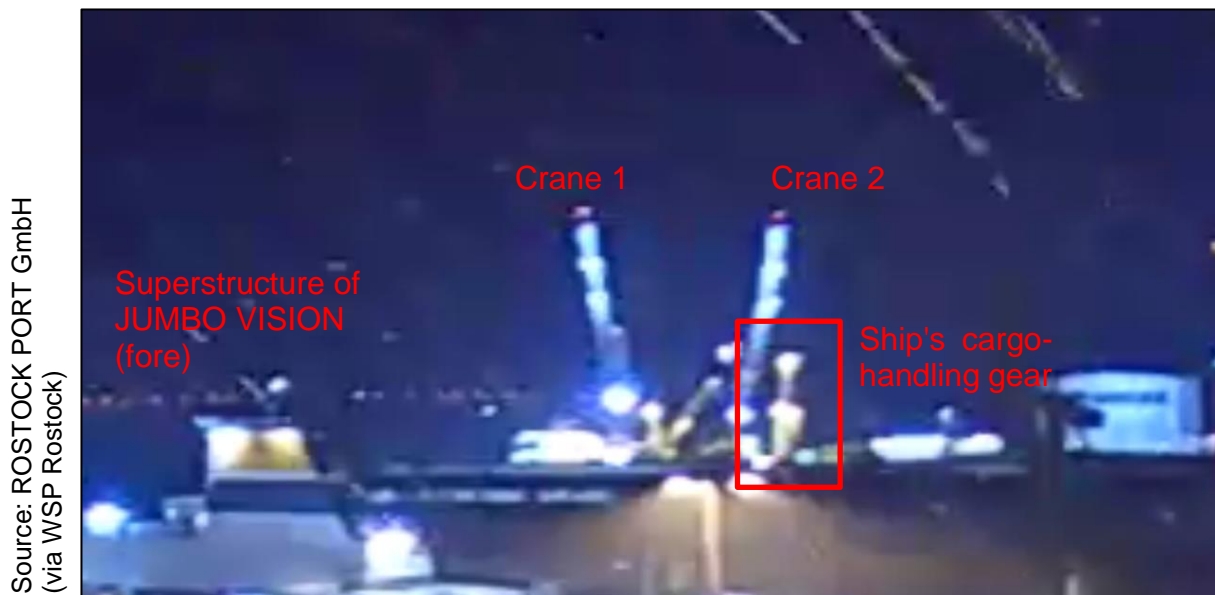
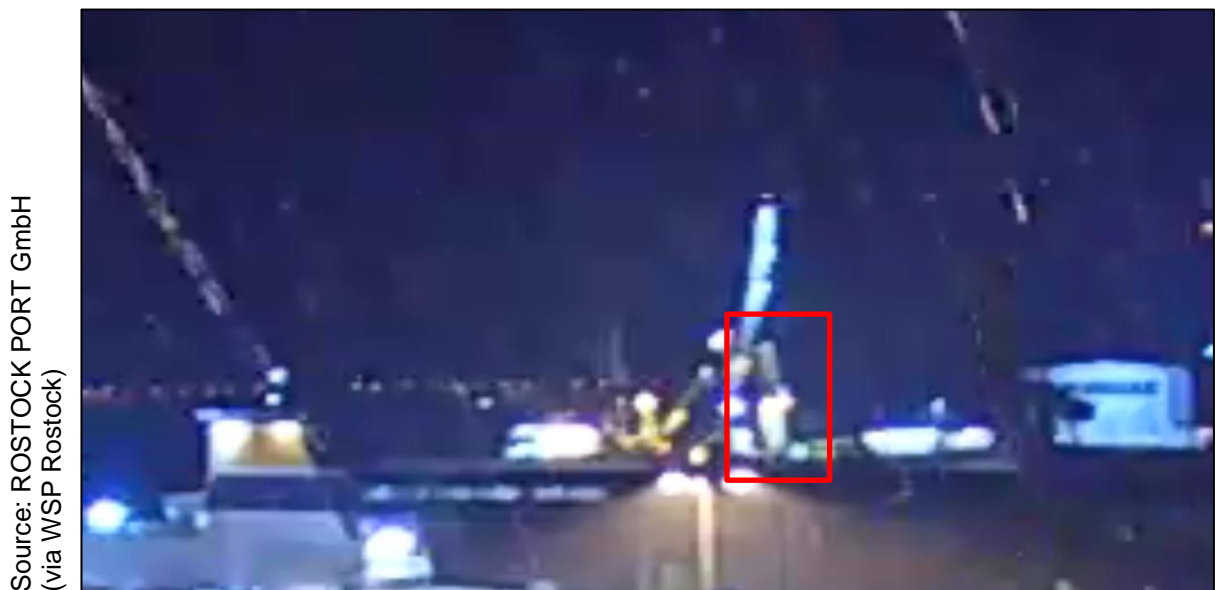
Figure 29: Screenshot: surveillance camera, shortly before slewing of ship's own cargo-handling gear (crane 1 still in operation)

Figure 30: Screenshot: surveillance camera, after slewing of ship's own cargo-handling gear (crane 1 no longer in operation)

The camera filming from the side shows this slewing process about two and a half minutes before the accident (Figure 29 and Figure 30). The statements of the witnesses on board indicate that the ship's cargo-handling gear was to be secured parallel to the cargo securing operations (see also p. 18). The video filmed from aft clearly shows how the ship responded to this slewing process.

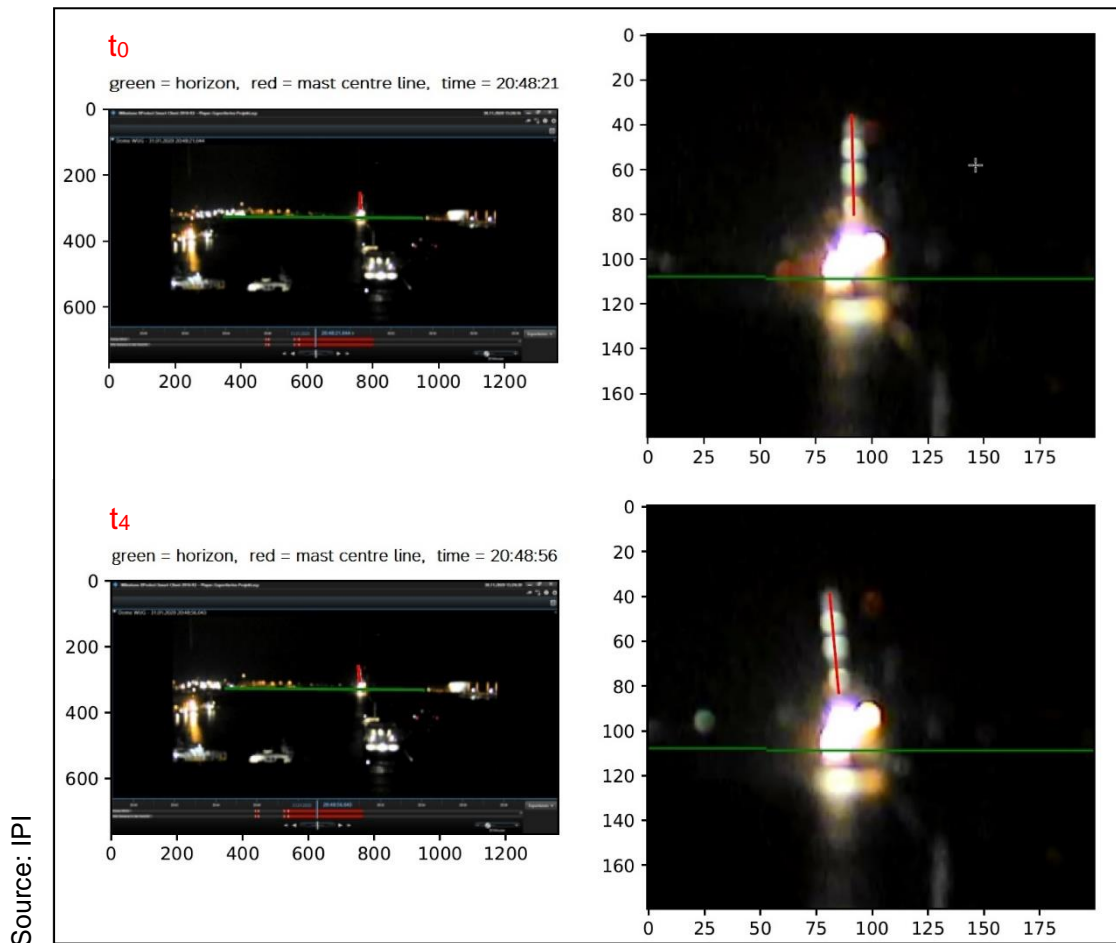
Figure 33: Photogrammetry: t_0 and t_4 comparison
 ($t_0 \triangleq 0^\circ$ heel, reading 88.31° ; $t_4 \triangleq 4^\circ$ seaward heel, reading 84.42°)

The increasing heel between t_0 (setting off) and t_4 (extending the support cylinders) is clearly visible in the video recordings (see Figure 33).

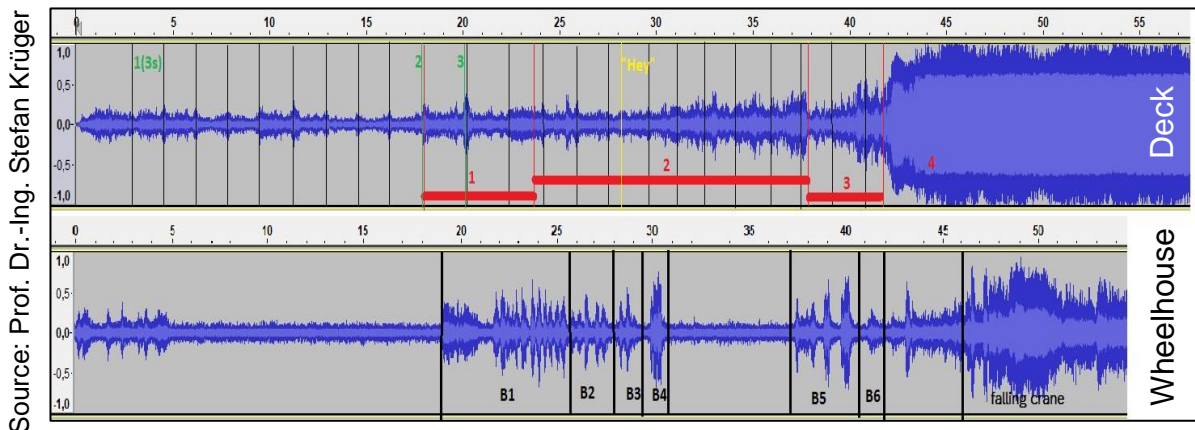
Figure 35: Visualisation of the two relevant VDR audio files
Recording starts at 20:48:15 VDR time (20:48:18 in all other media)

The two audio files were denoised and visualised using an audio editor, and the two visualisations were then synchronised and compared (see Figure 35). The audio track of the external microphone is shown at the top, and that of the wheelhouse microphone at the bottom. Furthermore, a number of events and time periods were graphically inserted to provide orientation.

The **wheelhouse microphone** recorded radio communication between the master, who was there to pump ballast, and the supervising persons on deck (chief mate and port captain). Only the master can be understood, the other side is strongly affected by noise. The bottom part of Figure 35 divides what the master said (with increasing urgency and volume) into six sections (B).

To begin with, a vertical black line was inserted in the visualisation of the deck audio file (Figure 35, upper part) for each acoustic movement signal. The signals start three seconds after the beginning of the audio file (at $t_0 = 20:48:21$) and continue almost to the end. It is only absent between 16 s and 20 s (i.e. between 20:48:34 and 20:48:38). Not a black line, but a red and a green line are inserted here. The movement signal actually stops at the exact same moment at which the control lever (and thus the master switch signal) is set to neutral (see Figure 20). However, the rapid change of direction at the beginning (after noticing the wrong direction two seconds after starting up) did not cause the acoustic signal to stop, because the holding brakes did not have enough time to engage (see also chapter 3.4.1.2 Liebherr LHM 550).

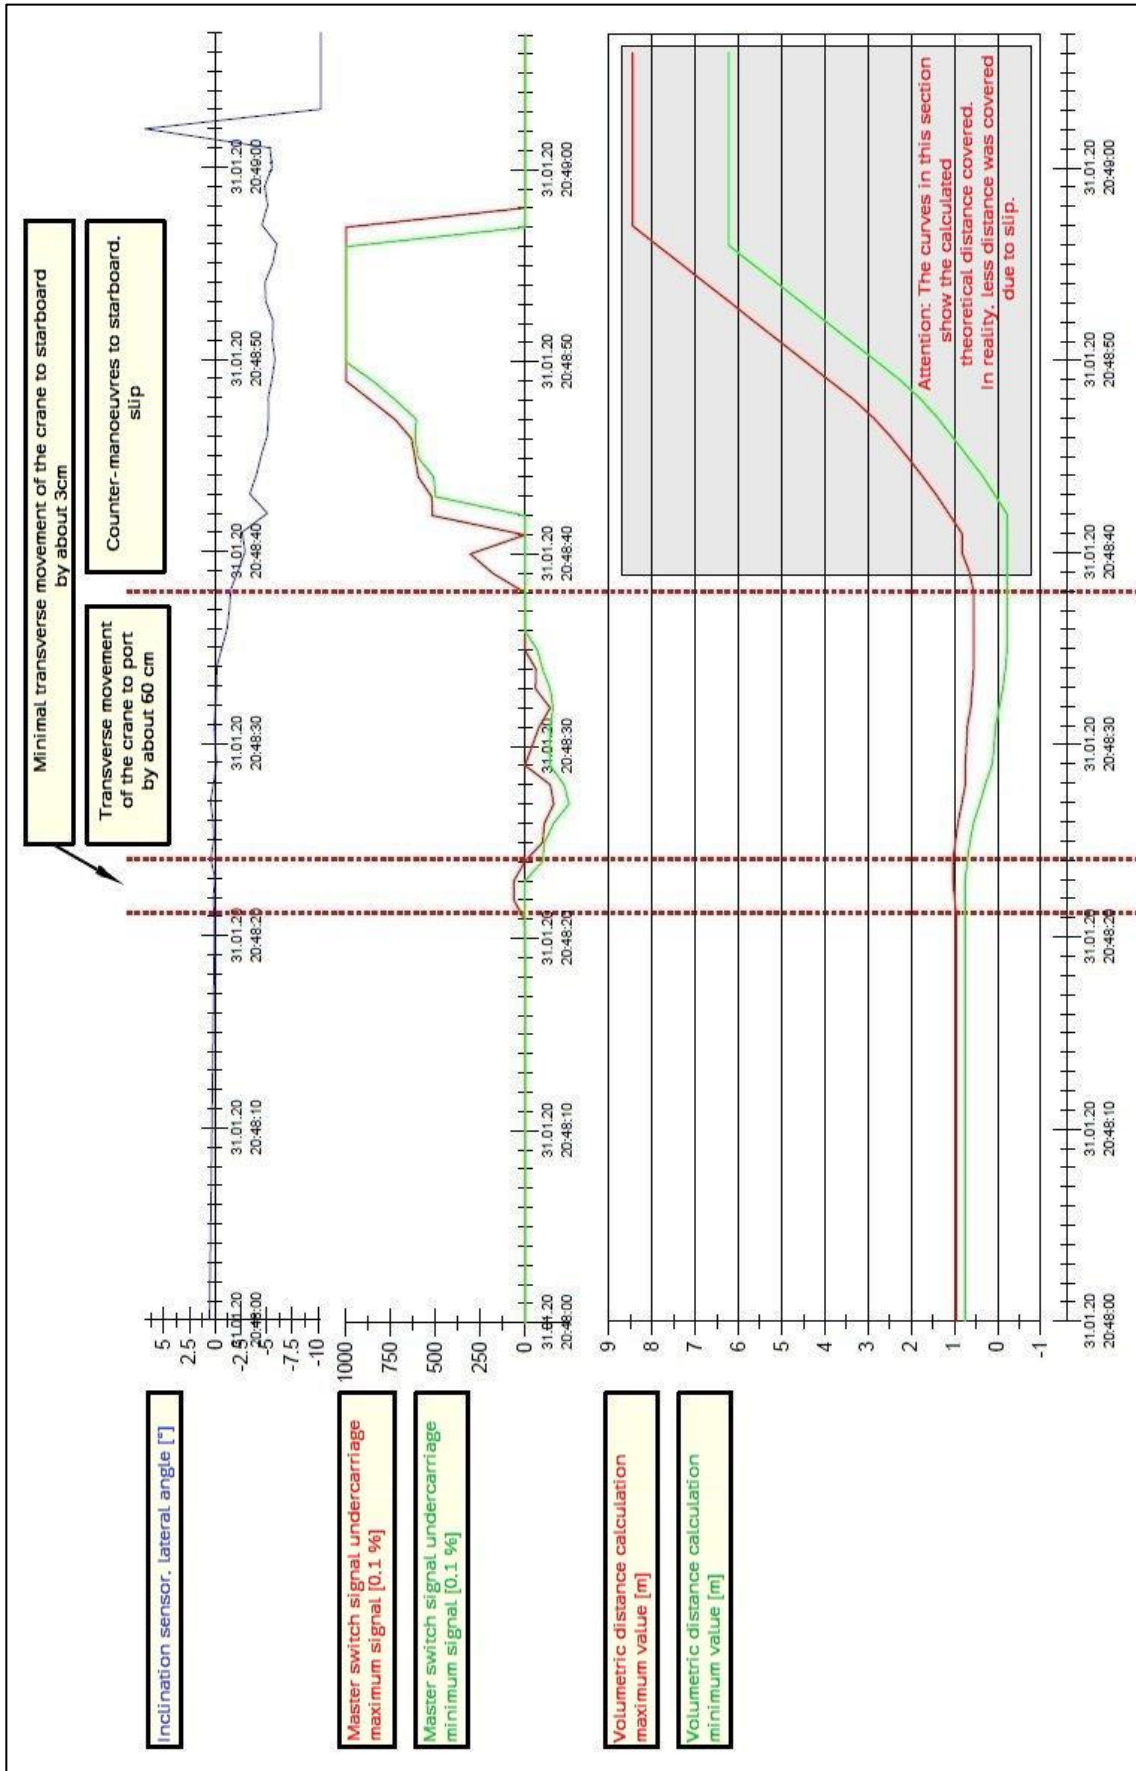
Figure 36: Detail: Inclination, master switch signal, calculated travelled distance

Liebherr also provided the BSU with a comparison of the progressing angle of heel (recorded by crane 2's inclination sensor) and the master switch signal (see upper two curves in Figure 36). Various events up until the accident are inserted here, too.

The third, bottommost curve (or pair of curves) in this figure is the calculated distance travelled by the crane. Among other things, this is based on the hydraulic oil volume flow transferred in a certain period of time and its pumping direction, as well as the circumference of the LHM 550's wheels.

If (as happened at the time of the peak – see Figure 36, master switch signal at the same time) the control lever (master switch) is set to neutral, then the hydraulic pump for driving the motors also stops transferring oil. The hydraulic motors stop due to the resulting pressure build-up on the opposite side of the motors. This counter-pressure adjusts according to the load required to brake or hold the crane.

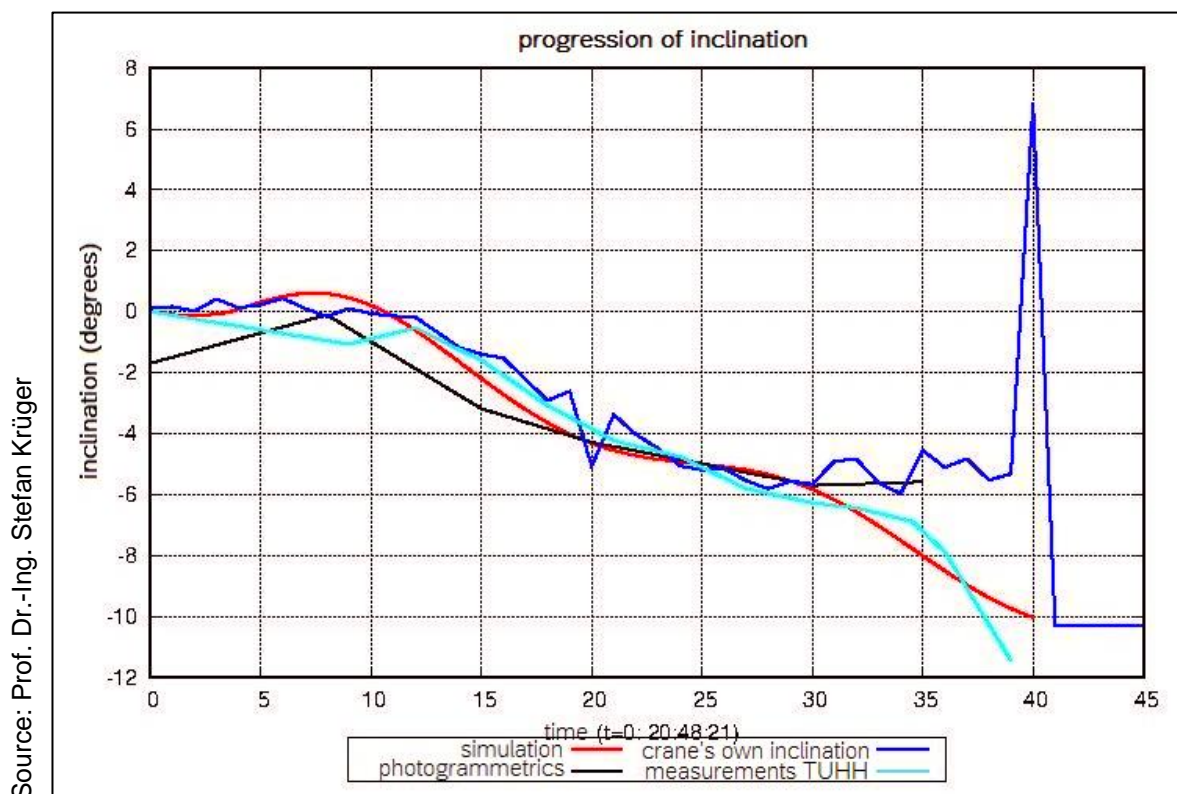
Figure 38: Roll angle over time according to all three measurement methods plus simulation values

At the time of the unsuccessful attempt at a direction change after 18 s (*), the simulation calculated an effective heel angle (static angle plus roll acceleration component) of 3.7°, i.e. 6.5%. This is more than three times the maximum permissible transverse surface inclination of 1.15° specified by the manufacturer (even if a slight increase in this value due to the missing counterweights is considered).

The comparison with the other measurement methods of the JUMBO VISION's heeling curve shows that the simulation (red curve) reflects the rolling behaviour of the ship in the given time segment to a good degree of accuracy (Figure 38). The simulation and readings also confirm that the ship's roll period was indeed closer to the value determined by the TUHH (19.81 s) than that calculated using the IMO weather criterion (17.35 s; see also p. 55).

However, all of these calculations lead to significantly less relevant results²⁹. Compared to the simulation curve shown in Figure 38, either phase and/or amplitude correspond far less to the heeling curve measured by the IPI (Figure 38), or they show almost no influence on it at all. Therefore, these control calculations confirm the assumptions made at the beginning regarding initial stability and crane travel distance, as well as the values shown in Figure 38.
