**Bundesstelle für Seeunfalluntersuchung**  
**Federal Bureau of Maritime Casualty Investigation**  
Federal Higher Authority subordinated to the Federal Ministry  
of Transport and Digital Infrastructure

**Investigation Report 338/19**

**Very Serious Marine Casualty**

**Fire in the engine room on board the  
multi-purpose carrier KELLY  
with one deceased and two injured  
crew members on the River Elbe  
on 6 September 2019**

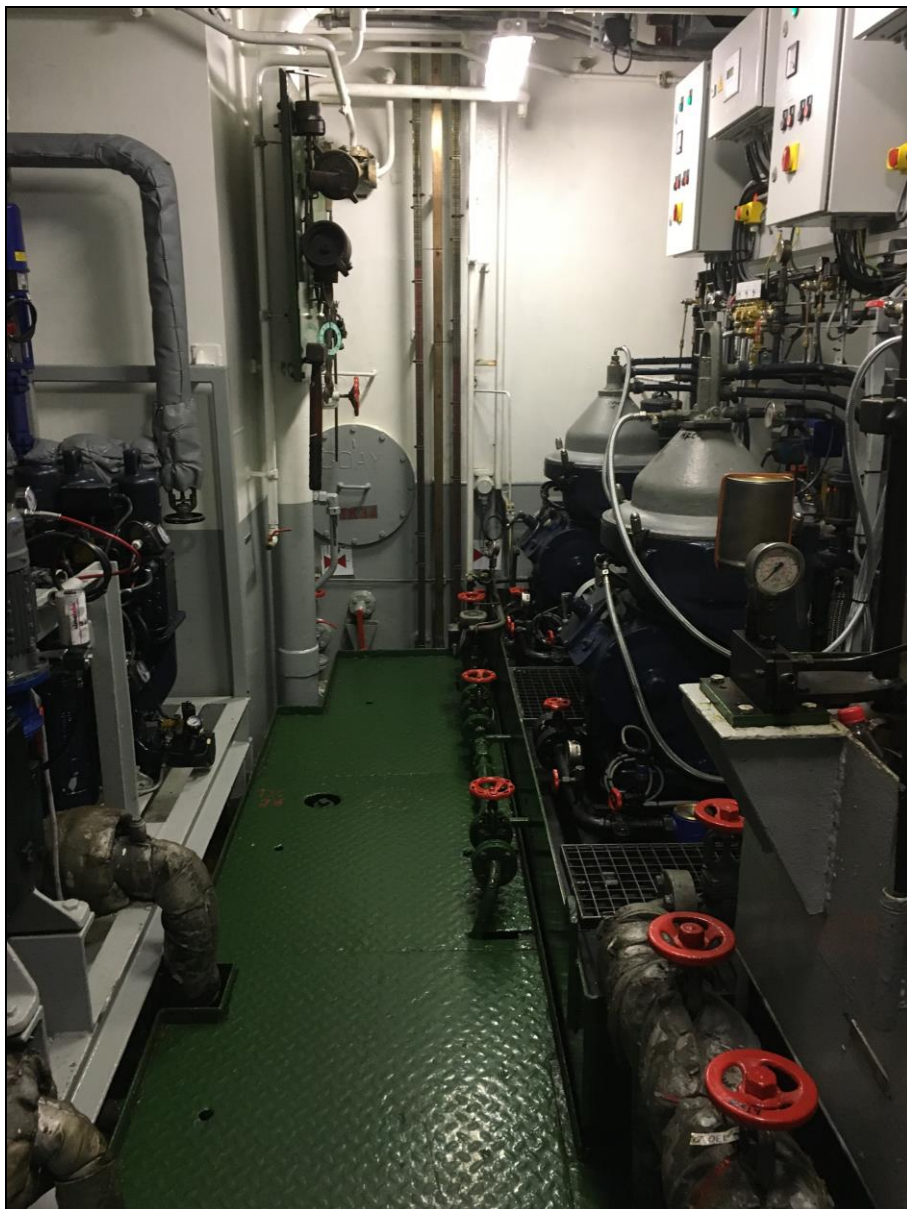
Figure 6: Rear part of the separator room

*Shortly after the motorman was recovered, the firefighting team returned to the separator room. The last casualty was found there, squatting with his back to the wall in the rear of the room (Figures 5 and 6). As far as could be seen, the supply of oxygen via a mask did not prompt any response. Due to his size and weight of about 130 kg, as well as his squatting position, it was not possible for the two rescuers to pull the motorman out of the corner of the room. Consequently, the chief mate, the second officer and the chief engineer were asked to provide assistance. It took an enormous effort for them to move the casualty to the deck, where they immediately tried to resuscitate but were unsuccessful.*

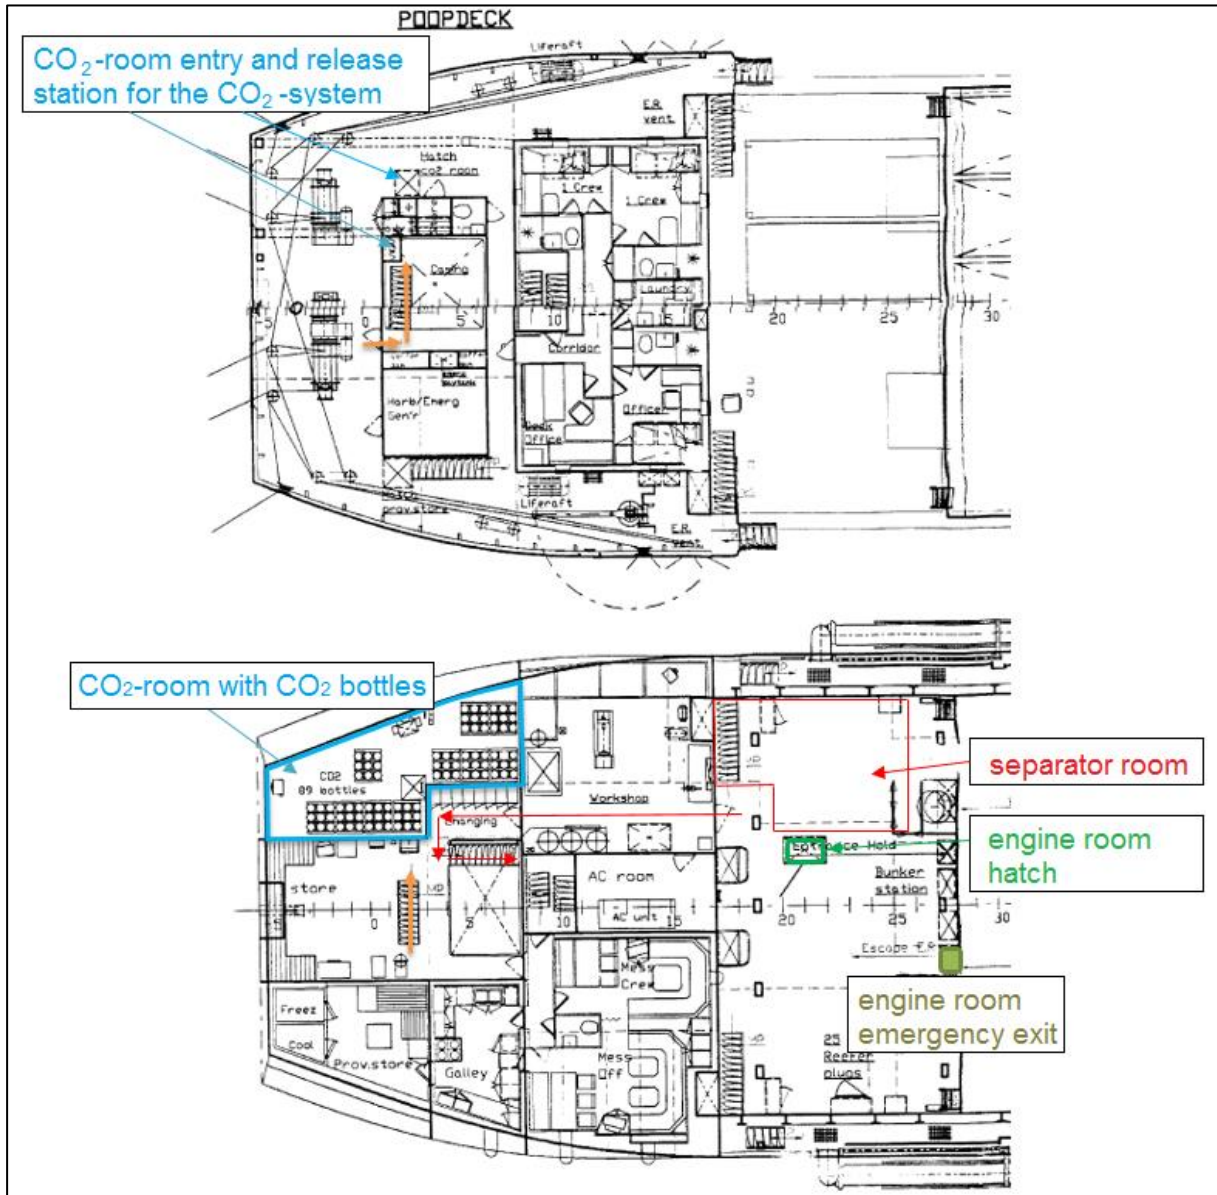
Figure 7: Entrances to the engine room

The engine room has two entrances. One is at the forward edge of the superstructure at main deck level (red arrows in Figure 7) via the workshop. The other is aft of the superstructure on the poop deck<sup>7</sup> (orange arrows in Figure 7). This is marked as a primary escape route on the ship's safety plan.

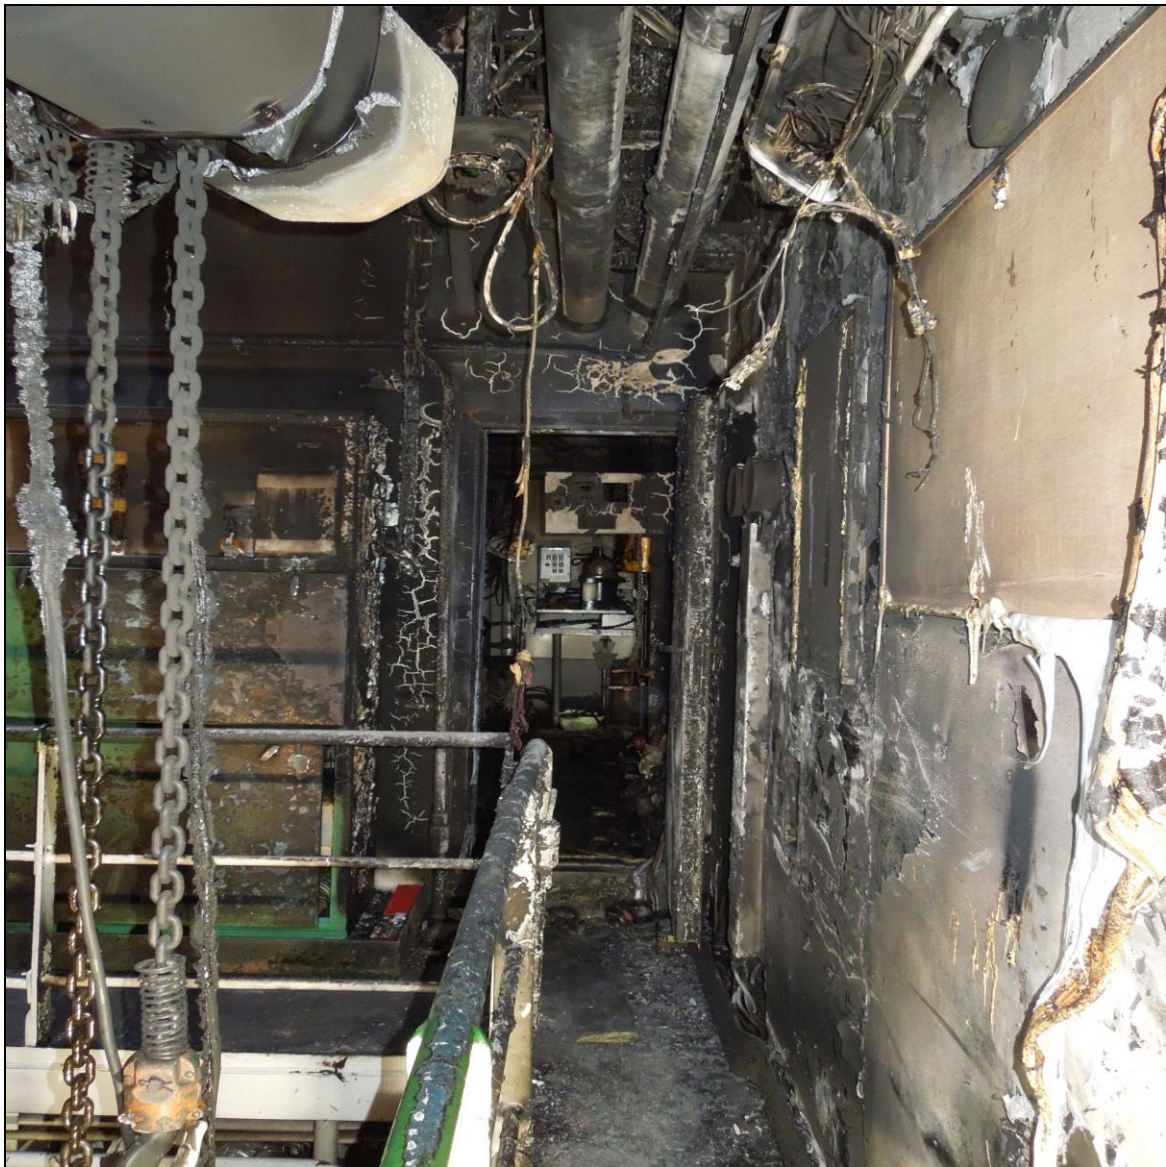
Figure 11: View from the engine control room opposite into the separator room

There was an open control cabinet on the right-hand side of the separator room's entrance area. The mounting height was measured at 1.40 m to the lower edge and 1.80 m to the upper edge. Integrated and attached parts of the cabinet were lying on the floor and in front of as well as behind the passage door. It was not possible to reconstruct whether these parts were hurled out of the room by the explosion or had found their way there as a result of the crew's recovery measures. The components only exhibited traces of fire on one side. They were located on the side facing out of the housing, i.e. the control panel.

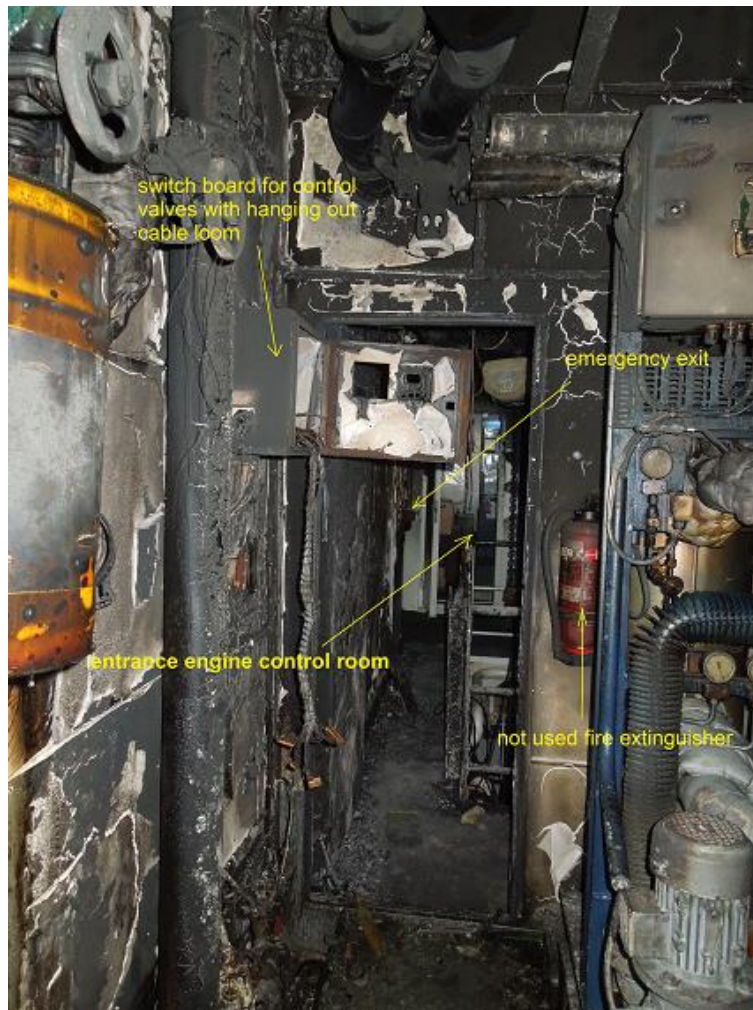
Figure 17: View from the separator room into the engine room  
The entrance to the engine control room can be seen opposite.

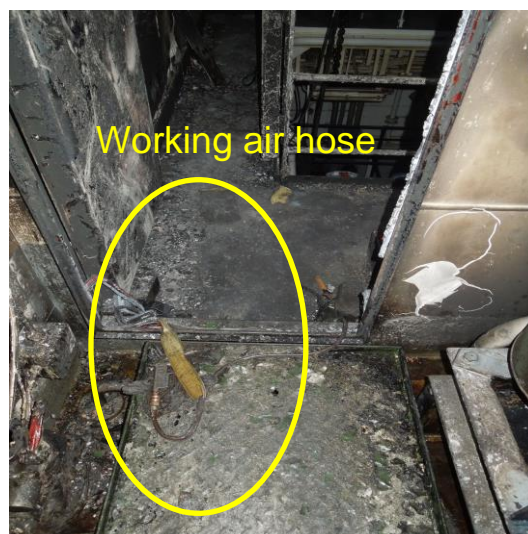
Figure 18: View from the separator room into the engine room  
An air hose that had been used for clearing the dismantled pipe section can be seen lying on the floor.

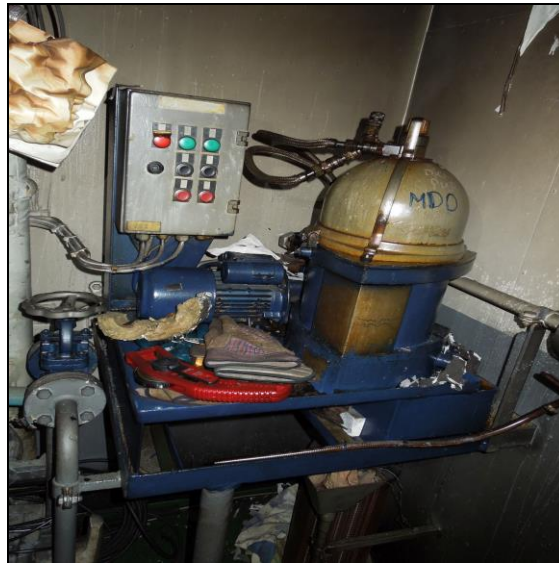
Figure 21: MDO separator (less than 2 m away from the position at which the fire broke out)

Immediately to the left of the scene of the fire was a separator marked MDO<sup>10</sup> standing on a platform. The second engineer stated that this was not in operation.

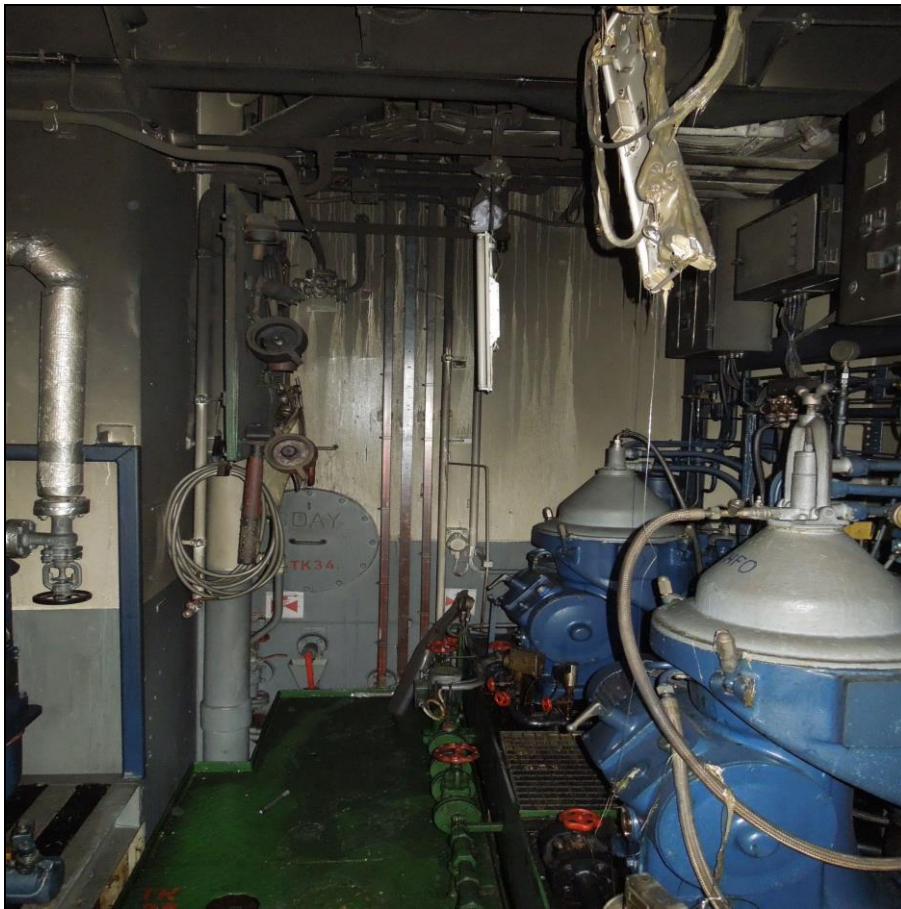
Figure 23: Rear part of the separator room

In summary, with regard to the extent and severity of the damage in the engine room, it is noted that this is localised but in places severe on the forward bulkheads, ceilings, control cabinets and cable bundles, in particular. Other fixtures, such as lamps, have apparently only melted down. Consequently, it can be assumed that the event was rapid but spatially and temporally confined, even though no action was taken to cool down the area or actively contain the fire.
