Bundesstelle für Seeunfalluntersuchung
Federal Bureau of Maritime Casualty Investigation
Federal Higher Authority subordinated to the Federal Ministry
of Transport and Digital Infrastructure

Investigation Report 405/20

**Allision with a quay wall by
the tanker NORTHSEA RATIONAL
in Hamburg
on 25 November 2020**

25 November 2021

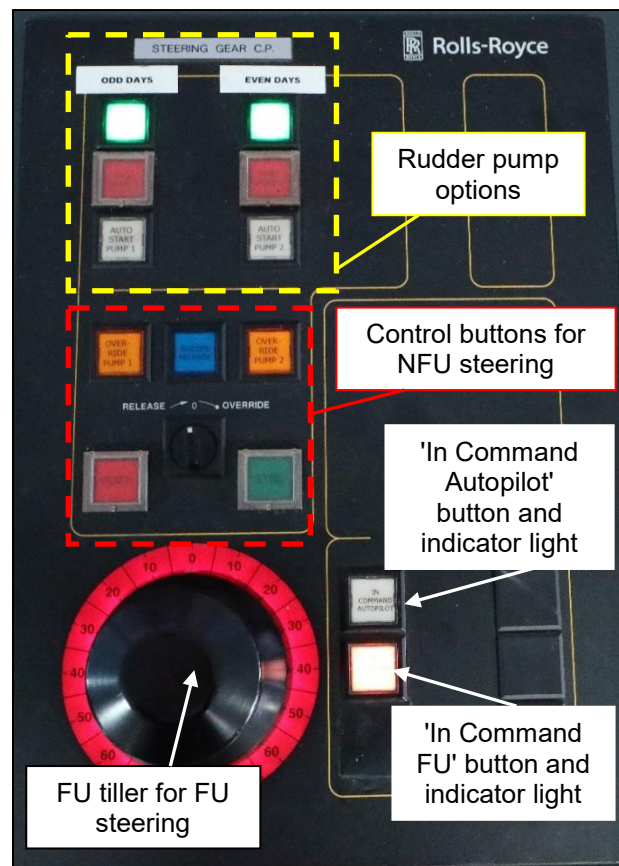
Figure 16: Steering gear control system panel

It was only possible to switch from FU to NFU steering and back on the rudder position control panel in the central console (marked with a red dashed line (---) in Figure 16). FU steering constitutes normal operation. NFU steering is the emergency steering. When NFU steering is switched to, the normal signal path is bypassed. For example, this means that pressing the push-button for starboard directly activates the hydraulic circuit for moving the rudder to starboard. This is also known as the override function.

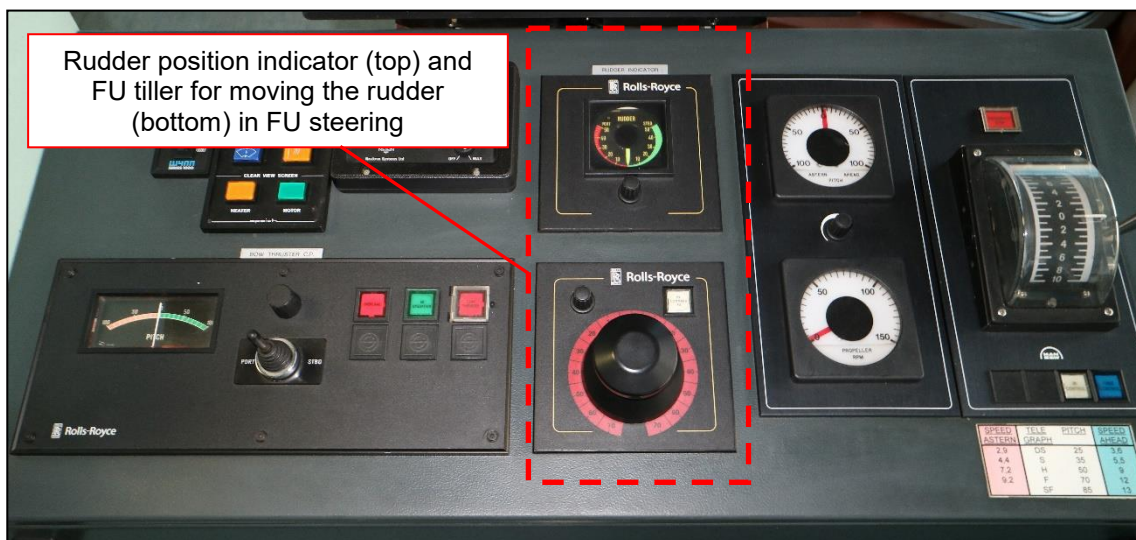
Figure 18: Control position in the starboard wing

Only a small rotary wheel for the FU steering and a display for the rudder position were installed (Figure 18) at the respective control positions in the closed wings.
