Bundesstelle für Seeunfalluntersuchung
Federal Bureau of Maritime Casualty Investigation
Federal Higher Authority subordinated to the Federal Ministry
of Transport and Digital Infrastructure

Investigation Report 452/19

Very Serious Marine Casualty

**Accident with subsequent Loss of Life
on board SAJIR
in the Roadstead off Ningbo (China)
on 19 December 2019**

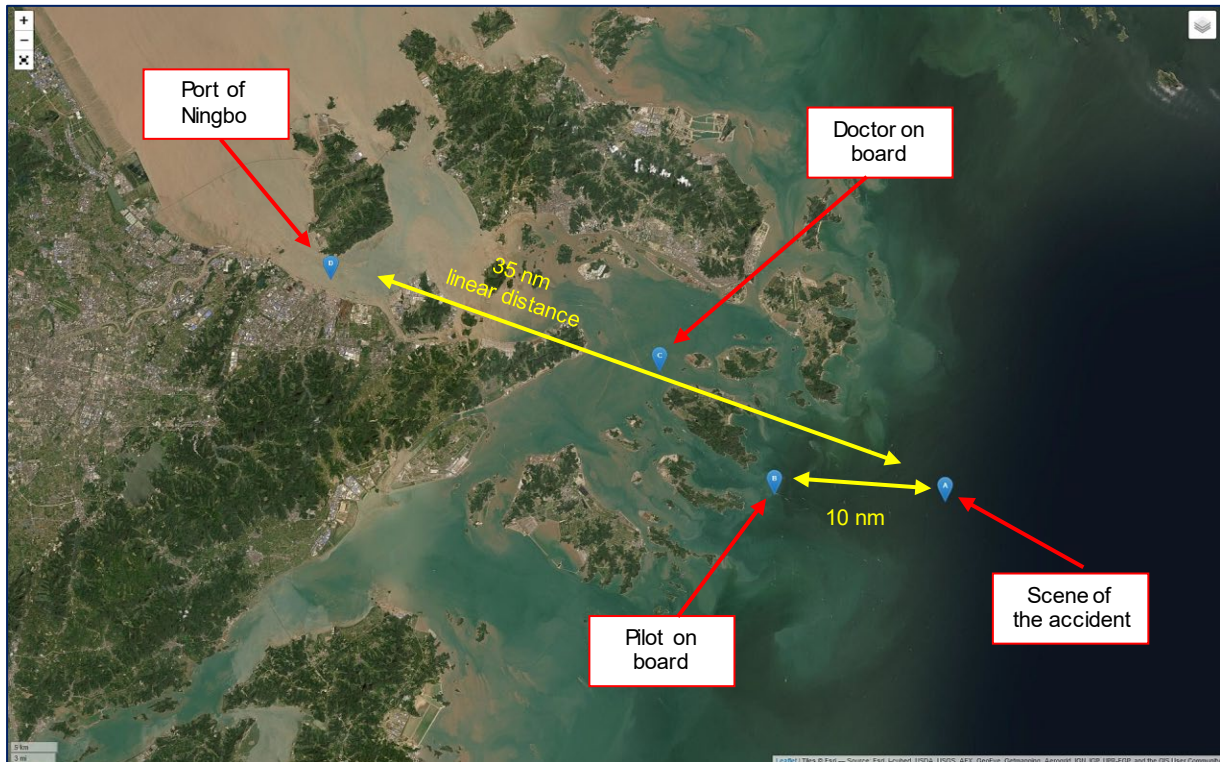
Figure 2: Scene of the Accident and Distances⁷

Type of marine casualty:	Very serious marine casualty – crew member falls from a height into cargo hold with subsequent loss of life
Date, time:	19/12/2019, 1700
Location:	Xiashimen (roadstead off Ningbo)
Latitude/Longitude:	φ 29°44.4'N λ 122°31.5'E
Ship operation and voyage segment:	At anchor in the roadstead
Place on board:	Cargo Hold No. 9
Human factor:	Yes
Consequences:	Death of a crew member

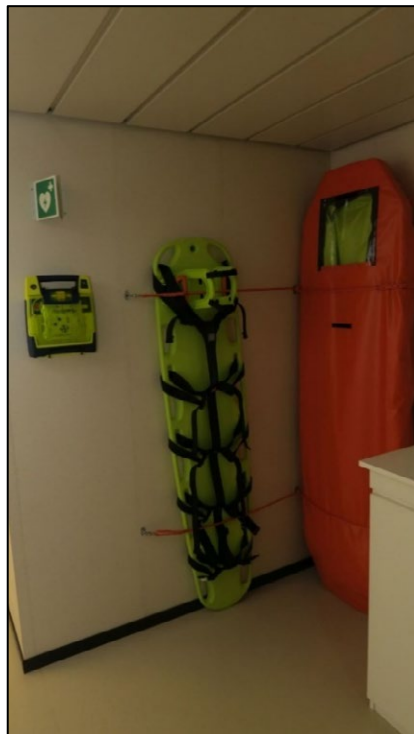
Figure 13: Stretchers in SAJIR's Hospital⁴⁸

Two rescue stretchers were available to the crew – a Ship Safety Division approved stretcher⁴⁷ with integrated vacuum mattress and a spineboard.

Due to the spatial conditions at the accident site and the transport route, the crew decided to use the more handy size spineboard.

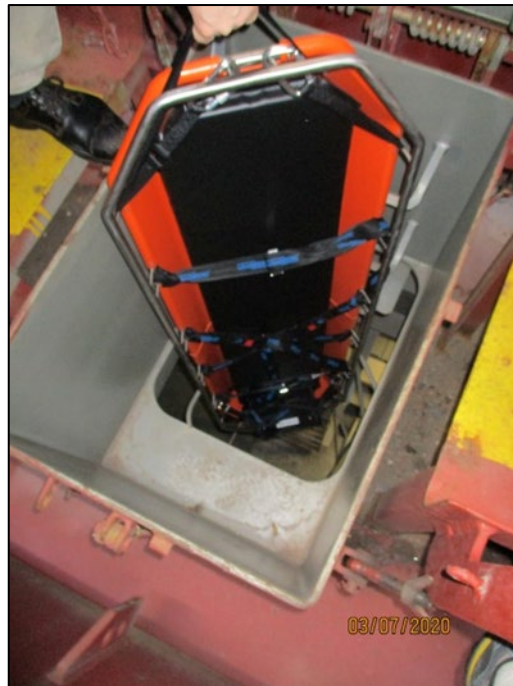
Figure 18: Rescue Stretcher in Hatch Entrance⁵³

The width of the access to cargo hold no. 9 in the upper platform area was 55 cm.

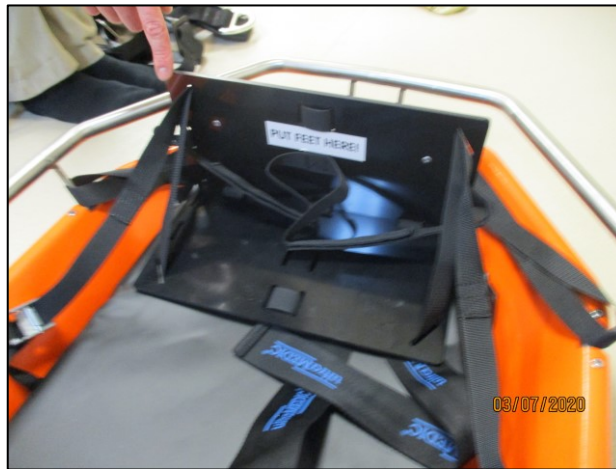
Unlike the spineboard, the approved rescue stretcher has a vacuum mattress and an integrated footrest, allowing people to be transported in a stable position.

Figure 21: Footrest on the Rescue Stretcher⁵⁶

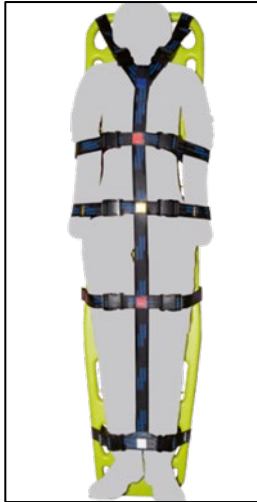
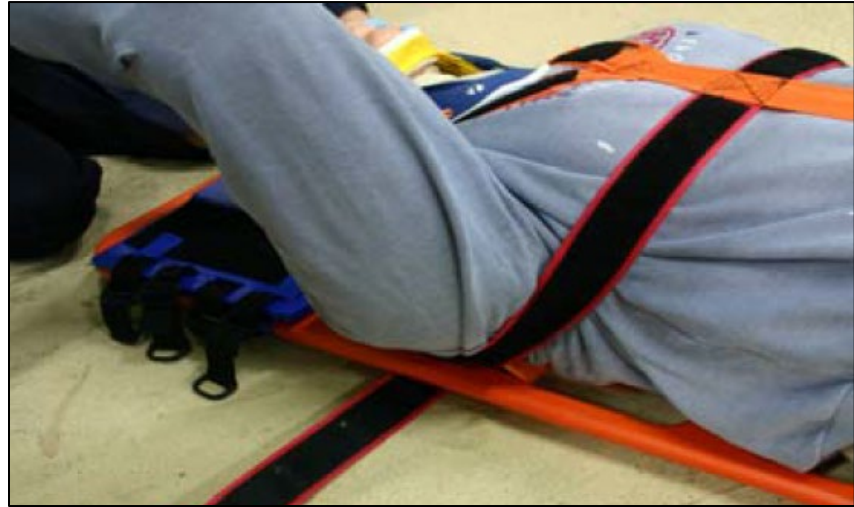
On the spineboard the body can only be secured by the belt system. The manufacturer's instructions for using the belts do not correspond to the recommendations of such organisations as the International Trauma Life Support (ITLS)⁵⁷, which state that the chest strap should be passed under the armpits through the highest accessible handle and secured with Velcro fasteners.
