Investigation Report 74/20

Less Serious Marine Casualty

**Catamaran SEEWIND I suddenly pitches
into a wave in the North Sea
with ensuing physical
injuries and damage
on 3 July 2020**

1 July 2021

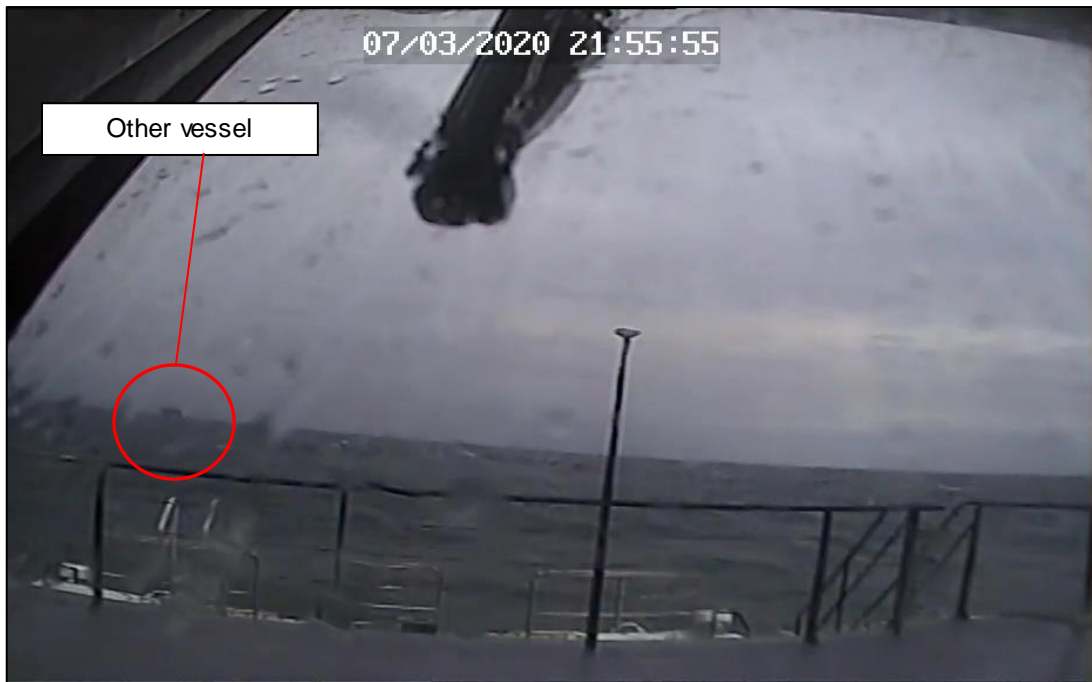
Figure 10: Front camera screenshot at 215555²³

At the start of the recording, another vessel is visible far ahead on the port bow (Figure 10). This vessel moves outside the field of view of the front camera from time to time due to the yawing of the SEEWIND I. However, she always remains in the field of vision of the ship's command.

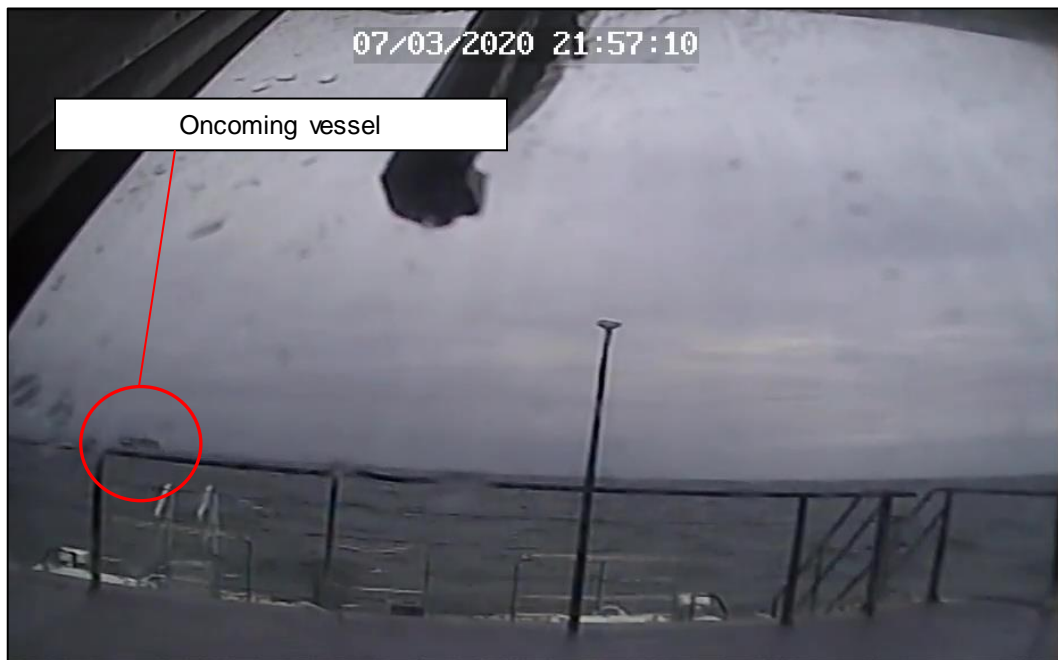
Figure 11: Front camera screenshot at 215710

As this vessel is approached, it later becomes apparent that she is an oncoming large laden container vessel and her superstructure is amidships (Figures 11 and 12).

During the course of the investigation, this vessel was identified as the COSCO PHILIPPINES.

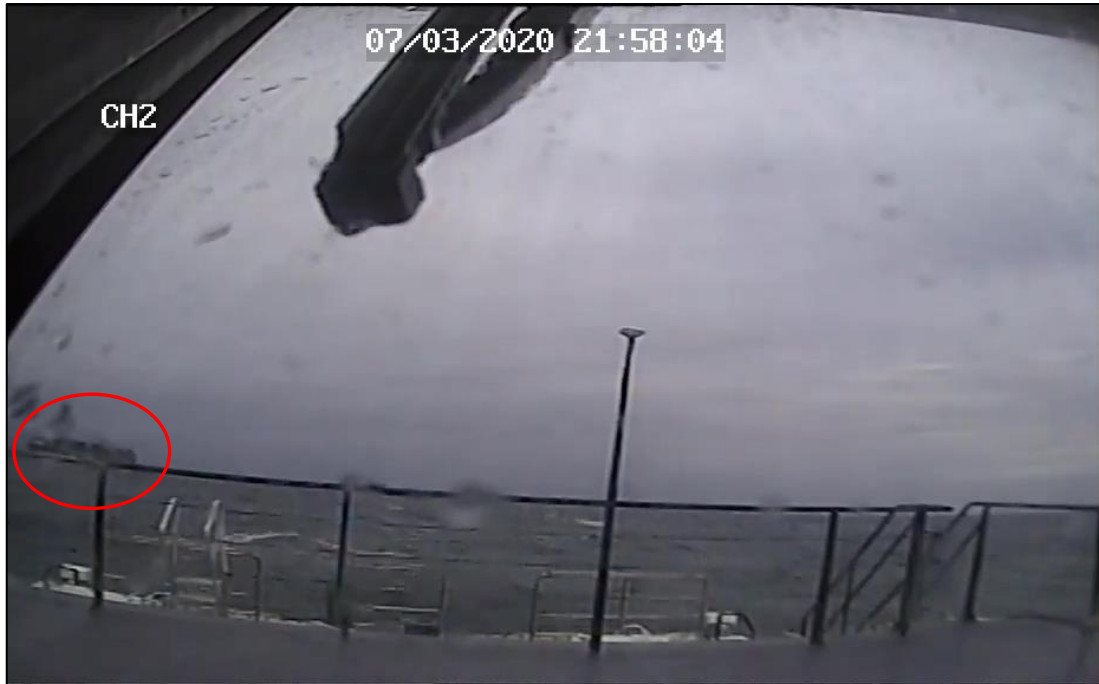
Figure 12: Front camera screenshot at 215802

The oncoming vessel moves outside the camera's field of vision at 215715. She then reappears at a closer distance at 215802. This is due to the course alteration to port carried out by the SEEWIND I in the meantime. After eight seconds, this vessel moves to the left and outside the camera's field of vision again.

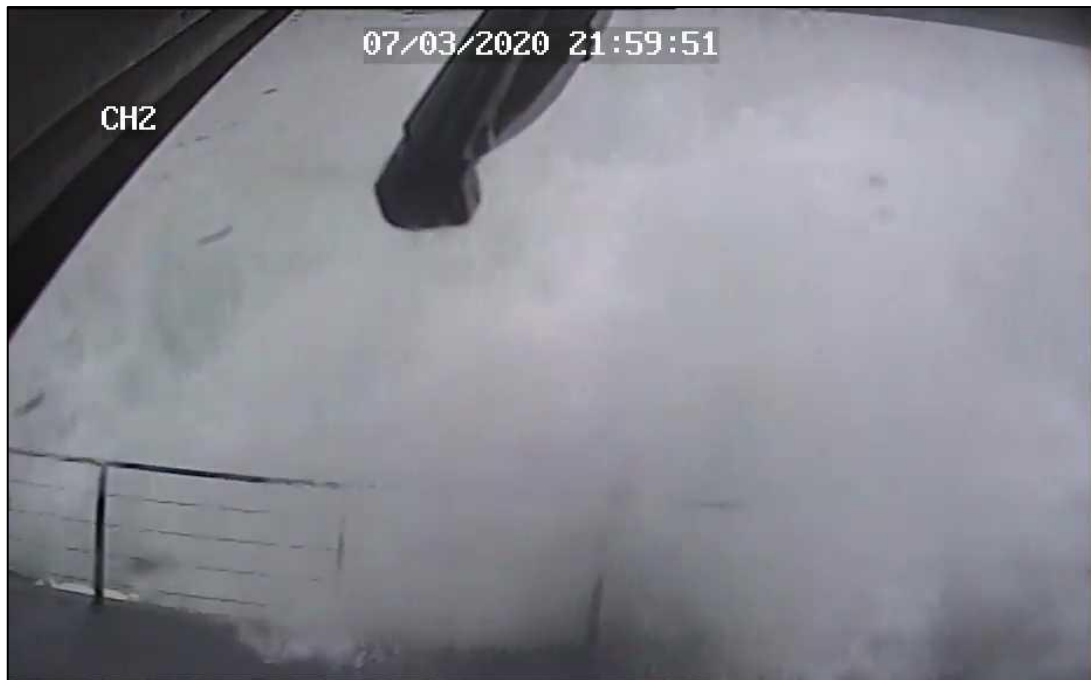
Figure 15: Front camera screenshot at 215952

At 215950, the SEEWIND I entered a wave system that had not occurred previously. This appeared to be longer and steeper. As a result, the bow initially dropped further and had not yet risen again when the vessel sailed into the next wave crest (Figures 13, 14 and 15). The SEEWIND I then sailed into this subsequent wave hard at almost 26 kts and stopped abruptly.

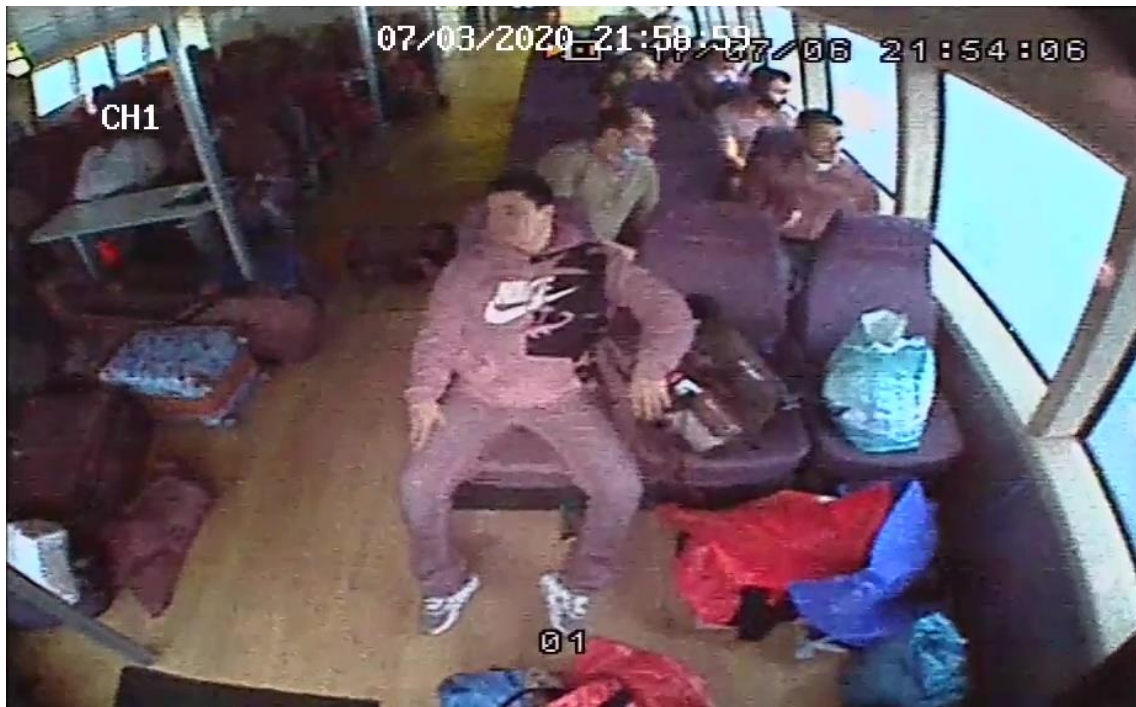
Figure 17: Passenger compartment screenshot at 215859

The total duration of the recording of events in the passenger compartment is one minute and 34 seconds. Figure 17 shows the situation in the passenger compartment shortly before the vessel pitched. The passenger in the first row in the centre of the image is not wearing a seat belt. Several pieces of luggage are located on and below the seats and in the forward area of the passenger compartment.

Situation in the passenger compartment before the accident

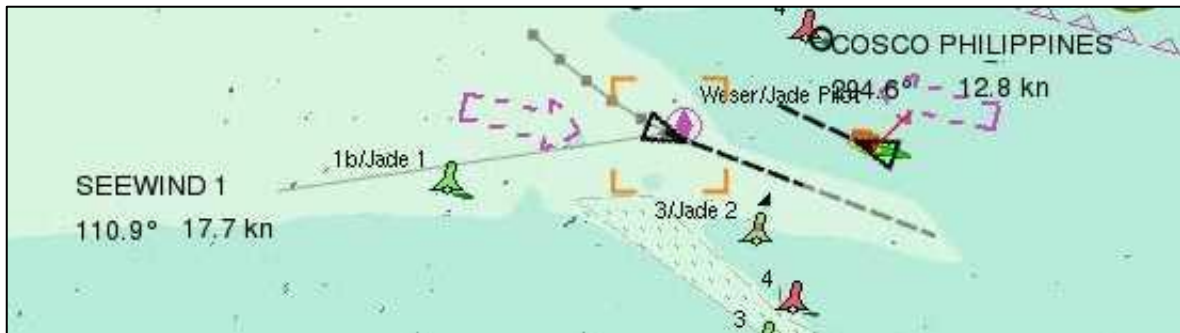
Figure 24: Screenshot at 215500

Course alteration to port toward the COSCO PHILIPPINES and the Weser fairway completed.

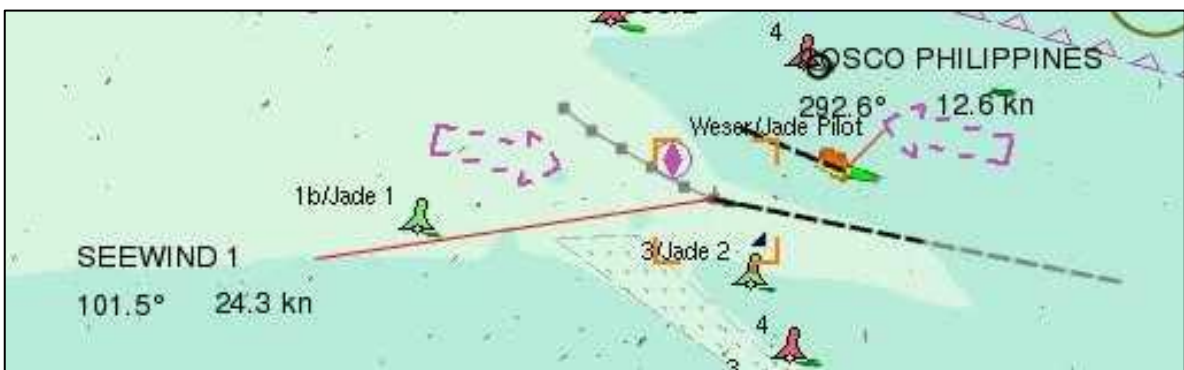
Figure 25: Screenshot at 215600

Further course alteration to port to follow the fairway.

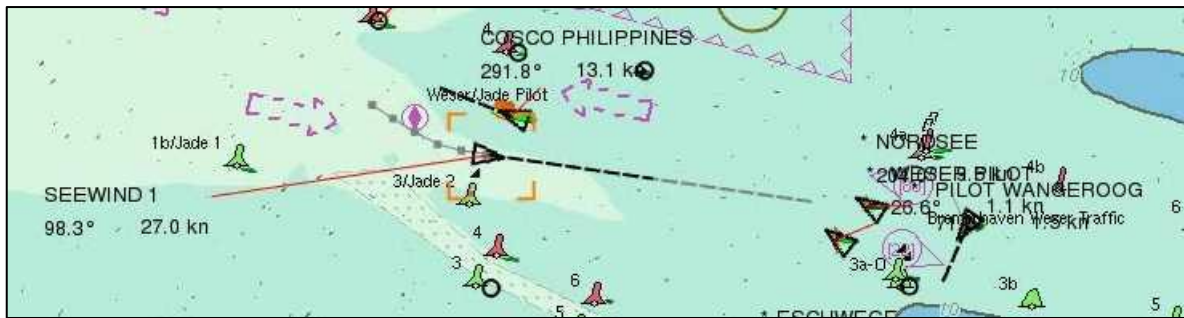
Figure 26: Screenshot at 215700

The closest point of approach (CPA) between the vessels is about 4 cbl.

The investigators consider it likely that the COSCO PHILIPPINES last appeared in the field of vision of the SEEWIND 1's front camera at between 2156 and 2157 (Figures 25 and 26 – see Figure 12; time on front camera: 215802). This would result in a time lag of at least one minute between the time superimposed on the front camera image and the time of the AIS data playback. Since no other references are available, this cannot be resolved further. The time of the AIS display is used for the time of the accident.

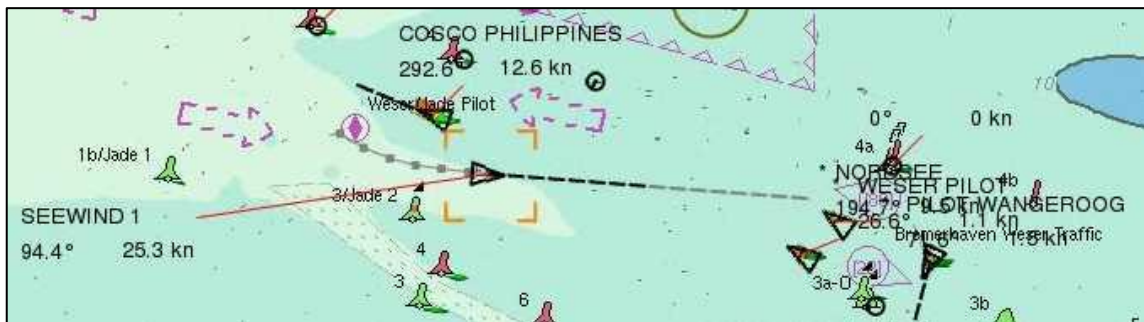
Figure 27: Screenshot at 215800

Further course alteration to port. This may be to increase the CPA to the group of vessels near buoy 3a.

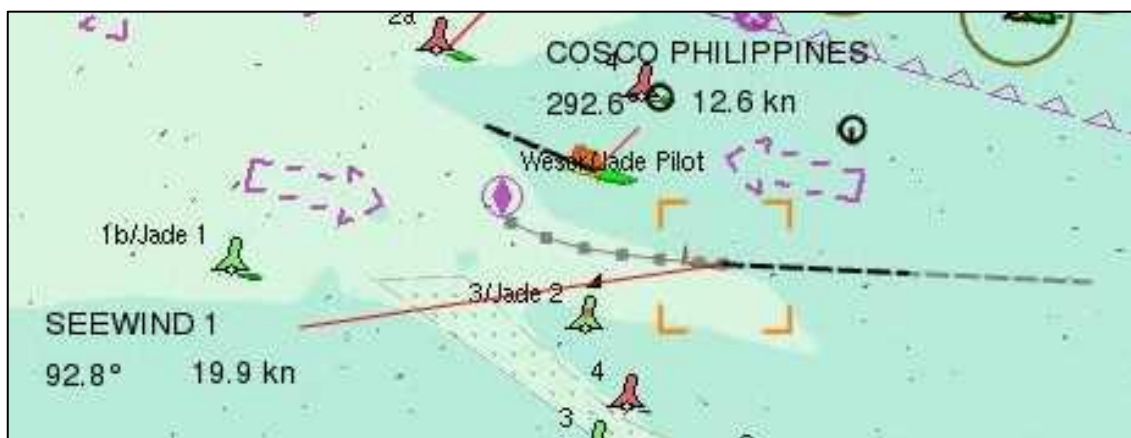
Figure 28: Screenshot at 215829

As can be seen in this Figure, the SEEWIND I's speed begins to drop at 215829 at the latest. The investigators attribute the fact that the speed does not drop immediately to the linearity of the speed measurement and smoothing of the values possibly used in the GPS system (Figures 29 and 30). It is also likely that the SEEWIND I continued to move due to the incoming tidal current and the wind. The BSU investigators assume that the accident thus occurred between 215800 and 215829.

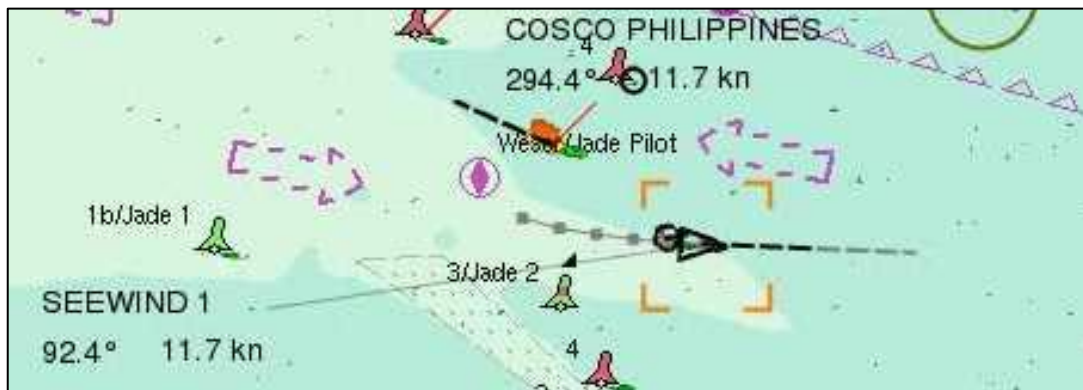
Figure 29: Screenshot at 215900

The speed continues to drop.

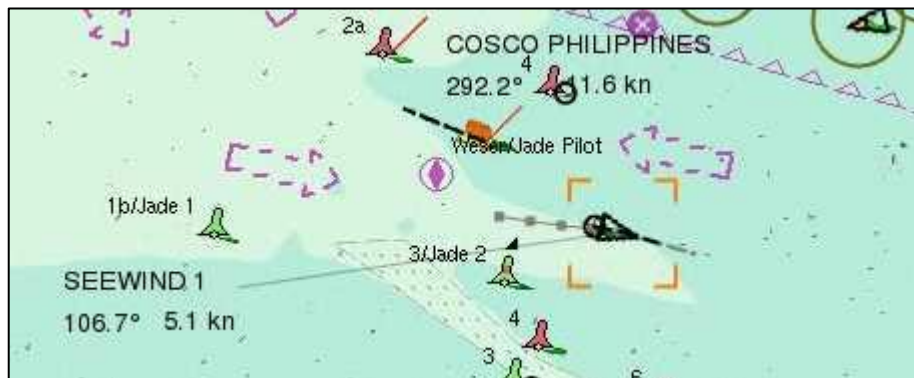
Figure 30: Screenshot at 215930

It can be seen subsequently in the replay that the SEEWIND I continued her voyage toward Bremerhaven at around 2201 (time of the AIS display; no image).
