**Bundesstelle für Seeunfalluntersuchung**  
Federal Bureau of Maritime Casualty Investigation

## **Interim Investigation Report**

**Very Serious Marine Casualty 301/21**

**Foundering of the fishing vessel RAMONA in the  
Elbe estuary on 21 September 2021**

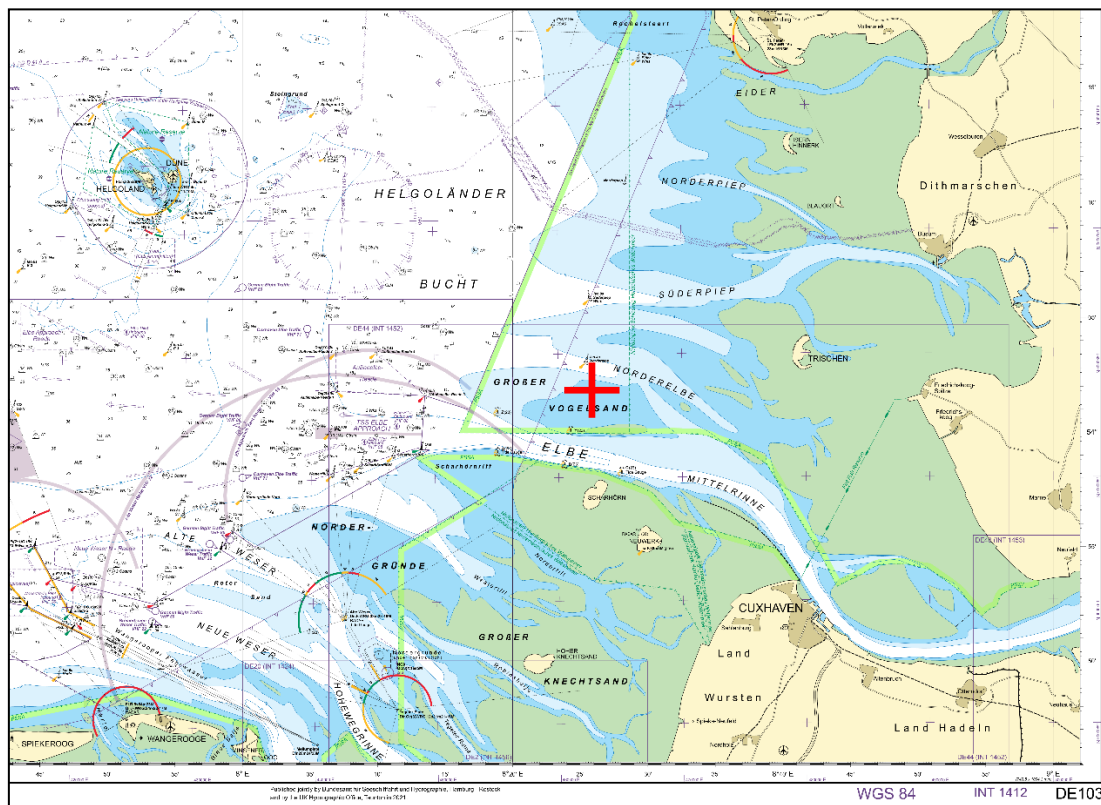
Figure 2: Scene of the accident

Type of marine casualty: Very serious marine casualty;  
Foundering due to water ingress  
Date/Time: 21.September 2021 at about 0921, master reported  
water ingress to the VTS  
21 September 2021 at about 1026 foundered  
Location: North of light buoy.8, Großer Vogelsand  
Latitude/Longitude:  $\varphi$  54°01,3'N  $\lambda$  008°26,3'E (scene of the foundering)  
Voyage segment: Sailing (Interruption of fishing operations)  
Place on board: Bow  
Consequences: Foundering of the fishing vessel, nobody injured,  
environmental pollution by operating fluids  
(especially diesel fuel)

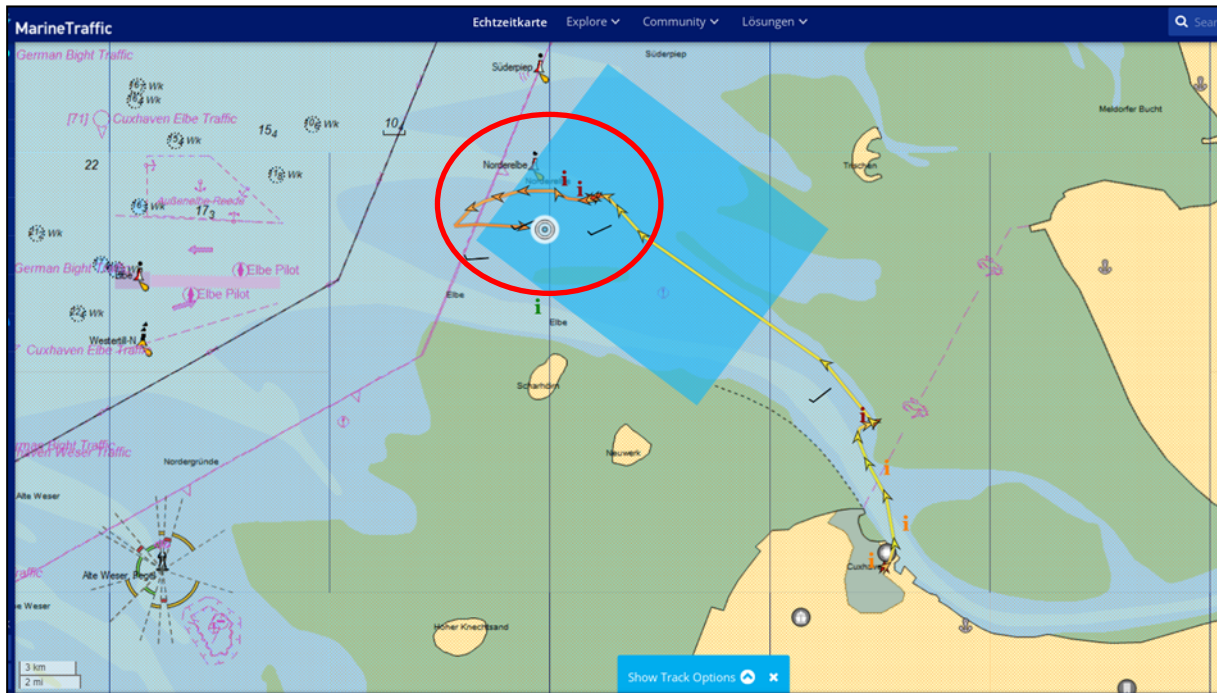
Figure 4: Course of the voyage of the RAMONA and the scene of the accident<sup>6</sup>

The following figure 4 shows the course of the voyage of the fishing vessel, recorded by the AIS-Portal Marinetraffic. The voyage starts in the morning at about 0530 by leaving the port of Cuxhaven and ends with the last AIS-Signal at 1008. The rescue cruiser ANNELIESE KRAMER confirmed the complete foundering of the fishing vessel RAMONA at 1026.
