Bundesstelle für Seeunfalluntersuchung
Federal Bureau of Maritime Casualty Investigation

Investigation Report 103/21

Very Serious Marine Casualty

**Personnel Accident with Subsequent Loss of Life
on board the Container Ship SEOUL EXPRESS
at Sea between Manzanillo and Long Beach
on 27 March 2021**

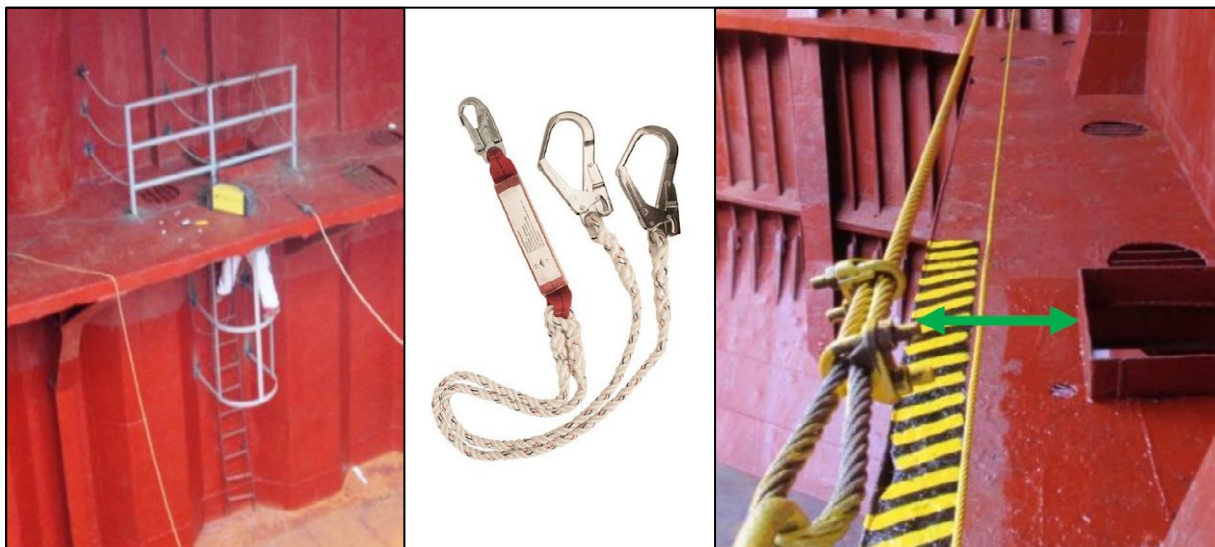
Figure 6: Measures and Equipment to Prevent a Fall²⁷

Left: New railings at ladder access point and new safety cage on the actual ladder
Middle: Energy absorber for attachment to the safety harness with two safety hooks
Right: Yellow and black markings and newly attached steel wire ropes

- installation of a system for fastening safety belts;
- installation of warning and signal markings;
- replacement of ladders and installation of handrails and safety cages (see Figure 6);
- safety briefings and drills for the crew;
- publication of internal safety circulars, and
- revision of the SMM and classification of descents in a cargo hold via vertical ladders as hazardous work.

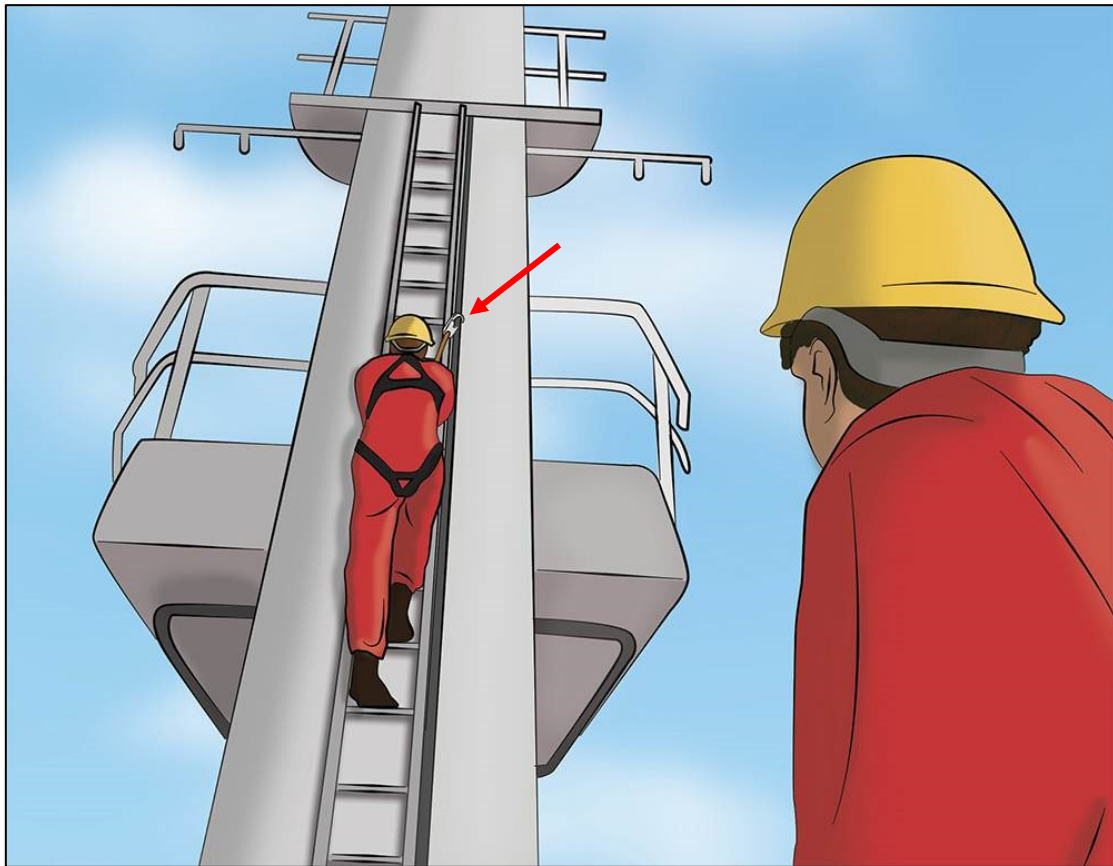
Figure 16: Wearing PPEaF when Using a Climbing Ladder¹⁰⁰

From the point of view of the BG Verkehr (Prevention Division), the mere use of long vertical ladders (without carrying out works on or near the ladder) is not classified as dangerous work. Although the Seafarer's Compendium contains illustrations of people wearing PPEaF while using a long vertical ladder (see Figure 16), it is not explicitly required for this activity in any section of the Compendium.

The person in the image is using a guided-type fall arrester on the ladder's right-hand side (red arrow).
