Bundesstelle für Seeunfalluntersuchung
Federal Bureau of Maritime Casualty Investigation

Investigation Report 117/20

**Collision between the coastal motor vessel
SCHELDEBANK and Kiel Canal (NOK) ferry
HOCHDONN on 8 May 2020**

9 May 2022

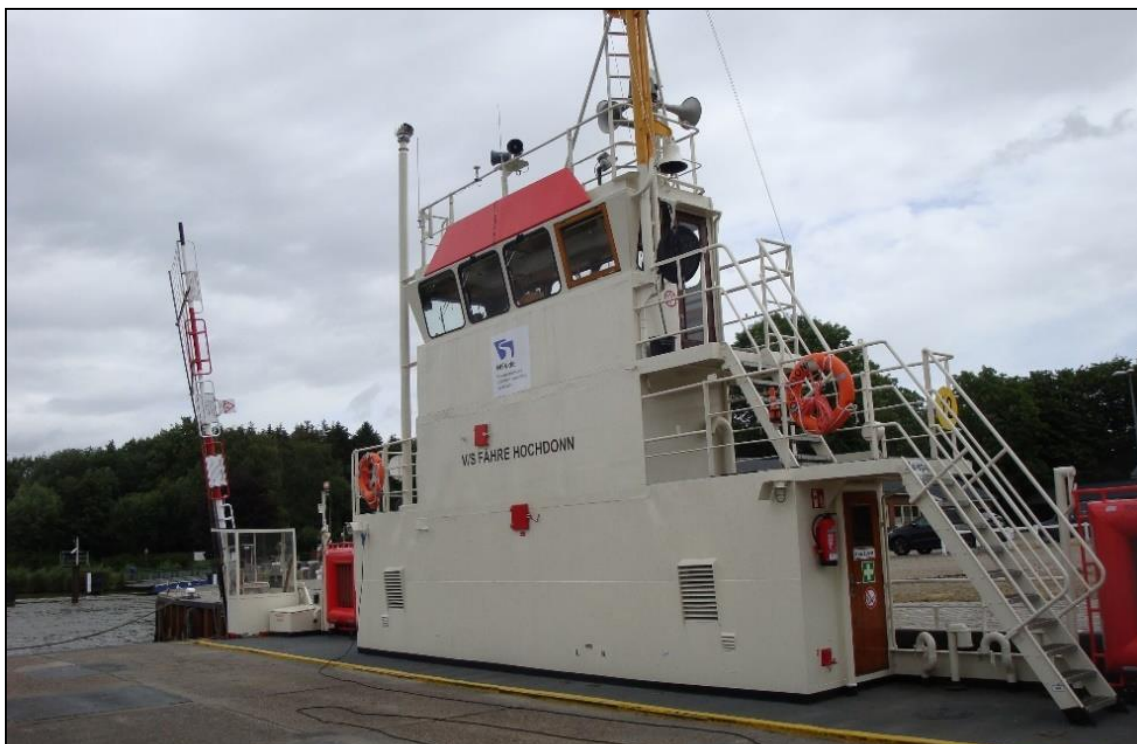
Figure 9: Side deck superstructure with bridge operator stand

Over the decades, the three above ferries have been modernised in terms of navigational equipment and technically. For example, the side control position (see **Figure 9**) has been raised so that the ferry pilot can still look over the vehicles that have 'grown' in height over the years. Nevertheless, bridge ergonomics and general comfort (e.g. with regard to heating, air conditioning, windows, insulation, visibility) no longer meet today's standards.

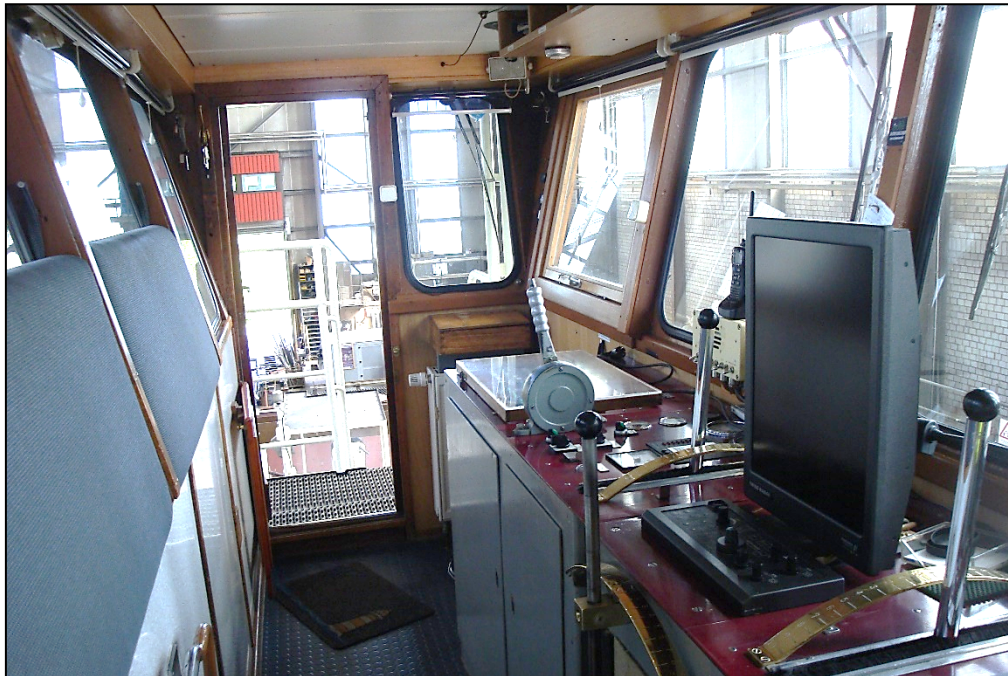
Figure 10: Control position on the HOCHDONN with lever control (view towards the bridge door)

The control/operation of the ferries, which are equipped with two Voith Schneider propellers for redundancy reasons and are very easy to manoeuvre, is carried out via so-called levers, which is why these ferries are also referred to internally as 'lever ferries' (see **Figure 10**).²⁵

Depending on the time of day, the ferry pilot works alone in the extremely narrow bridge operator stand during his seven- or ten-hour shift (see **Figures 10 f.**). He stands (or sits temporarily on a folding seat – see red dashed outline in **Figure 11**) while steering the ferry. Since the console with the various controls, the VHF radio, the radar screen and the AIS display also runs in the longitudinal direction of the vessel, the ferry pilot must turn his gaze, which is normally directed at the vehicle deck or in the longitudinal direction of the NOK, 90 degrees to the left or right in order to visually 'aim' for the respective berthing position. This, in turn, is an essential part of executing the berthing manoeuvre. There is no technical assistance in this regard (in the sense of automatic/semi-automatic guidance or a graphic display).

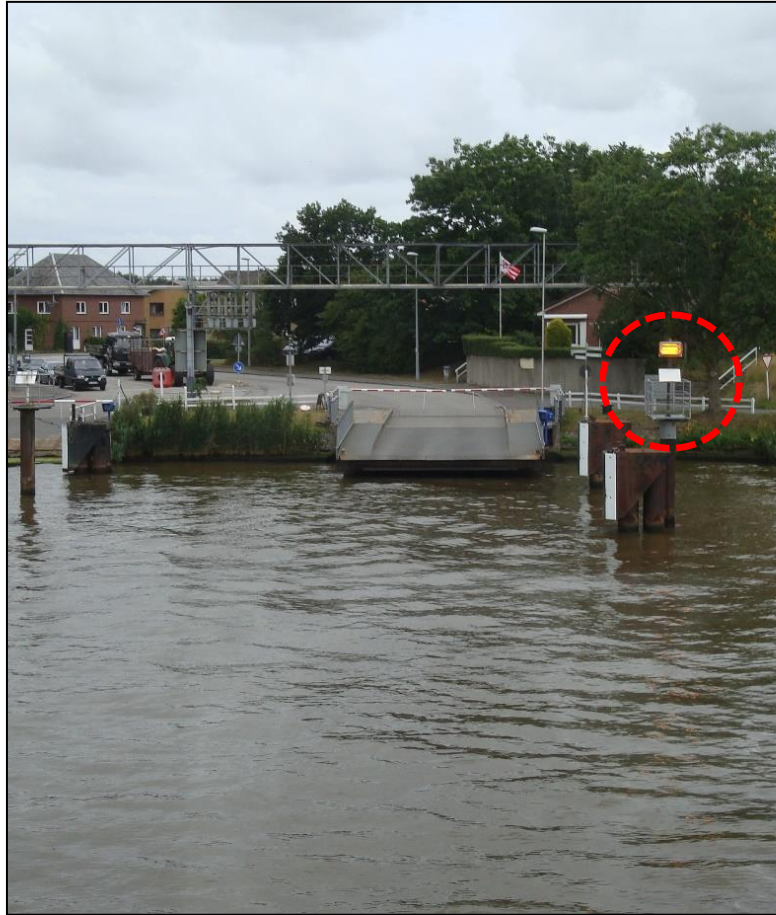
Figure 12: The northern ferry terminal at Hochdonn (fog light switched on)

In adverse visibility conditions, the ferry pilot has the option of using a special searchlight mounted at the ferry terminal (the so-called fog light) for guidance when approaching the ferry terminal (see **Figure 12** below). However, the light in question is not switched on remotely from the control position, but rather by the deckhand using a switch at the respective ferry terminal, i.e. when the ferry has made fast there. This means that the light at each ferry terminal must be switched on in good time when visibility begins to deteriorate so as to be able to use the guidance function during the next berthing manoeuvre.

When speaking with the investigators, the HOCHDONN's ferry pilot commented critically on the fact that under certain circumstances the lights have a dazzling effect, which may impair their guidance function.

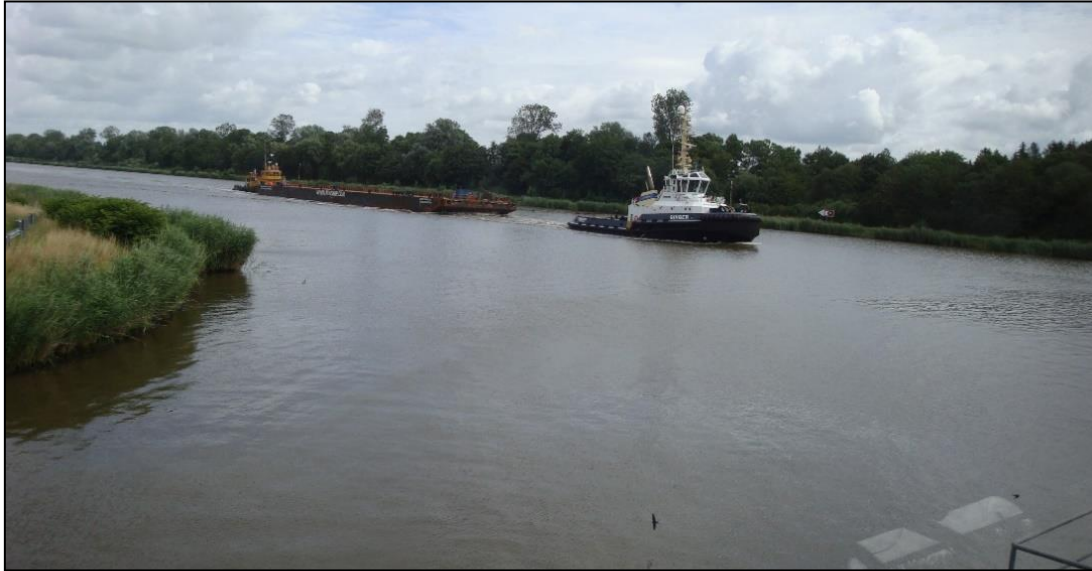
Figure 13: View of a tow approaching from the east from one of the rear windows on the AUDORF's bridge

Moreover, the atypical situation that there is only one bridge/operator console at the control position, notably, one configured in the longitudinal direction, means that regardless of the ferry's direction of travel, the ferry pilot actually has to change his gaze by 180 degrees (i.e. turn away from the bridge console completely) if he wants to observe the traffic approaching the ferry from the east instead of from the west (i.e. from the direction of the railway bridge), which is in his usual line of sight.

The following images, which were taken when the investigation team travelled on her sister ferry (the AUDORF) after the accident, illustrate this problem. The AUDORF was situated at the northern ferry terminal when the images were taken. The ferry pilot was waiting for the passage of a westbound tow. To be able to see the tow approaching 'behind his back' from the east, he was forced to turn around and look out from one of the rear windows of the bridge operator stand (**Figure 13**). He could then turn back to his control position after the tow had passed and thus look back towards the railway bridge, i.e. to the west (**Figure 14**).

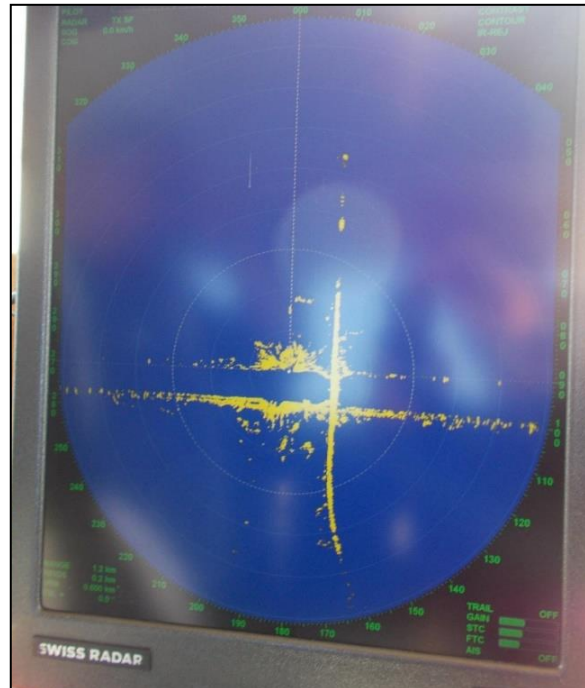
Figure 17: TFT monitor³⁴

It should be noted that the radar image above in **Figure 17** was taken shortly after the accident when the HOCHDONN had been taken out of service and moored alongside at a pier near the southern ferry terminal. The radar image orientation corresponded with the setting used by ferry pilots in shuttle service. It is a modified head up display, where head up refers to the ferry pilot's forward viewing direction when standing at the control position, rather than the direction of travel as is normally the case. Accordingly, the view ahead from the control position of the ferry, which was moored alongside, was directed towards the canal's southern bank; therefore, in **Figure 17** it is at right angles to the apparent ahead direction and the railway bridge to the west is parallel to the line of vision.

Ferry pilots use the 1.2 km range with range markers displayed at an interval of 0.2 km as the default setting. This setting was reportedly also selected on the day of the accident. Reportedly, a variable range marker with a radius of 0.6 km was also set (see **Figure 17** above).

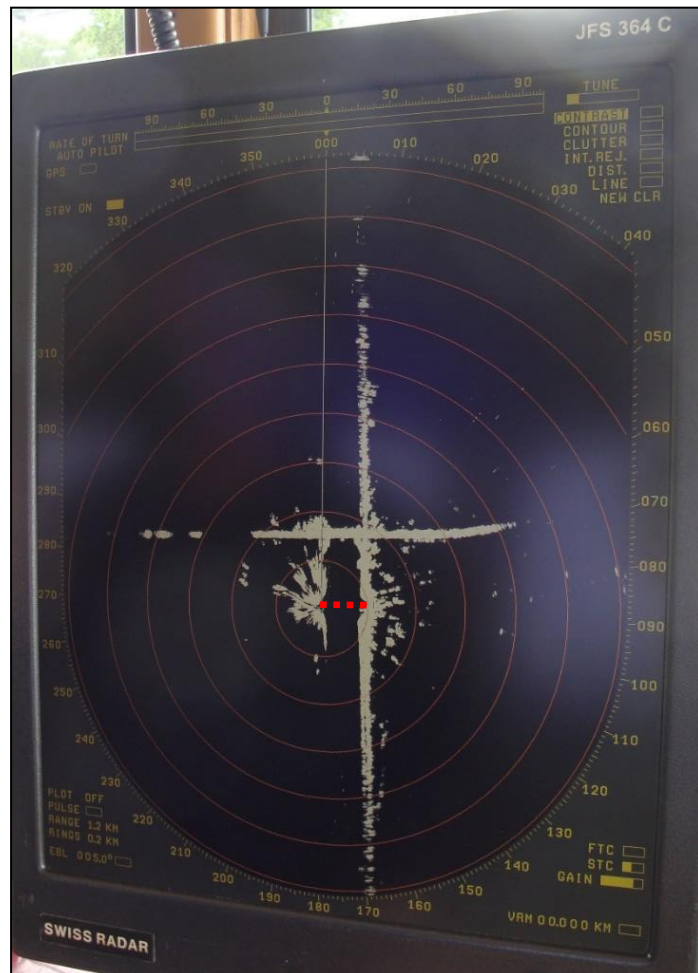
Figure 19: Radar image (the AUDORF), range = 1.2 km³⁶

In contrast, regardless of whether the ferry is travelling from north to south or from south to north, the ferry pilot's view ahead is of the railway bridge when she is in regular shuttle service, while the respective canal banks are abeam of the radar's apparent forward direction. In **Figure 19** below, which was taken on the AUDORF's control position during a regular shuttle crossing on the NOK, the modified head up image (logically) implies that the railway bridge in the radar image runs at right angles to the ferry's apparent ahead direction and parallel to her actual course (= red dashed outline in **Figure 19**).

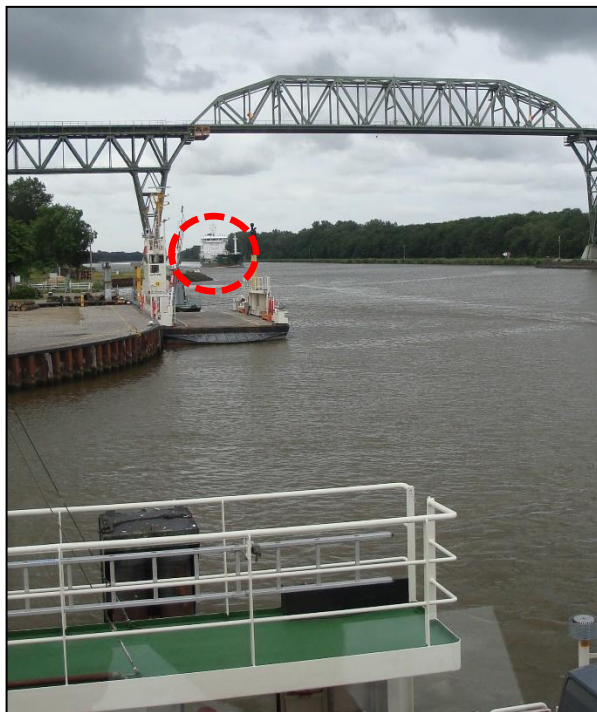
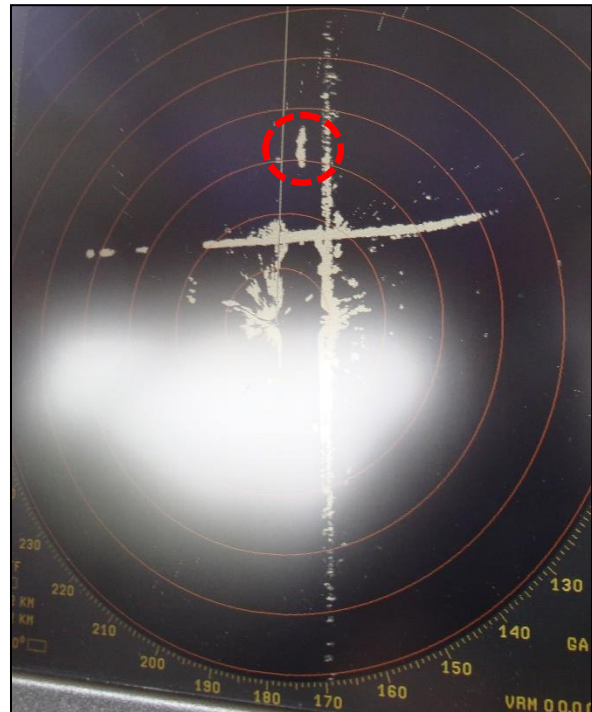
In the below images (**Figures 20 f.**), the AUDORF was situated at the southern ferry terminal. The images show a chemical tanker (length: 119 m) approaching the railway bridge as a photograph and next to that as a screenshot of the radar image (in the above default setting) eight seconds later. In the ahead direction (i.e. in relation to the ferry pilot's view straight ahead, or west of the ferry line), the echo of the railway bridge crossing the canal is clearly recognisable in the radar image section as a horizontal bar crossing the radar heading line. The tanker, having just reached the 0.6 km range marker, is clearly indicated as an echo even at this rather unfavourable 'viewing angle' of the radar antenna, i.e. in spite of the interference caused by the canal bank running parallel to the radar's visual beam. The bridge situated between the ferry and the tanker has no adverse effect on the visibility of the vessel approaching the ferry line. The tanker passed the ferry crossing almost two minutes after these images were taken.

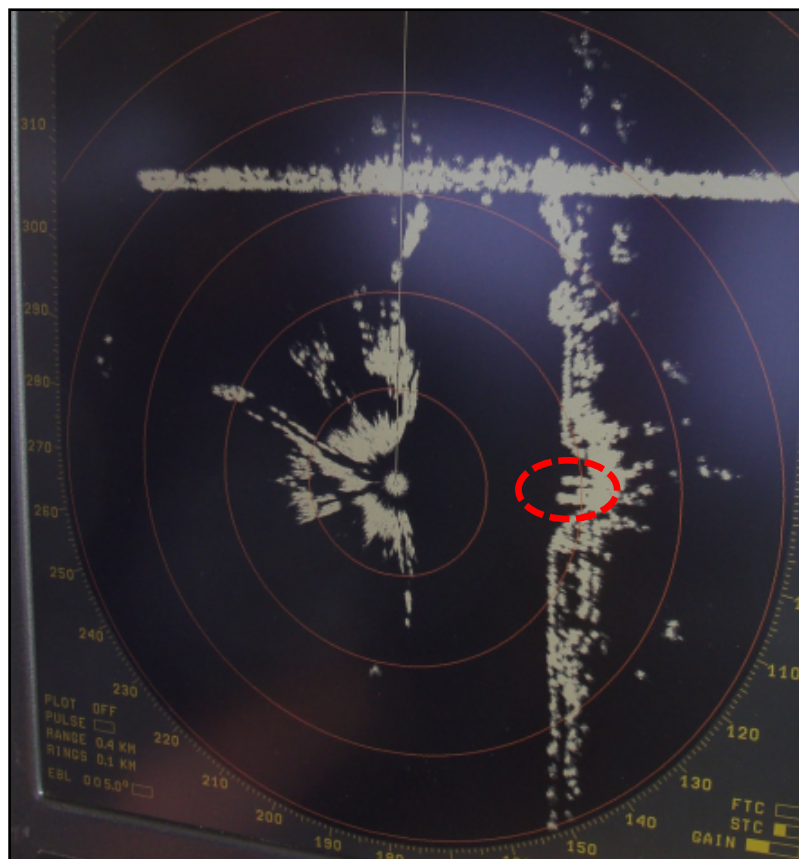
Figure 22: Radar view of the northern ferry terminal at Hochdonn

The image below (see **Figure 22** – range of 0.4 km and marker intervals of 0.1 km; ferry at the southern terminal) was set by the AUDORF's ferry pilot to illustrate to the investigators that he can only display the ferry terminal (the northern one in this case – see red dashed outline in the Figure) by radar very roughly when he approaches it in dense fog.

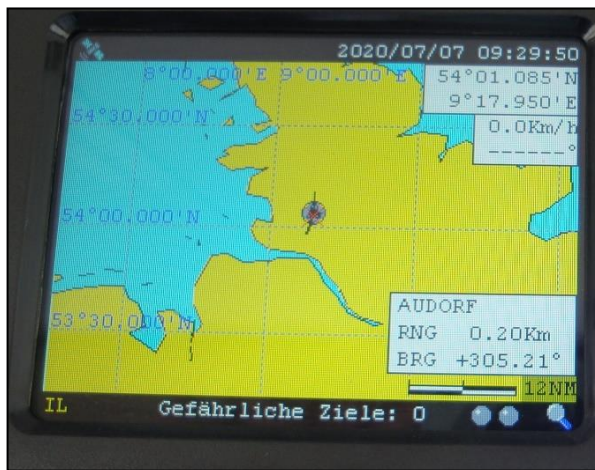
Figure 24: AIS display (coastal view mode)

In **coastal view mode**, received AIS signals are embedded in a graphical representation of the coastline. The user has various zoom levels available to change the scale in which the coastline is displayed. It should be noted that the chart display only provides summary information to assist with orientation. It is not based on an official (electronic) navigational chart and as such (apart from the entirely unsuitable display size) cannot be used for navigation. The lack of functionality in this regard is already evident in relation to the use in the NOK by the fact that as a waterway the canal is not displayed as hydrographic information at all (see **Figure 24** below).

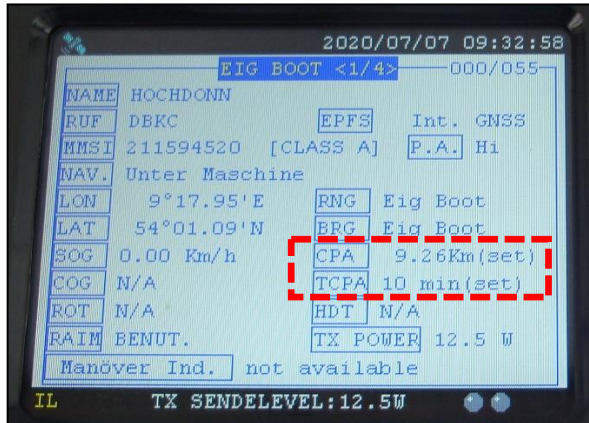
Figure 31: AIS display (own ship data 1/4)

Of particular practical importance (at least in maritime navigation) is the option to set an alarm range for the CPA⁴³ (i.e. a defined radius for AIS targets) and the alarm time for the TCPA⁴⁴ for these targets (see area in red dashed outline above in **Figure 31**). As soon as AIS targets cross the relevant limits, the device adds them to the **list of dangerous targets**. The user can select the corresponding tabular overview as a display mode with the same name as an alternative to the other display options. In the coastal view and radar view modes, AIS symbols of vessels triggering an alarm are no longer displayed as black but rather as red triangles that are additionally circled in red. An audible alarm that indicates that the CPA and TCPA limits have been crossed can also be enabled.

The CPA reading of 9.26 km, which can be seen in **Figure 31** above and which is meaningless in terms of the operation of the NOK ferry, shows that the CPA/TCPA alarm function was evidently not used on board the HOCHDONN.

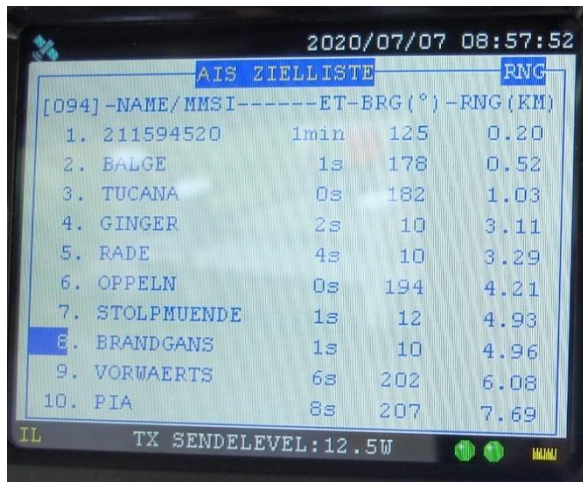
Figure 35: AIS target list on the AUDORF (0857)⁴⁵

Immediately after the trip on the AUDORF, the investigation team went on board the HOCHDONN, which was moored alongside at a berth on the southern bank of the canal, and gained an understanding of the operating concept, the range of functions and the performance of the AIS device. The device was evidently not working as it should at this point in time, either, as it only listed three AIS signals even though there was heavy traffic on the NOK at the time in question and the AIS target list seen on board the AUDORF shortly beforehand had been far more extensive accordingly (see **Figures 35 f.** below).

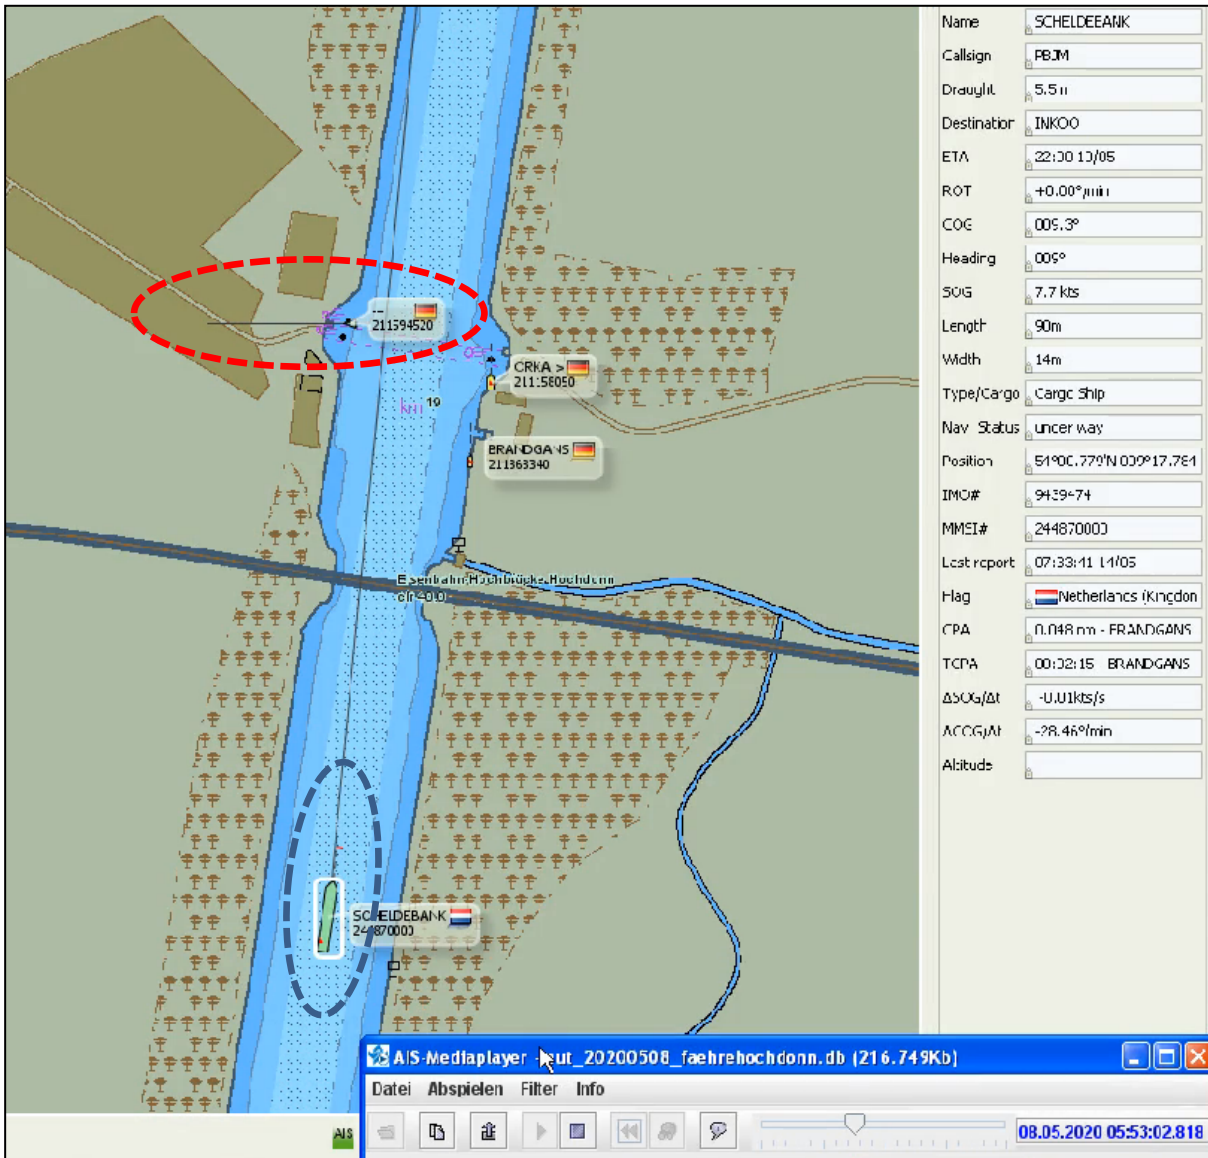
Figure 37: WSV AIS recording (situation at 055302 UTC)⁴⁷

In **Figure 37** (about three minutes before the accident), the SCHELDEBANK (blue dashed outline) is still some 350 m west of the railway bridge, which crosses the canal horizontally in the middle of the image. The HOCHDONN's AIS symbol (red dashed outline) gives the impression that the ferry has just or only recently arrived at the northern terminal due to the vector pointing northwards beyond the northern ferry terminal.

All in all, the sequence of events described above demonstrates – even under the premise that the reporting rate⁴⁸ for dynamic AIS information with regard to the HOCHDONN (as well as the SCHELDEBANK) stood at 10 seconds – very clearly that their AIS device did not transmit the ship's own data correctly. The error in this respect should be taken as an indication that the device was generally defective on the day of the accident (i.e. with regard to transmitting the ship's own AIS data as well as with regard to receiving or displaying external AIS data).

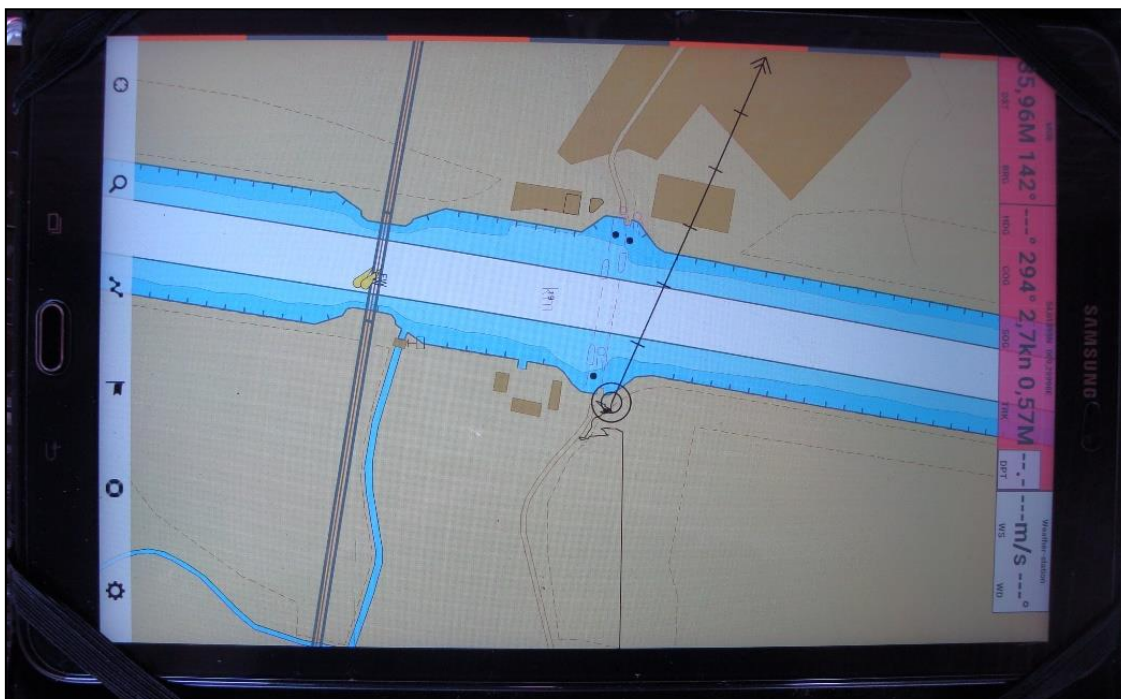
Figure 43: Tablet computer with navigational chart view (area of the railway bridge and Hochdonn ferry crossing)⁴⁹

During a meeting near the southern ferry terminal at Hochdonn, the ferry pilot on the HOCHDONN explained that he had reportedly purchased a tablet computer (made by Samsung) privately to facilitate navigation on the canal due to what he considered to be the completely inadequate user-friendliness of the ferry's navigation equipment. He had installed navigational chart software on this device (see **Figure 43** below), which he demonstrated during the meeting.

However, the navigational chart software used (just like the radar on board) does not have the option of displaying AIS targets. This shortcoming was explicitly acknowledged by the ferry pilot and he made it clear that he would consider purchasing the additionally available option of having AIS data from an online database fed into the chart software.

Since the device in question is not an officially approved navigation instrument, the investigation team dispensed with examining its technical details. Irrespective of the device's regulatory classification, it was completely unsuitable for use as an aid to maritime traffic monitoring or collision avoidance from a practical point of view in any case due to the lack of an option to display AIS targets.

⁴⁹ The demonstration of the tablet computer took place on the canal's southern bank a few metres from the Hochdonn ferry terminal. Accordingly, the tablet's GPS position is shown on the navigational chart software in the area in question, although the meaning of the displayed vector is not readily apparent.
