Bundesstelle für Seeunfalluntersuchung
Federal Bureau of Maritime Casualty Investigation

Investigation Report No. 261/20

**Fire in the engine room on board the ferry BERLIN in
the access to the port of Rostock on 13 August 2020**

30 November 2022

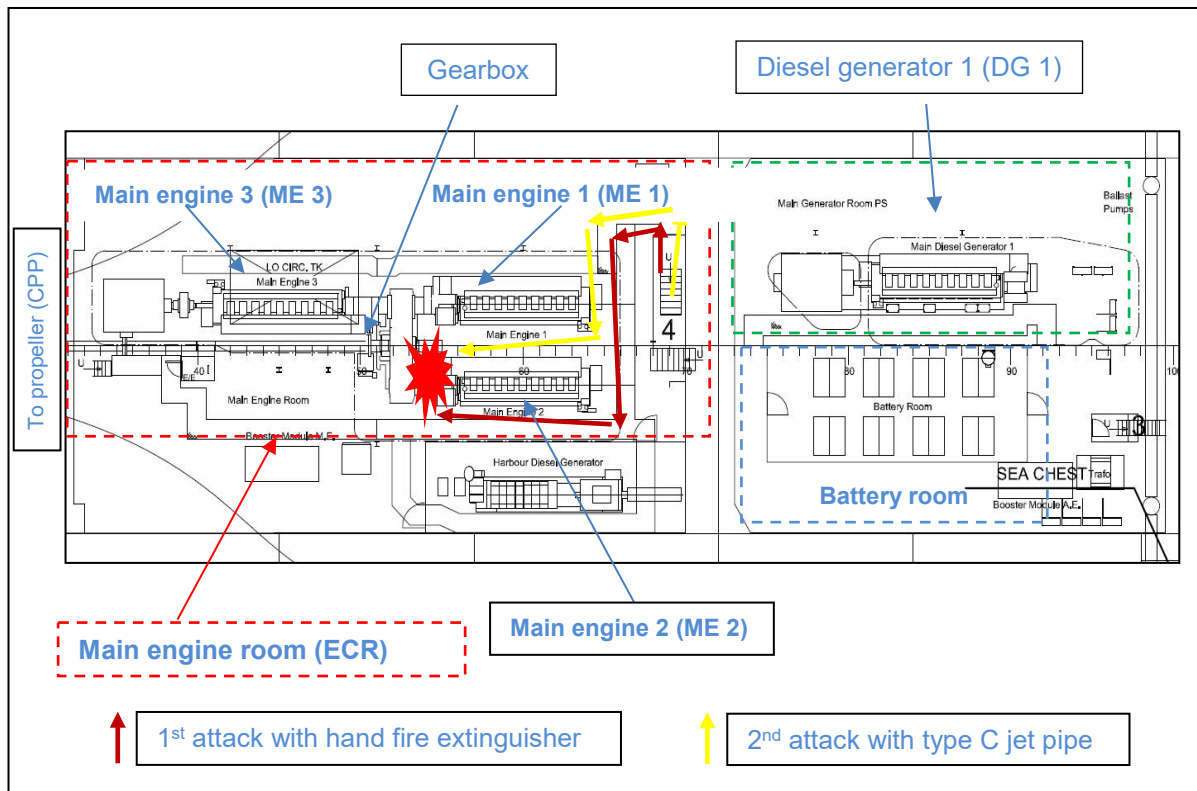
Figure 4: Floor plan of engine room with fire area on Deck 0

The engine room watch crew (TO, SM 1 and SM 2) now began manual firefighting using hand fire extinguishers (see Figure 4).

in the turbocharger area. The technical officer cooled the machinery space casing from Deck 1 until this was taken over by SM 1 (see Figure 4).

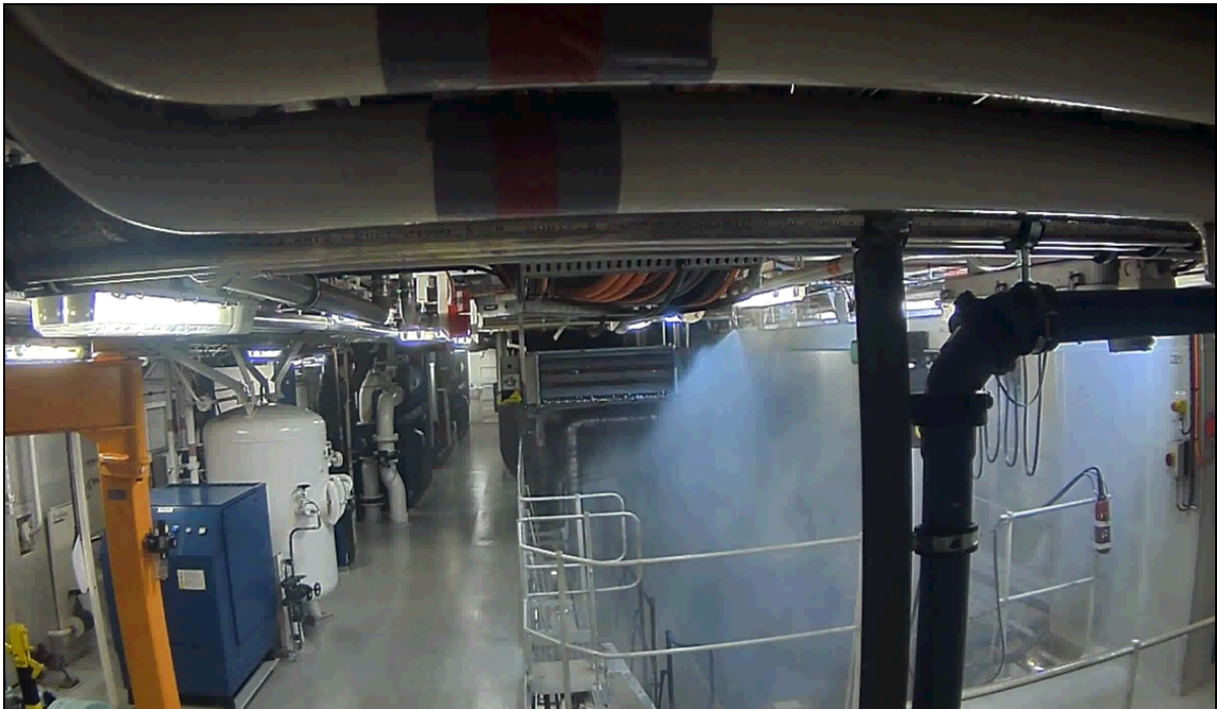
Figure 5: Object protection system triggered above ME 3¹⁰

The hose squad prepared fire hoses. At this time, the Chief Engineer started the object protection system above ME 3.

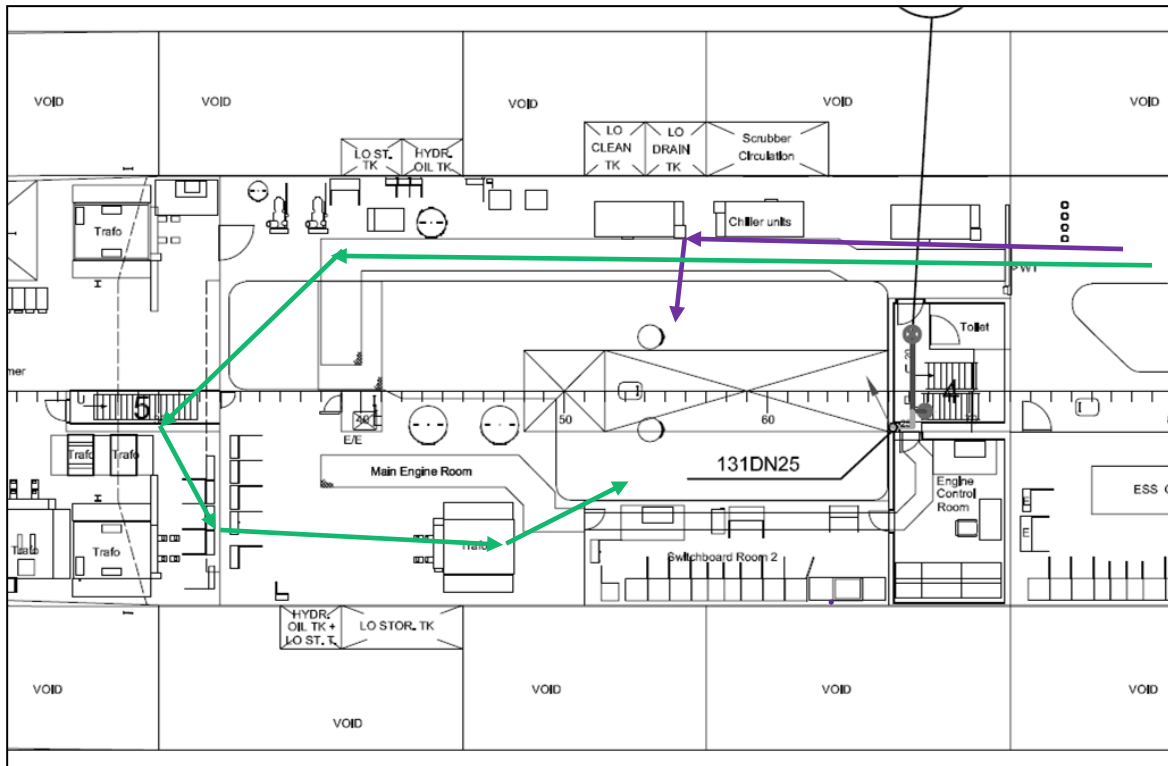
Figure 6: Floor plan of the engine room with the fire area on Deck 2

At 1504, the fire squad started local firefighting. They dispersed the extinguishing agent F-500¹¹ using a hose and a Venturi jet pipe¹², and low-expansion foam using a second hose (see Figure 6). Due to the active ventilation and outflow of the gases via the exhaust duct, visibility remained good.

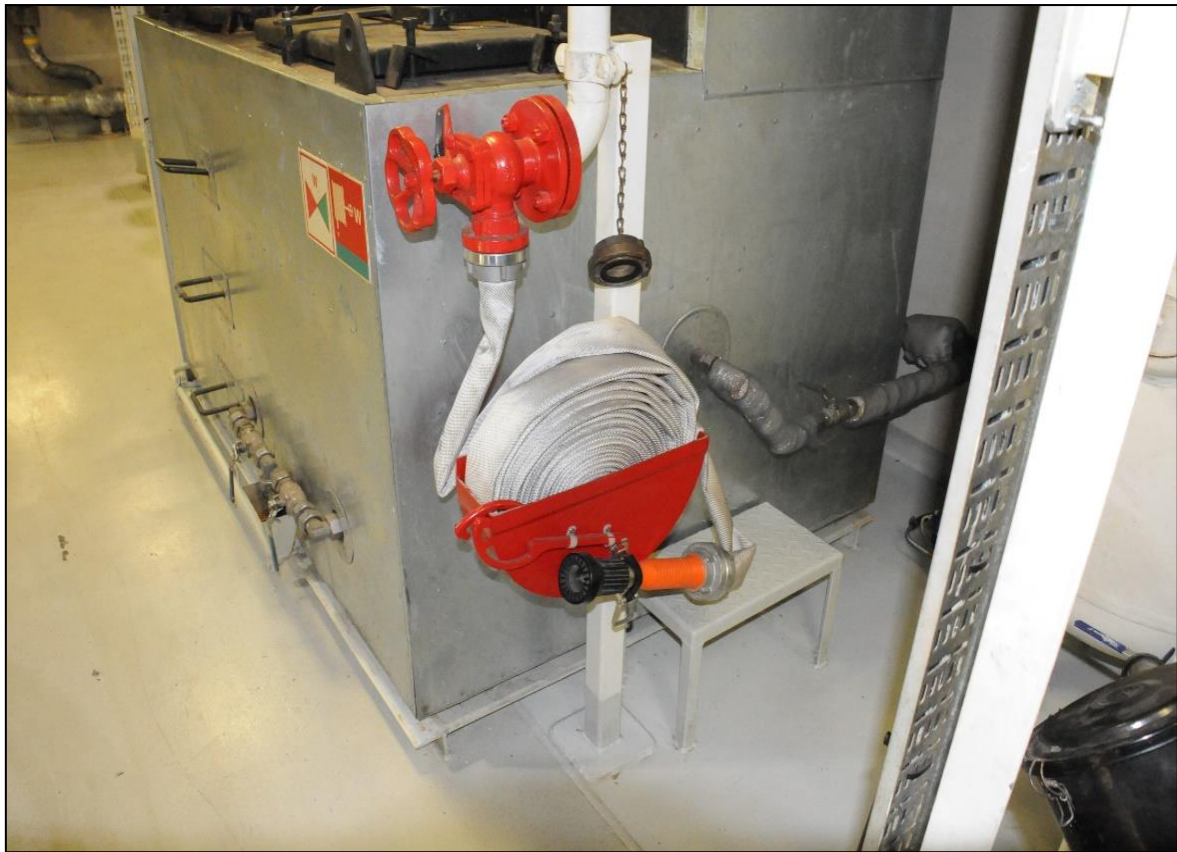
Figure 25: Standard jet pipe / hydrant system

- Standard jet pipes of the simplest design with option of water curtain (see Figure 25)

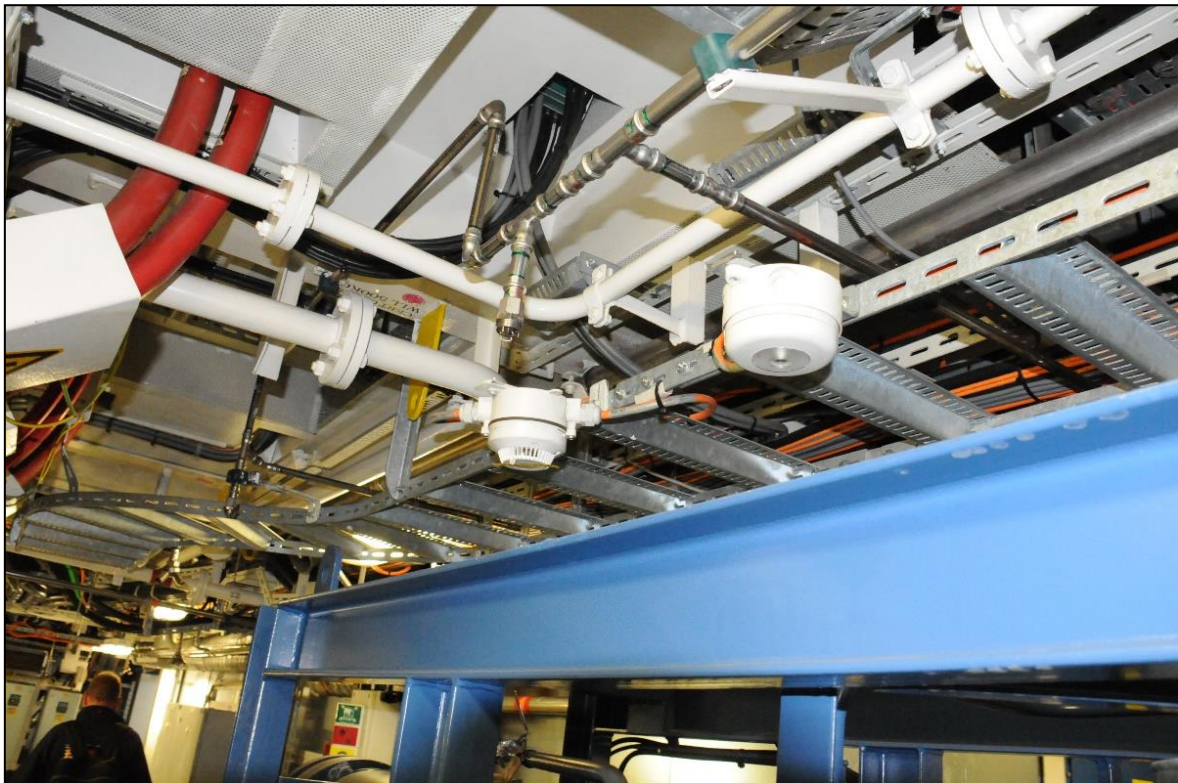
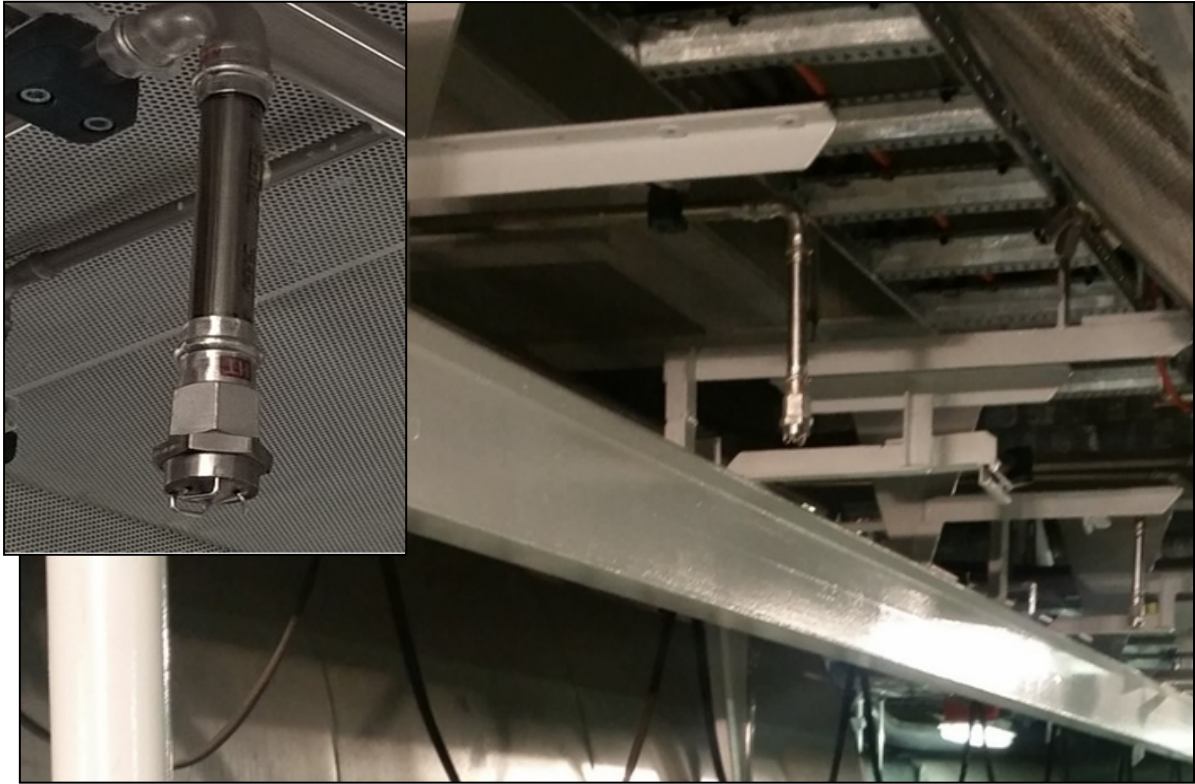
- Low-pressure system of the simplest design, spray cone formation via baffle hooks²⁴
- System design: Ceiling system with six nozzles above the cylinder heads (ME 1 & 2), no extended object protection system for e.g. the pump area or the turbocharger area. (see Figures 28 and 29)
- Problem: Dependency on two detectors, in this case flame detector and combined smoke/heat detector (so-called "combination detector").
Because the turbocharger covered the flames, the combination detector responded but the flame detector did not, so that the system did not trigger automatically. Additionally, the hot flue gases were expelled via the exhaust duct, so that the combination detector signal was not constant either.

Figure 28: Object protection system

Figure 29: Object protection assembly above engine

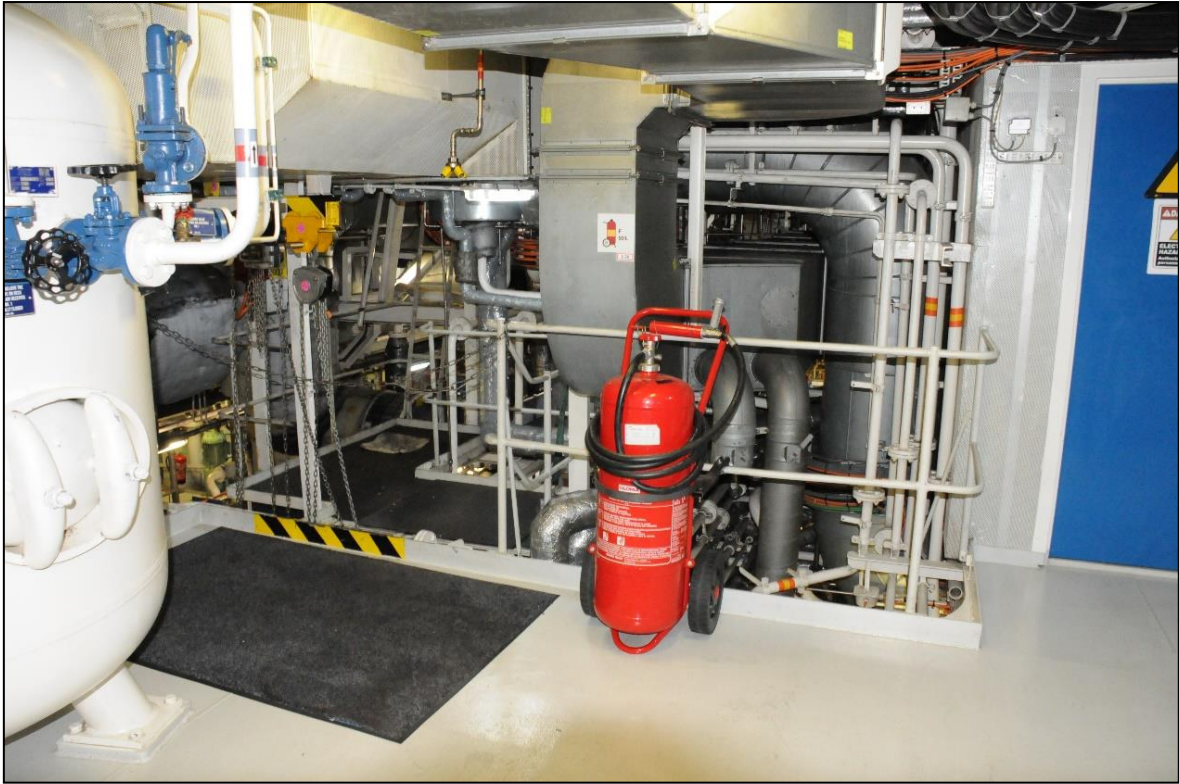
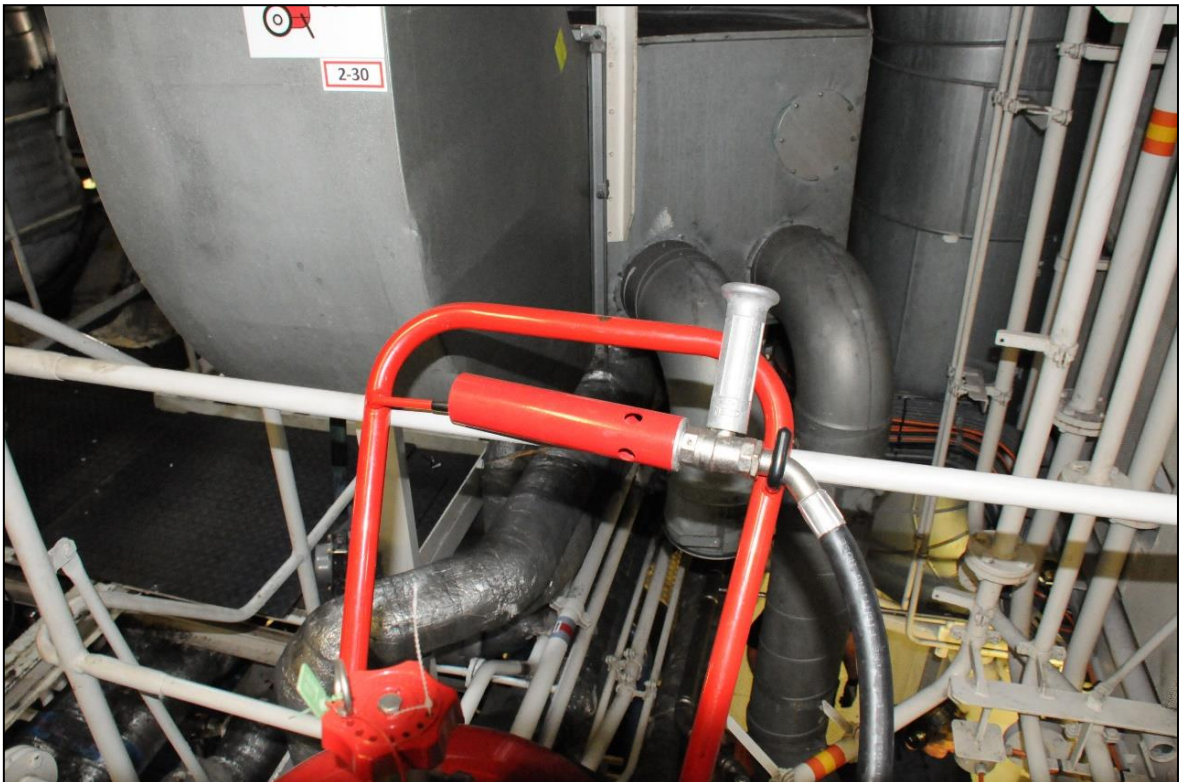
Figure 32: Foam trolley (in risk area)

Figure 33: Low-expansion foam pipe (trolley) for incipient firefighting

On the technical side, equipment weaknesses were identified, evaluated and rectified. Additional mobile extinguishing technology was purchased, such as foam trolleys and fog nozzles with wetting agent / foam / capsule agent admixture (see Figures 32 and 33). It is possible to apply a heavy foam of comparable quality to the more bulky low-expansion foam with these fog nozzles, if required. By controlling the flow rate directly at the nozzle, the firefighter can determine when to add foam concentrate or F-500 EA.

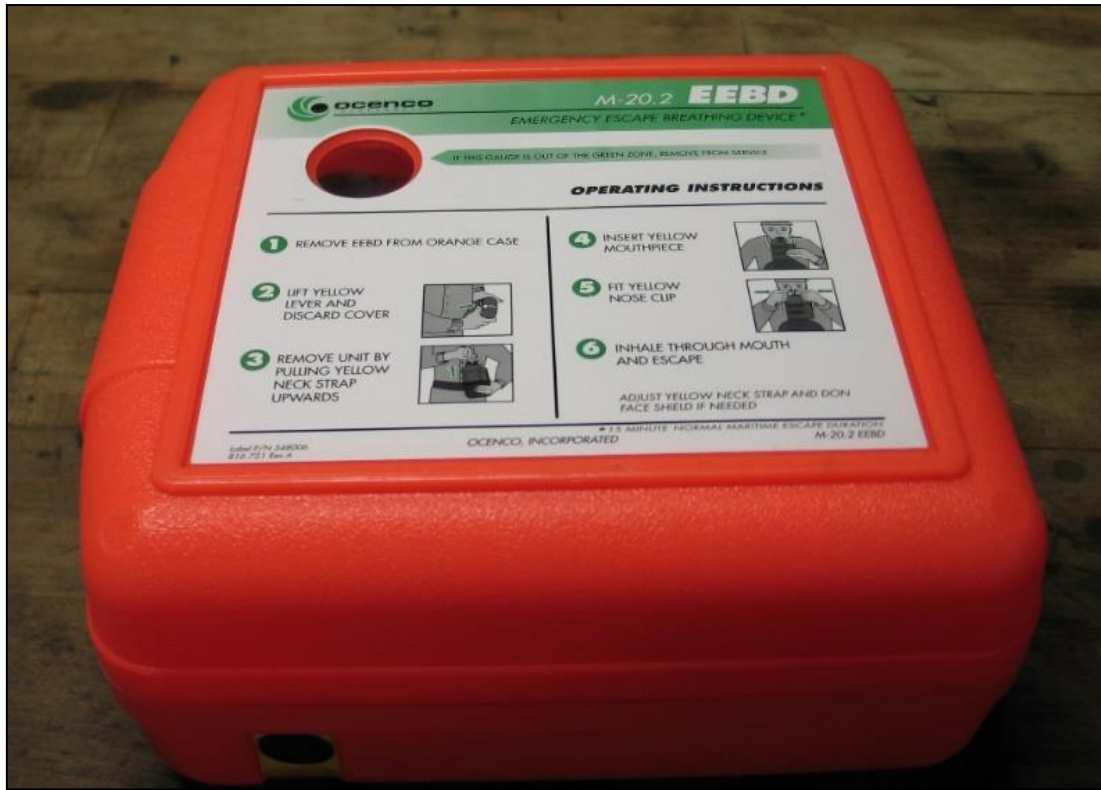
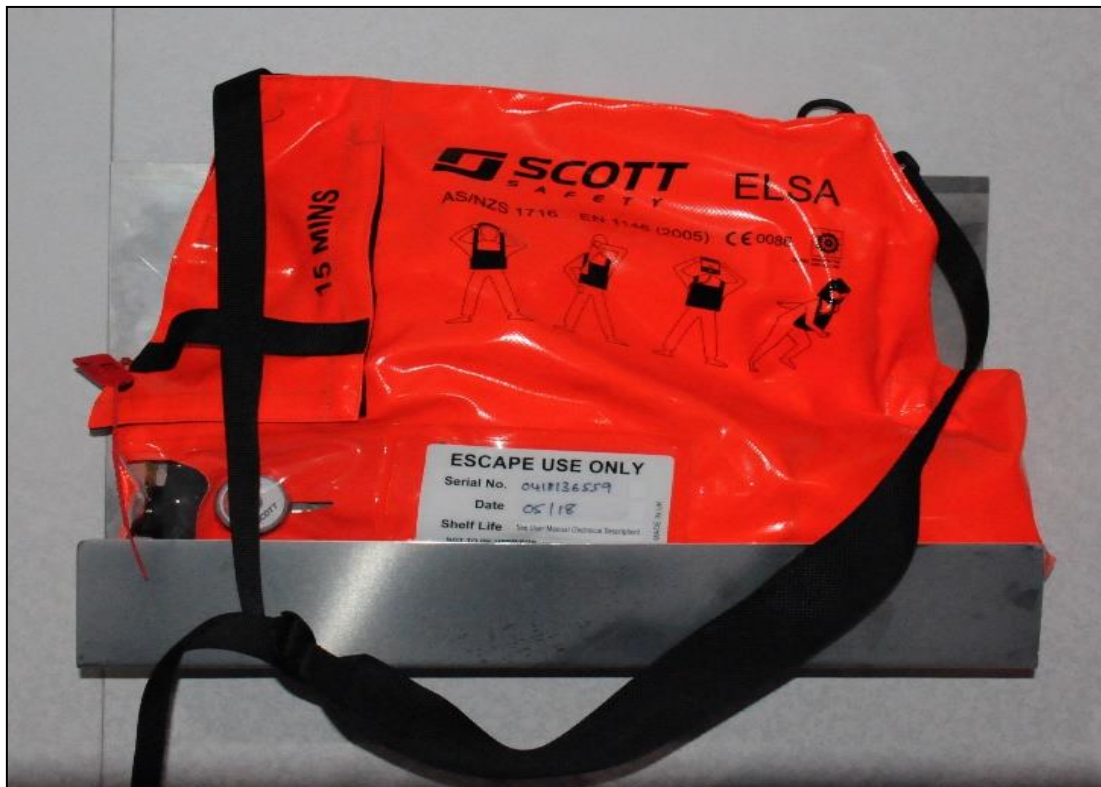
Figure 48: Conventional escape breathing device on board

Figure 49: ELSA for protection of retreating ER staff after incipient firefighting

In addition to conventional EEBDs³¹, additional Emergency Life-Saving Apparatuses (ELSA)³² were provided for the safe retreat of the engine room staff after incipient firefighting (see Figures 48 and 49).
