Bundesstelle für Seeunfalluntersuchung
Federal Bureau of Maritime Casualty Investigation

Investigation Report 276/21

**Foundering of the sailing boat SILJA and death of a
crew member in the Accumer Ee tidal inlet on
26 August 2021**

8 December 2022

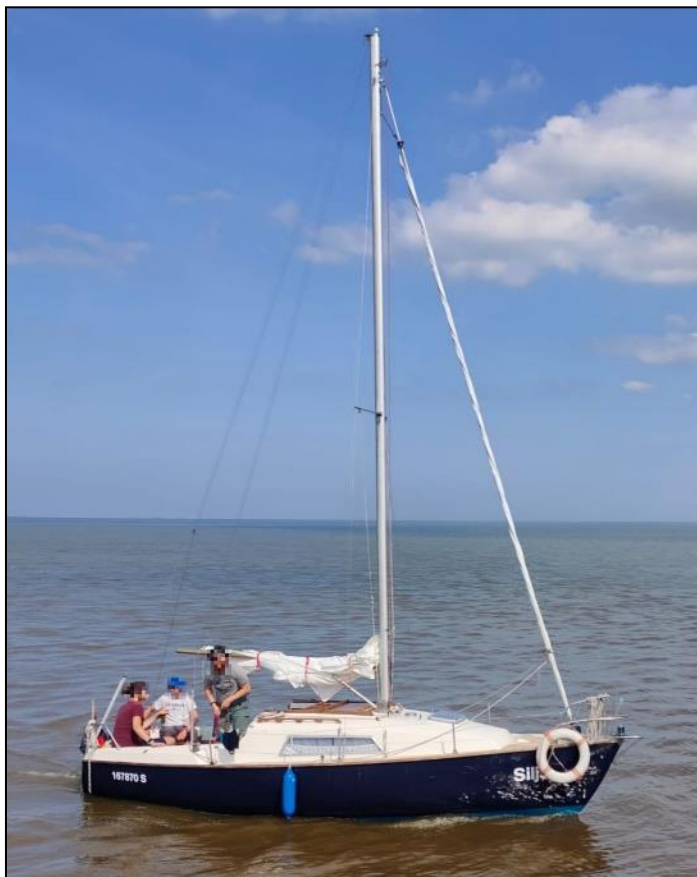
Figure 1: The SILJA a few weeks before she foundered⁷

He had also purchased three SECUMAR lifejackets in May 2018. The lifebuoy visible in the fore section (see Figure 1) had been on board for years.

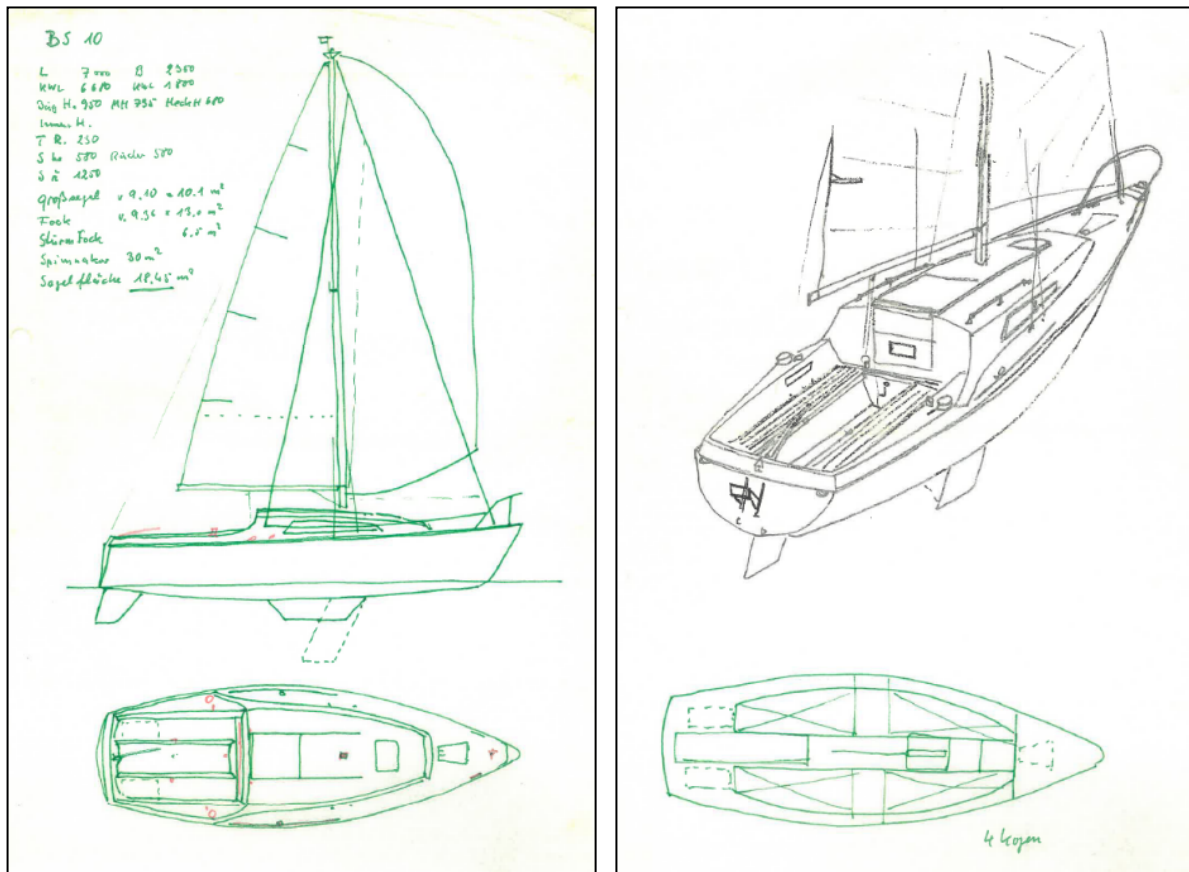
Figure 27: Drawings of the SILJA from the contract of sale (selection)

Some significant deviations from the SILJA were found during the survey of a Nautica 23 by the BSU and the investigators are therefore not sure whether the SILJA is actually the boat type stated. The investigators believe they gained a good impression of the spatial conditions on a comparable boat.

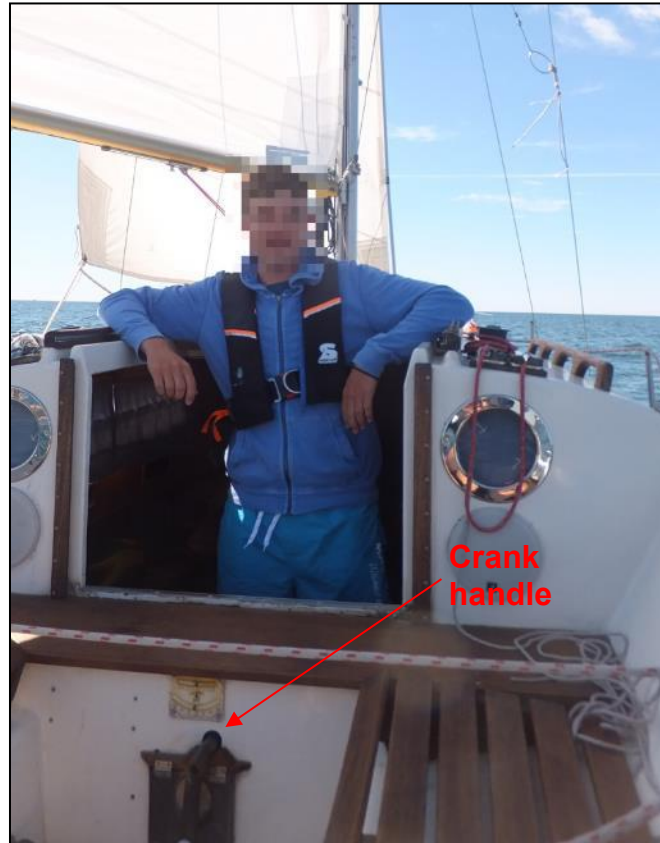
Figure 30: Crank handle for the centreboard⁷⁸

The integral centreboard sailing boat had a variable draught of 0.58 m to 1.25 m. The centreboard position could be changed from the cockpit with a crank handle.

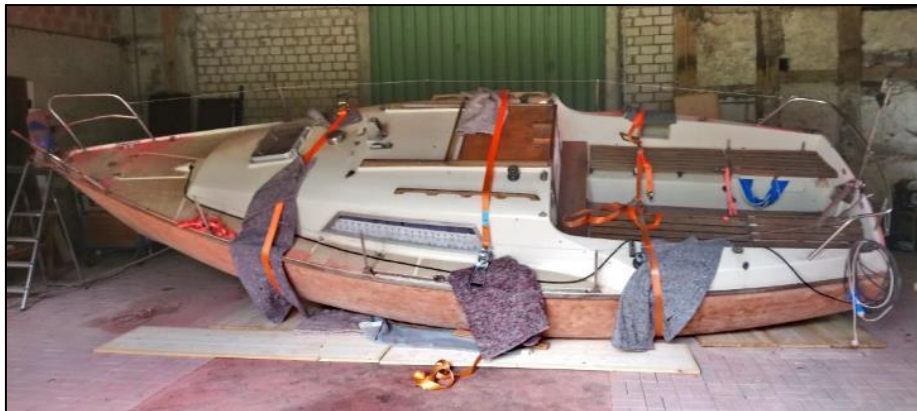
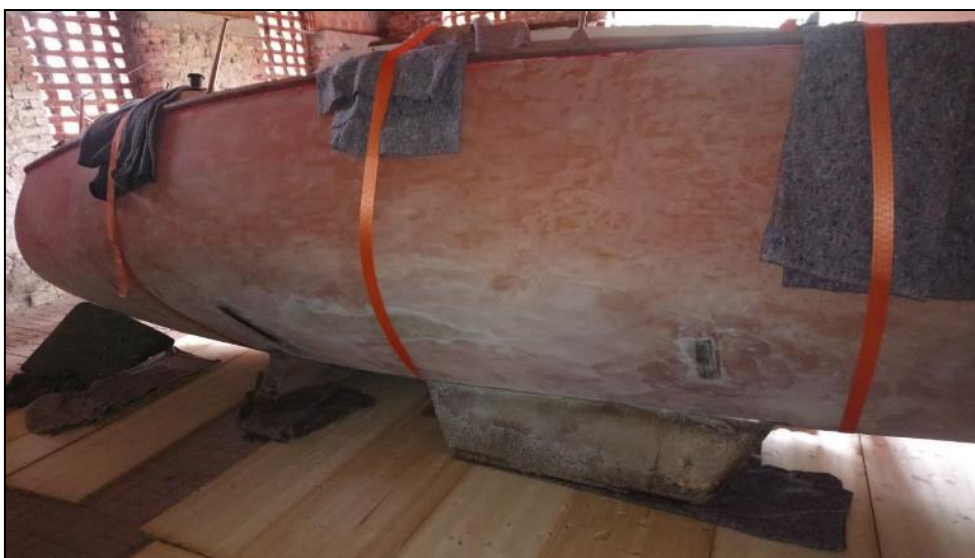
Figure 31: The SILJA during her major overhaul⁸⁴

The skipper had maintained and serviced the SILJA. In 2017, before the actual purchase, he concentrated on the interior. In 2019 and 2020, he overhauled the exterior of the boat and, *inter alia*, repainted the hull.

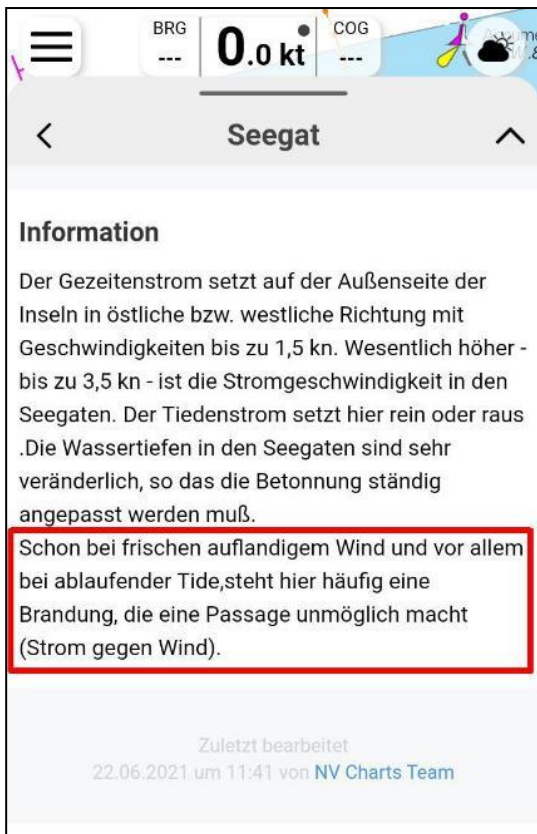
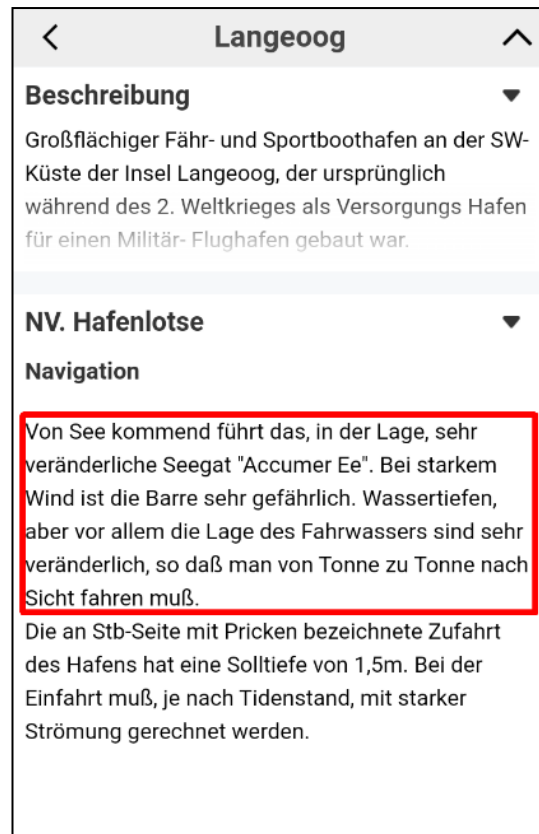
Figure 41: Accumer Ee navigation information¹¹⁴

Figure 42: Information on the port of Langeoog

The skipper was basically familiar with the POIs. He had essentially only used them for the port entrances and tidal information¹¹⁵. He was not aware of the information on the Accumer Ee tidal inlet (see Figure 42).

According to the POI located directly at Accumer Ee, surf that makes passage impossible can often be expected even in fresh onshore winds and especially when the tide is going out (current against the wind), see Figure 42. According to the Beaufort scale, wind speeds of 5 Bft (16–21 kts) are referred to as a fresh breeze. The navigation advice on the port of Langeoog indicates that the bar at Accumer Ee only becomes very dangerous in strong winds, see Figure 43. According to the Beaufort scale, wind speeds of 6 Bft (22–27 kts) are referred to as a strong wind.

According to the skipper's statement, he did not read the POI entered directly at Accumer Ee, which clearly stated: *Even with a fresh onshore wind and especially when the tide is going out, there is often surf here that makes passage impossible (current against wind)*, see Figure 42.

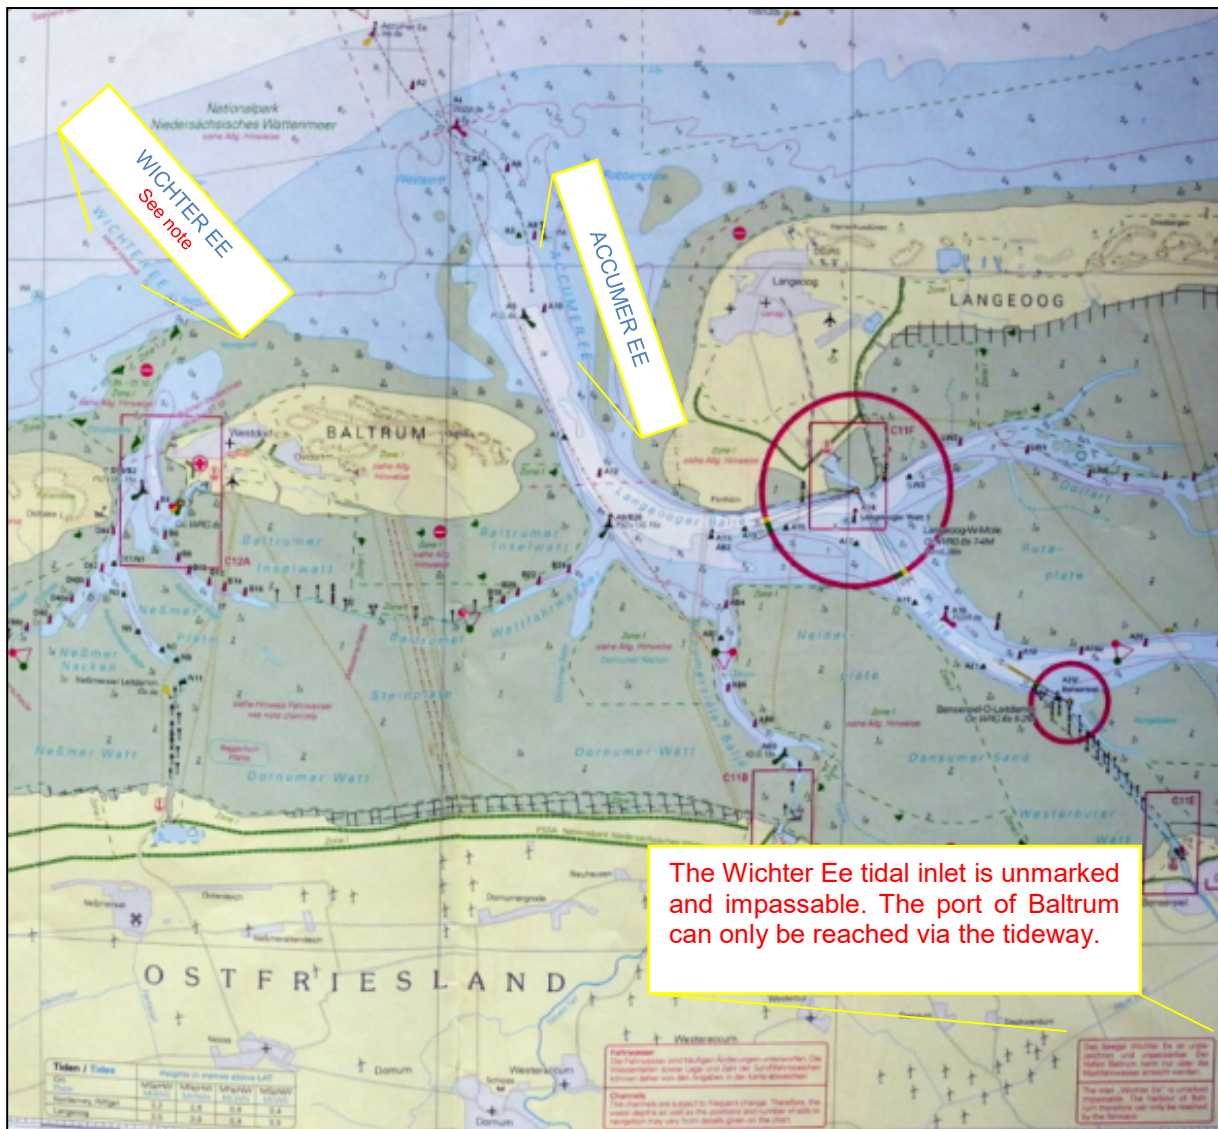
The paper navigational chart used for planning the route contains only a few references in the footnotes, in smaller chart extracts or a reference to the general notes published in the atlas corresponding with the POI. There were no specific notes for the Accumer Ee. In the entire atlas, only a note on the Wichter Ee tidal inlet was found during the investigation, which is described there as unmarked and impassable.

Figure 43: Notes in the Norderney to Langeoog paper navigational chart DE13 C7

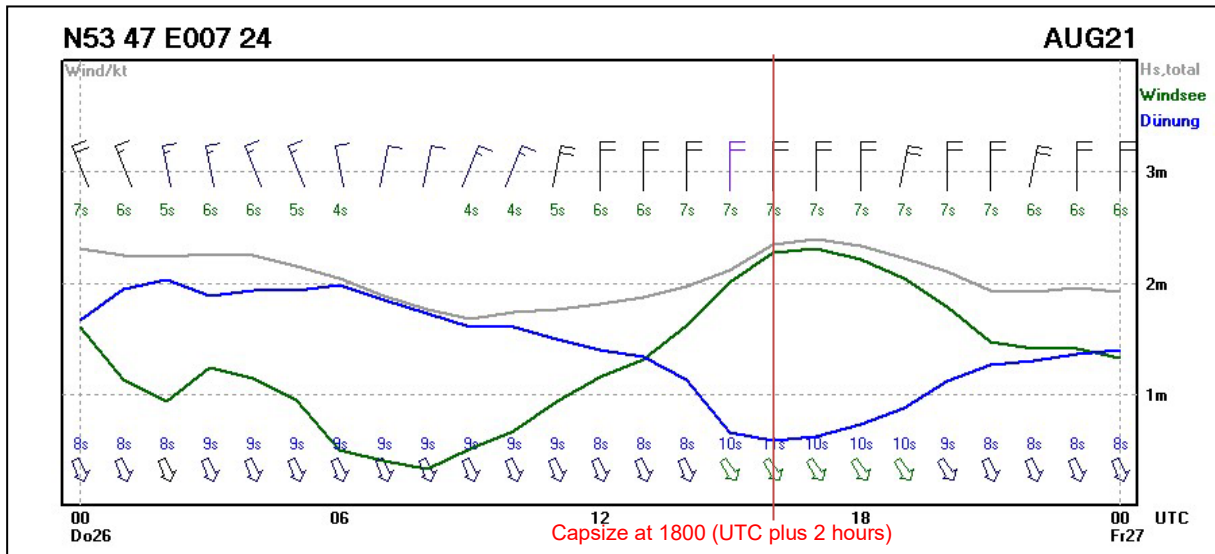
Figure 45: Time series in UTC for 26 August 2021 at the scene of the accident¹²¹

The diagram shows a northerly wind of 4 Bft in the model calculation. Since wind speeds of 27 kts (6 Bft) were measured slightly north of Wangerooge at the time of the accident, it is reasonable to assume that higher winds were also highly likely at the accident position. The wind sea component dominated the significant wave height of up to 2.5 m. The swell component was negligible.

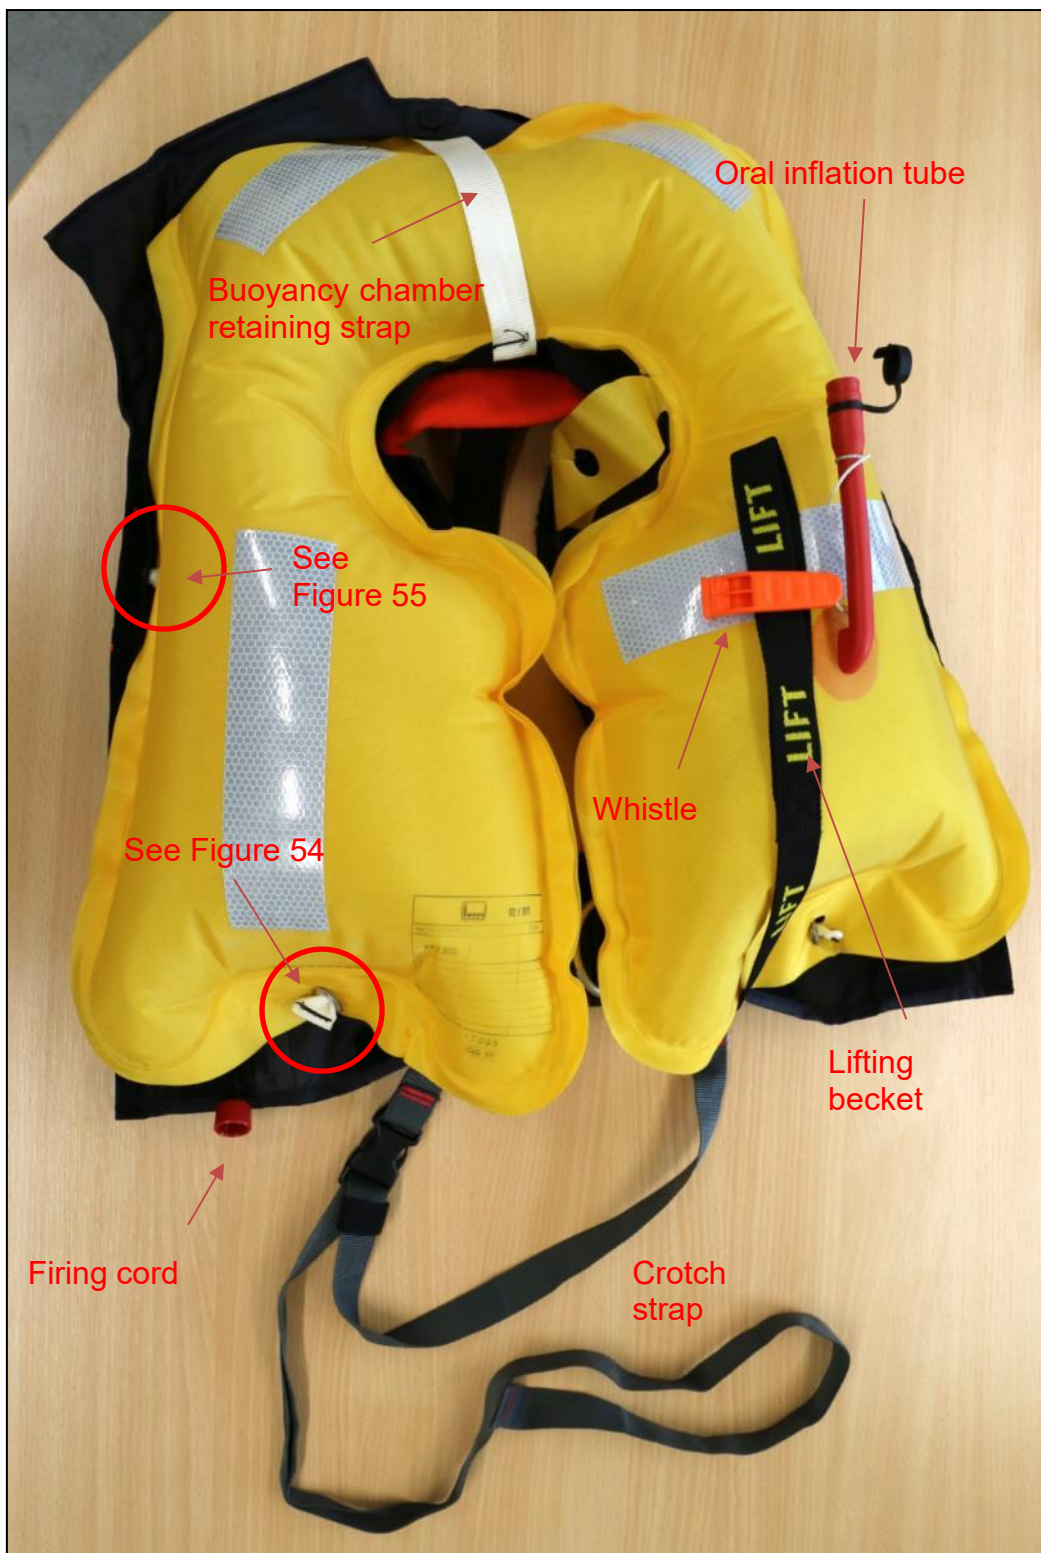
Figure 53: Ultra AX 150 with harness (buoyancy chamber inflated)¹⁴²

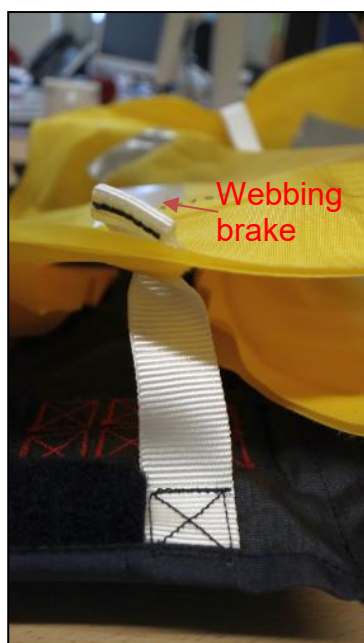
However, after an indeterminable period of time, at the latest after the SILJA foundered, the buoyancy chambers on the lifejackets of all three sailors were floating more or less next to their bodies. The buoyancy chamber fastenings had become detached from the protective covers (with integrated harness) at the bottom of the lifejackets and in the case of two of the three lifejackets were only connected to their lifejacket harness at one point.

Figure 54: Buoyancy chamber retaining strap; webbing brake¹⁴³

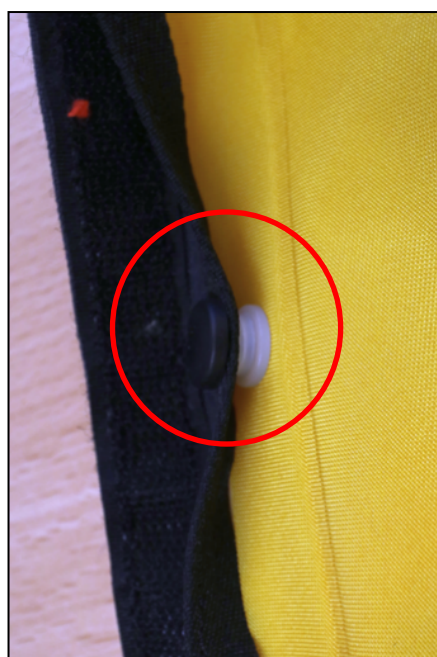
Figure 55: Press stud¹⁴⁴
