Investigation Report 282/20

Serious Marine Casualty

Grounding of the RUBINA after steering gear failure on the River Weser on 27 August 2020

7. April 2022

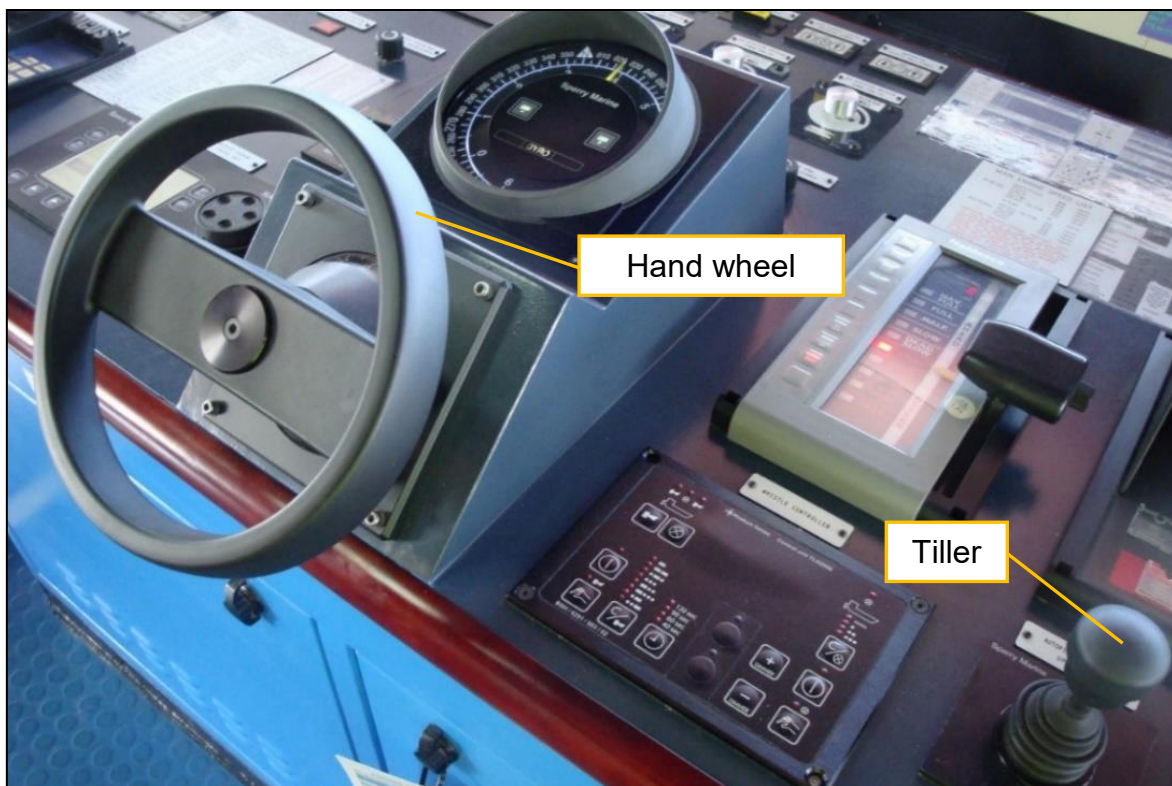
Figure 3: Hand wheel and tiller⁶ on the RUBINA

At around 2154, the helmsman tried to return the rudder to midships from a rudder angle of about 15° starboard. Initially, nothing happened, despite a correct had steering wheel position; the rudder remained at 15°. The helmsman immediately reported the problem to the pilot and the ship's command. After about three seconds, the steering control system automatically switched into so-called “override”⁵, accompanied by a clearly audible alarm.

At the same time, the rudder angle changed further to starboard to the hard-over angle of 45°, where it remained. As events unfolded, more helm orders were issued to the helmsman at the hand wheel, who continued to try and steer. However, the rudder failed to respond.

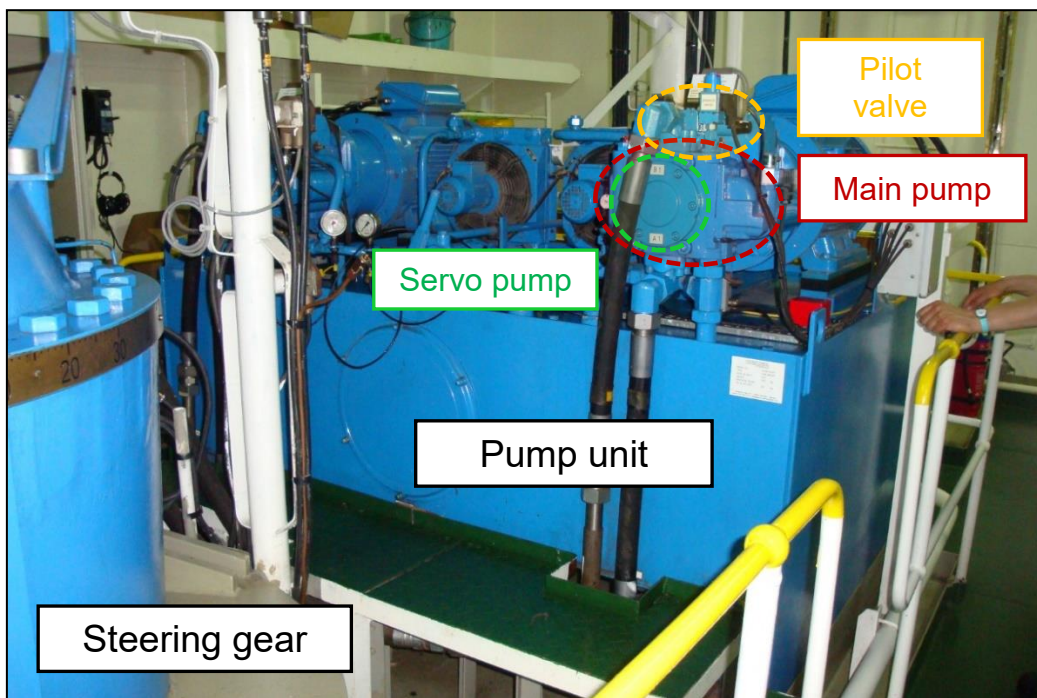
Figure 7: Steering gear on board the RUBINA (pump unit)

The cause of the non-responsive rudder was found to be a pilot valve of steering gear pump no. 2, which had stuck in an open position for a while. It was not possible to establish conclusively what had caused the pilot valve to stick.

A member of the engine department investigated the alarm and "noted abnormal noise from the pressure relief valve of hydraulic pump no. 2." In addition, the associated pressure gauge "was found overpressed" (needle at the stop, outside of scale) and a minor, unspecified damage was reported.

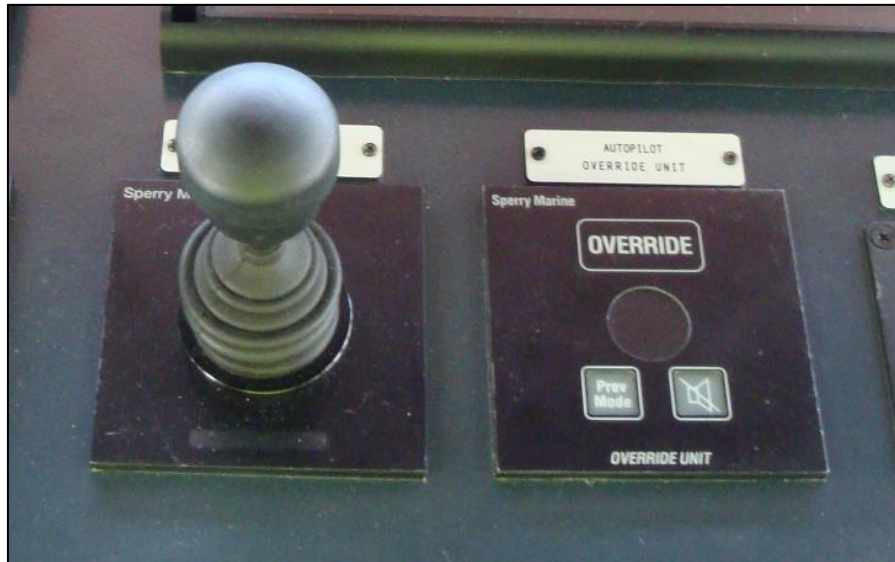
Figure 11: Tiller and Steering Override Unit SOU

This *intended and manual activation of the override* is indicated by an alarm on the so-called 'Steering Override Unit' (SOU) located next to the tiller. The 'Prev[ious] Mode' button (see Figure 11) can then be used to deactivate the override and return to FU mode.

However, after a Steering Failure Alarm (i.e. after an *unintended and automatic activation of the override* due to a problem with the rudder angle, i.e. a 'steering failure'), a reset is not possible this way. In such cases, a reset must be carried out by switching to NFU mode and back to FU. Of course, the override can then be expected to reengage after another three seconds if the underlying problem has not been solved in the meantime.

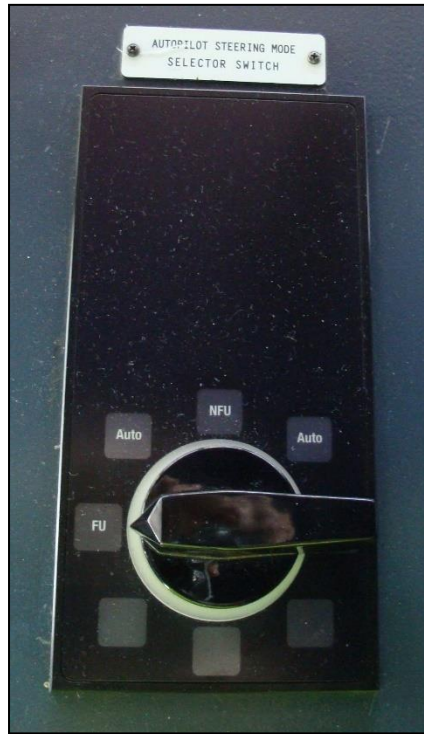
Figure 12: Steering mode selector switch
(FU: hand wheel; NFU: tiller; auto: autopilot)

What occurred on the RUBINA was an *unintended and automatic* activation of the override. The helmsman had put the hand wheel to midships, but the rudder remained at 15° starboard ('steering failure').

Due to this unchanging system deviation, the override automatically engaged after three seconds, and the Steering Failure Alarm sounded. This means that NFU mode (and thus the NFU tiller) was activated, even though the hand wheel was still selected as input device (steering mode selector switch was on FU, see Figure 12 and Figure 17). The closed-loop control was therefore inoperative from the moment the alarm sounded, and none of the switching contacts for the originally selected FU mode had an effect. In other words, the rudder orders via hand wheel had no effect from this point on.

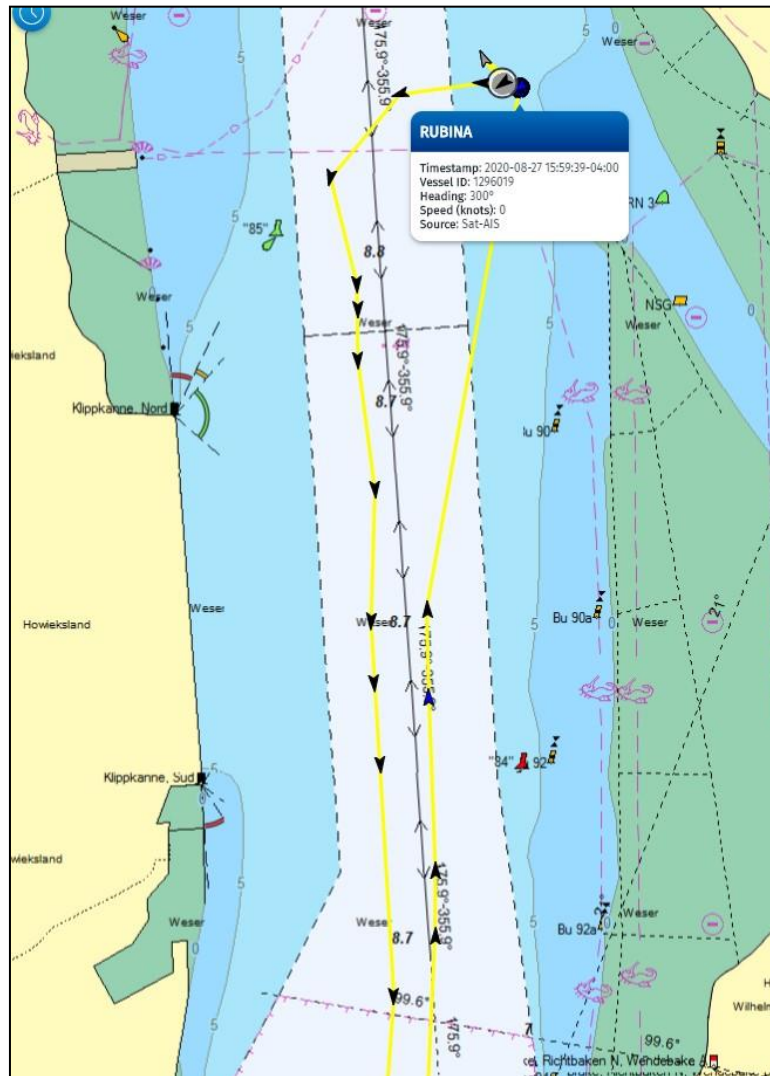
Figure 13: Past track of the accident (external recording)²⁷

The RUBINA's prow ran aground outside the fairway before any of these immediately initiated measures could have any effect (at about 2157). Rudder control was regained almost at the same time. Luckily, the grounding occurred in a relatively 'harmless' position on the river: at the mouth of a Weser tributary (the so-called 'Rechter Nebenarm') and outside the fairway, roughly level with Sandstedt (see Figure 2, Figure 4 and Figure 13). About two and a half minutes had passed since the rudder had jammed.

The RUBINA's track could be retraced using various ship tracking and information platforms. However, since the data used there originate from the ship's AIS signal²⁵ (ultimately the GPS device²⁶), it is consistent with the track found on board (see Figure 4) and has no standalone meaning.
