Bundesstelle für Seeunfalluntersuchung
Federal Bureau of Maritime Casualty Investigation

Investigation Report 285/20

Serious Marine Casualty

**Allision with a lock gate at Kiel-Holtenau on the
Kiel Canal (NOK) by the multi-purpose vessel ELSE
on 29 August 2020**

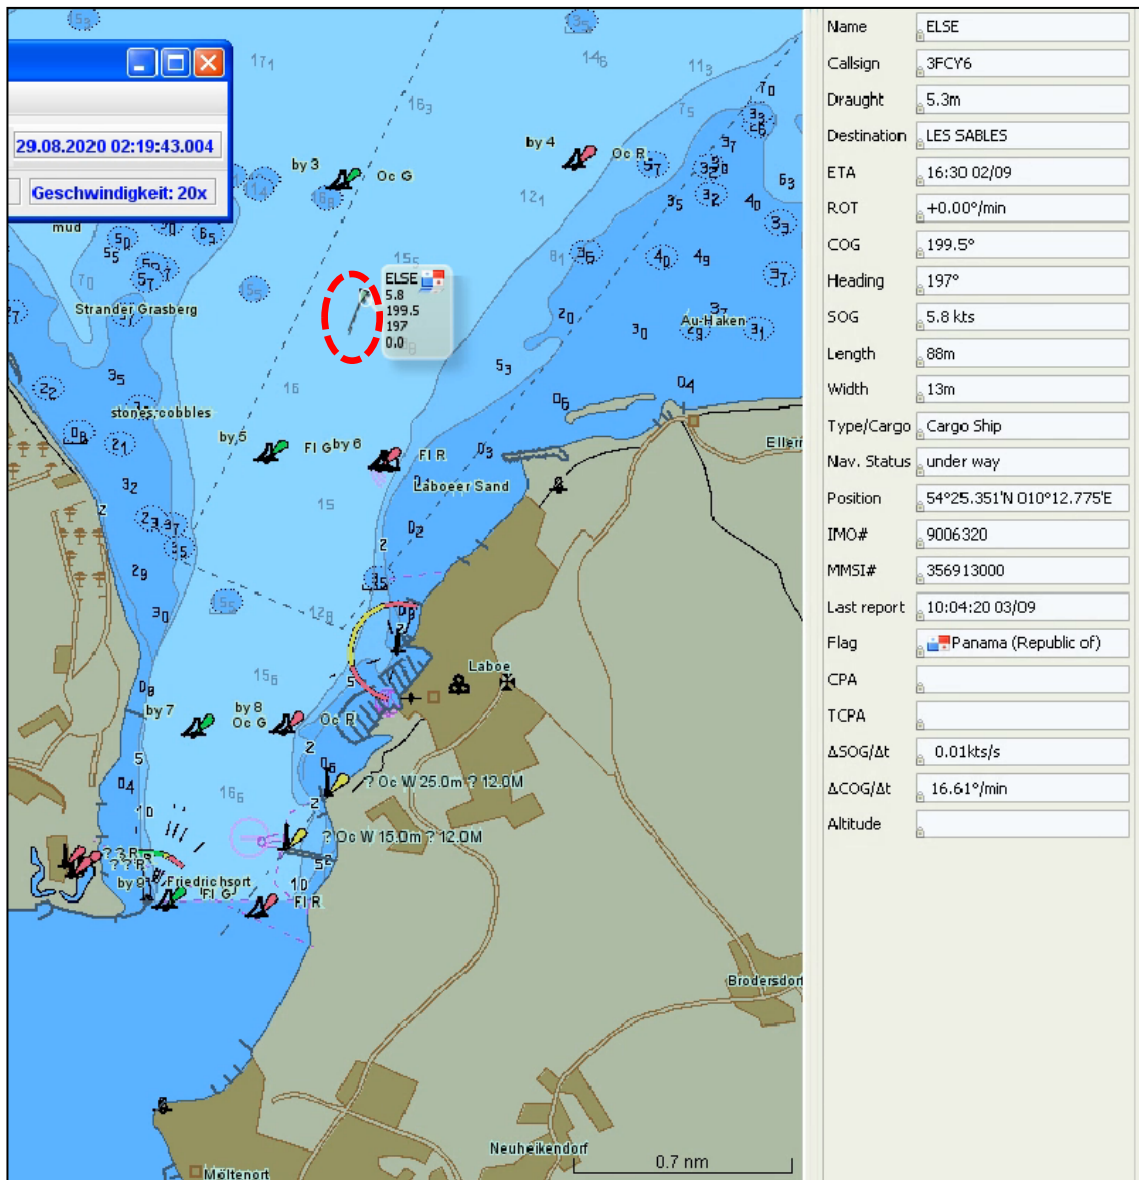
Figure 25: Position of the ELSE in the fairway between buoys 3 and 5 at 0420⁴³

The following screenshots (**Figures 25 ff.**) of the course of the ELSE's voyage are taken from the AIS recording of the WSV. They confirm that the ship (outlined in red in the below figures) initially used the buoyed fairway completely inconspicuously and in accordance with the rules and observed the course alteration points due to the course of the fairway on Kiel Fjord until she reached the pilot boarding point at the southern edge of the Holtenau roadstead. The ship's SOG was a consistent 5-6 kts throughout the voyage, until immediately before the collision with the lock gate.

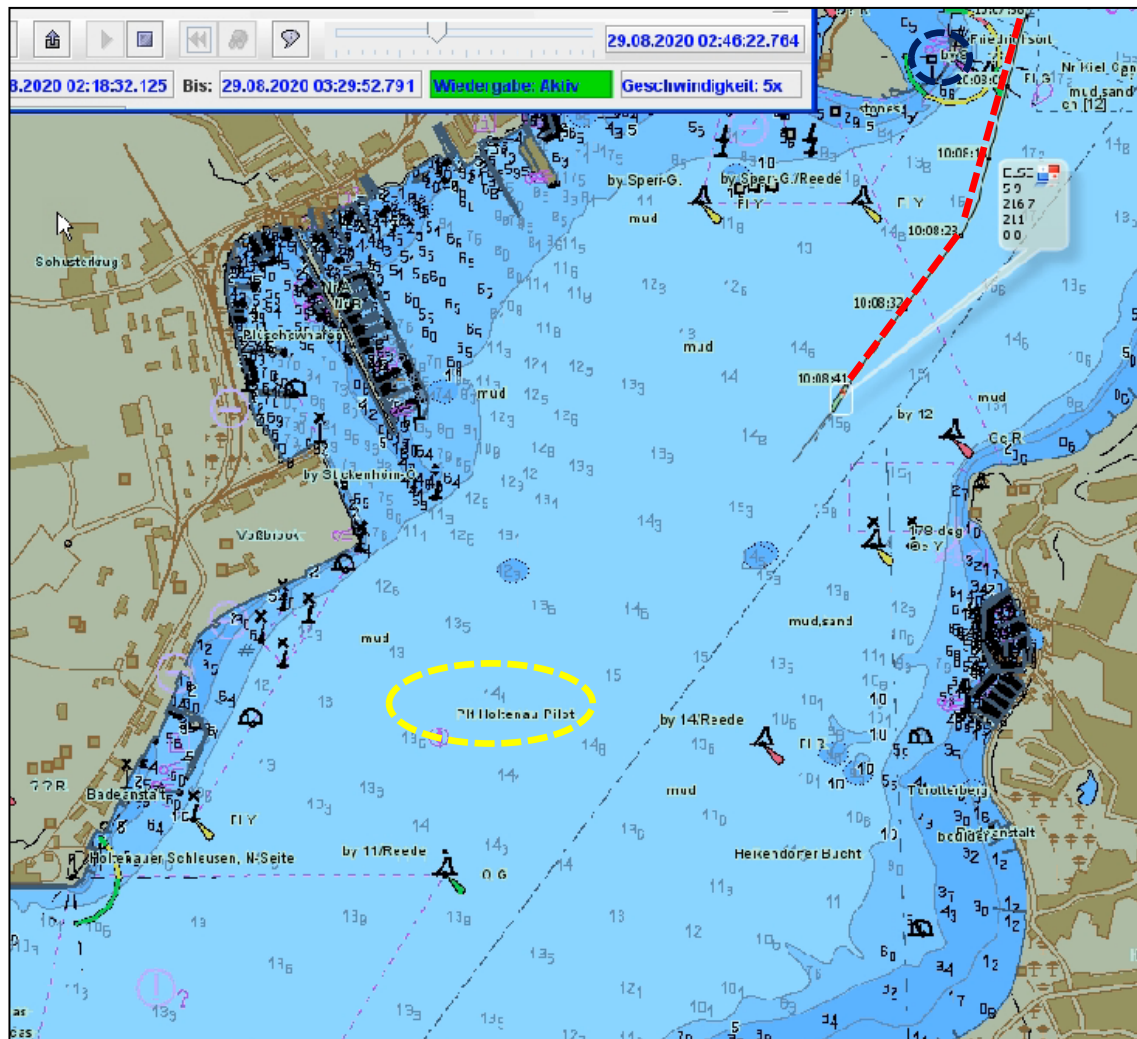
Figure 26: Course of the ELSE's voyage (red highlighting) after passing buoy 9⁴⁴ (in this case up until 0446)

Shortly after passing fairway buoy 9 (level with Friedrichsort Lighthouse), the ELSE duly altered course for the Holtenau roadstead at **0442** (see **Figure 26** below).

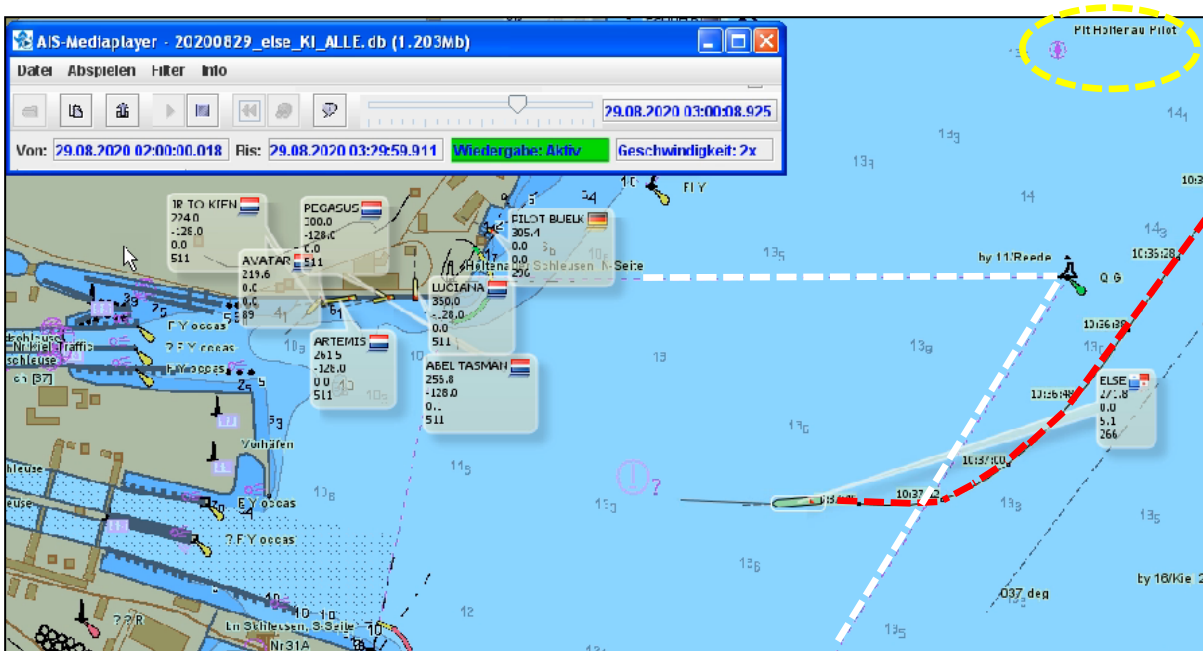
Figure 28: The ELSE alters course towards the entrance to the lock (track here until 0500)

Shortly afterwards (from about **045630**), the ship began to make a continuous course alteration to starboard, turning into VTS NOK's area of responsibility at about **0458** (see white boundary marking in **Figures 28 ff.**). The ELSE then maintained a more or less constant course (or rather even with minor course adjustments and at an unchanged speed) directly towards the entrance to the north chamber of the 'Neue Schleuse' lock. She inevitably sailed into the closed lock gate at **0507** (see **Figures 29 f.**).

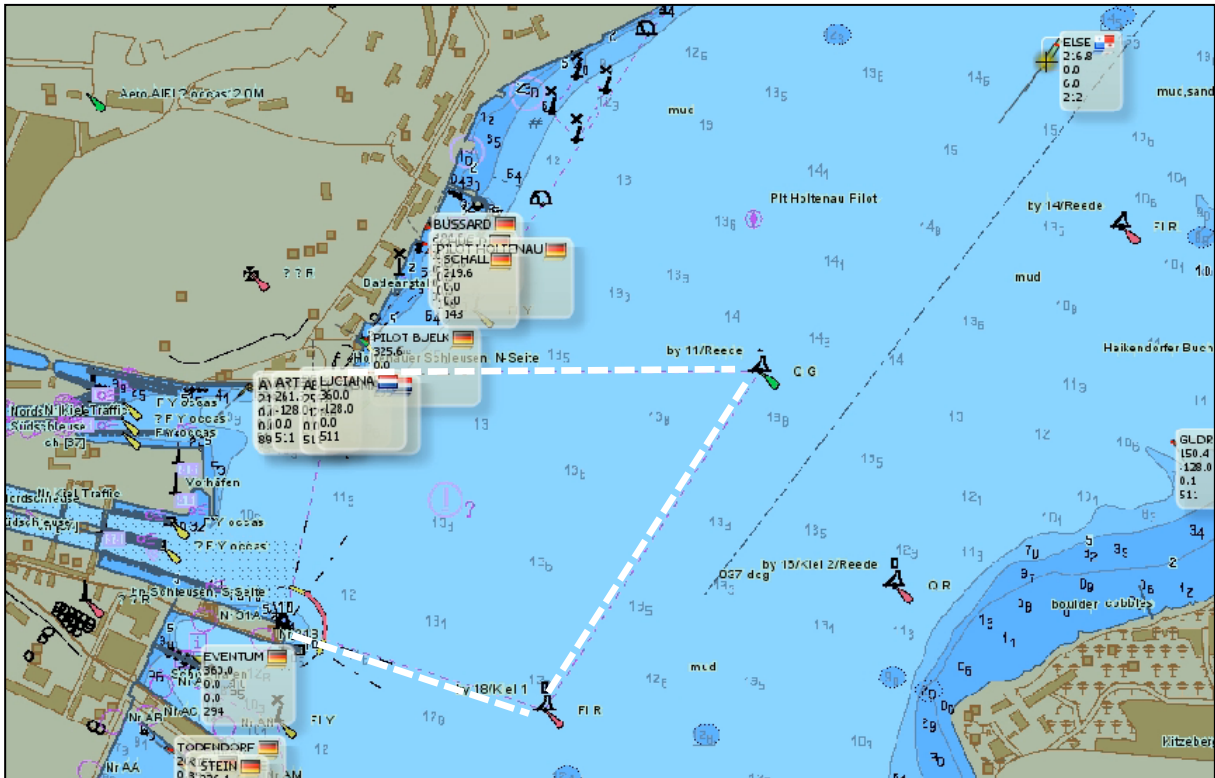
Figure 31: Entrance to the NOK lock facility at Kiel-Holtenau;
boundary of the areas of responsibility of the VTSSs⁵²

5.) Accordingly, the following responsibilities apply to the navigation police control of traffic in the approach to the NOK (coming from the Baltic Sea; see the boundaries of the area of responsibility marked in white below in **Figure 31**):

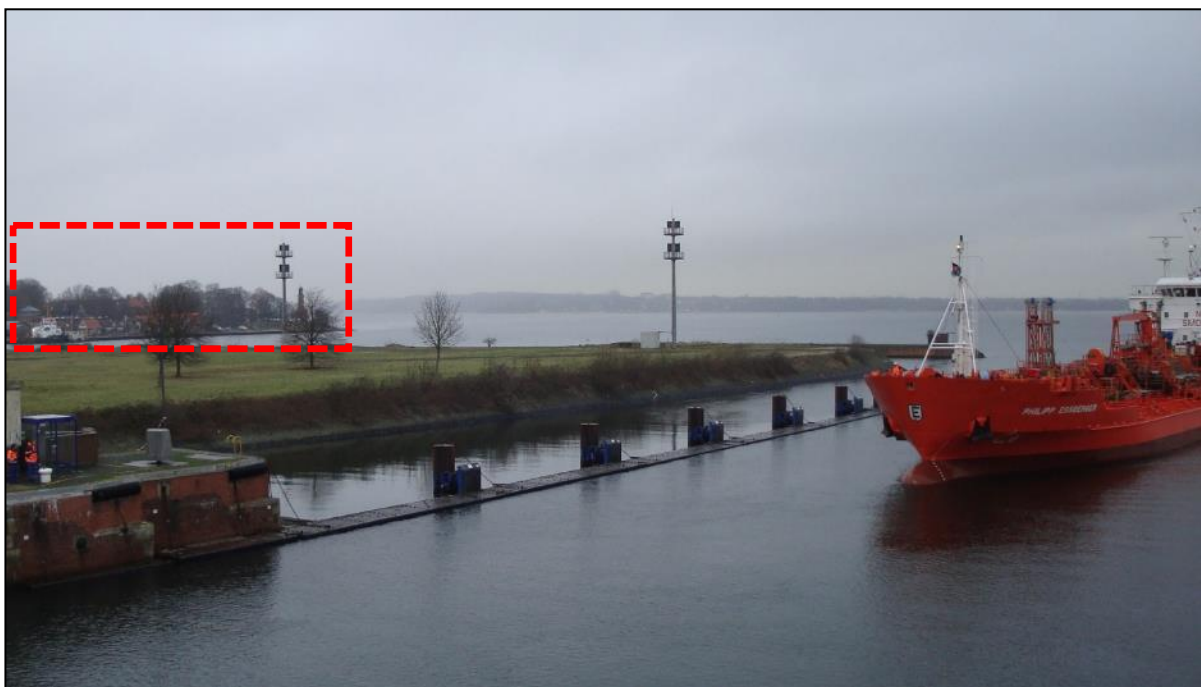
Figure 36: View from the lock control station in Kiel-Holtenau towards Kiel Fjord

However, the view of the approach to the canal on the Baltic Sea side is significantly restricted by Kiel Fjord's western shore area in the vicinity of Holtenau. A direct view of the pilot boarding point at a distance of 1 nm to the north-east or even of the area of Kiel Fjord situated to the north of it is impossible due to the geographical conditions (see the headland highlighted red below in **Figure 36**, which prevents the view of the pilot boarding point and course of Kiel Fjord there).

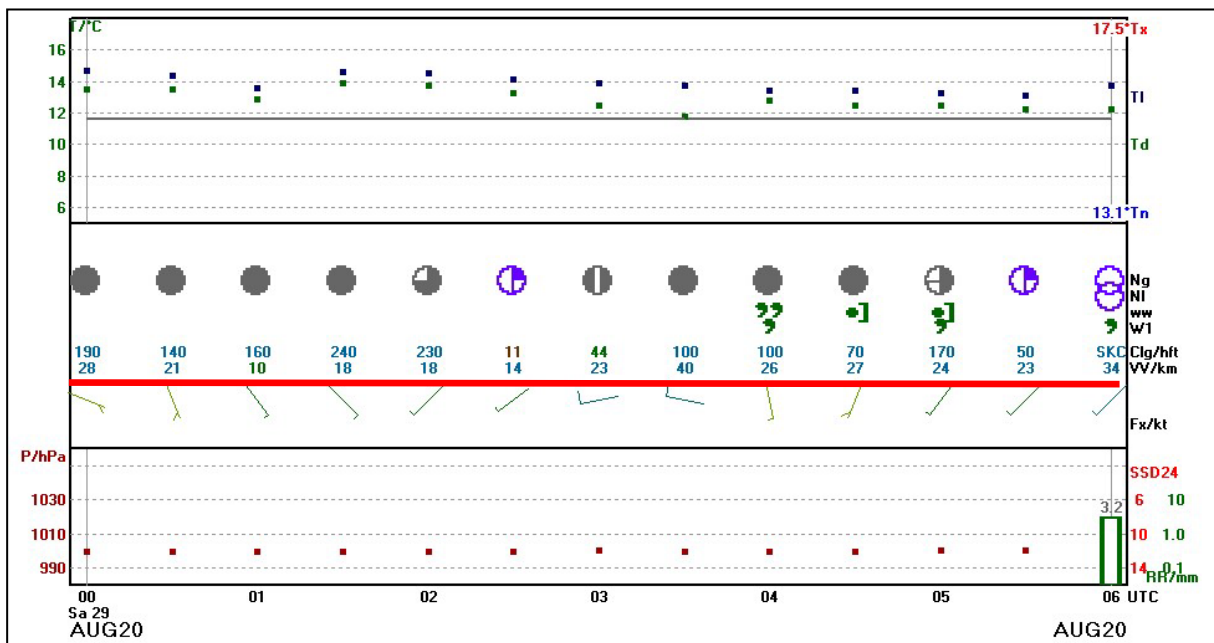
Figure 38: Ground weather reports for Kiel-Holtenau on 29 August 2020 (DWD)

The overview taken from the official report (see **Figure 38** below) contains the ground weather reports from the Kiel-Holtenau weather station on the day of the accident for the period 0000 to 0600 UTC. It also shows that the weather conditions were benign. In particular, good visibility prevailed at the time of the accident (see the red underlined row in the overview with visibility figures in km).

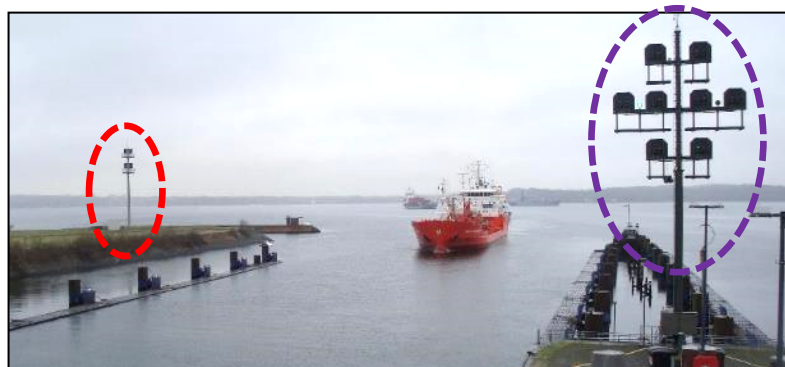
Figure 39: Signal installations (entries into the approach channel and the Neue Schleuse)

At the end of the lock island on the Baltic Sea side and on the middle wall of the 'Neue Schleuse' lock, light signal installations point in the direction of the Baltic Sea. These signals are legally binding and indicate whether entry into the approach to the 'Neue Schleuse' lock facility or entry into its lock chambers is permitted or prohibited (see red or purple highlighting of the signal installations below in **Figure 39**). The meaning of the signals displayed is explained in nautical publications concerning the NOK (for example, see the information on Navigational Chart INT 1366 (NOK); relevant extract below in **Figure 40**) and can also be understood intuitively, at least as far as a single red light is displayed to prohibit entry.

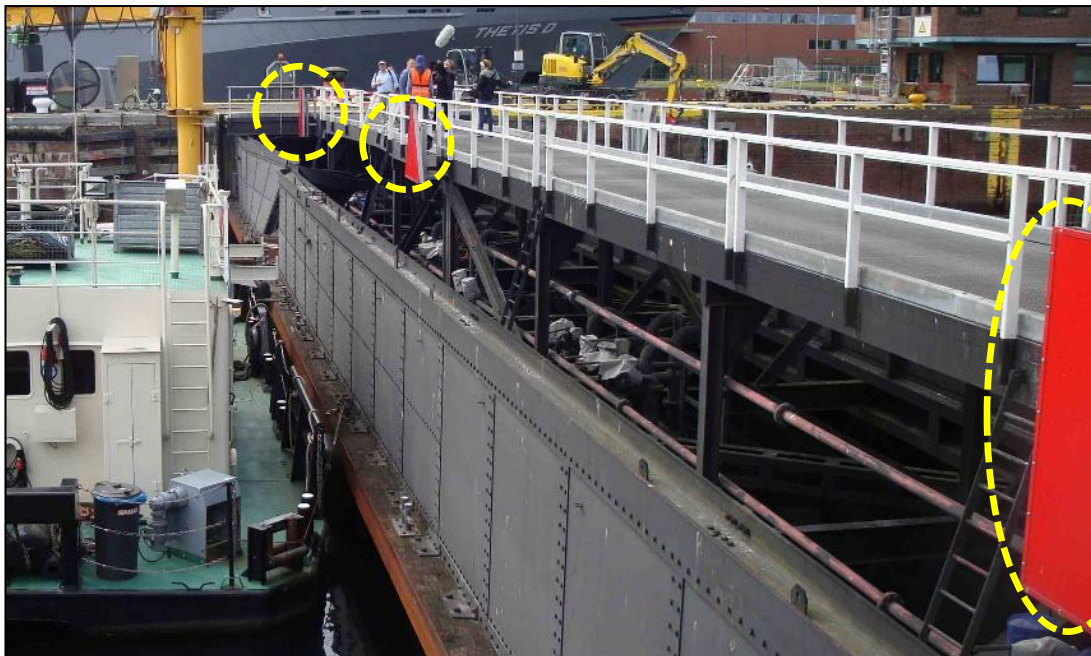
Figure 42: Position of the three warning lamps at the top edge of the closed lock gate

In addition to the traffic control signal installations, three large red warning lamps are mounted on the upper edge of the respective lock gate on its right-hand side, in the middle and on the left-hand side (left and right in the form of a rectangle in vertical format and in the middle in the form of a triangle; see **Figures 41 f.**). This warning system informs ship's commands and pilots clearly and unambiguously that the lock gate is closed if, for example, the above-mentioned signal installations have failed and/or the closed gate's contours cannot be clearly identified in the dark or due to other visual restrictions.
