**Bundesstelle für Seeunfalluntersuchung**  
**Federal Bureau of Maritime Casualty Investigation**

## **Interim Investigation Report 138/22**

### **Very Serious Marine Casualty**

**Person Over Board Resulting in Fatality  
on Board the Sailing Yacht SPEEDY GO  
on the Flensburg Firth on 8 April 2022**

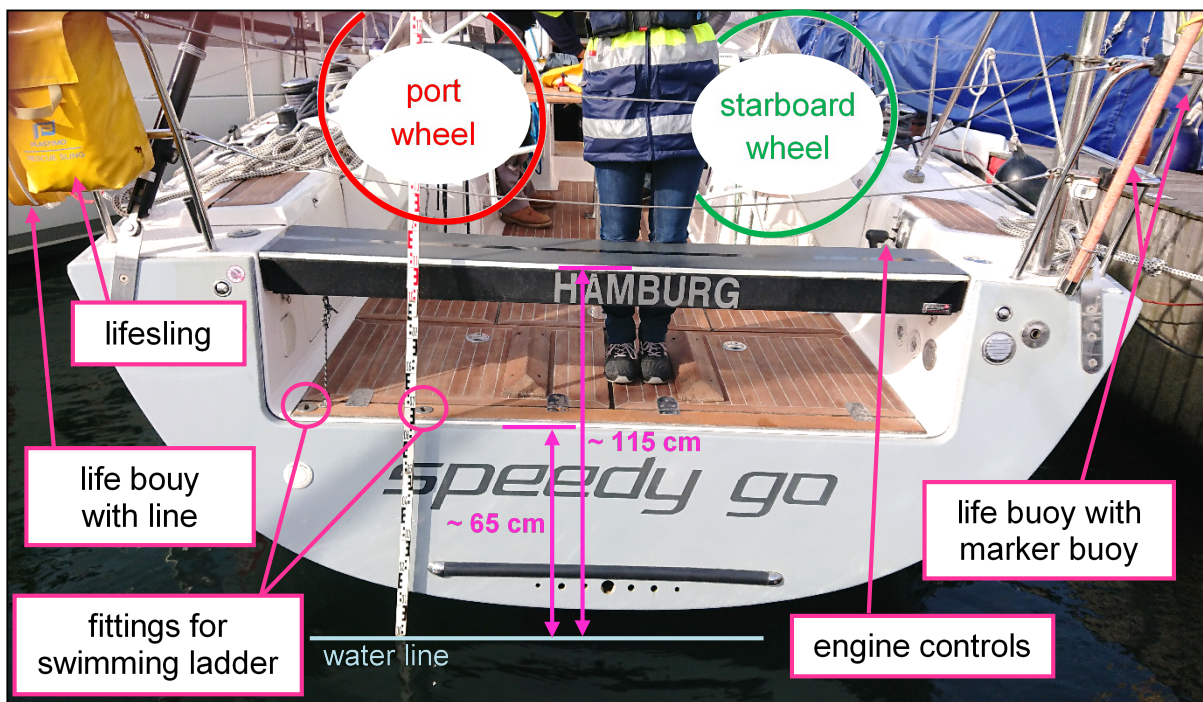
Figure 9: SPEEDY GO's cockpit viewed from the aft<sup>20</sup>

The skipper shouted from the water to his fellow sailors, "The swimming ladder!" The swimming ladder was then retrieved from the starboard side storage locker and inserted into the designated receptacles on the port side at the rear of the cockpit (cf. Figure 9 and Figure 12). The skipper was no longer able to climb the swimming ladder and was held by both hands as he was also unable to hold onto the ladder on his own.

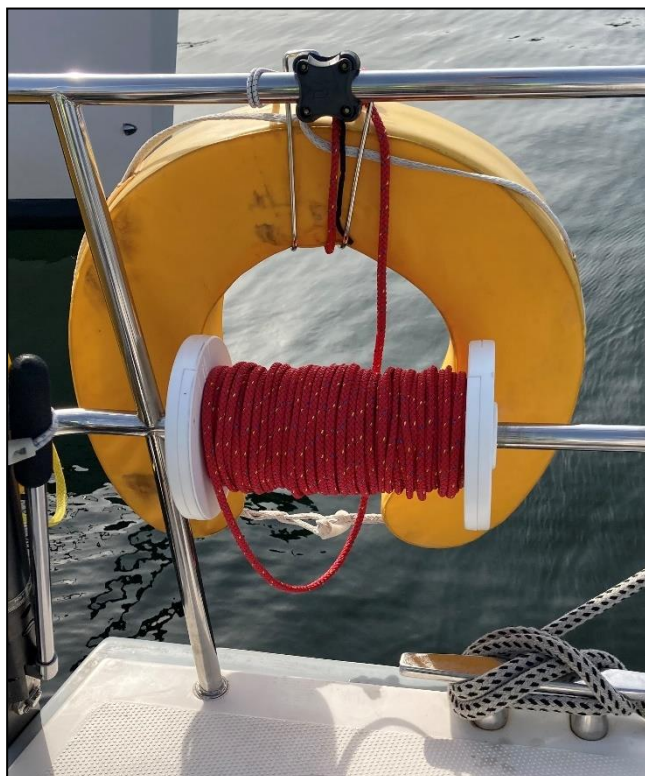
Figure 7: Portside horseshoe life buoy with line<sup>20</sup>

It was decided to proceed to the fellow sailor who was drifting in the water. With the help of the floating line from the portside lifebuoy, the fellow sailor reached the stern of the yacht, and the previously prepared mooring line with bowline was thrown to him. With one foot he went through the eye of the bowline, then pulled it further up around his thigh and held on to the line leading up into the cockpit. The end of the line was then placed on a winch to secure it against unintentional rushing out. The fellow sailor on the radio came up into the cockpit from below and saw the situation on deck. His co-sailor who had gone over board had already been pulled a little out of the water, he then grabbed him and let his weight fall backwards. By joining forces and winching up the line, the fellow sailors thus managed to rescue their colleague from the water at around 12:35.

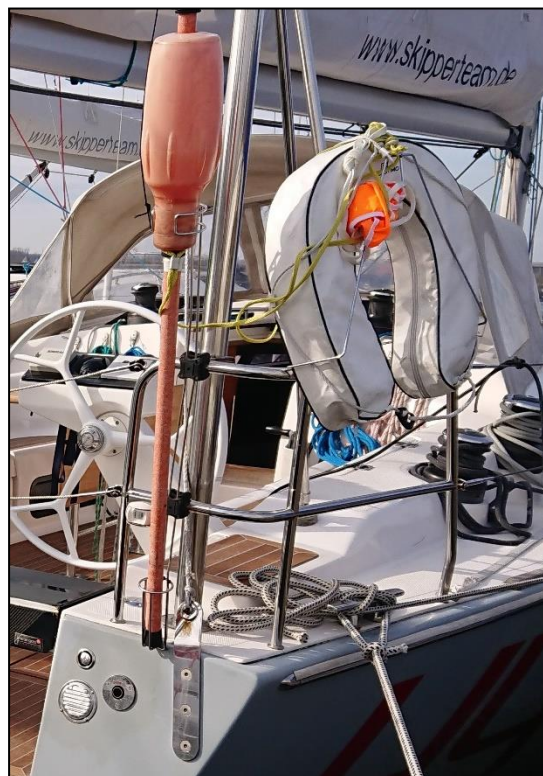
Figure 8: Starboard horseshoe life buoy with POB marker buoy<sup>20</sup>

The fellow sailor on the forecandle immediately shouted loudly, "Man over board!" The starboard horseshoe lifebuoy with position-marking POB buoy was given overboard. One of the fellow sailors started the engine on the starboard side of the cockpit, took over the helm there as well without communication and initiated a course change to port. Meanwhile, the port side horseshoe life ring attached to a self-feeding line (cf. Figure 9) was also thrown into the water. In order to reduce the yacht's speed due to the forward thrust of the headsail, both jib sheets were released. The jib killed loudly in the wind, causing unrest on deck. The headsail was then taken in collectively.

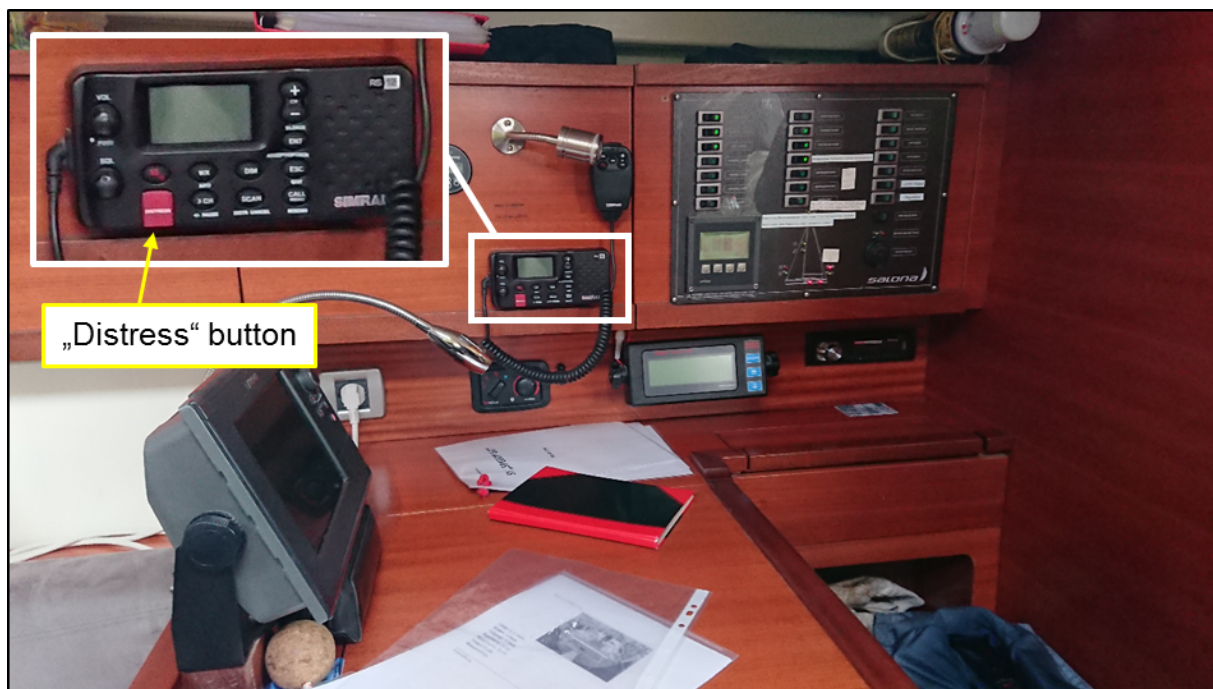
Figure 11: Desk / chart table with radio and other equipment<sup>22</sup>

One of the fellow sailors voiced that one of them had to make a distress call, whereupon another sailor went downstairs to the salon and pressed the "Distress" button on the radio. He was then downstairs most of the time and dealt with the subsequent radio traffic with various radio stations.

At 12:25, the radio message "MAYDAY, MAYDAY, MAYDAY. MMSI 211664360, call sign DG2167, man over board." was transmitted on VHF channel 16. The coastal radio station Lyngby Radio responded and asked questions about the position of the SPEEDY GO and the person in the water. Further, the SPEEDY GO was requested to keep the person in the water in sight and to stay close to the person with the yacht.<sup>23</sup>
