Bundesstelle für Seeunfalluntersuchung
Federal Bureau of Maritime Casualty Investigation

Interim Investigation Report 582/22

Serious Marine Casualty

**Allision of a mobile harbour crane, transported on
the heavy-lift vessel MERI, with two overhead bridge
constructions crossing the Kiel Canal
on 30 November 2022**

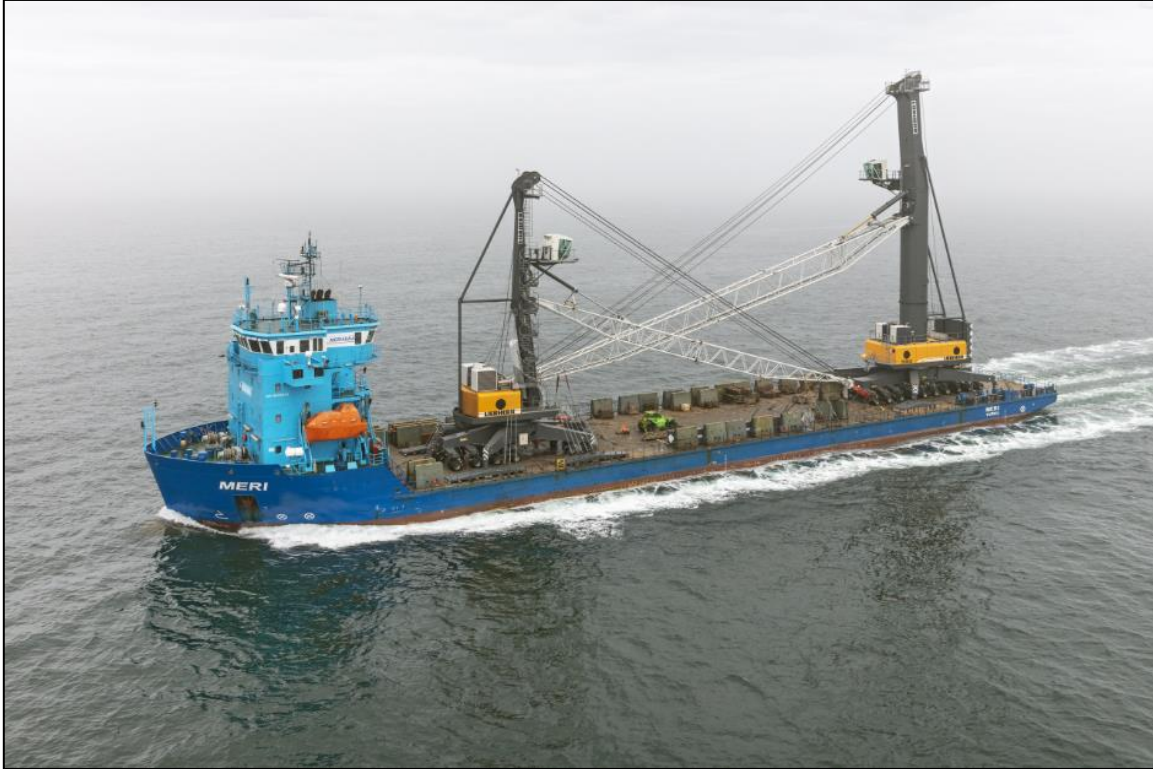
Figure 1: Photograph of the MERI, loaded with two mobile harbour cranes¹

¹ Source: Meriaura Oy. There was only one crane on board on the day of the accident.
