Bundesstelle für Seeunfalluntersuchung
Federal Bureau of Maritime Casualty Investigation

Interim Investigation Report 600/22

Serious Marine Casualty

Grounding of the PARANA on the Ems on 9 December 2022

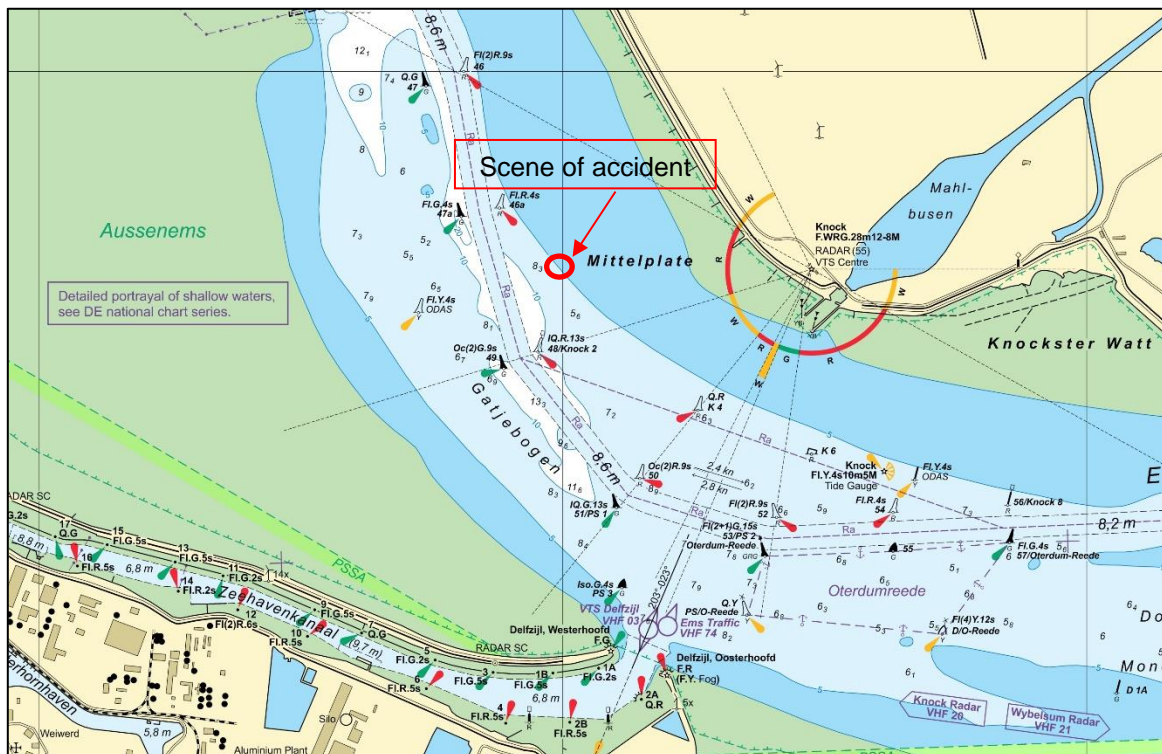
Figure 2: Sea chart with accident location³

Type of marine casualty:	Serious Marine Casualty, grounding
Date / time:	9 December 2022, 2356 ²
Location:	Ems, north of Buoy 48 / Knock 2
Latitude / Longitude:	$\phi = 53^\circ 20.38'N$, $\lambda = 006^\circ 59.92'E$
Voyage segment:	Pilotage waters
Place on board:	Bottom
Consequences:	Grounding outside the fairway
