**Bundesstelle für Seeunfalluntersuchung**  
Federal Bureau of Maritime Casualty Investigation

## **Investigation Report 138/22**

**Person Over Board Resulting in Fatality  
on Board the Sailing Yacht SPEEDY GO  
on the Flensburg Firth on 8 April 2022**

1 June 2023

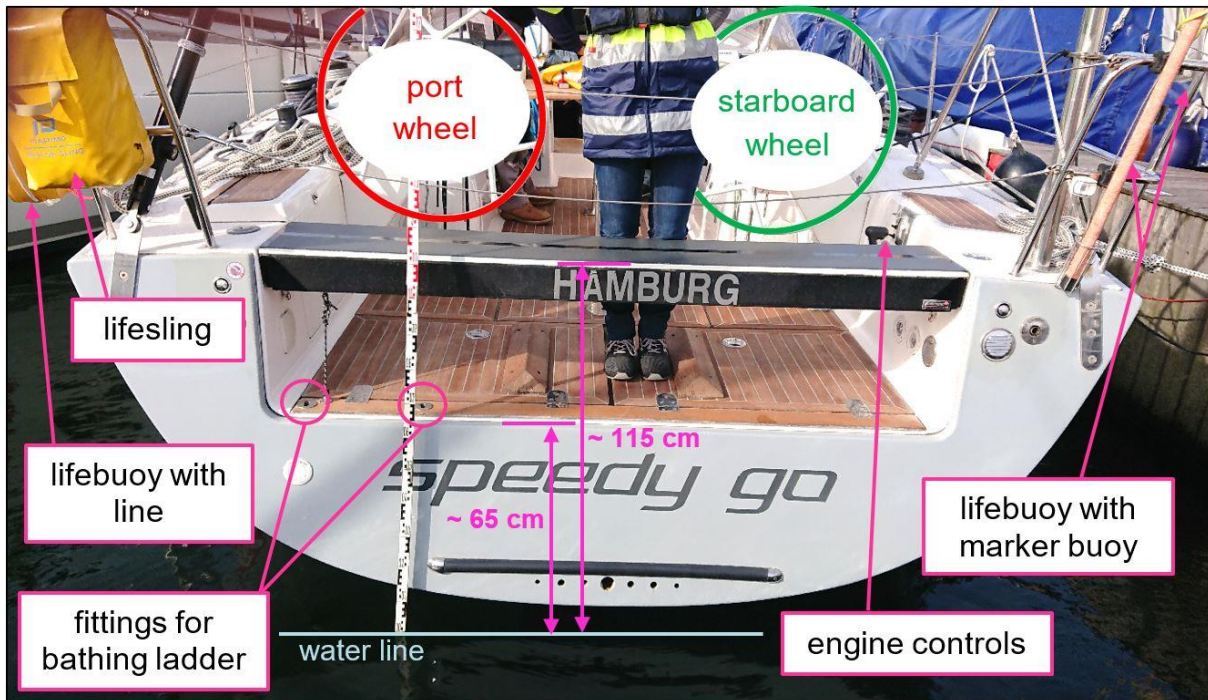
Figure 7: The SPEEDY GO's cockpit viewed from the aft<sup>27</sup>

Using the line floating in the water from the port-side lifebuoy, Alpha reached the yacht's stern again and Bravo threw the mooring line with the bowline knot, which had been prepared earlier on, out to him. He climbed into the eye of the bowline knot with one foot, then pulled it further up around his thigh and held onto the line, which led up into the cockpit. Charlie placed the end of the line on a winch, thus also securing it against accidentally running out. Bravo yelled loudly to Charlie at the winch: "Winch, winch, winch!" Echo came up to the cockpit from below and saw the situation on deck. Alpha had already been pulled a little out of the water, Echo grabbed Alpha and let himself fall backwards with his weight. With their combined efforts and by winching up the line, the co-sailors thus managed to rescue Alpha from the water at about 1235. Since the fellow sailors were unable to loosen the fittings of the anthracite-coloured aft bench in the cockpit, Alpha had to be lifted about 1.15 m out of the water and over the bench (see Figure 7).

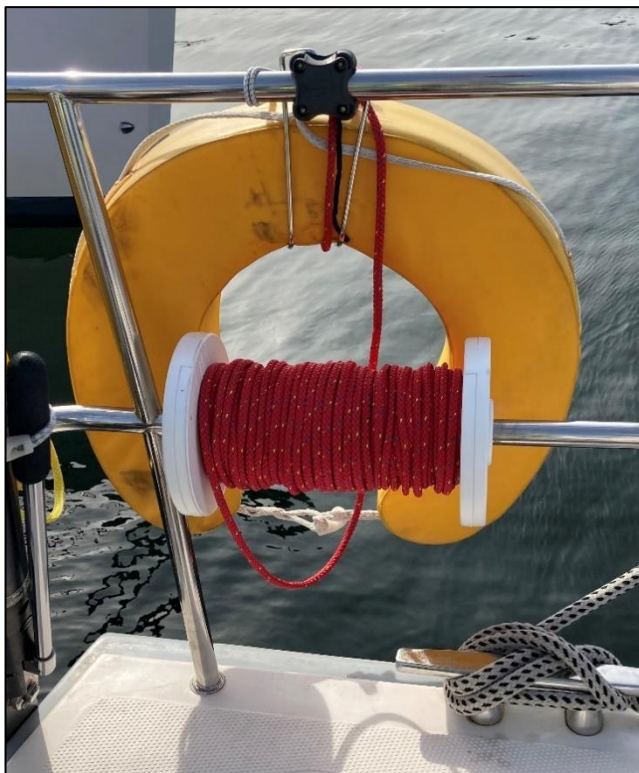
Figure 8: Port side horseshoe lifebuoy with line<sup>27</sup>

The lifesaving appliances on board the SPEEDY GO were also located aft of the cockpit (see Figure 7 ff.). Several fellow sailors described the difficulty of releasing the lifesaving equipment, secured by thin rubber expanders, from their mounts on the guardrail with their gloves on. (see 0)

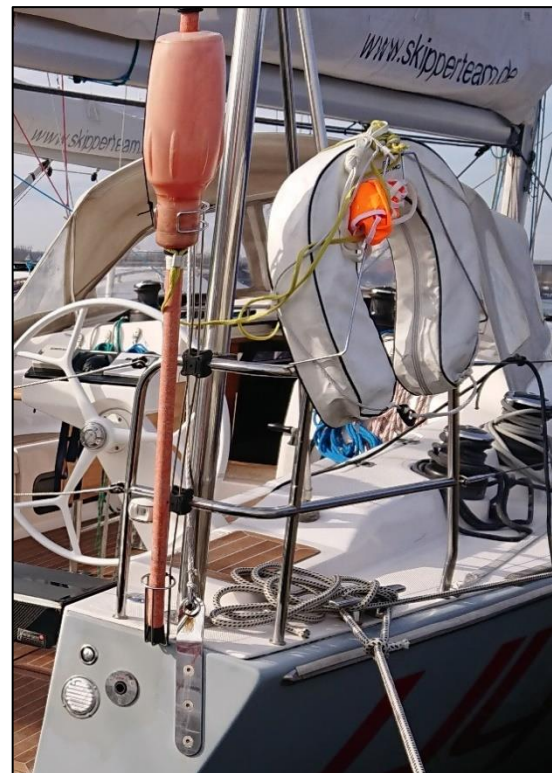
Charlie immediately called out loudly: “Man overboard!” Bravo loosened the horseshoe life ring on the starboard side behind him, which was attached to the POB buoy used for marking the position (see Figure 9 and Figure 15), and threw both overboard. Alpha continued to stand at the port side wheel. Bravo started the engine on the starboard side of the cockpit, took over the rudder there without communication and initiated a course alteration to port. In the meantime, Echo threw the horseshoe lifebuoy (see Figure 8) on the port side, which was attached to a self-feeding line, into the water. Bravo and Echo both had difficulty removing the lifesaving equipment, secured by thin rubber expanders, from the guardrail with their gloves on. To reduce the yacht's speed due to the propulsion from the headsail, the other co-sailors released both jibsheets. The jib beat loudly in the wind, causing unrest in the cockpit. Bravo and Charlie collectively took in the headsail.

Figure 9: Starboard horseshoe lifebuoy with POB marker buoy<sup>27</sup>

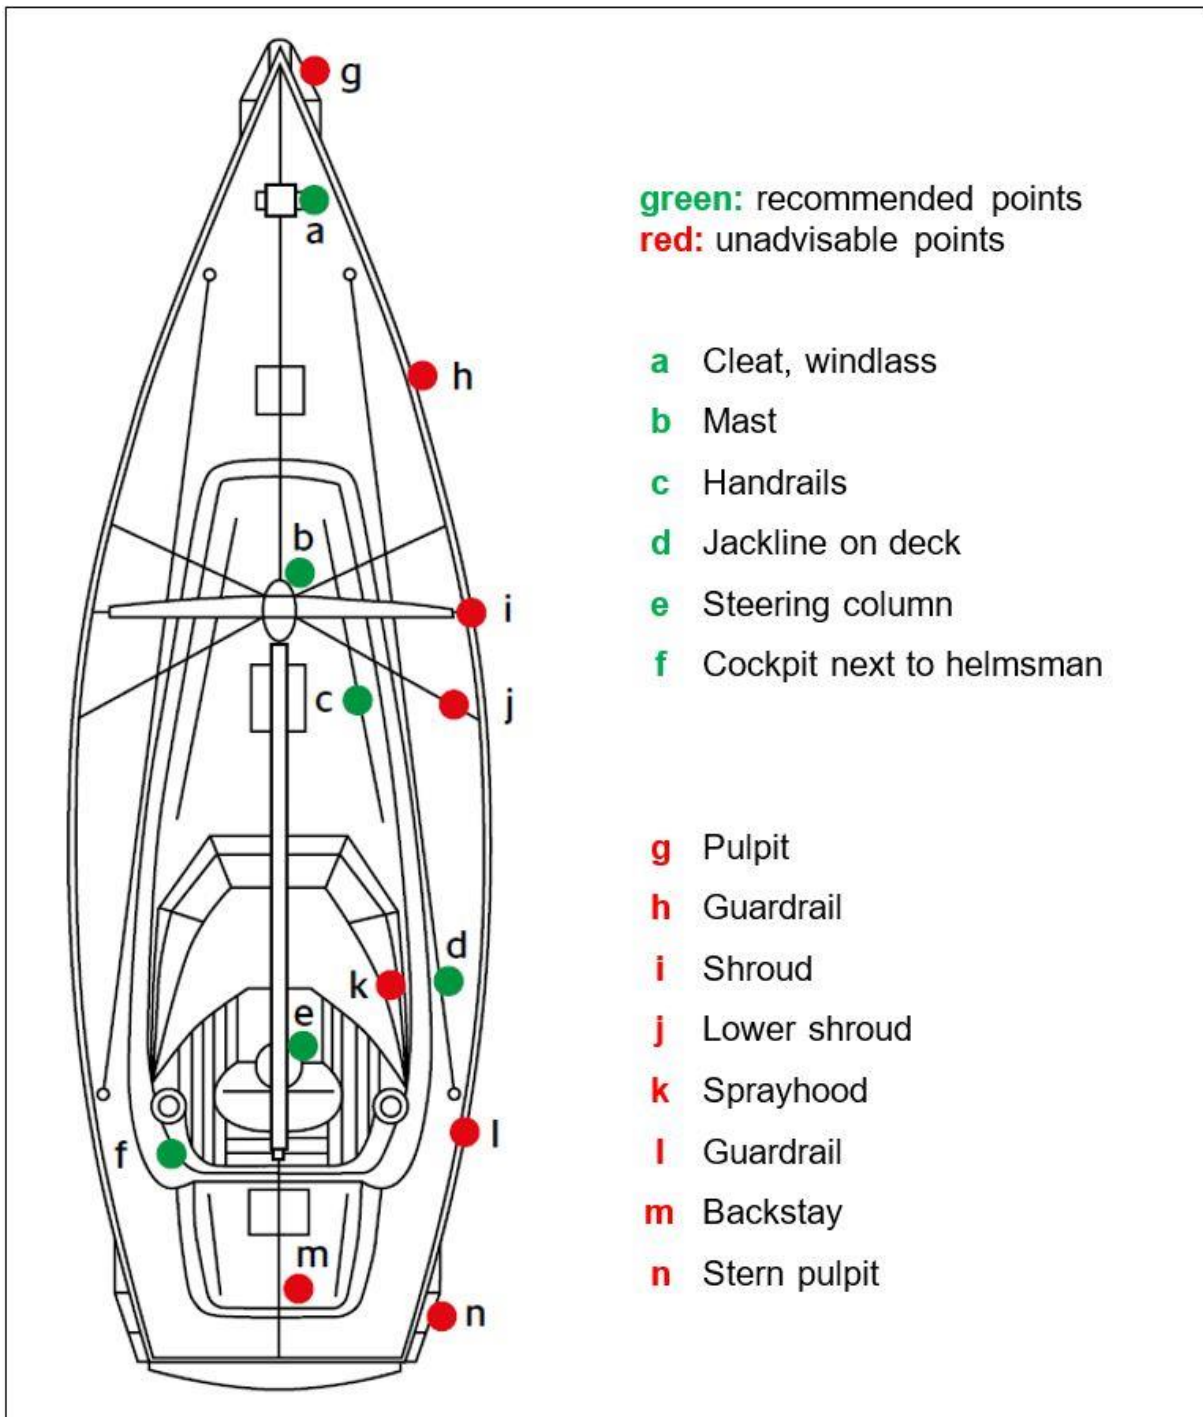
Figure 20: Lifeline anchor points on board a sailing yacht<sup>85</sup>

At the time of the accident, jacklines made of belt straps were deployed on the SPEEDY GO's deck to facilitate self-protection by means of a lifeline. It is unlikely that the jacklines on deck will prevent a fall over the guardrail, as they run uncrossed in the gangboard and therefore the slack is pulled out of the system under load. There are several other options for clipping the lifeline's karabiner directly at the mast, preventing the risk of falling overboard in case of a loss of balance.

In addition to the use of lifelines, safety-conscious behaviour on board can also reduce the risk of a POB accident, e.g. keeping a clean and tidy deck, but also always having three points of contact with the vessel (e.g. two feet and one hand) and staying crouched when moving on deck.

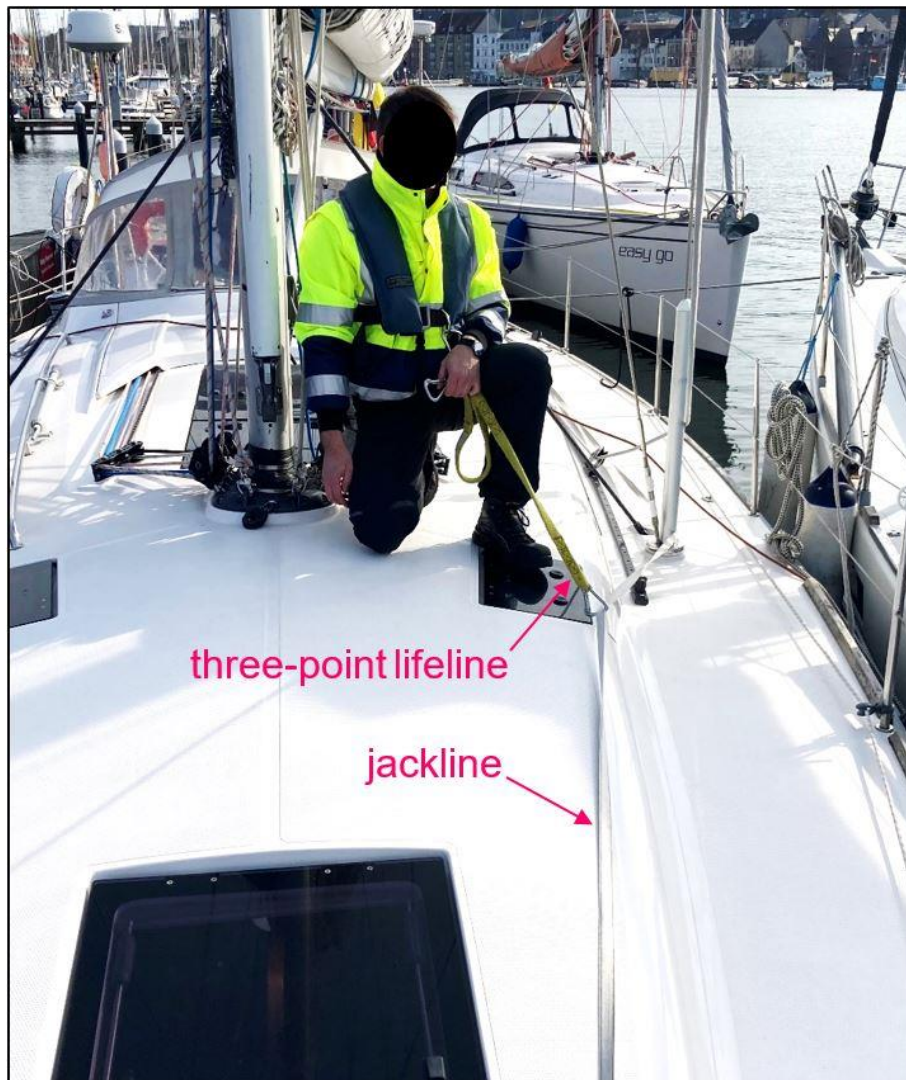
Everyone (including the skipper) on board the yacht was provided with an automatically inflatable lifejacket with three-point lifeline (see Figure 21 and Figure 19). The NAUTOMATIC ALTERNA lifejackets were made by KADEMATIC and had a crotch strap and buoyancy of 150 N. The service interval was maintained. The vessel operator had marked all the lifejackets with the name of the yacht and a serial number. This makes it possible to assign a personal lifejacket which is adapted to individual body measurements (circumference of the lifejacket and length of the crotch strap) to everyone on board at the beginning of the sailing trip.

On recreational crafts like the SPEEDY GO, self-protection on deck with a lifeline is possibly more important than wearing a lifejacket. In low water temperatures, heavy seas, darkness, with a small crew and e.g. on yachts with a high freeboard, falling overboard is especially dangerous – even with a lifejacket. Under such conditions, the probability of losing sight of the person in the water or of the person in the water no longer being able to assist in reboarding, e.g. due to hypothermia (see 3.2.10.3), is greatly increased in such cases. Accordingly, wearing lifelines and selecting suitable anchor points is especially necessary in adverse environmental conditions, as well as when working on deck or during sailing manoeuvres in order to prevent falling overboard from the outset. Not all anchor points on board are suitable. Depending on the length of the lifeline, points should preferably be chosen that are as far amidships as possible or on the windward side, as the likelihood of going overboard is greater on the leeward (low) side.

Figure 21: Use of the vessel's lifejacket with lifeline<sup>86</sup>

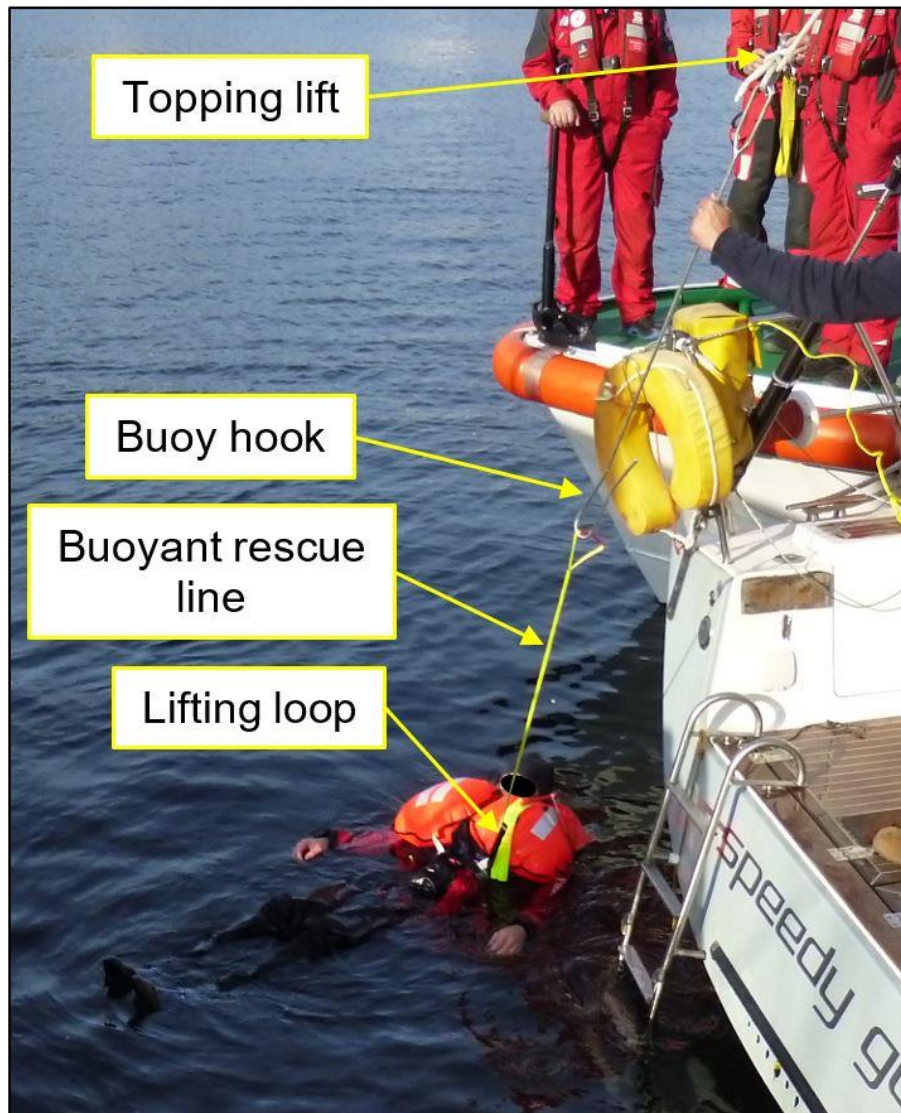
Figure 27: Rescue using a buoy hook attached to the topping lift<sup>100</sup>

The lifesling attached to the aft guardrail (see Figure 30) and the buoy hook in conjunction with the topping lift or a halyard (see Figure 27) were not made use of on board the SPEEDY GO. Accordingly, the co-sailors only used the equipment stipulated by the Ship Safety Division (BG Verkehr). The additional lifesaving equipment was not addressed in the skipper's safety familiarisation and no (emergency) manoeuvres were

5. Skiff hook on the topping lift  
*Remove topping lift from main boom and attach a buoy hook with which the eyelet or lifting loop of the lifejacket or a safety harness can be 'fished' (option chosen by the vessel operator of the SPEEDY GO);*

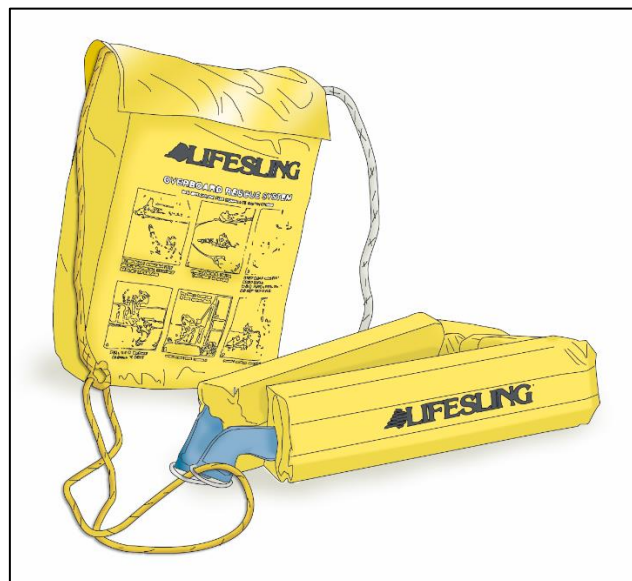
Figure 30: Lifesling (not mandatory)<sup>105</sup>

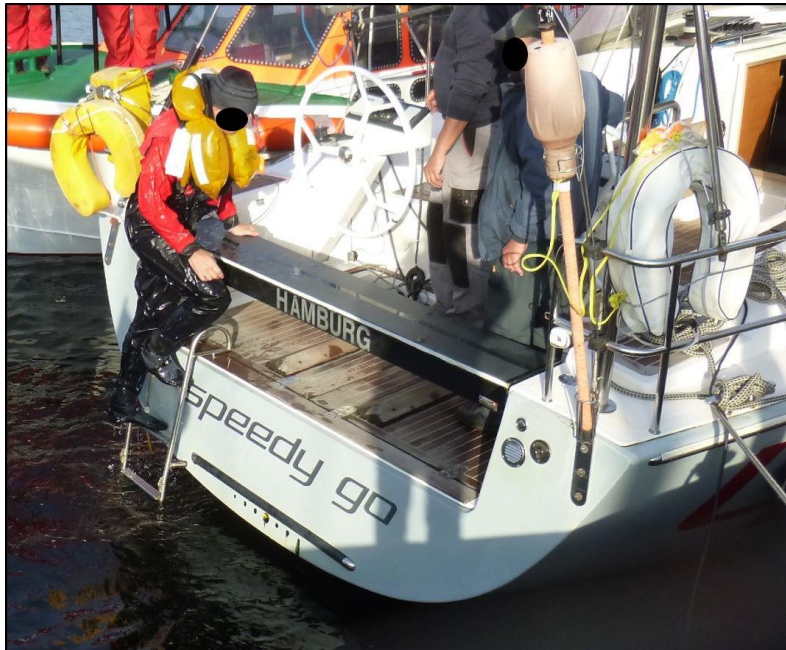
- use of the (reconstructed) **bathing ladder**
  - with a 150 N lifejacket from the vessel and the aft bench seat installed;

Figure 31: Test No 1<sup>115</sup>

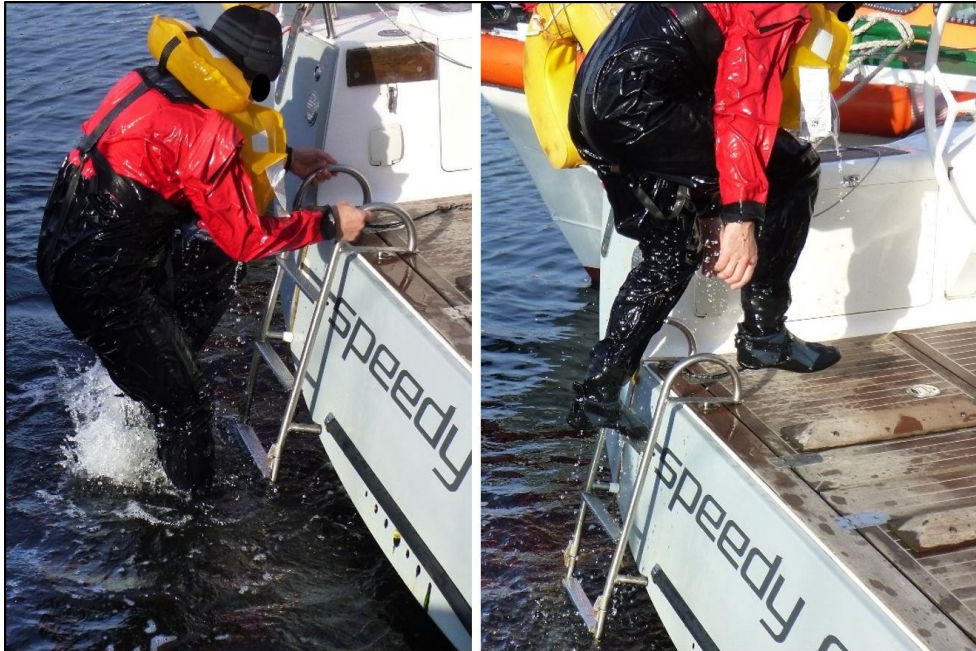
Figure 32: Test No 2<sup>116</sup>

- with a 150 N lifejacket from the vessel and the aft bench seat not installed;

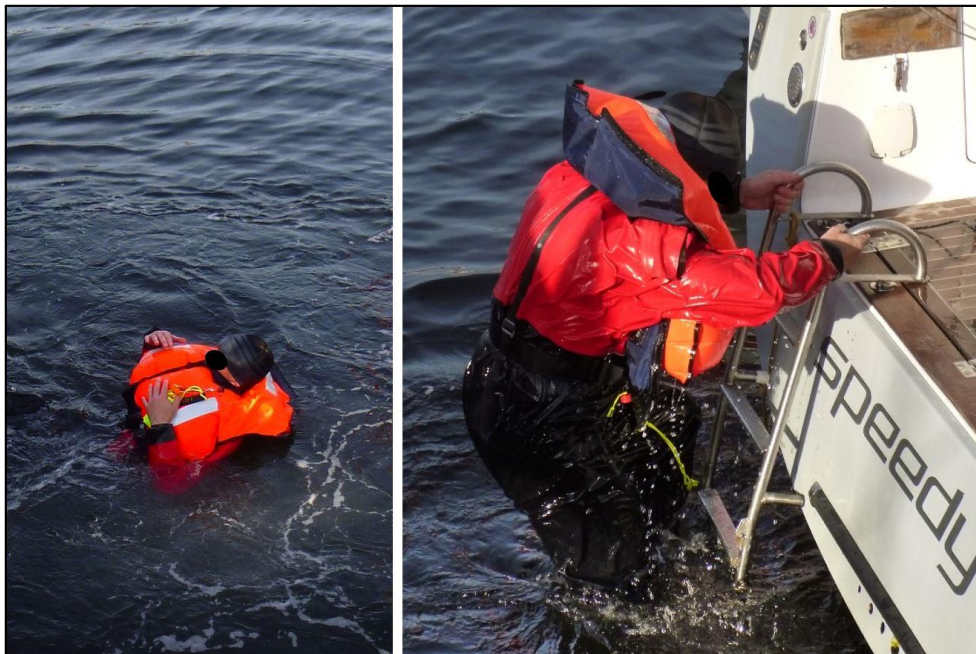
Figure 33: Test No 3<sup>117</sup>

- with a 275 N lifejacket from the BSU and the aft bench seat not installed;

- When the reconstructed bathing ladder, which was not bolted down, was shaken lightly, it quickly came loose from its anchorage on the deck and disengaged. (see Figure 12)

After the loss of the bathing ladder during the rescue operation on 8 April 2022, the vessel operator immediately ordered another portable bathing ladder to be manufactured as a replacement (see Figure 12, Figure 24 and Figure 32 ff.). The lowest rung of the reconstructed bathing ladder was about 52 cm below the water surface. The distance between the rungs was about 27 cm. This bathing ladder could be climbed without any problems during the series of rescue tests carried out on 26 October 2022 by the BSU in cooperation with the vessel operator and the DGzRS (see 3.2.12). However, if the ladder was jolted, as would be unavoidable in stronger wind and swell, it lifted out of its anchorage easily because it could not be secured with knurled thumb screws like the original ladder.

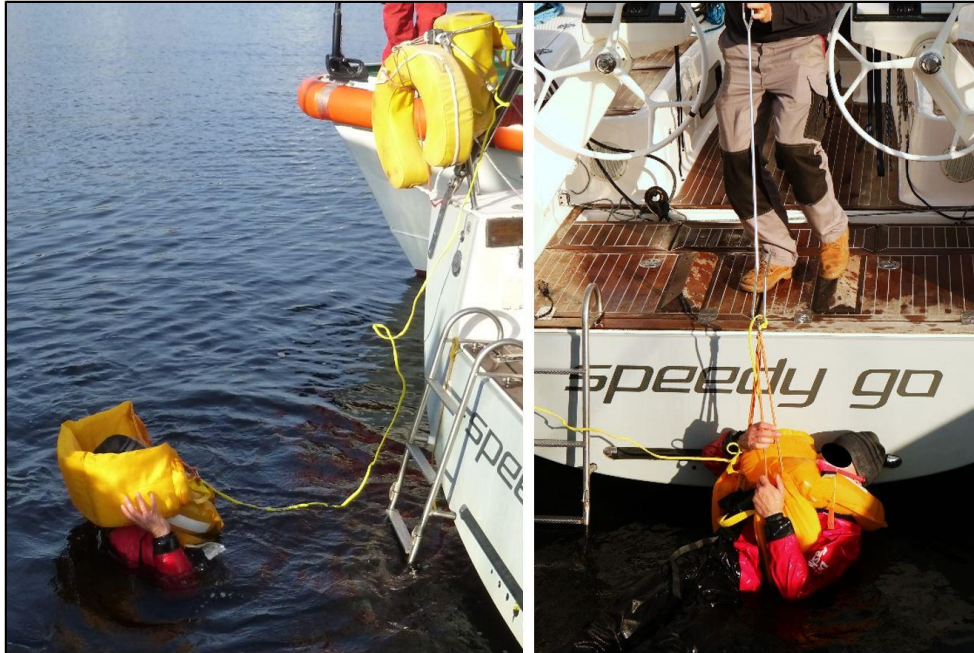
Figure 34: Test No 4<sup>118</sup>

- haul up using a **lifesling** with the assistance of the topping lift in conjunction with the vessel's buoy hook;

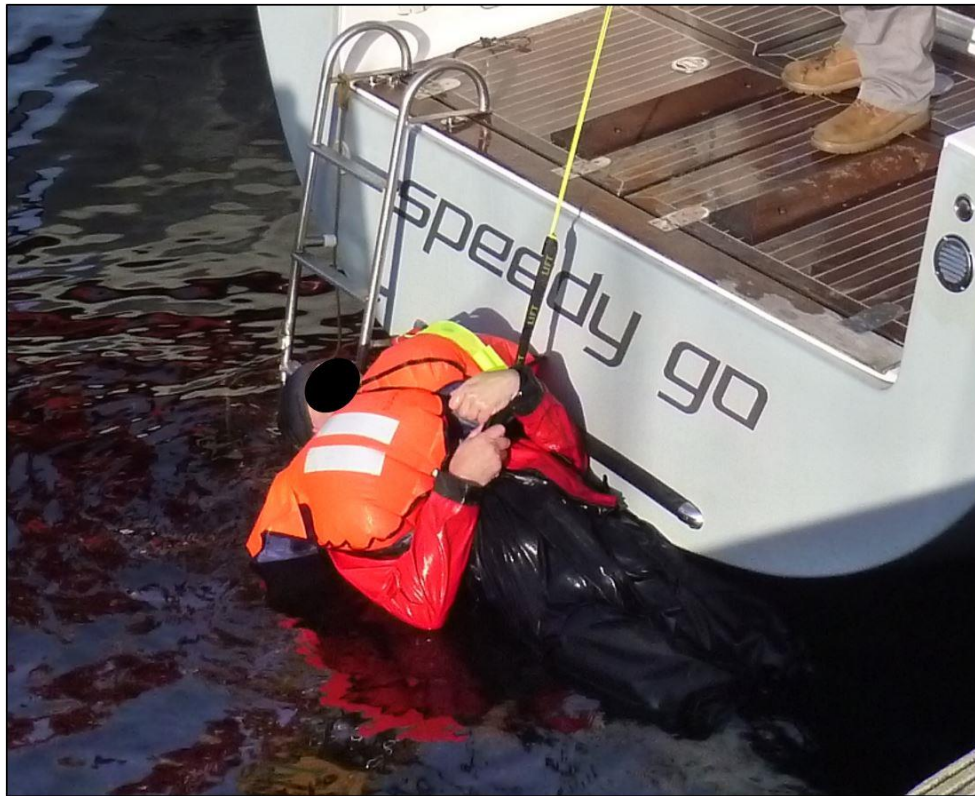
Figure 35: Test No 5<sup>120</sup>

- haul up using the **lifting loop on the lifejacket** and 'MOB Lifesaver'<sup>119</sup> (with the assistance of the topping lift in conjunction with the vessel's buoy hook, which was hooked into the triangular loop on the MOB Lifesaver – see also Figure 27);

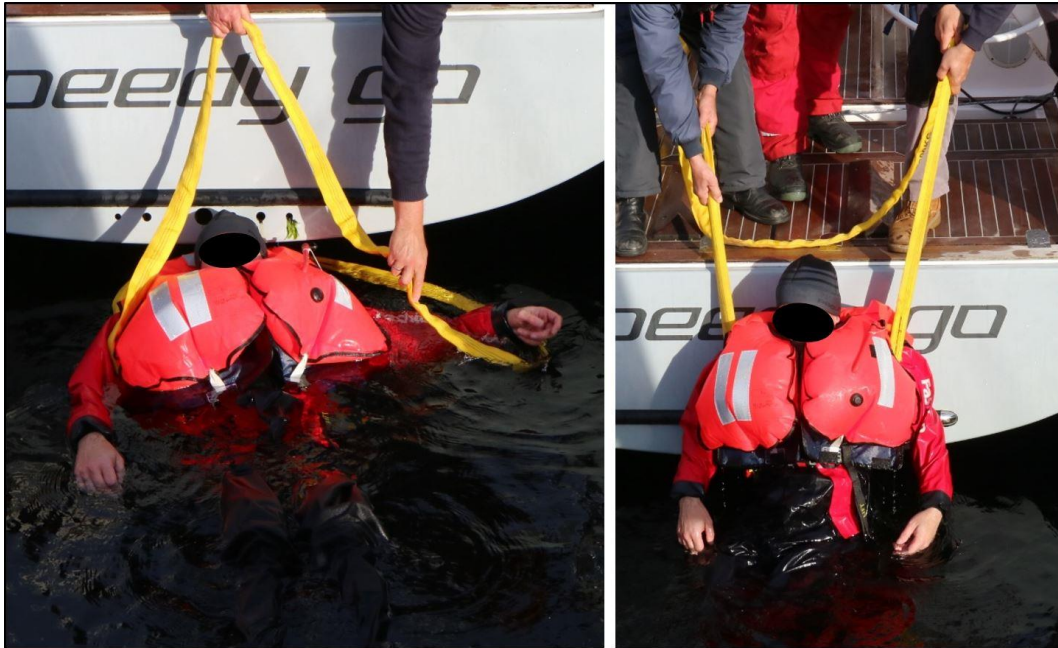
Figure 36: Test No 6<sup>121</sup>

- haul up using a **round sling**;

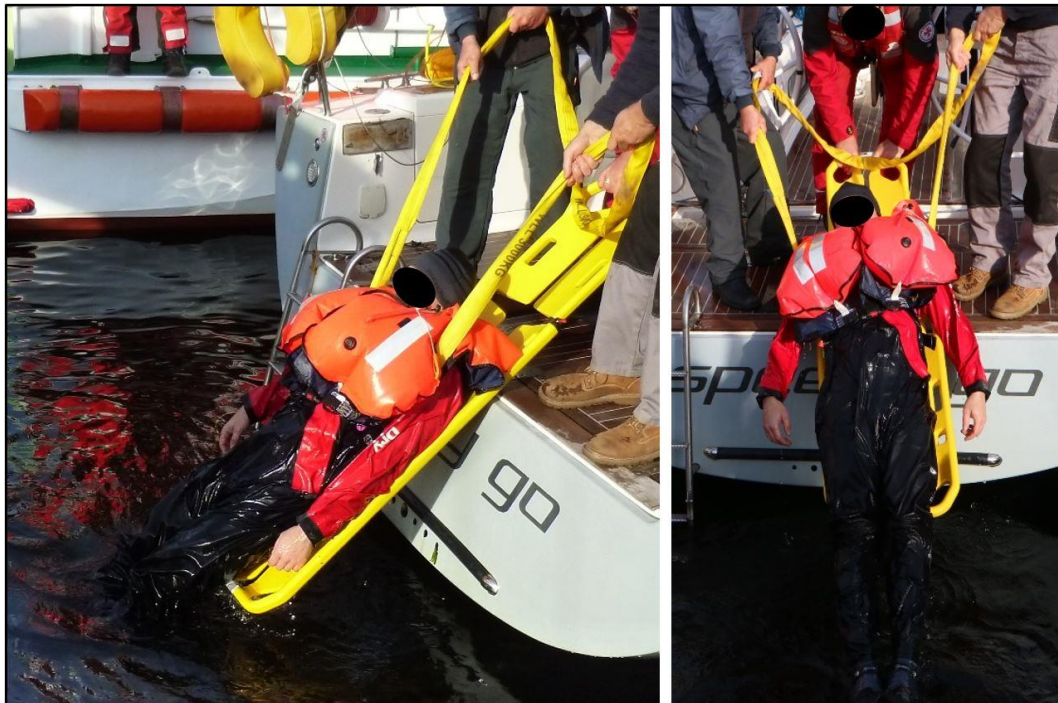
Figure 37: Test No 7<sup>122</sup>

- haul up using a **round sling and scoop stretcher**;

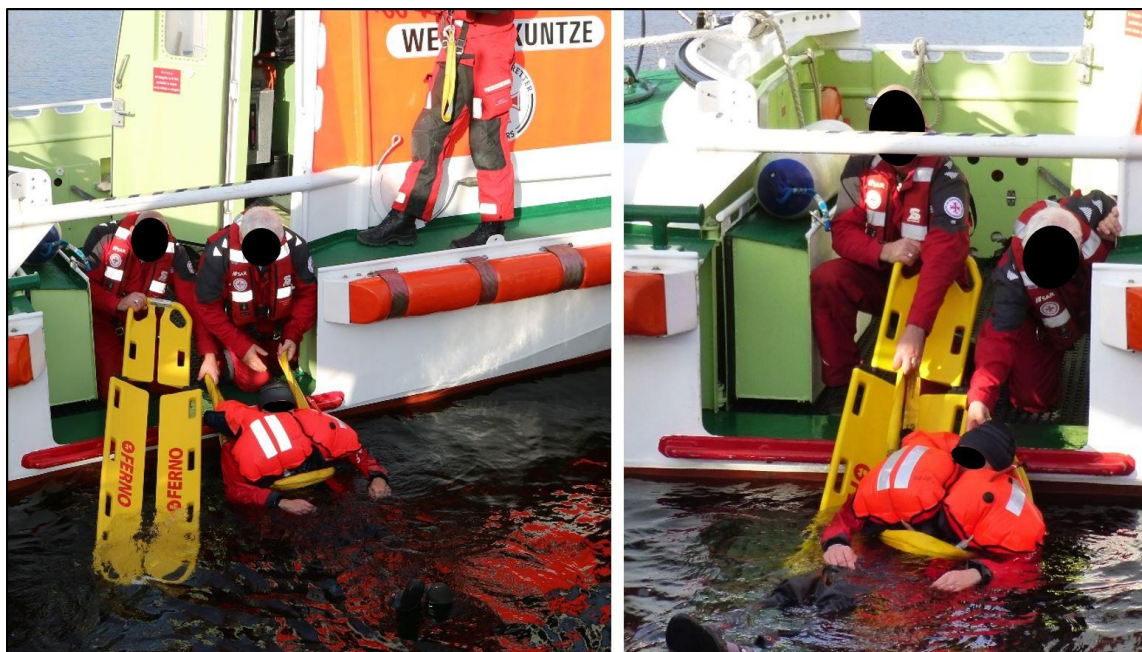
Figure 38: Test No 8<sup>123</sup>

- rescue using a round sling and scoop stretcher by the **WERNER KUNTZE**.

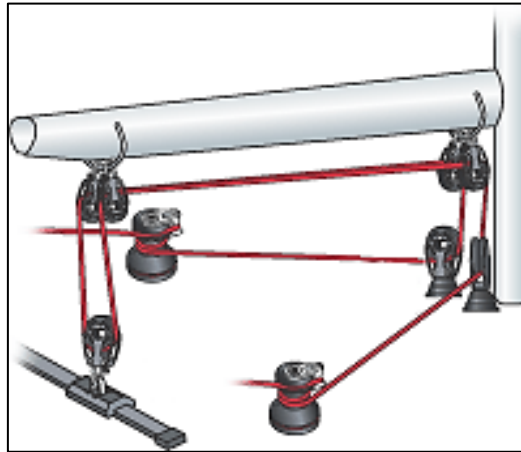
Figure 39: Main sheet configuration in the German mainsheet system<sup>128</sup>

On board the SPEEDY GO, the lifesling would probably have been the only way to bring the skipper back on deck immediately after he fell overboard, i.e. when he was still partially able to actively assist in a rescue. However, the co-sailors did not know about this lifesaving appliance because it was not included in the safety familiarisation. A rescue tackle was not on board. The co-sailors would hardly have been able to haul up the skipper in the headsail or mainsail via the halyard winch, with topping lift and mainsheet or via a boom out of the main boom with the mainsheet as a rescue tackle (see 3.2.10.2 points 2-4). On the one hand, they were not familiar with the configuration of the SPEEDY GO's running rigging, as neither were included in the familiarisation and not even 90 minutes had passed since the start of the sailing trip. On the other hand, it would not have been easy to convert the headsail to a recovery sail due to the furling system without travellers. The mainsail was not set and the SPEEDY GO's mainsheet is run in the rather unusual 'German mainsheet system' (see Figure 39 and

Chapter 4.4 of BSU Investigation Report 143/11). This would have complicated the use of the mainsheet for rescue, as the sheet has two ends that would have had to be operated and secured.
