**Bundesstelle für Seeunfalluntersuchung**  
Federal Bureau of Maritime Casualty Investigation

## **Investigation Report 236/20**

### **Serious Marine Casualty**

#### **Fire in the main engine scavenge air duct on board the EBBA MAERSK on 29 July 2020**

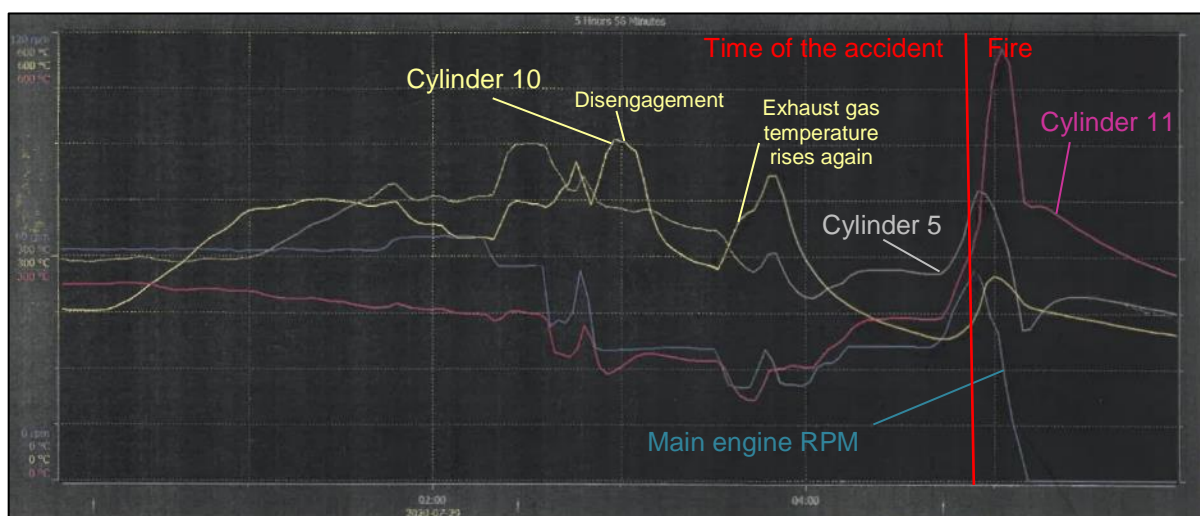
The exhaust gas temperature of cylinder 10 started to rise again only half an hour after it had been disengaged (after initially dropping as expected), even though the ICU was not being actuated, meaning that no injection should have taken place.

Crewmembers whom the chief engineer had sent to the scene to gain an overview of the situation reported that pressure pulsations could still be felt on the forward injection line of cylinder 10, despite it being disengaged. These were described as having a high frequency – “like a machine gun.”

Figure 3: Development of individual exhaust gas temperatures and ME RPM<sup>14</sup> at between about 0200 and 0800 local time

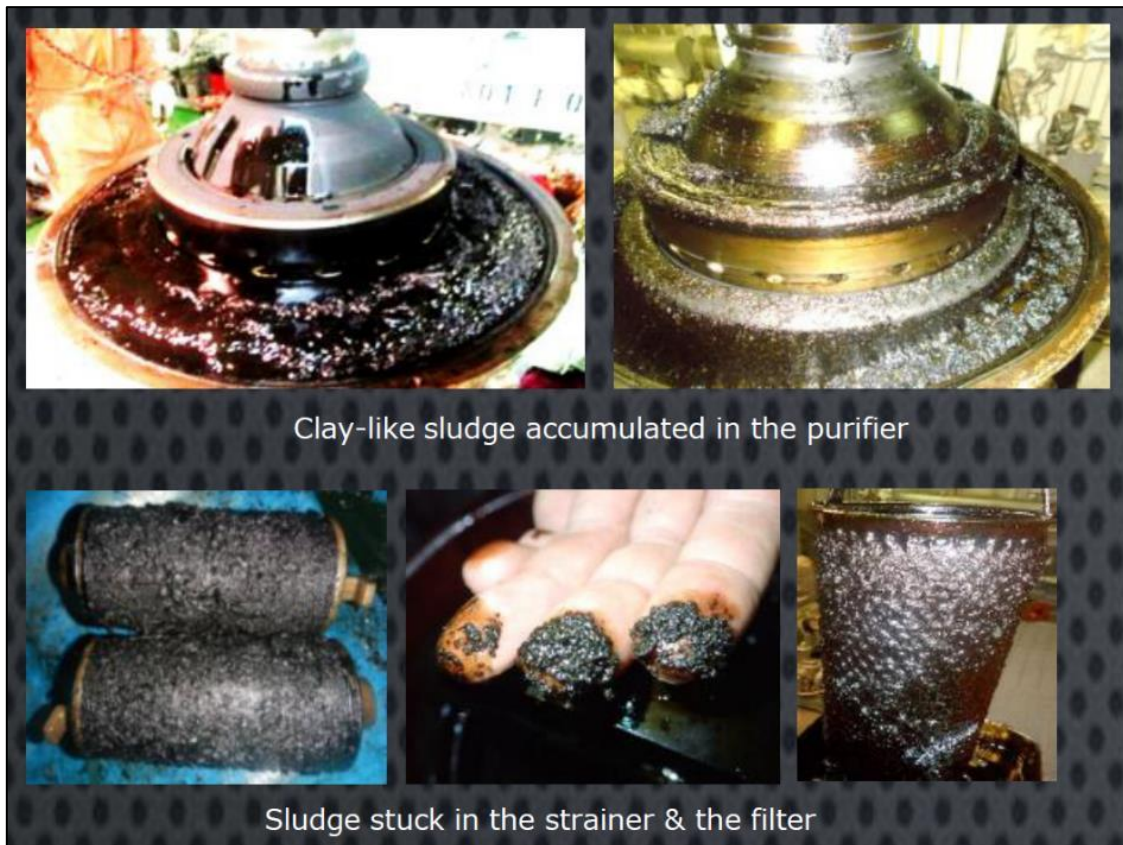
While the asphaltene particles were previously isolated and suspended in the 'stable', i.e. homogeneous and flowable heavy fuel oil, the polarised particles now begin forming clusters. The result is that at least one of the heavy fuel oils breaks down into its lighter components on the one hand, and a thick, solid, tar-like mass, sometimes described as 'clay-like'<sup>48</sup> (so-called 'sludge') on the other. This substance will settle in tanks and clog purifiers, filters, settling tanks, day tanks, and fuel lines. The heavy fuel oil has become 'unstable' (see Figure 13). In the worst case, this can lead to a seemingly sudden failure of the propulsion machinery.

Figure 13: Oily sludge in purifiers and filters after fuel blending<sup>48</sup>  
(precipitated asphaltenes)

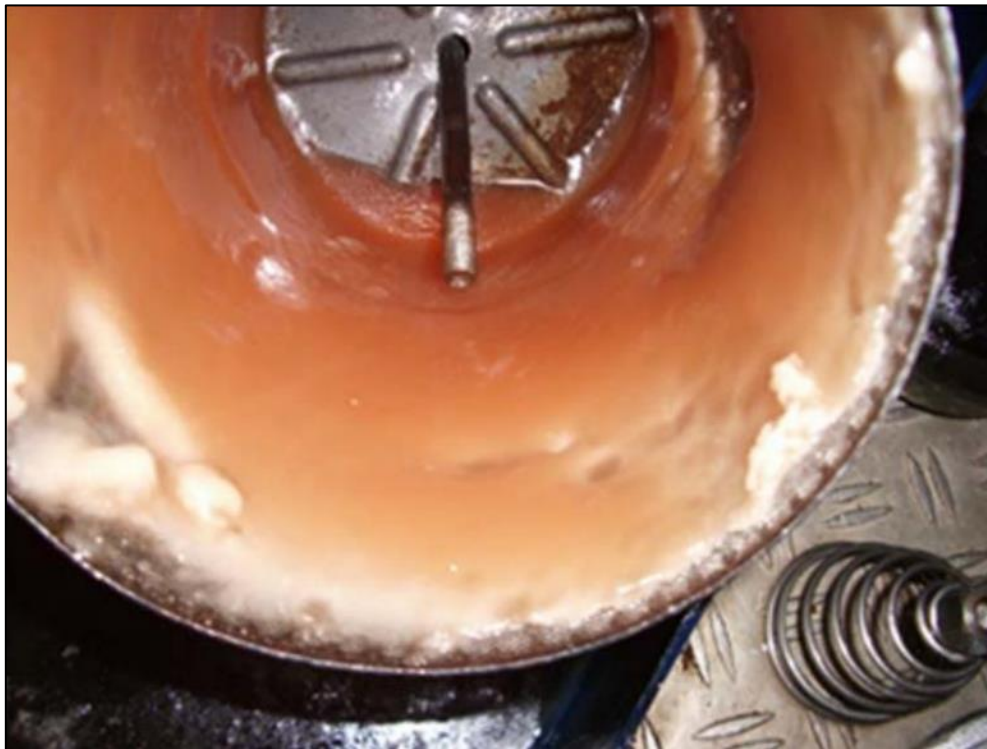
Figure 15: Filter clogged with solidified wax<sup>57</sup>

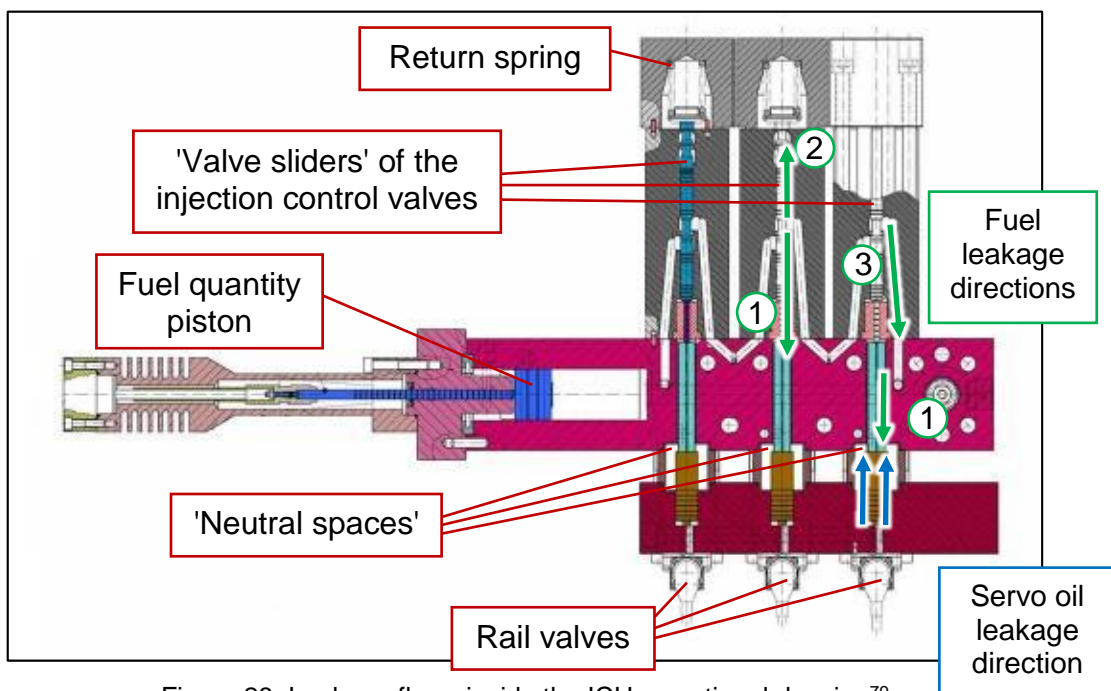
sealing surfaces (Figure 28, marked in blue), which is nevertheless ‘acceptable’ under normal circumstances, according to WinGD.

Similarly, if the sealing gaps are worn (i.e. enlarged), there will be a certain amount of fuel leakage through the seats (guides) of the so-called 'valve sliders'<sup>77</sup> into the neutral spaces (shown in green, leakage flow 1). This is intended and desired because fuel lubricates and cools (even at the prevailing fuel temperatures). Deposits can occur when control oil is exposed to much hotter fuel here and is then thermally decomposed, especially if the drain for discharging the leakage is clogged.<sup>78</sup>

Another unintentional fuel leakage flow originates at the valve slider seats into the so-called 'spring space' in which the return spring is located (leakage flow 2). A further unwanted leakage flow occurs in the area of the 'transverse flow', which originates from the fuel quantity piston and flows in the direction of the injection valve (leakage flow 3, see also Figure 21 to Figure 27). This leakage is evidently 'highly dependent on viscosity', i.e. especially prevalent when using light fuels, and can reach the injection valves.<sup>78</sup>

Figure 28: Leakage flows inside the ICU – sectional drawing<sup>79</sup>

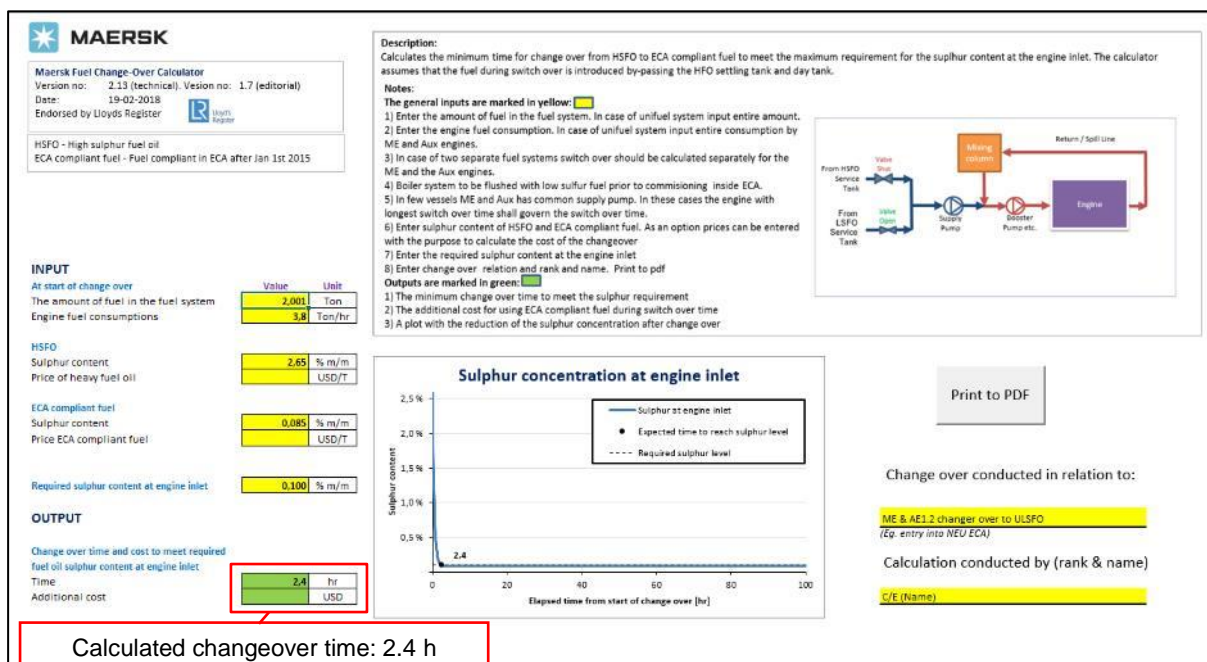
Figure 31: EBBA MAERSK fuel changeover spreadsheet<sup>84</sup>

The calculated changeover time of 2.4 h (2 hours and 24 minutes, see Figure 31) was adhered to and even slightly exceeded on the day of the accident. A longer time is favourable here (see course of the accident, Chapter 3.1.1: the changeover operation started at about 0150 and finished at 0327, corresponding to 2 hours and 37 minutes, i.e. 2.62 h).

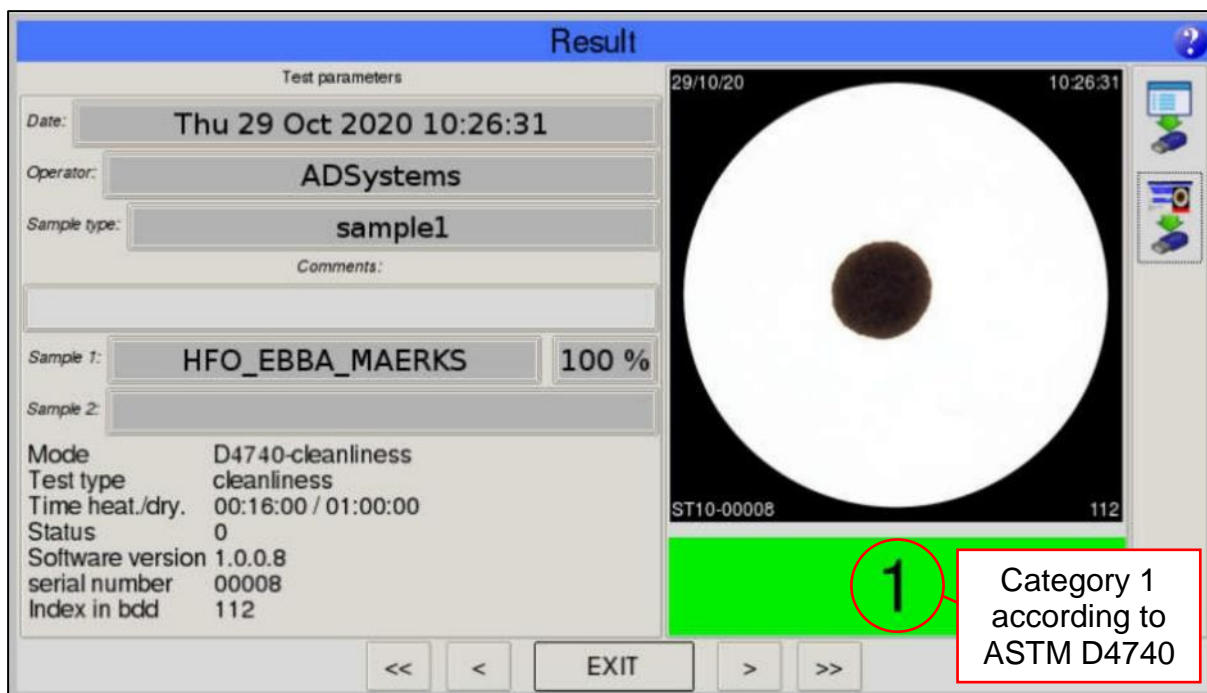
Figure 32: Spot test of the HFO used before the changeover<sup>90</sup>

The TUHH fuel laboratory carried out an automated, i.e. very precise and reproducible spot test on the sulphurous heavy fuel oil. This revealed that it was stable (see Figure 32).

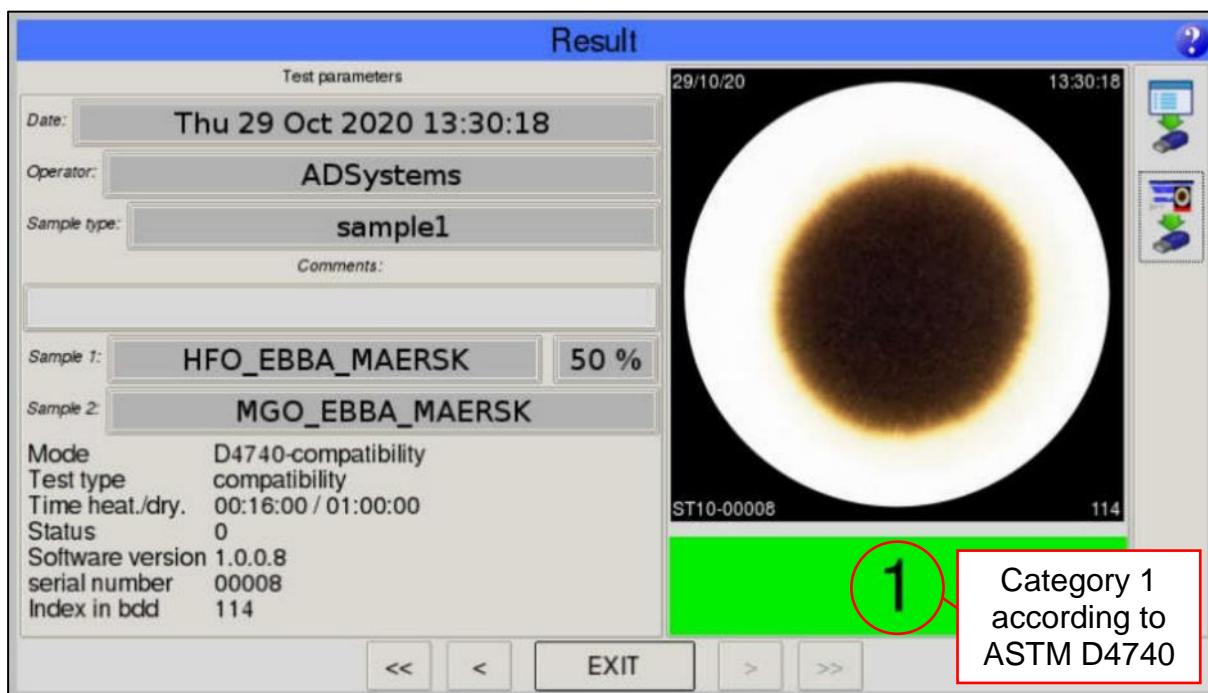
Figure 33: Spot test of the two fuels involved in the changeover

Another automated spot test was carried out in the TUHH fuel laboratory. This time the two fuels were blended at a ratio of 1:1. The test revealed that the blend was stable, i.e. the two fuels were compatible with each other (see Figure 33). Accordingly, the possible storage of the gas oil in a tank previously used for heavy fuel oil had had no influence on its stability.

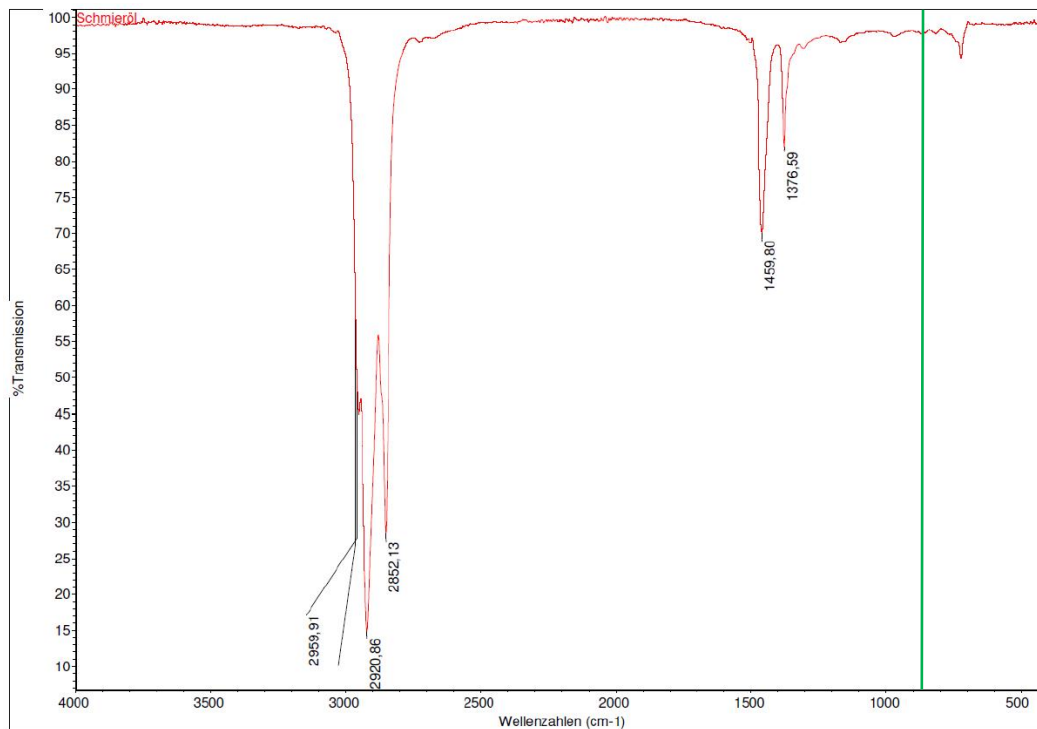
Figure 36: ATR spectrum of the subsequently delivered lubricating oil (875 cm<sup>-1</sup> marked)

Dr Bullermann requested a sample of lubricating oil from the EBBA MAERSK, which was sent accordingly. However, no calcium components were found in this.
