**Bundesstelle für Seeunfalluntersuchung**  
Federal Bureau of Maritime Casualty Investigation

## **Investigation Report 343/22**

### **Serious Marine Casualty**

**Allision with the Old Kattwyk bridge  
by FAIRPLAY 82  
on 21 July 2022**

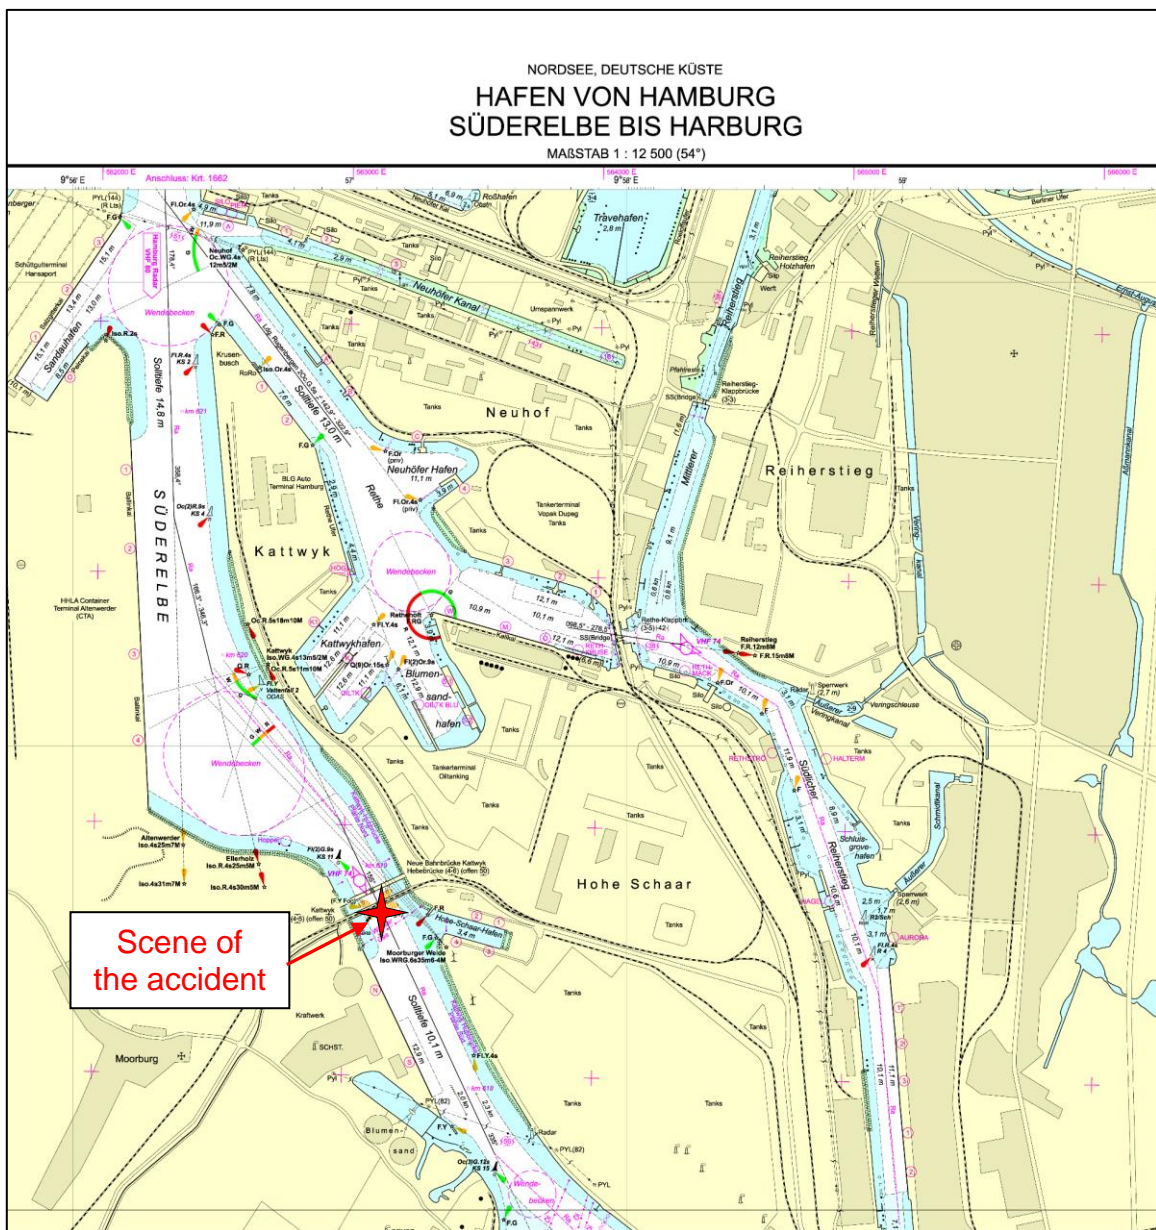
Figure 2: Navigational chart showing the scene of the accident

Type of marine casualty:	Serious accident, allision with a bridge by a tug
Date, time:	21/07/2022, 1817
Location:	Port of Hamburg, Kattwyk bridge
Latitude/Longitude:	$\Phi = 53^{\circ}29.4'N$ , $\lambda = 009^{\circ}57.1'E$
Ship operation and voyage segment:	Tug assistance completed, fairway mode
Place on board:	Amidships, wheelhouse
Consequences:	Three crew members with minor injuries, heavy damage to the tug's wheelhouse

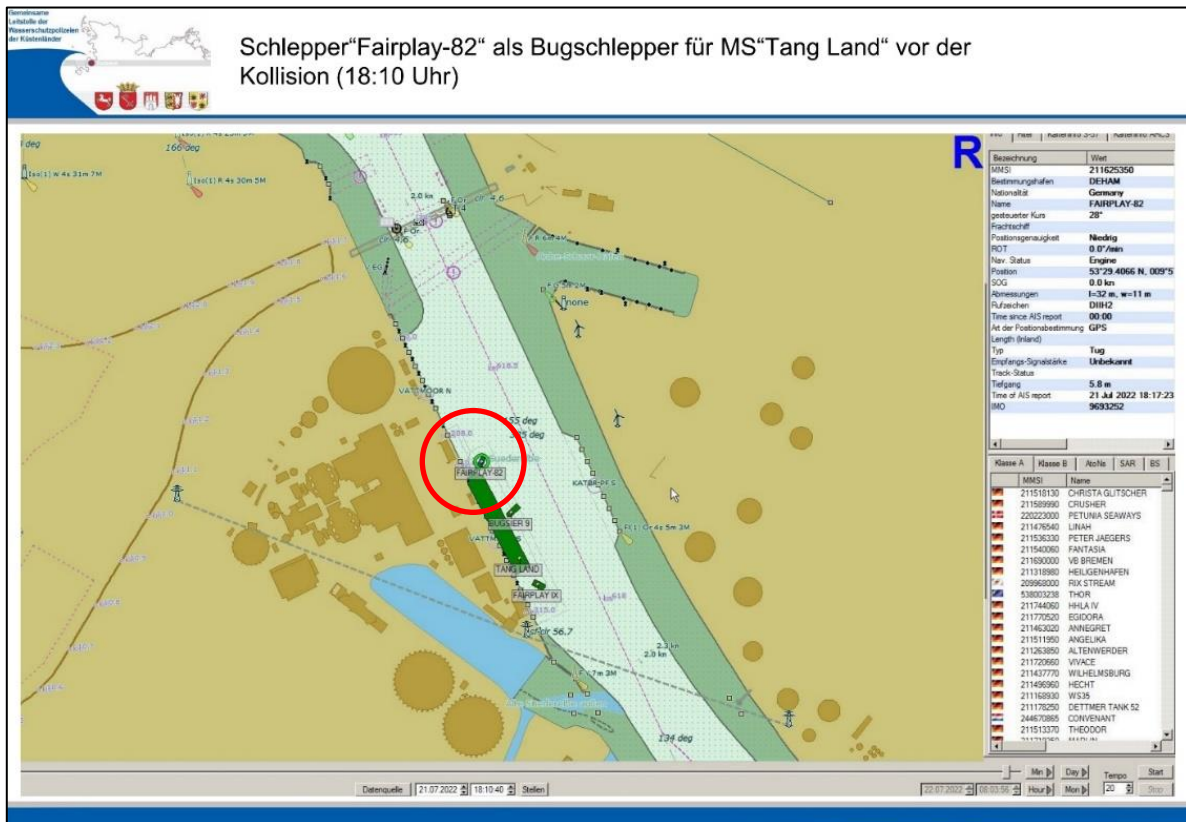
Figure 5: Course of the voyage at 1810<sup>8</sup>

The FAIRPLAY 82's involvement in the TANG LANG's berthing manoeuvre had finished by about 1810 and she left the berth at about 1814 to head for the Kattwyk bridge. Figure 6 shows the tug approach the bridge at increasing speed.

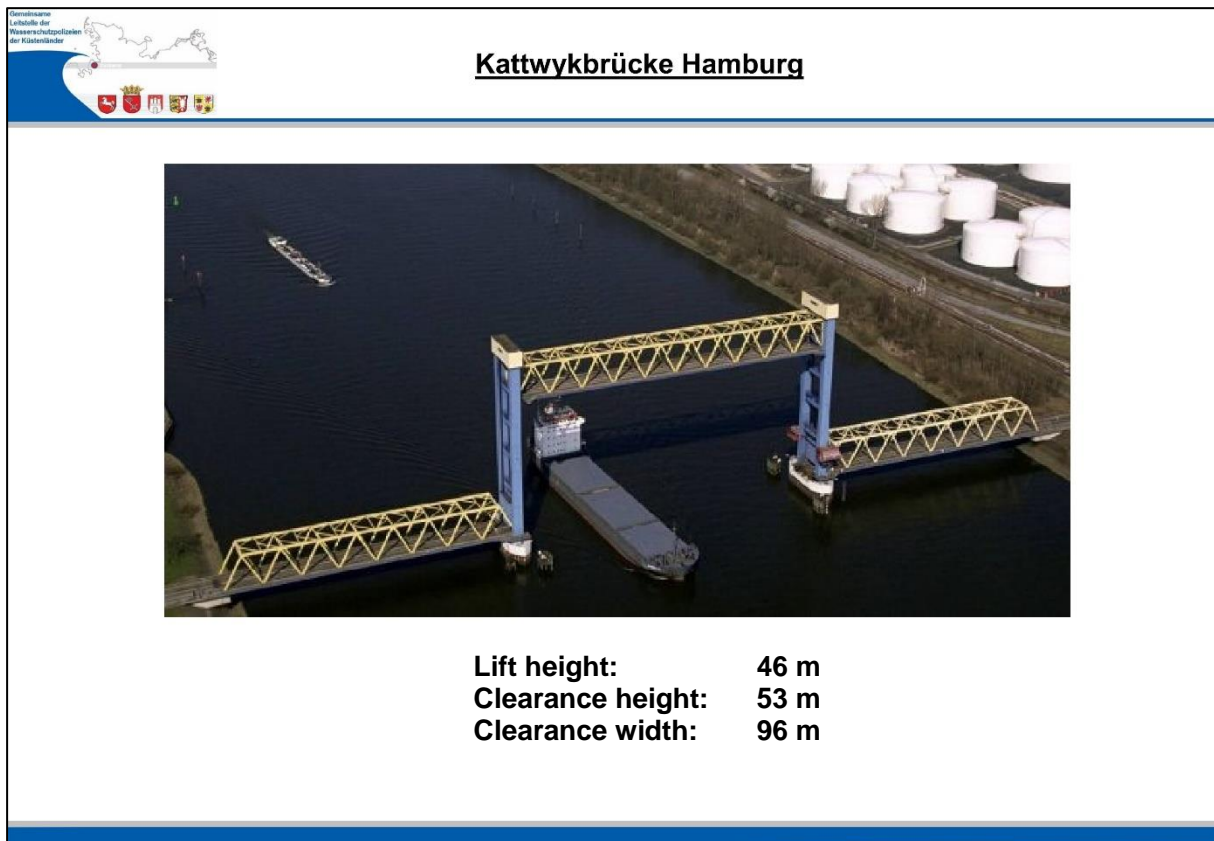
Figure 16: Schematic drawing of the old Kattwyk bridge involved in the allision<sup>20</sup>

He could not see the damage to the Kattwyk bridge from his control station. When the FAIRPLAY 82's master contacted him on VHF and recommended that the bridge be closed, the bridge master arranged for it to be closed to road traffic. It transpired in the course of the evening that the bridge was only slightly damaged and its closure would not have been necessary.

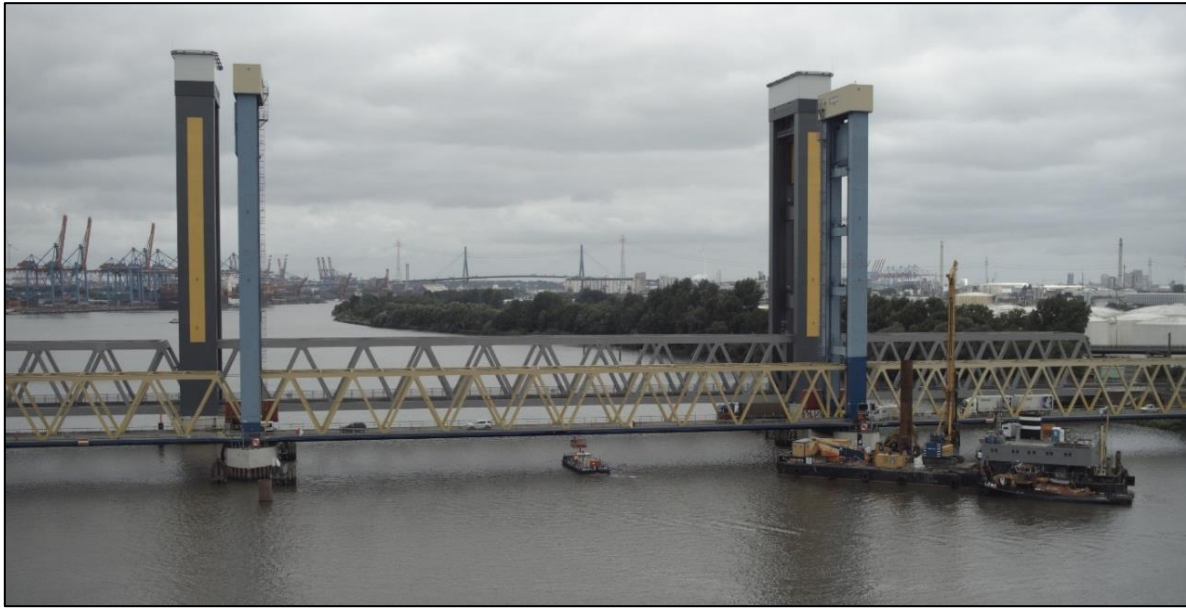
Figure 17: The Kattwyk bridges, which were also lowered at the time of the accident.<sup>21</sup>
