**Bundesstelle für Seeunfalluntersuchung**  
Federal Bureau of Maritime Casualty Investigation

## **Summary Investigation Report 284/21**

**Allision with a Pier Involving the Use of an  
Automatic Steering Control System  
by the Motor Yacht SANTA CECILIA  
in the Port of Hamburg on 5 September 2021**

15 November 2023

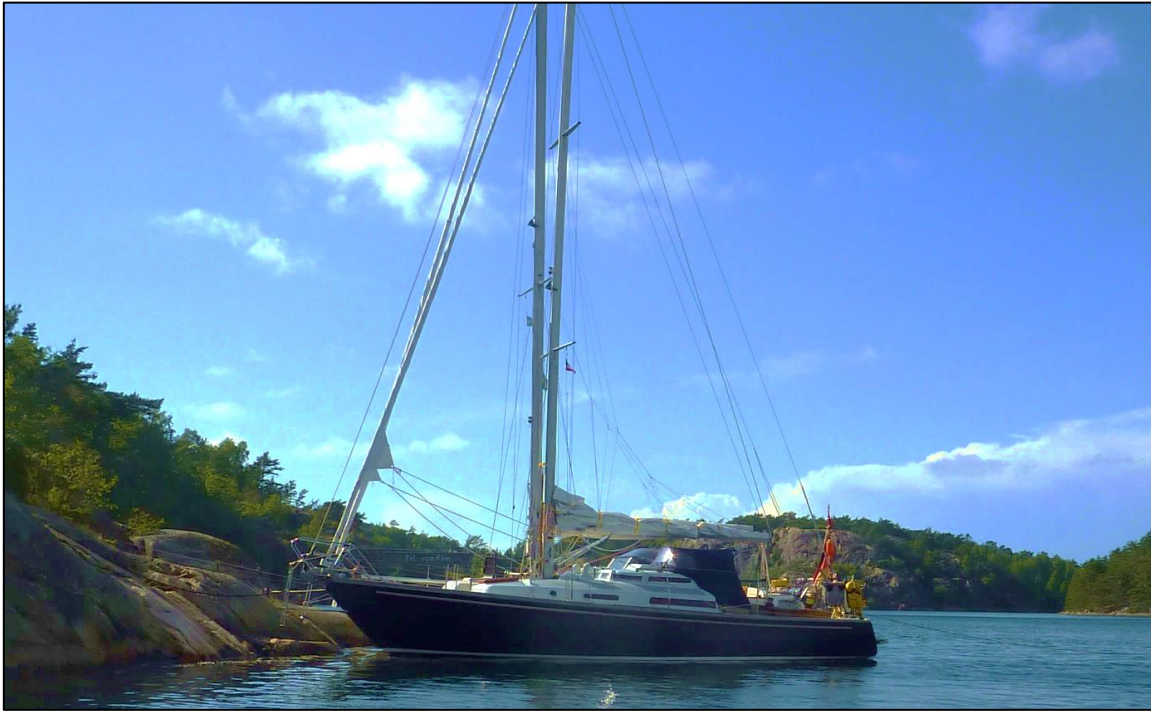
Figure 8: Photograph of the FRÄULEIN VOM RHIN<sup>11</sup>

On the day of the accident, the sailing yacht FRÄULEIN VOM RHIN was proceeding eastbound on the NOK at a speed of about 5.5 kts on a north-easterly course of  $039^{\circ}$  after a sailing trip. By all accounts, the skipper had been steering the yacht from the cockpit, while his female crew member had reportedly been on the forecastle. During the voyage, shortly after passing the Kudensee siding area, the boat hook attached to the backstay reportedly came loose. No other traffic was located astern or ahead on the long straight visible section of the canal.

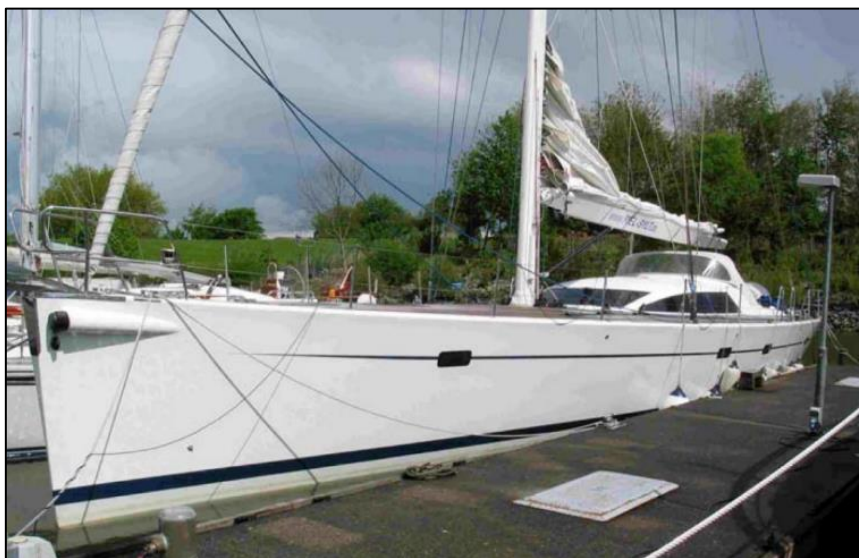
Figure 11: Photograph of the SINFONIE SYLT<sup>14</sup>

On 5 May 2005, the sailing yacht SINFONIE SYLT was involved in a very serious maritime accident on the Flensburg Firth, which resulted in the death of one person. On 1 June 2006, the BSU published the corresponding [investigation report 166/05](#). This accident is presented again in this summary investigation report in order to also shed light on the special aspects of using an autopilot under sail.

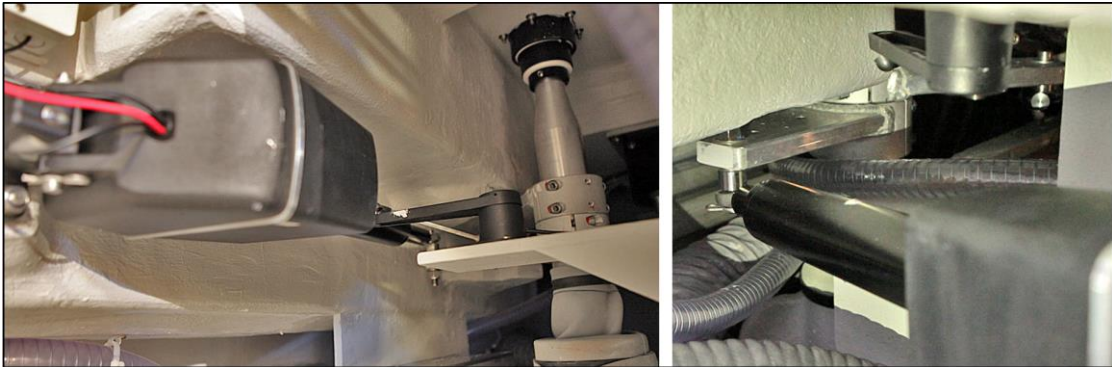
Figure 13: Linear Drives on Long-distance Yachts<sup>18</sup>

In addition to the specific requirements that an autopilot must meet (duration of use, precision, features, etc.), the dimensioning of the drive unit in relation to the size and displacement of the yacht, as well as the rudder pressure must also be considered when selecting the system. Possible types of drive include hydraulic (movement of the rudder by hydraulic pump and cylinder), linear (hydraulic or mechanical), geared motor (movement of the rudder by chain and gear wheel), and rotary (for steering systems by means of cable and steering rods).
