Bundesstelle für Seeunfalluntersuchung
Federal Bureau of Maritime Casualty Investigation

Summary Investigation Report 6/22

**Serious accident involving a person while a mooring
line was being handled on the tug ZP BOXER
in the port of Hamburg on 4 January 2022**

19 April 2023

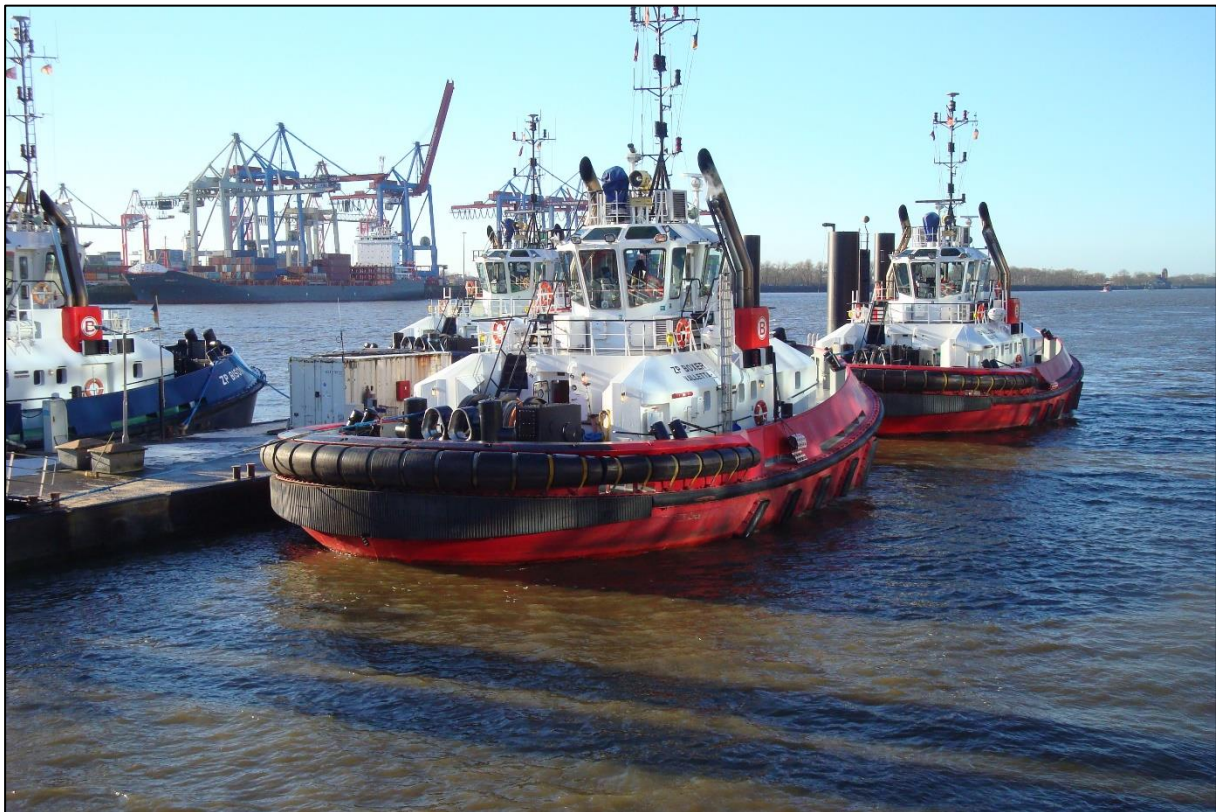
Figure 3: Berth of the ZP BOXER⁵

ahead to take the slack out of the lines, which were already preconfigured in terms of length, before the two head lines were then to be placed over the bollard. Suddenly, the deckhand reportedly went back to the spring in order to pull the head lines that were on top of it (or rather the eyes of the head lines, which he was holding in his hands) under the spring. Without realising, he reportedly put his right foot into the eye of the fore spring, which was still lying loose on the ground (without any tension on the line) but which he had already placed over the bollard. At that very moment, the fore spring tightened, as the tug was slowly moving forward to take up her final mooring position. The eye of the spring on the bollard pulled tight instantly and severed the deckhand's foot.
