Summary Investigation Report 218/21

Towing of the small vessel TÖWI VI after failure of the outboard motor on the voyage from Juist to Norddeich on 20 July 2021

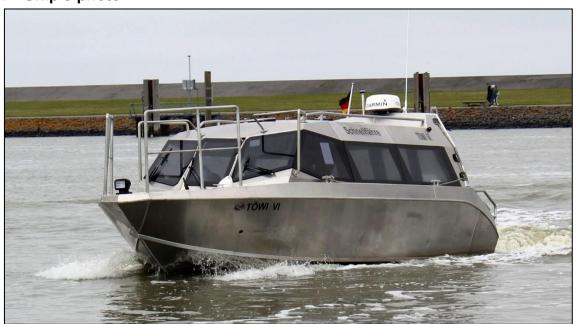
Figure 1: Small vessel TÖWI VI1
