Interim Investigation Report 97/22

Serious Marine Casualty

**Collision between the PAIVI and the BJOERKOE
in the Kiel Canal
on 29 March 2022**

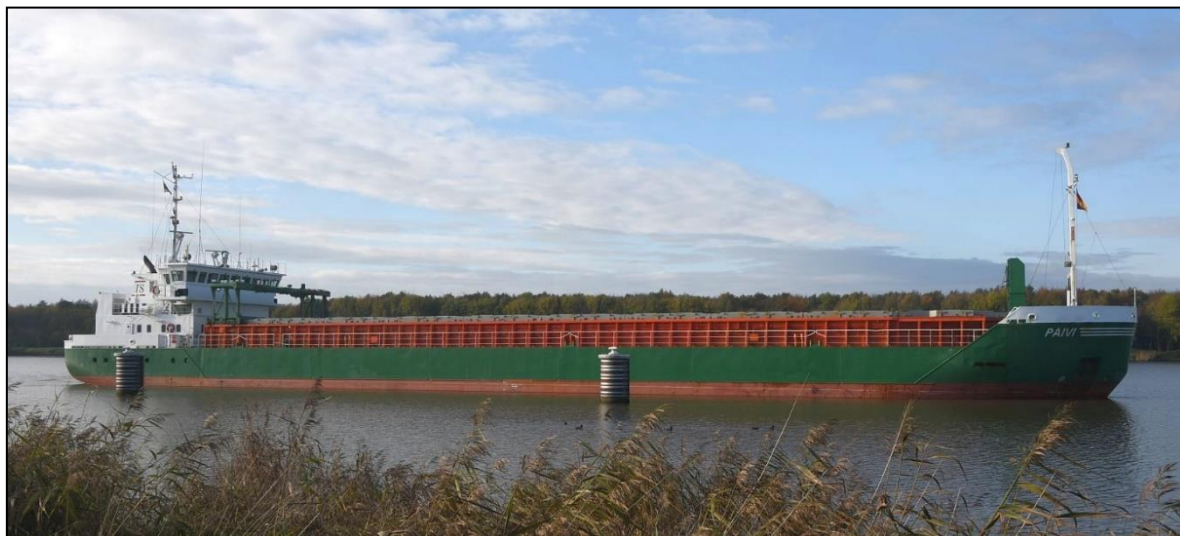
Figure 1: Photograph of the PAIVI¹

Name of ship:	PAIVI
Type of ship:	General cargo ship
Flag:	Cyprus
Port of registry:	Limassol
IMO number:	9434149
Call sign:	5BGW2
Owner (according to Equasis):	Paivi InterScan Shipmanagement
Shipping company:	InterScan Schiffahrtsgesellschaft mbH
Year built:	2008
Shipyard:	Marine Projects Ltd. and Bodewes Shipyards BV
Classification society:	Bureau Veritas
Length overall:	82.5 m
Breadth overall:	12.5 m
Draught (max.):	5.3 m ²
Gross tonnage:	2,474
Deadweight:	3,450 t
Engine rating:	1,850 kW
Main engine:	Caterpillar, 1 x 6M25
Service speed:	12.5 kts
Hull material:	Steel
Hull design:	Double bottom
Minimum safe manning:	6

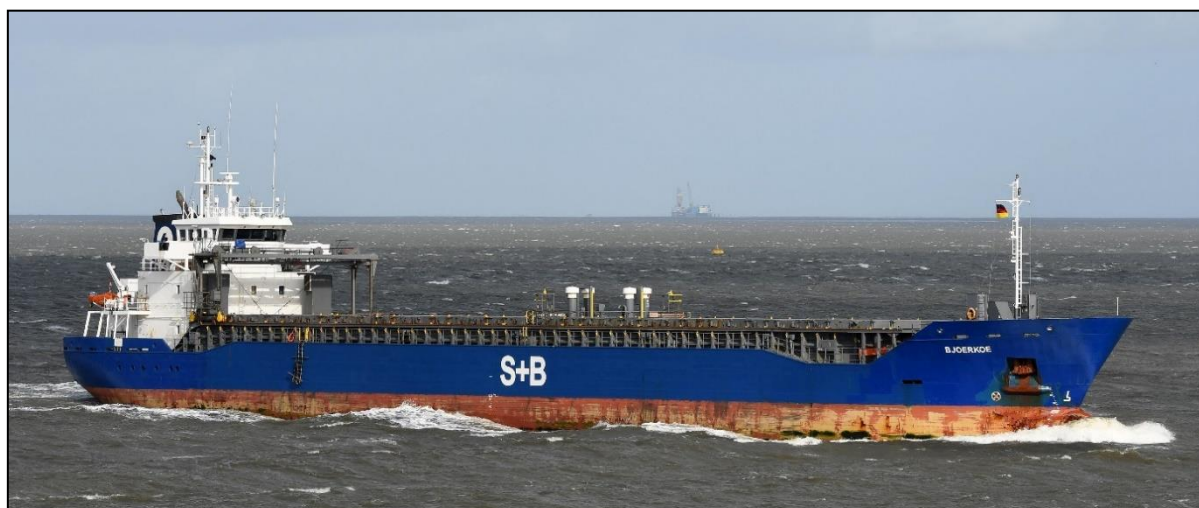
Figure 2: Photograph of the BJOERKOE³

Name of ship:	BJOERKOE
Type of ship:	General cargo ship
Flag:	Cyprus
Port of registry:	Limassol
IMO number:	9376787
Call sign:	5BRY4
Owner (according to Equasis):	Emden Coastal-Bulker UG
Shipping company:	Schulte & Bruns GmbH & Co KG
Year built:	2009
Shipyard:	Societatea Comerciala Severnav S.A. and Bodewes Shipyards BV
Classification society:	Det Norske Veritas
Length overall:	106.8 m
Breadth overall:	15.2 m
Draught (max.):	5.25 m

Gross tonnage:	4,102
Deadweight:	5,499 t
Engine rating:	1,980 kW
Main engine:	Caterpillar, 1 x 6M25
(Service) Speed:	11 kts
Hull material:	Steel
Hull design:	Double bottom
Minimum safe manning:	7
